Design and Access Statement

5 Elm Row, London NW3 1AA

Revision B 29 November 2021

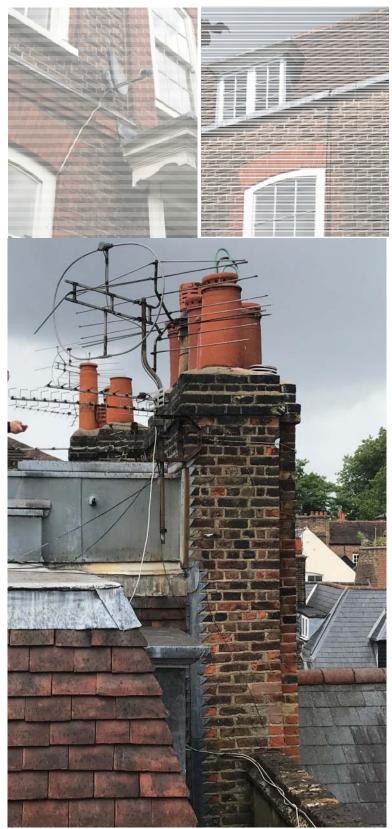
Figure 3 Typical surface mounted cabling on the outside of the building

It is proposed that a comprehensive re-wire of the entire system is made. This will include removal of all surface mounted wiring inside and outside the building, the removal of the TV aerials on the roof and satellite dish on the front elevation (see figure 3) removal of all downlights and pendant light fittings from the principal front rooms except at lower ground floor level, the repositioning and replacement of sockets and switches generally. The exact positioning of sockets and switches is not yet known but can be confirmed in due course if required. The specification of these items has not been confirmed, but it is the intention to specify units with the minimal visual impact.

<u>Justification</u> The services survey indicates that the current system is severely outdated and is due for a comprehensive re-wire. The photographs in the appendix to the services survey by SPS will help to justify this. Removal of surface mounted wiring will have a positive contribution to the visual appearance of the rooms.

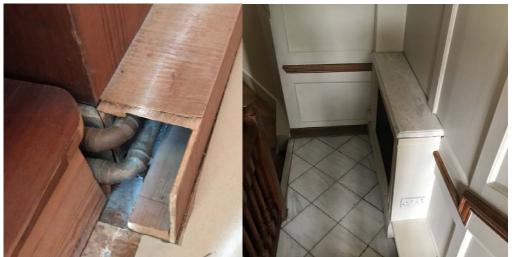
Figure 4: internal heating pipework and boxed in radiators on the main stairs

The building has a collection of pressed metal radiators and cast iron radiators. These have been placed in various positions, including inside built-in joinery, in window bays

(with boxing in, covering the existing panelling) and on stair landings, where they have been boxed in and constrict the limited space available. This proposal effectively returns the rooms to a state close their original appearance and additionally removes unsightly bulkheads and visible pipework. The work by the energy consultants have shown that – if the proposed improvements to insulation and ventilation are made underfloor heating will work in these rooms, despite its general lower output than traditional radiators.

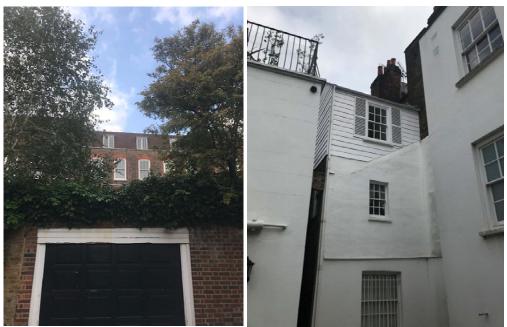
Figure 5 View of the front elevation from Elm row

Figure 6 View of the water tank from Stanford Close

It is proposed that the current cold water tanks on the roof are re-built as housings for a pair of air source heat pumps. The housings will be 200mm higher than current and will be open at the top. Finish will be to match the current patinated lead. There will be some provision for air transfer at the sides, but the final design can be presented as a reserved matter.

The specialist energy consultants have proposed these as a significant contribution to the sustainability of the proposed works, contributing to up to 85% of the heat energy provision in cold weather and all of it at other times. They have performed calculations to prove that this position is suitable for acoustic separation from the neighbour's property. Visually, the existing rooftop water tanks make almost no impact on the appearance of the building: from the front, they are not visible at all. Figure 5 shows the view from the far side of Elm row, which is the only public viewing position from the front, and Figure 1 shows the view from inside the building curtilage, indicating that even the chimneys behind the tanks are not visible from the steps in Stanford close behind: the minor change to the visual appearance will be outweighed by the sustainable benefits of a low carbon heat source, and removal of the television aerials. (see electrical proposals above and figure 3)

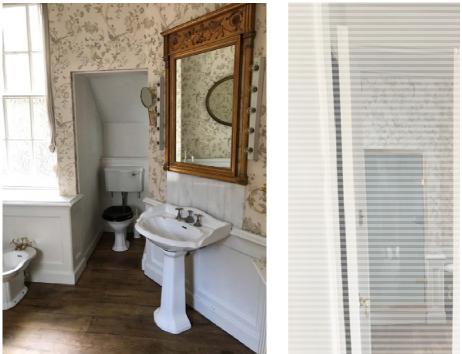
Figure 7 First floor bathroom, showing WC alcove and built-in shower

It is proposed that the existing built in shower enclosure is removed and that the inner lining of this room is lined as per section 3. An amended layout is proposed that also accommodates the moved WC, necessitated by the proposal to enclose its current position. See drawings 14 and 15. It is proposed to keep the existing floor boards if possible, as these have some merit.

It can be seen from inspection that none of the linings or fittings in this room are anything other than 20th Century additions; Figure 7 indicates this. The proposals provide a much better layout at no cost of damage to original historic fabric

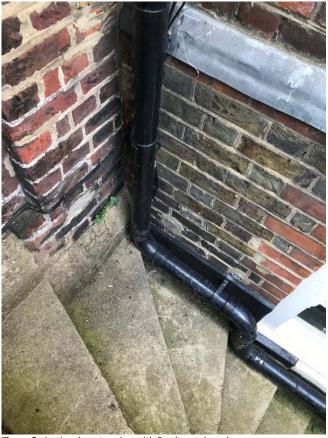
Figure 8 plastic rainwater pipe with Doulton tubes above

This window is smaller than the other windows at this level to accommodate the external steps to the basement – see drawing 103 and figure 8 below. The result of this is that the kitchen is noticeably darker than the other lower ground floor rooms. It is proposed that the steps are remodelled so that the rainwater pipework can be hidden and that they do not touch the building to the current extent. Loss of the uPVC

pipework will be a visual benefit to the external appearance, and modification of the stairs will help to resolve a current water penetration issue at this point, as is evidenced by the Doulton ventilation tubes directly above the steps.

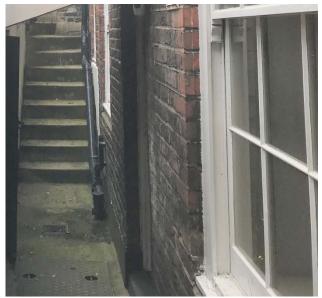
Figure 9 Elevation of steps from front area
