# Design Statement, Heritage Statement and Statement of Justification

## 8 Mornington Crescent, London

Listed Building Consent Submission for Installation of Temporary Mechanical Ventilation for Noise Attenuation as part of the HS2 Construction Works

Author: Arup/CSjv.

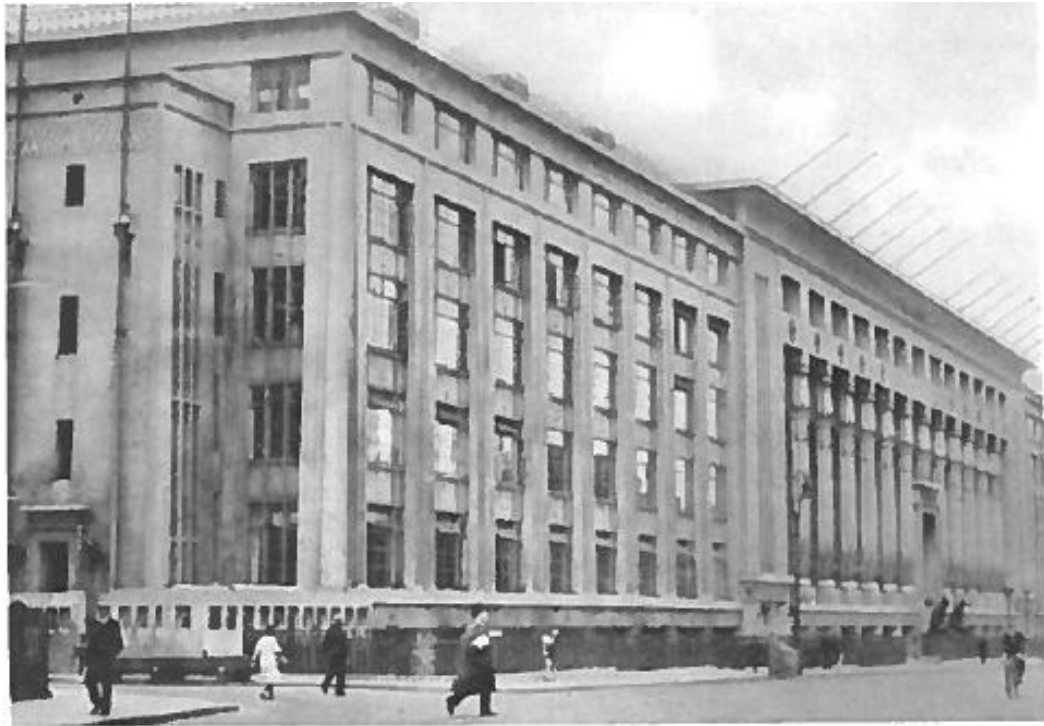
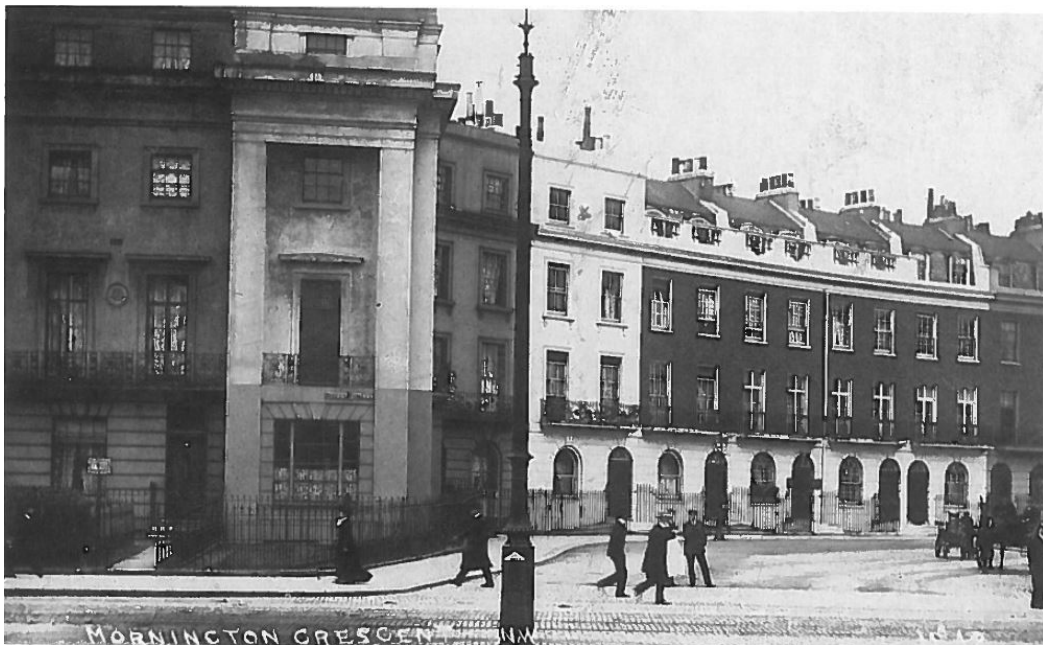
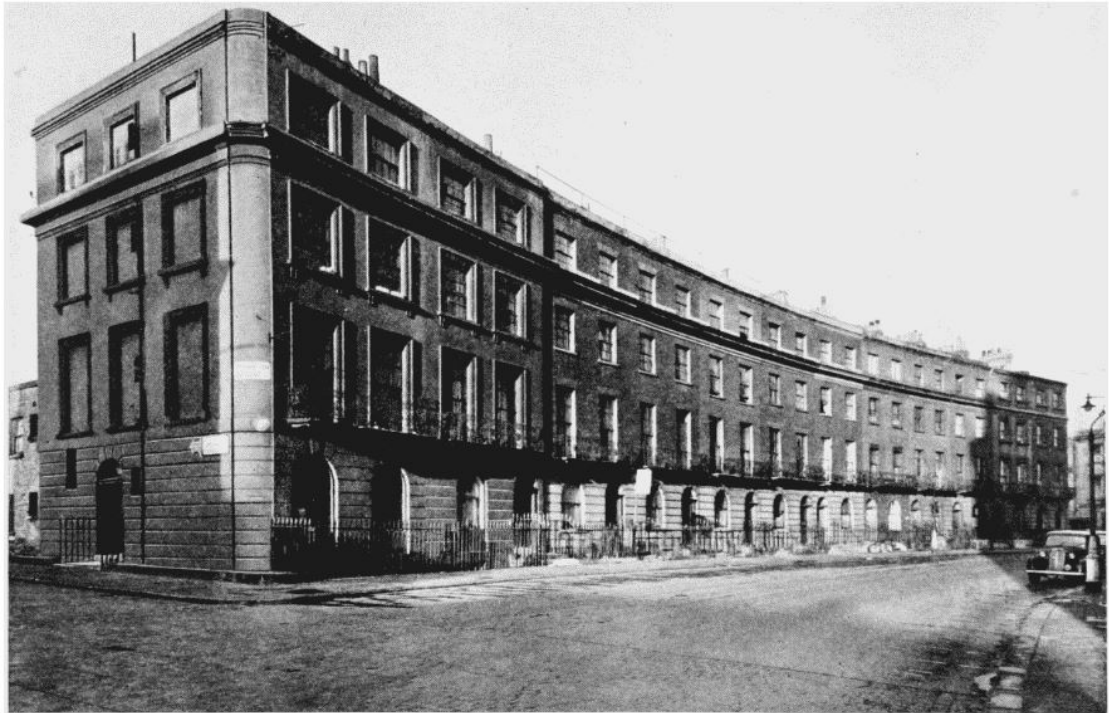
- 2.1.4 The segment between Hampstead Road and Mornington Crescent was originally laid out in gardens but since 1926 has been occupied by the Carreras building (**Figure 4**). The latter was originally built as the Carreras tobacco factory and was designed by M & O Collins. In 1998, it was converted to offices and renamed as Greater London House.
- 2.1.5 Mornington Crescent encompasses 36 houses, comprising blocks of either four storeys of brick and stucco, raised on basements with mansard roofs and dormers. Most of the houses have a bold cornice above the second floor and architraves to the windows (**Figure 5, 6**).

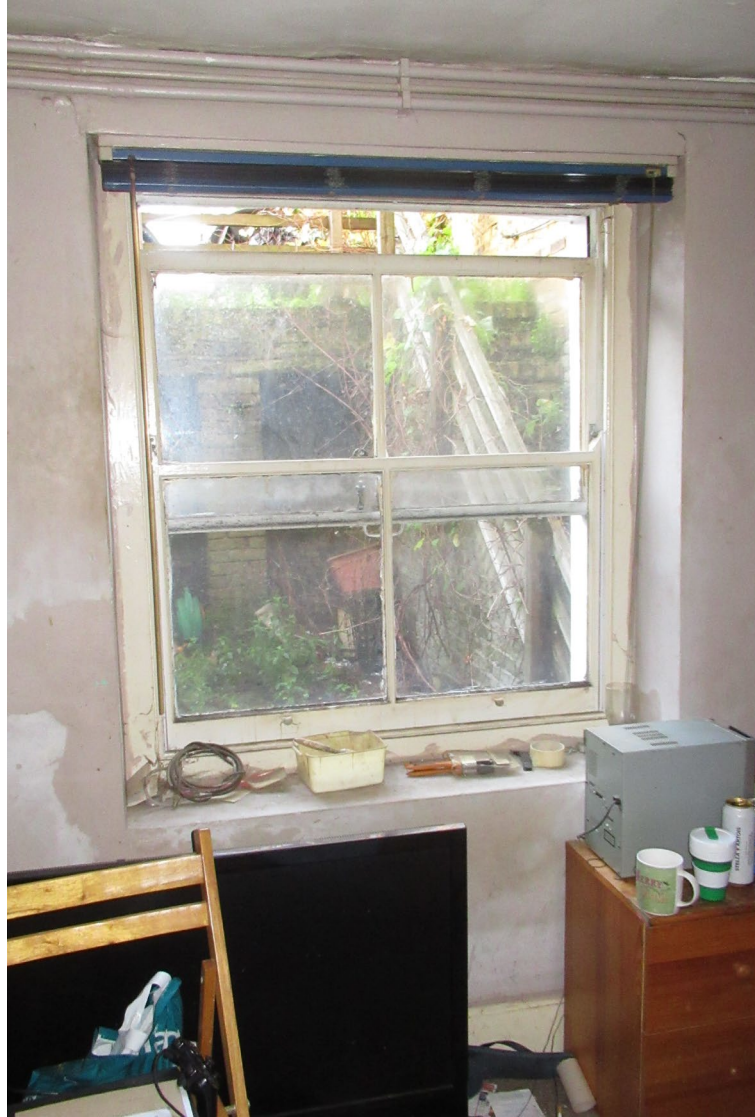
*Figure 7:* Internal view of window at basement level

4	Room interiors (space, proportions, size and scale)	Internal rooms	c.1821	Evidential, Historic & Aesthetic values	<b>Low Significance</b>	<p><b>Basement</b></p> <p>All rooms at basement level have been subject to extensive alterations during the C20th, therefore the significance of the interiors of rooms at this floor is low. Changes on a temporary basis could be justified provided they were easily reversible with low to very low physical impact.</p> <p><b>First Floor</b></p>

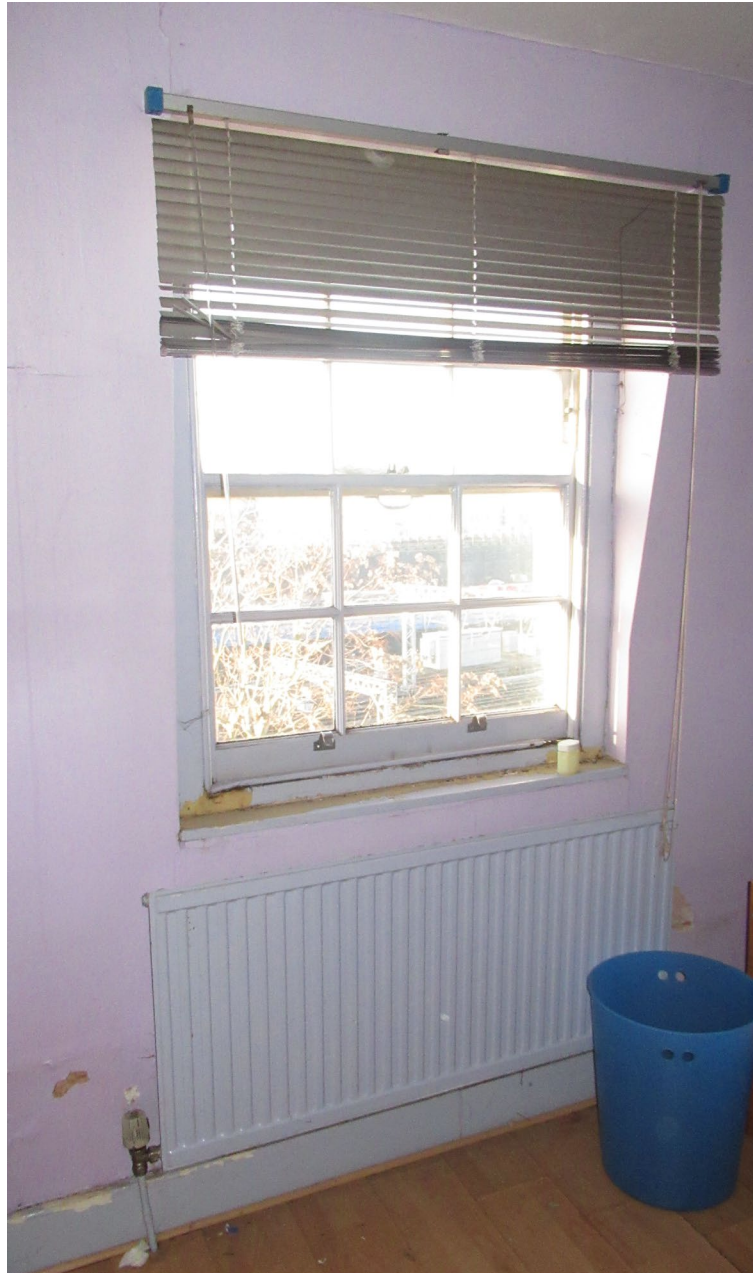
*Figure 9:* Internal view of window at third floor

4.7.4 The proposed works in this application are subject to prior repair of the existing third floor rear window by the London Borough of Camden. In view of the existing cracking to the walls and ceiling throughout the property, structural assessments should be undertaken prior to installation of these works to determine the structural integrity of the building.
