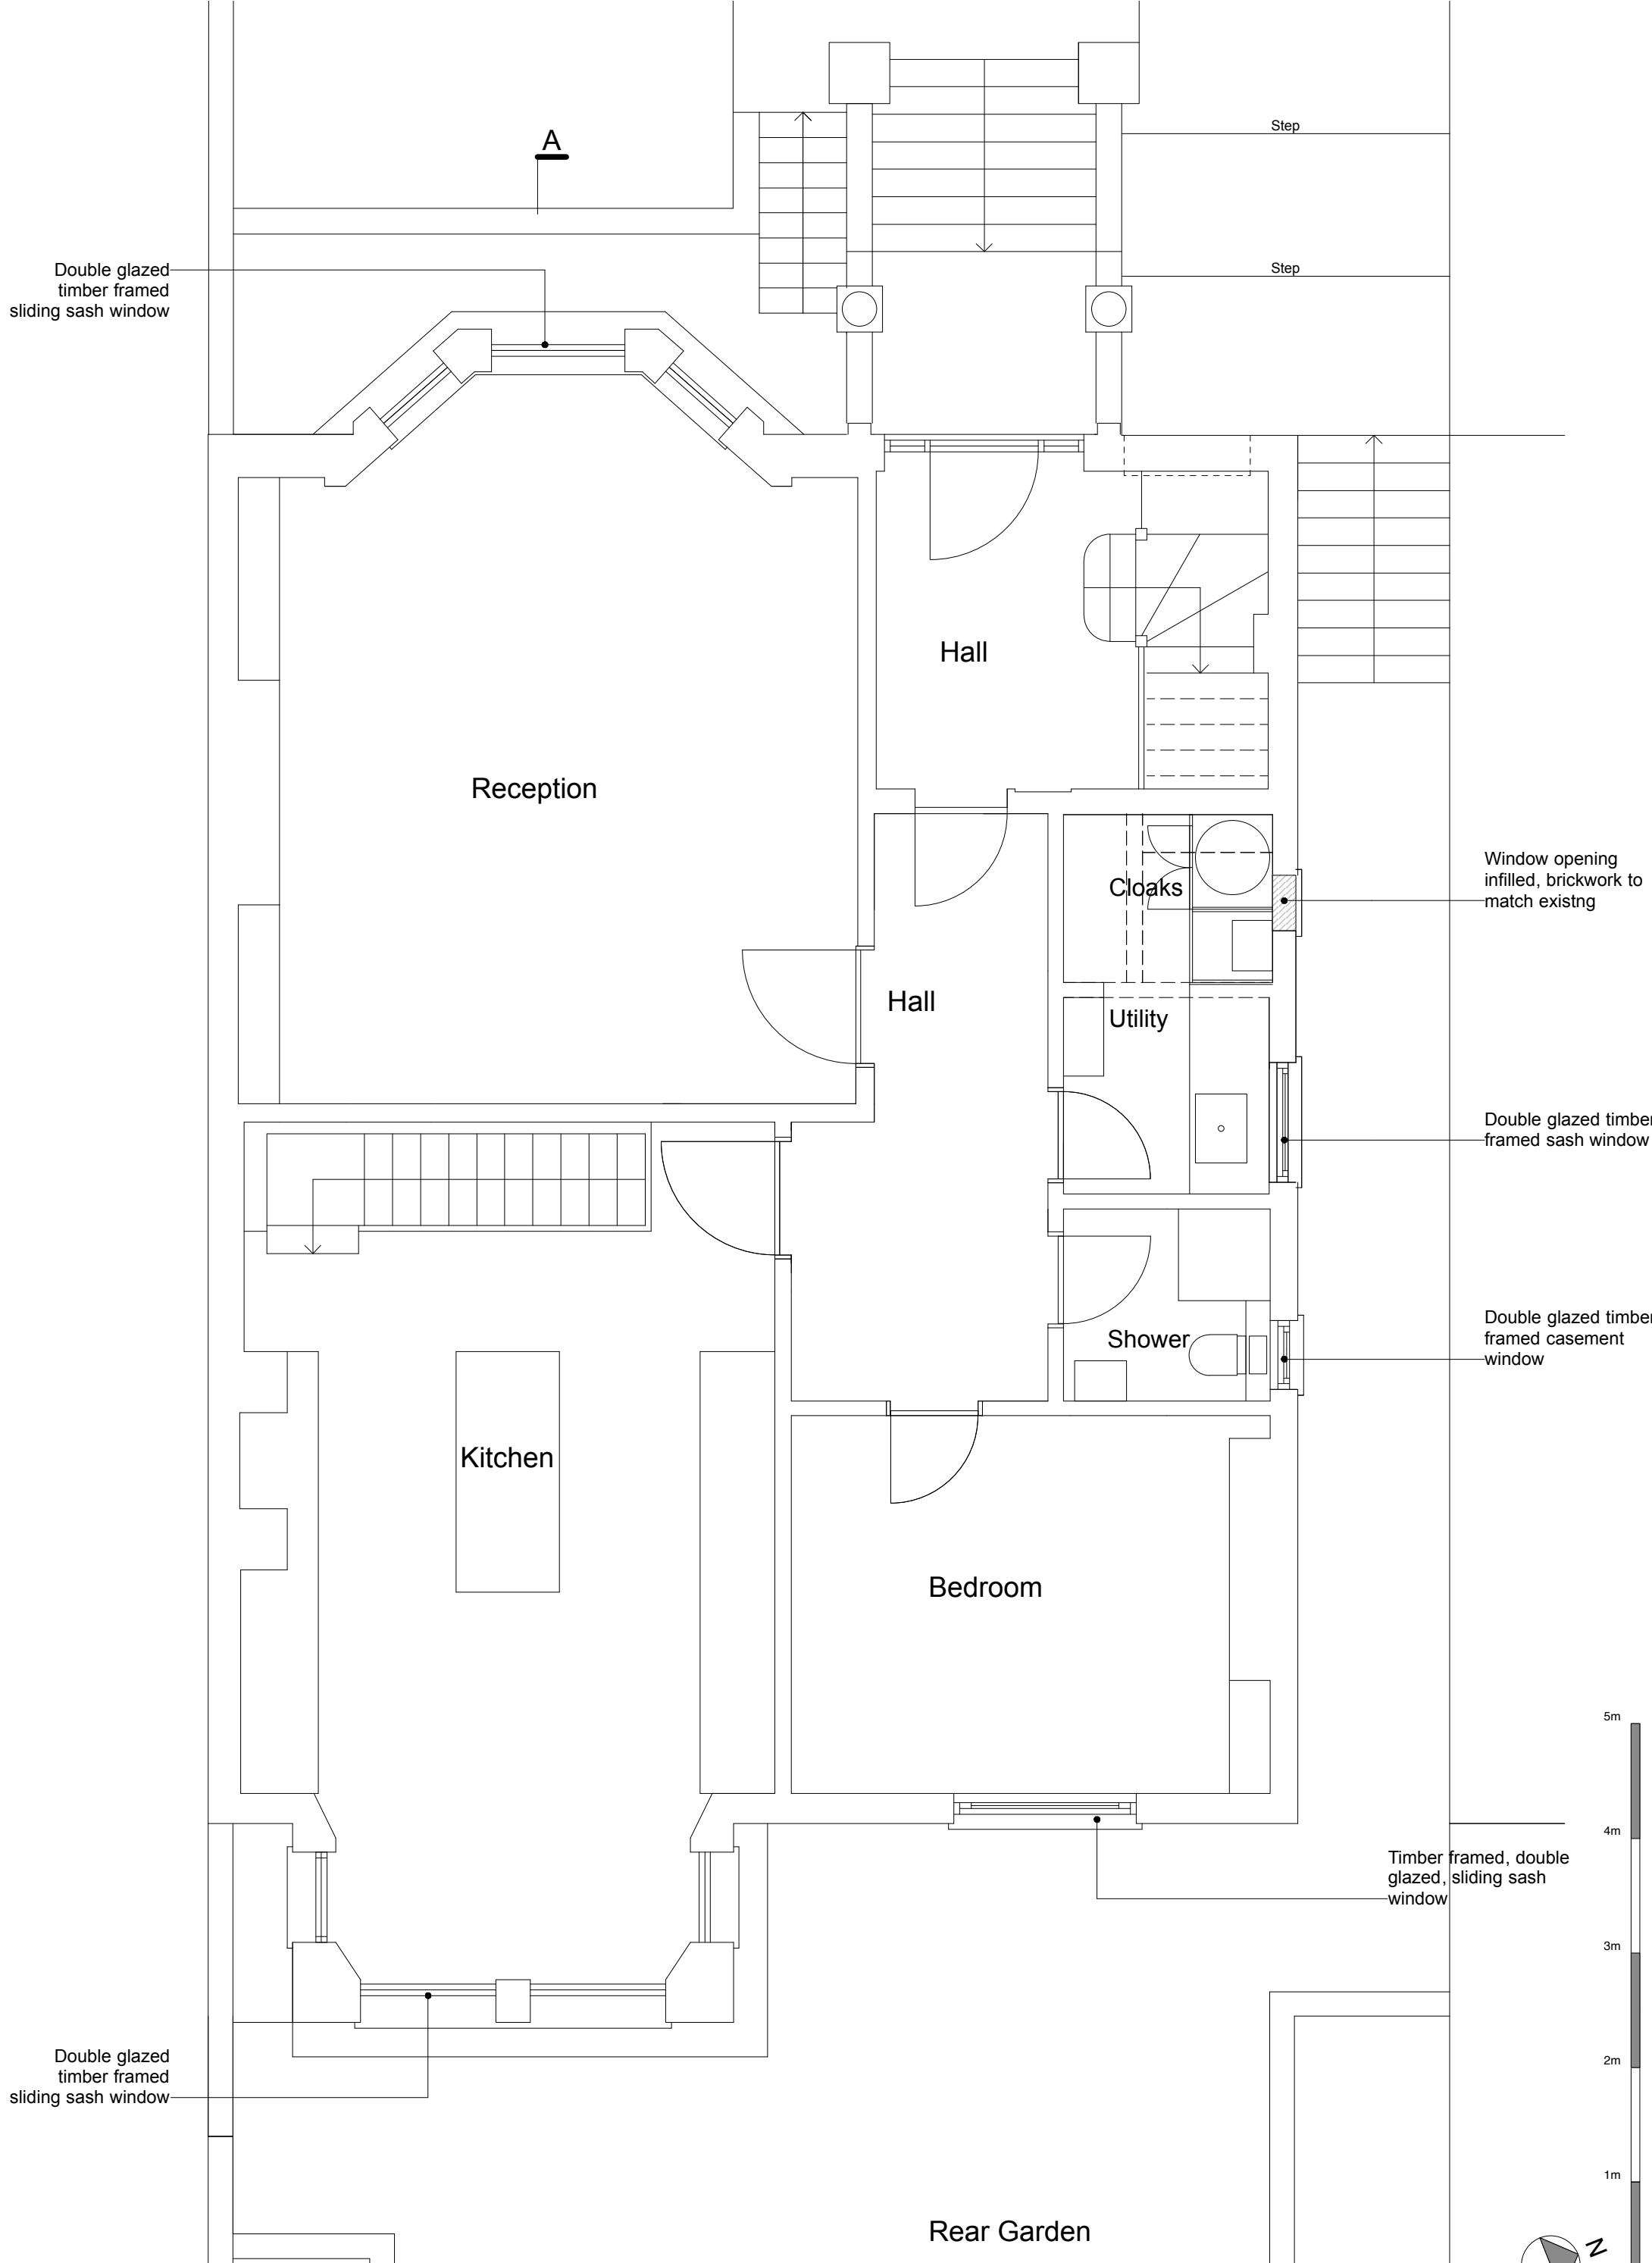
Double glazed timber framed sliding sash window

Double glazed timber framed sash window

Double glazed timber framed casement window

Double glazed timber framed sash window with fixed panel below

Double glazed timber framed French doors

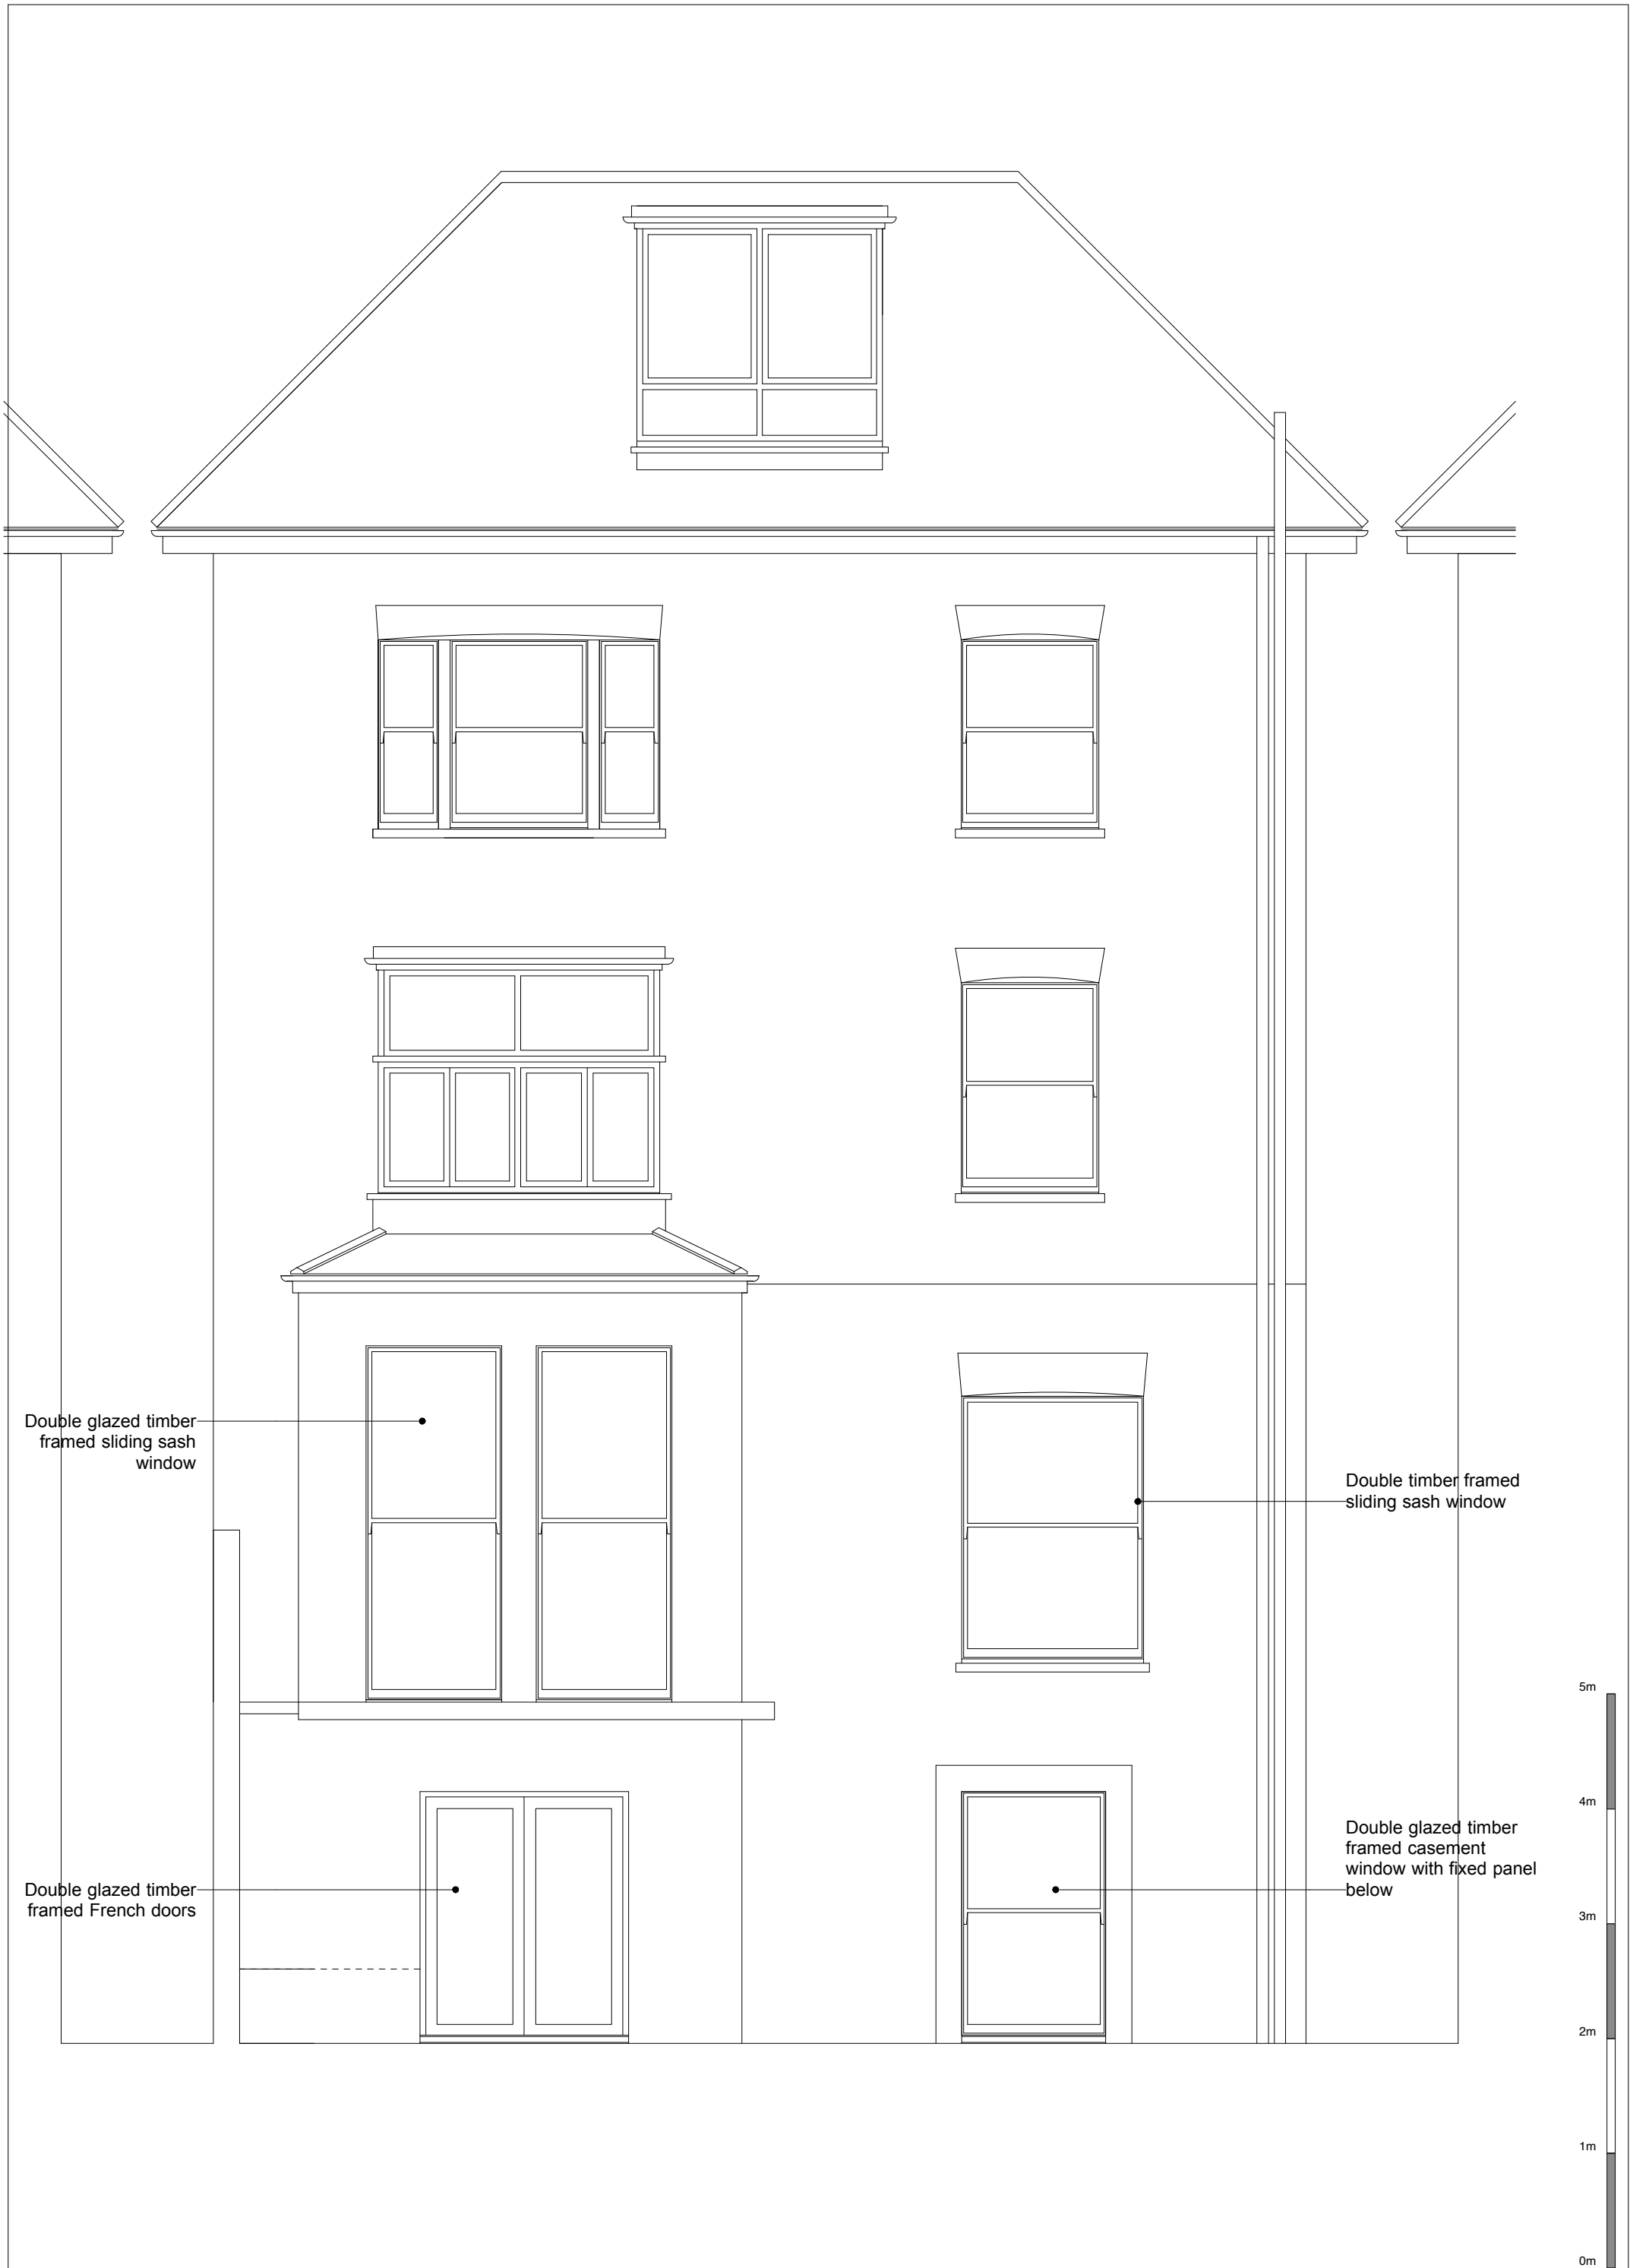
Double glazed timber framed sliding sash window

Window opening infilled, brickwork to match existing

Double glazed timber framed sash window

Double glazed timber framed casement window

Timber framed, double glazed, sliding sash window

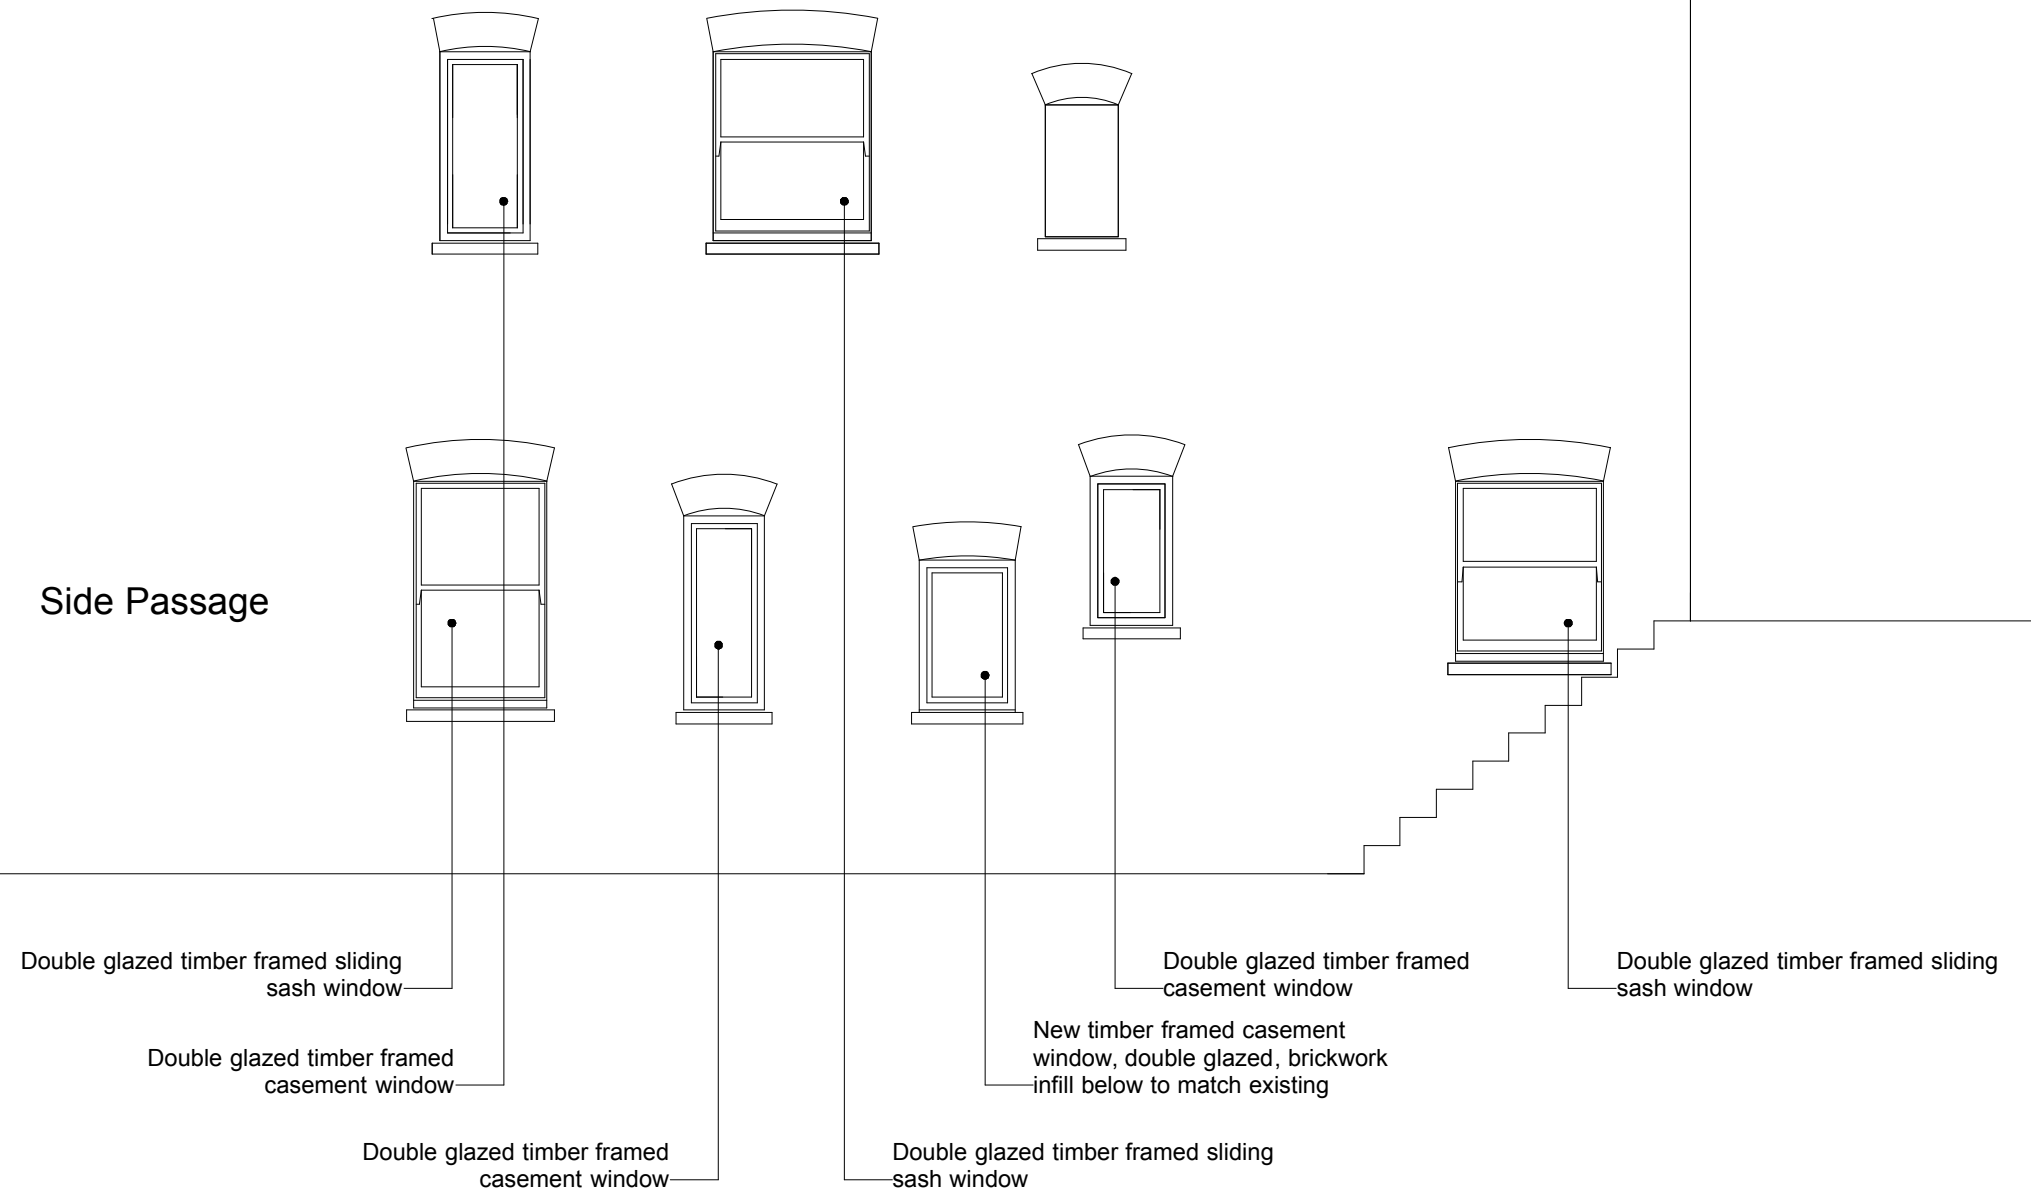
Double glazed timber framed sliding sash window

Double timber framed sliding sash window

Double glazed timber framed French doors

Double glazed timber framed casement window with fixed panel below
