## 2.3 Existing 20 Bedford Way

## 2.3 Existing Bedford Way

### Accessibility

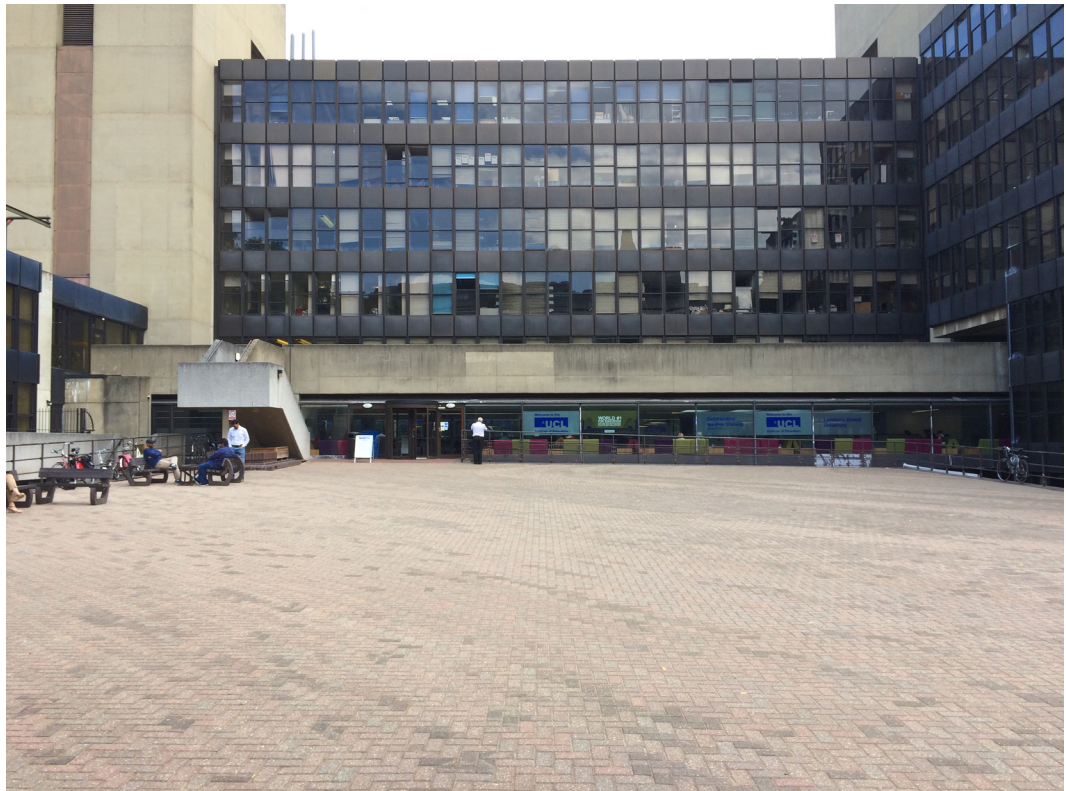
A secondary entrance leads pedestrians from the terrace from Thornhaugh Mews, to level 4. The original entrance was through a pair of revolving doors. This was changed to a single revolving door and automatic opening pass door to provide an accessible entrance.

Photograph of terrace to Thornhaugh Mews entrance

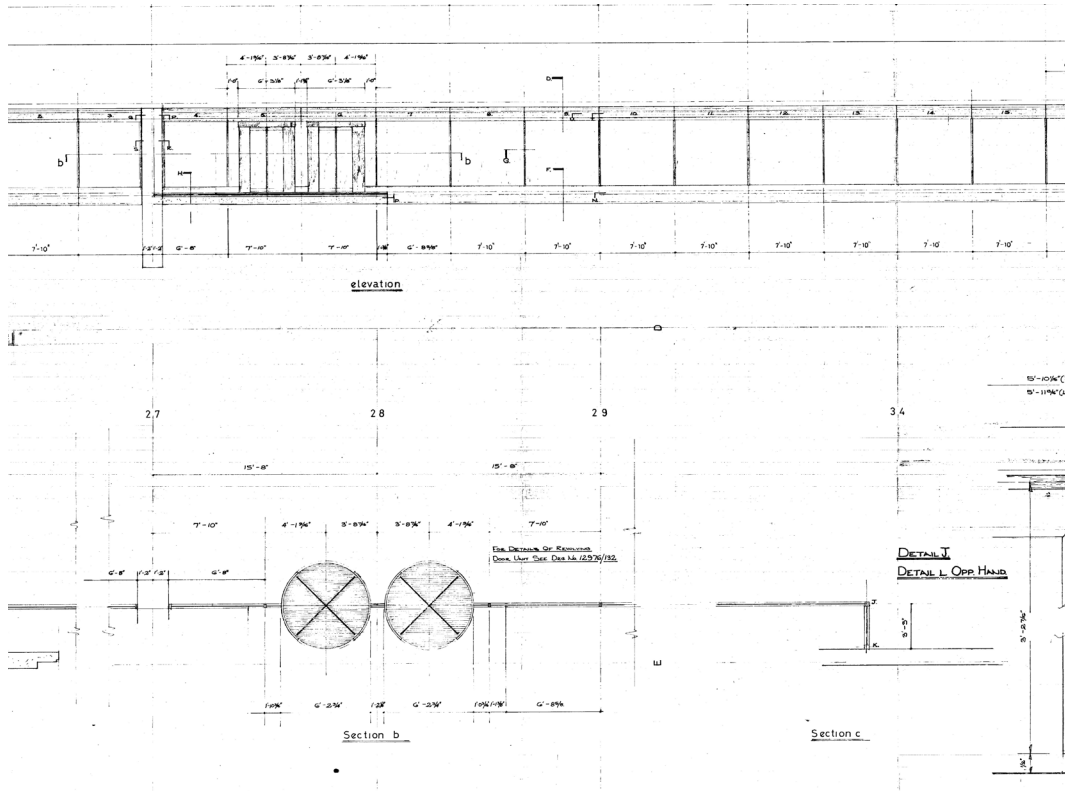
Drawing - Original Elevation/Plan Drawing of UCL IOE Thornhaugh Mews entrance

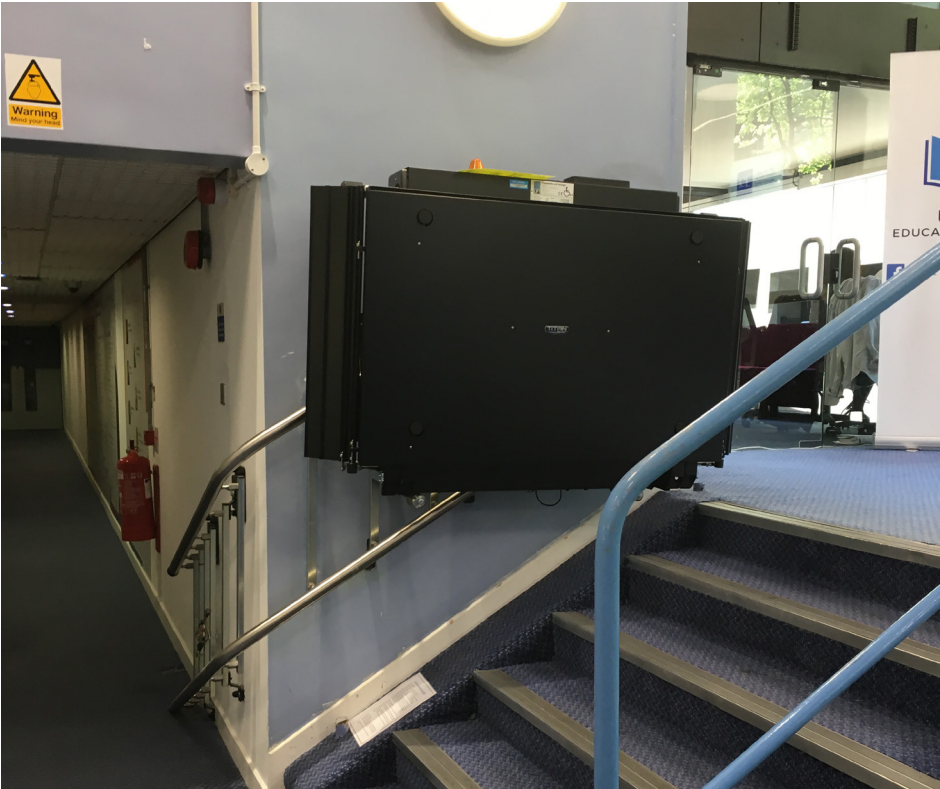
To provide access to wheelchair users, a folding stair lift has been installed to the side of the steps. The existing stair lift cannot be operated independently, is heavy, slow to operate and prone to breakdown. The current lift is unable to take the weight of some larger, heavier power wheelchairs and their occupants. As one of the first barriers it does not create a welcoming and inclusive experience for disabled users.

On entering the building at level 3 the current platform stair lift is fairly dominant in the view through the building. At weekends this entrance is the only entrance available for external visitors and needs to provide suitable independent access for all.

Photograph of existing folding stair lift

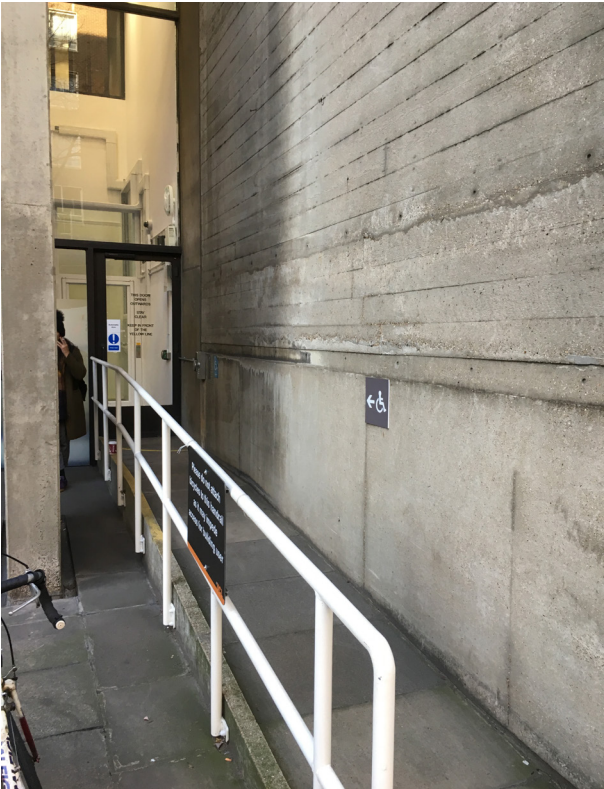
The existing direct access from the main entrance to Level 4 is via a platform lift located to the far side of the existing computer cluster. The lift can only be accessed externally, via a ramp and secondary entrance to the far side of the main entrance.

Wheelchair users visiting the building have to use an intercom located next to the door to provide access through the door. Once within the building through this entrance, there is no accessible route to level 3, with a step between the lift and the computer cluster.

Photograph of external ramp and door to existing platform lift

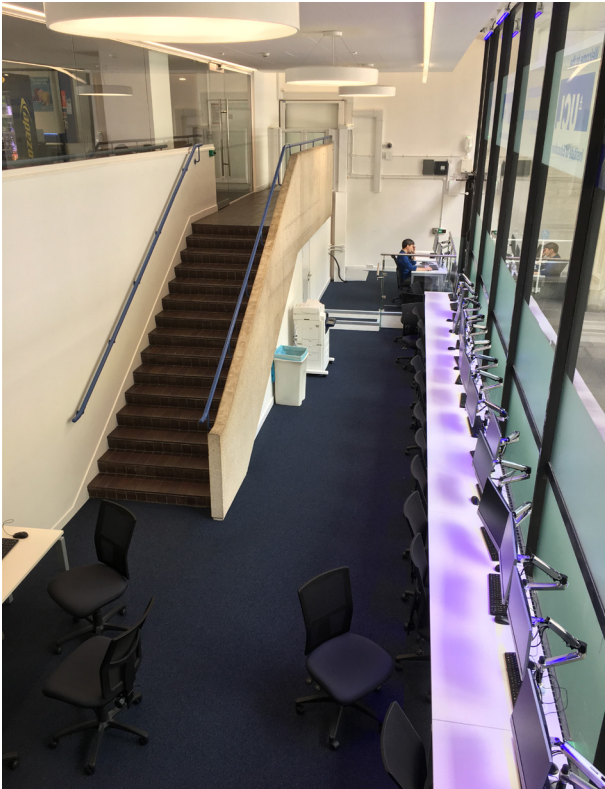
Photograph of internal route to existing platform lift

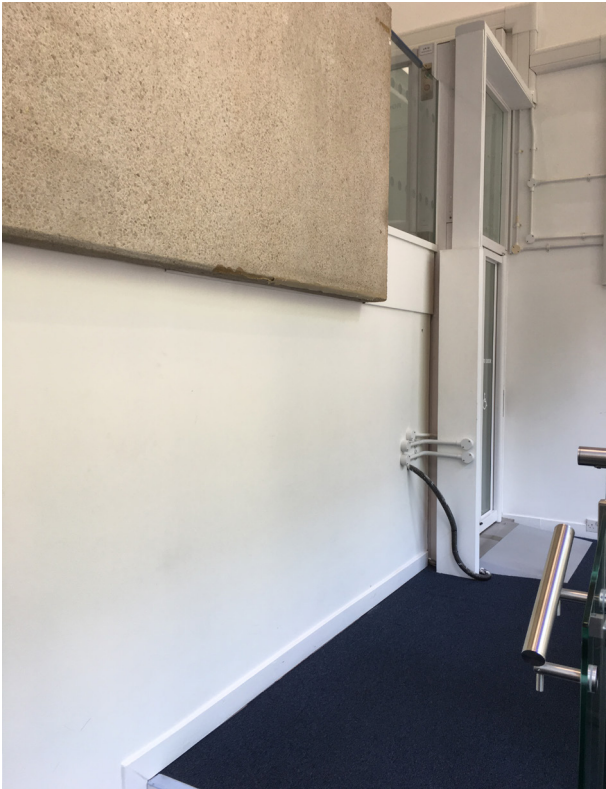
Photograph of existing platform lift
