AS PROPOSED

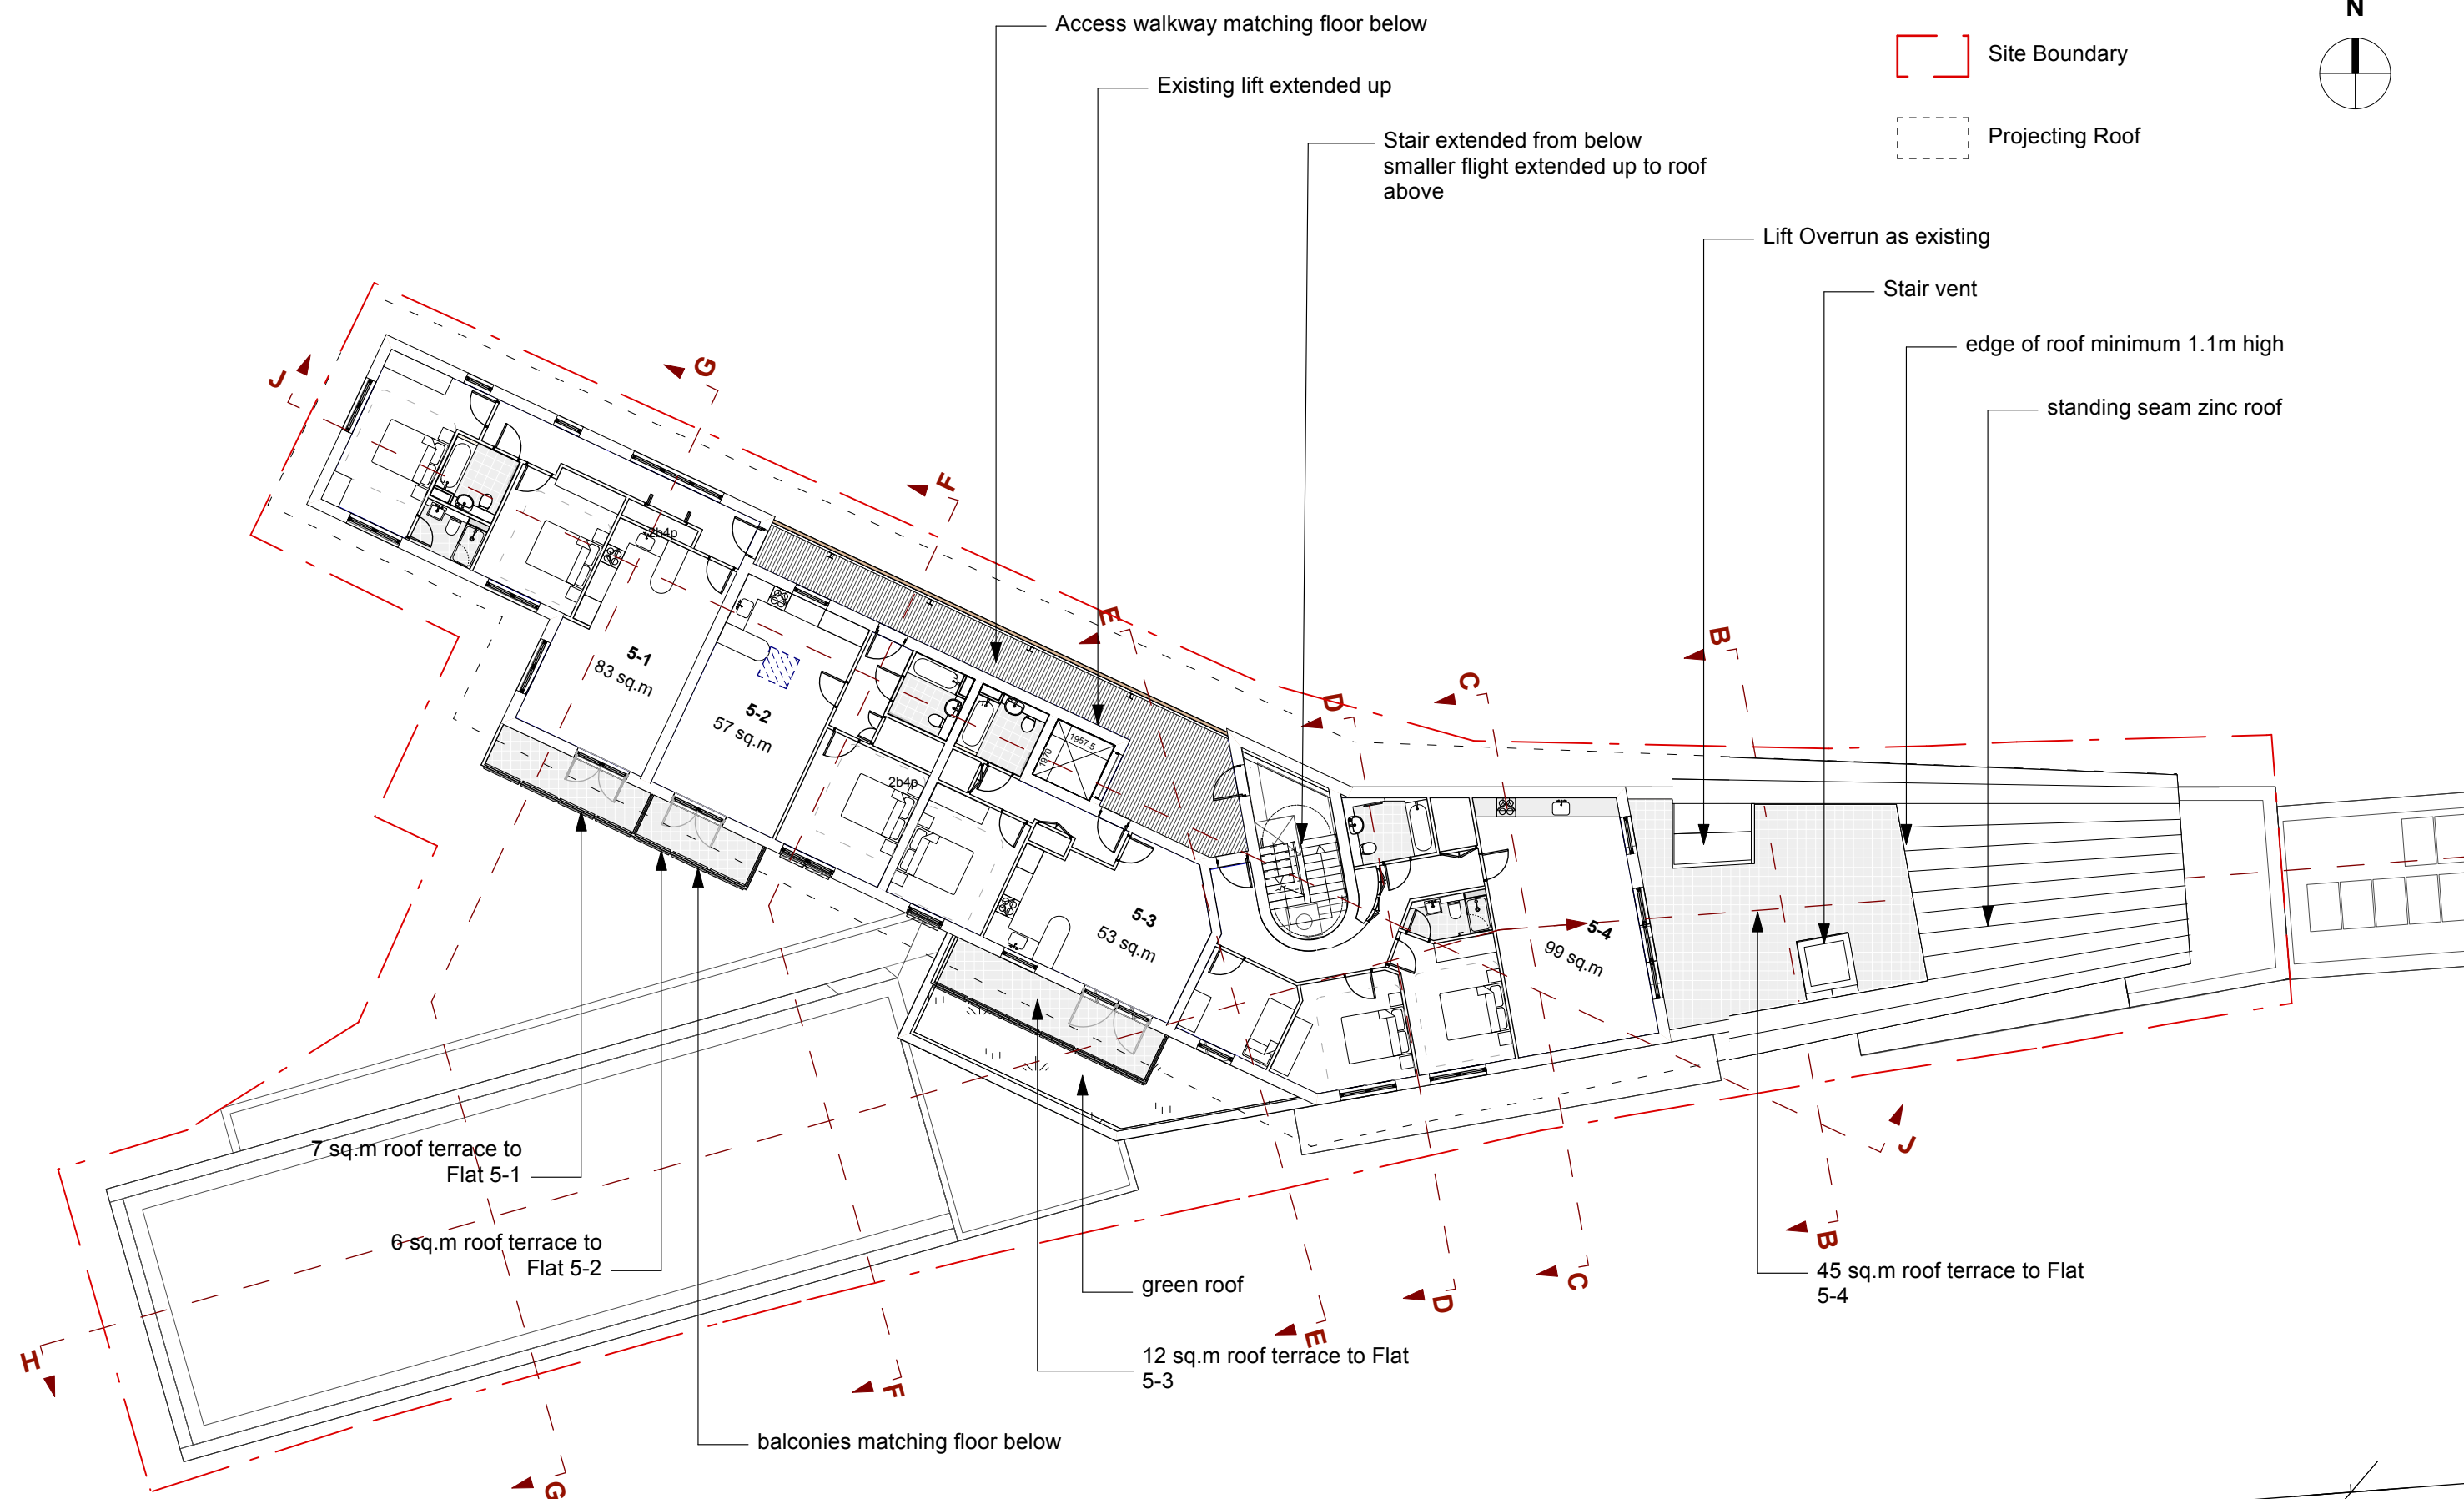
Projecting Roof

Access walkway matching floor below

Existing lift extended up

Stair extended from below
smaller flight extended up to roof
above

Lift Overrun as existing

Stair vent

edge of roof minimum 1.1m high

standing seam zinc roof
