Heritage and Design Statement

**Flat 4,
26 Mornington Terrace,
London, NW1 7RS**

January 2022

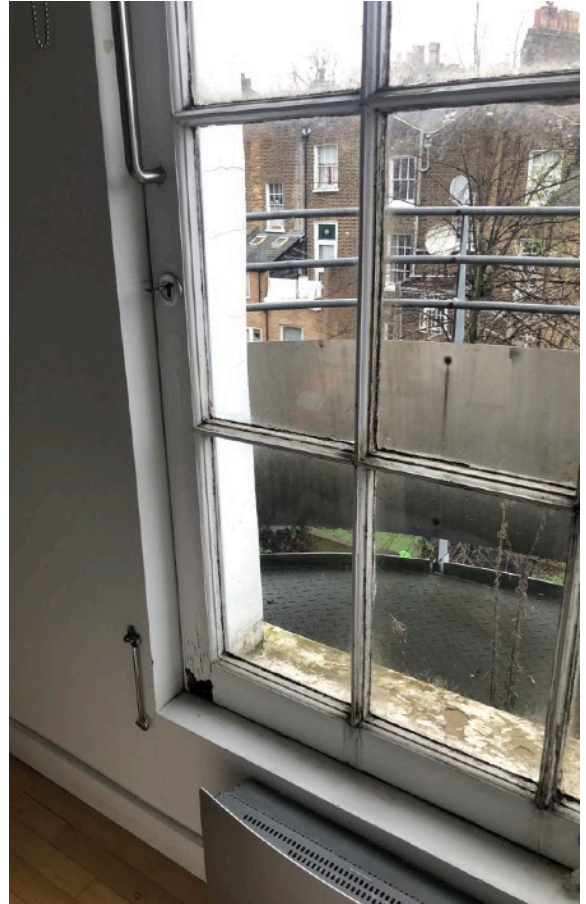
The existing door is in a very poor condition including the leaf and frame. A specialist historic window restorer (Dean Marie of The Sash Window Man) has inspected the joinery and advised it should be replaced with new painted timber door with 4mm single glazing.

Right: Internal view of door showing rotten stile and bottom rail

The replacement door will provide secure weatherproof enclosure to the dwelling with no impact to the existing character of the Grade II listed property.

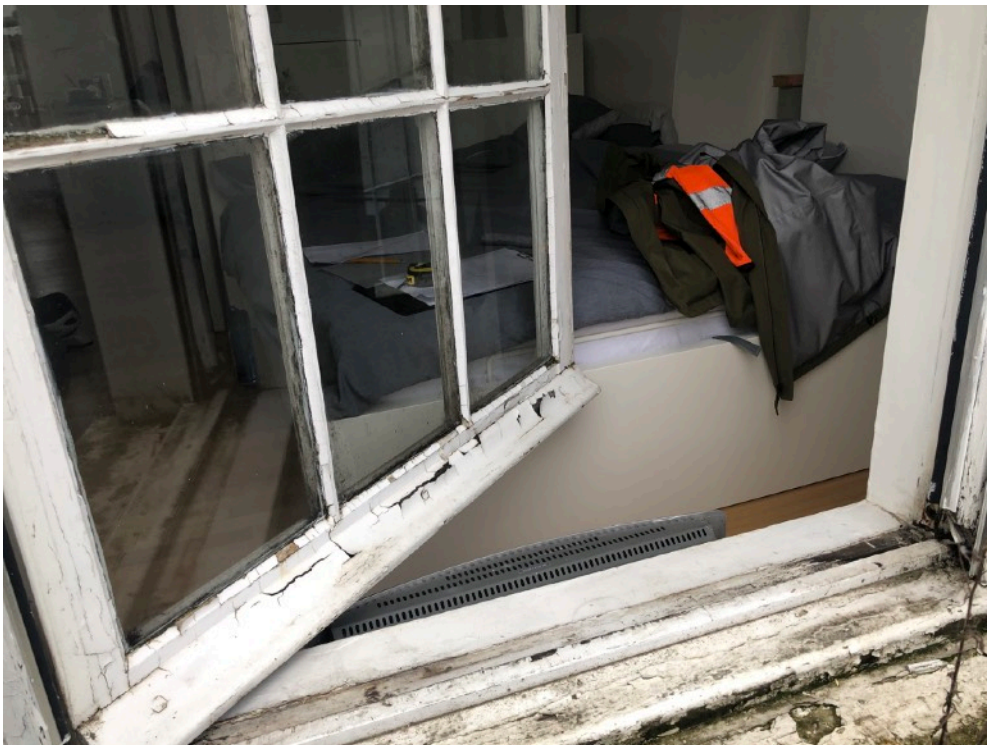
Below: External view of door showing defective weather moulding with bottom rail and softwood cill.
