IW/G.5 - Library

Luard Conservation 67 Selions Avenue London NW10 4UD	+44 (0)20 8961 7544 +44 (0)7963 741 117 info@luardconservation.com	The Elms, Fitzroy Park
	IW/G.5 Library Doors	
	NOT TO SCALE	
	Luard Conservation

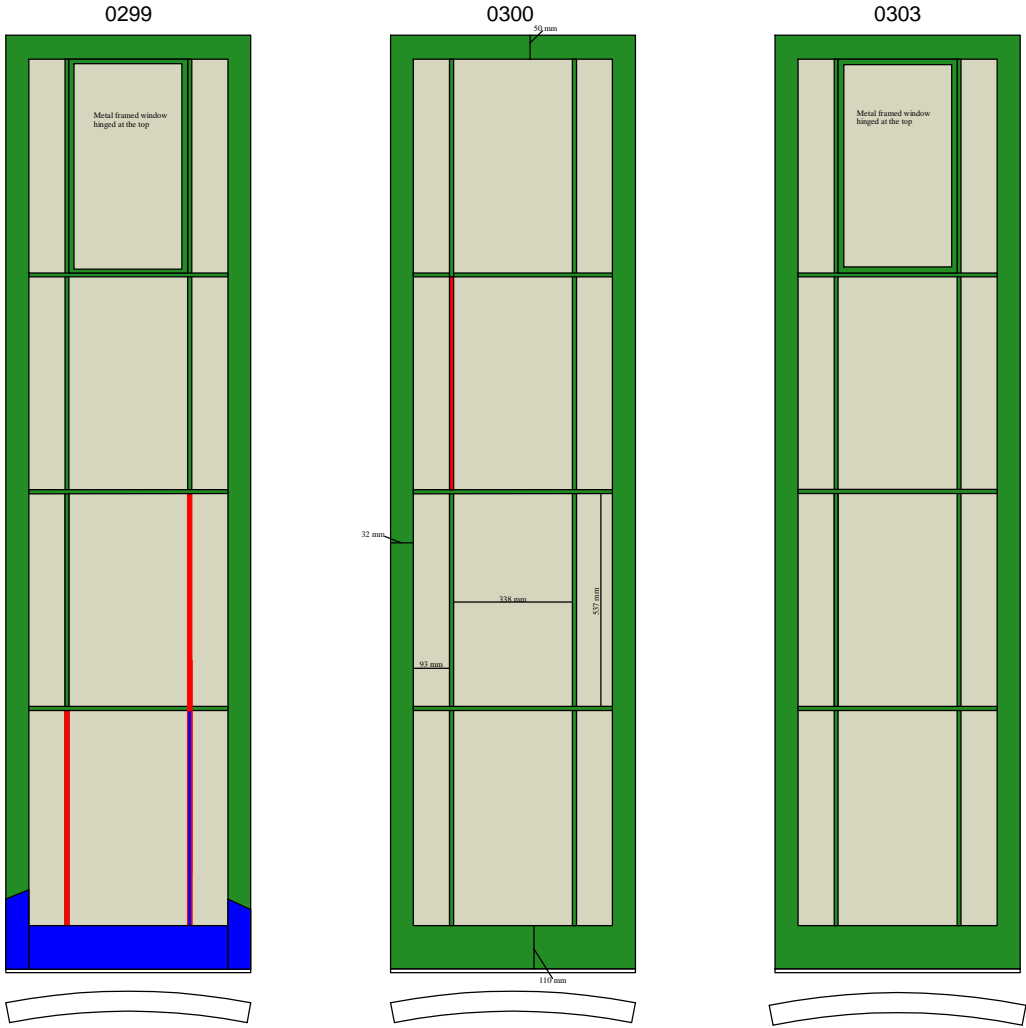
These doors have the most exquisite glazing mouldings. They appear to match those on windows EW/G.18, 16, and 19. Interesting that all these are in the same area of the original house. An attempt has been made to strip these glazed doors resulting in damage to the glazing bars, many of which will require repair or replacement

0300 is a door. Also extant are two of the mullions, one from an outside edge and the other from the hinge side of 0300.

The sill is in two parts and both are extant though would require some work to make them servicable.

Many of the glazing bars are damaged and will need replacing
