**GROUND MOVEMENT ANALYSIS REPORT**

**PROPOSED BASEMENT CONSTRUCTION:  
31 ELSWORTHY ROAD, LONDON NW3 3BY**

**Report ref:** **10588A/JRCB/R2**

**Date:** **3<sup>rd</sup> February 2022**

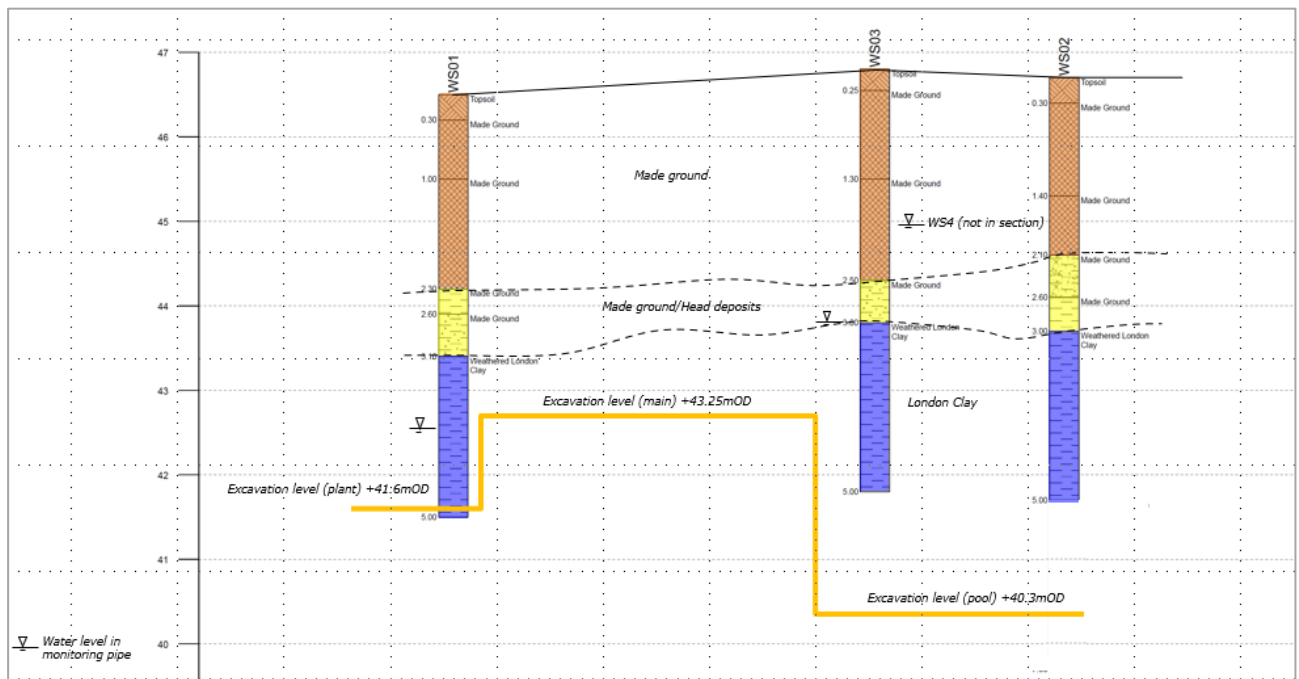
A schematic cross section through the boreholes is as follows:

It is noted that the boreholes did not extend to the level of the deepest basement. We are confident that the in-situ London Clay was encountered in the boreholes and that the risk of unforeseen ground below 5m depth is low. Historical BGS borehole records indicate that the London Clay extends to >50m depth in this area.

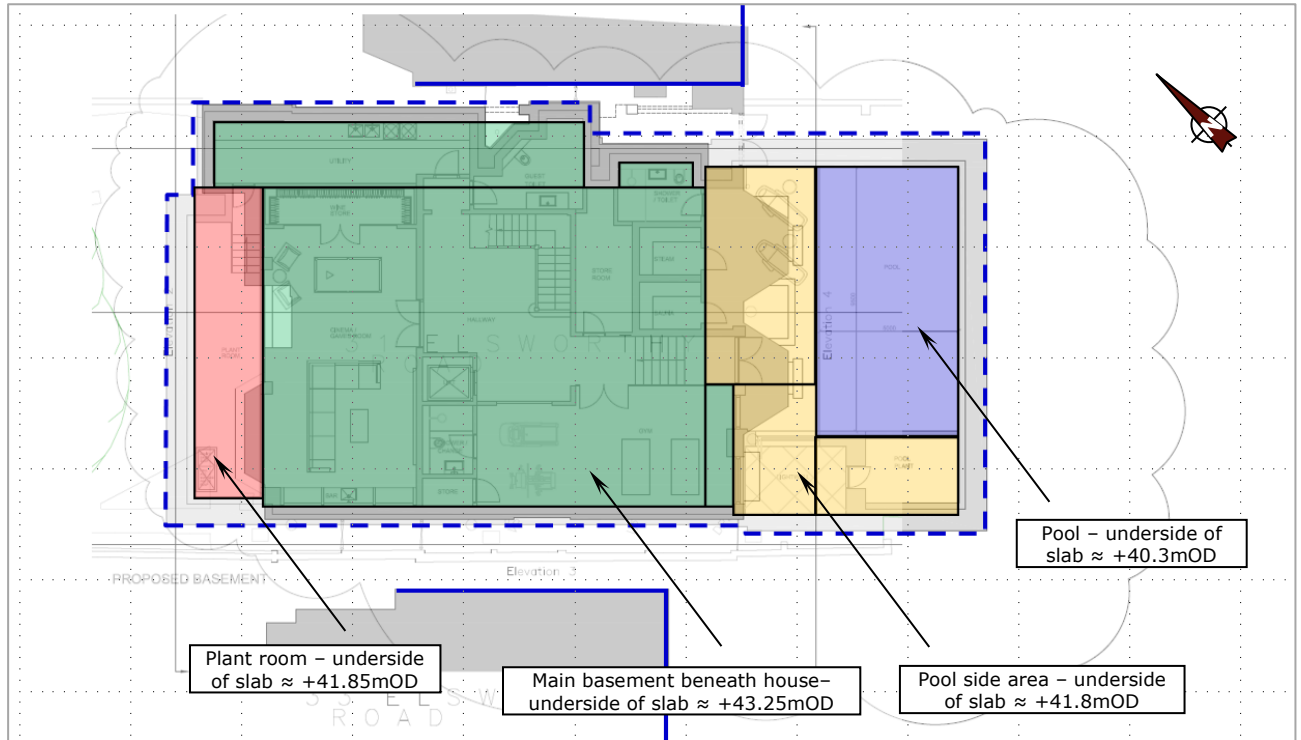
A plan of the proposed basement footprint is shown below (BB Partnership Ltd drawing GEO\_201, Jan 21):

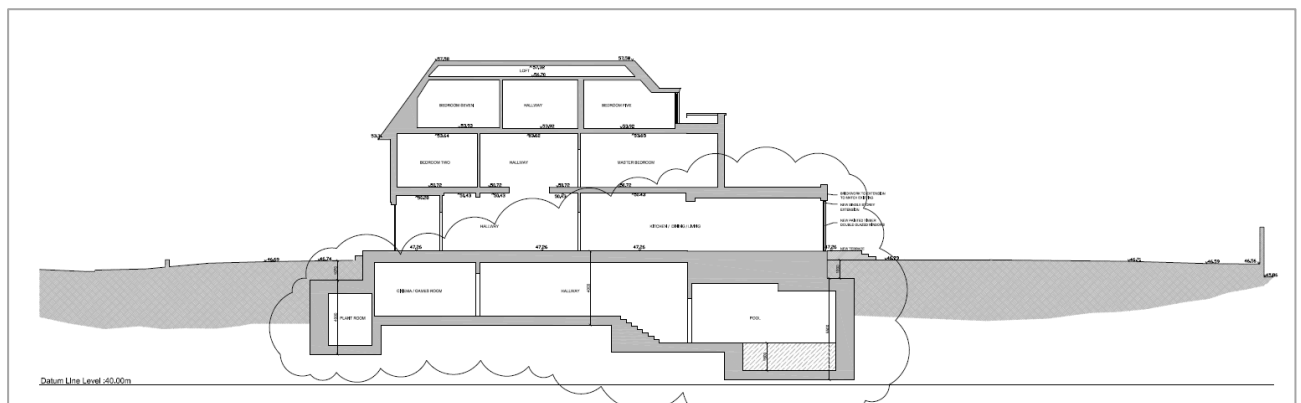
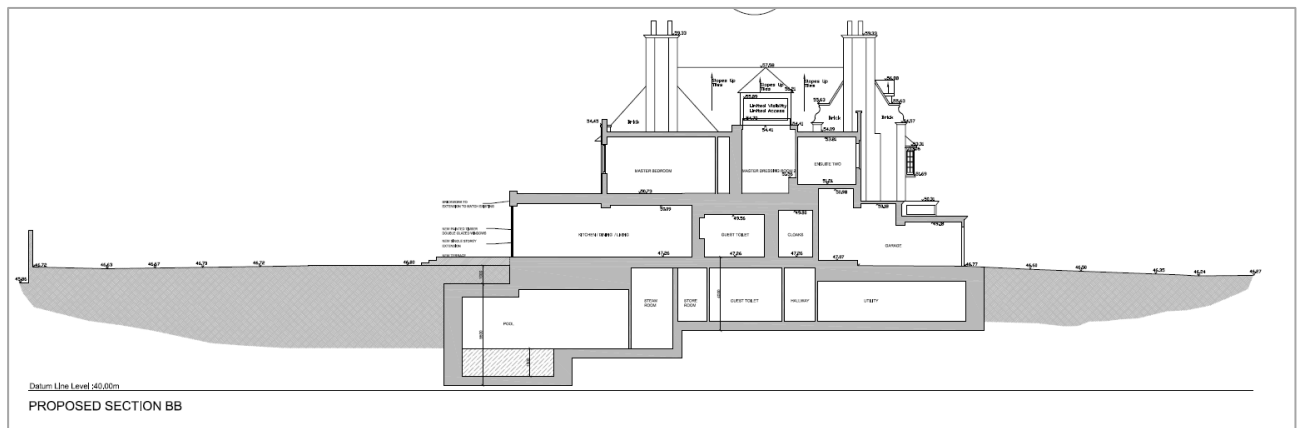
In section, the proposed layout is as follows (BB Partnership Ltd drawing GEO\_215/C, Sep 21):

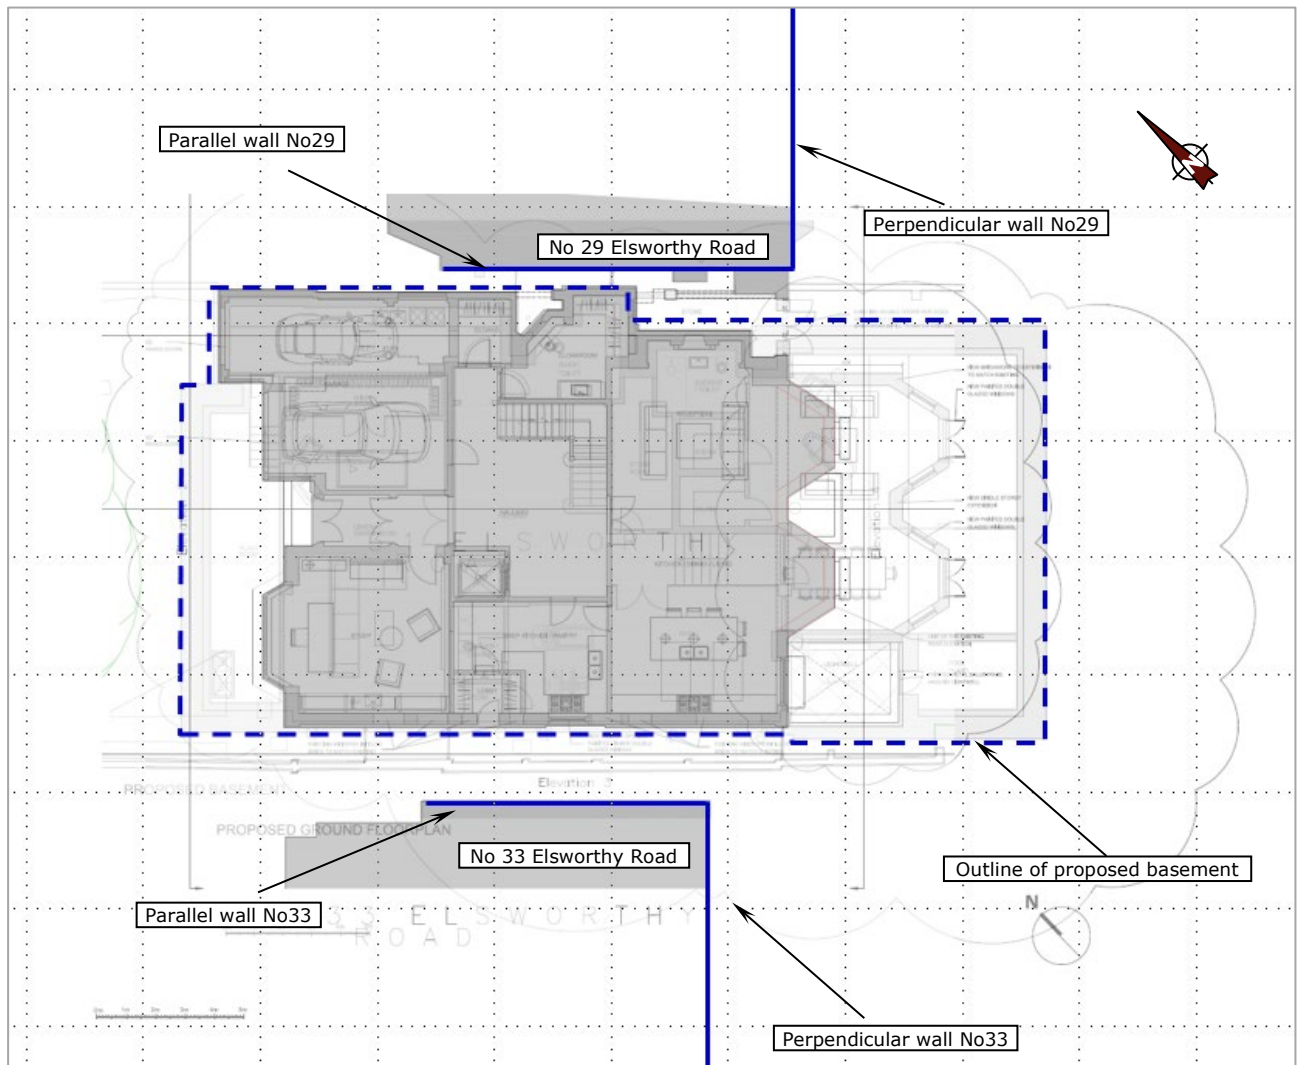
The purpose of this analysis is to calculate the potential horizontal and vertical movements beneath the most critical zones of the adjacent properties/infrastructure and allow an assessment of the damage classification. A sketch showing the existing site layout, the proposed basement and the adjacent properties is as follows:

Structures within the zone of influence of the basement excavation and potentially at risk (shown in solid blue above) are taken as the perpendicular and parallel walls of both adjacent properties.

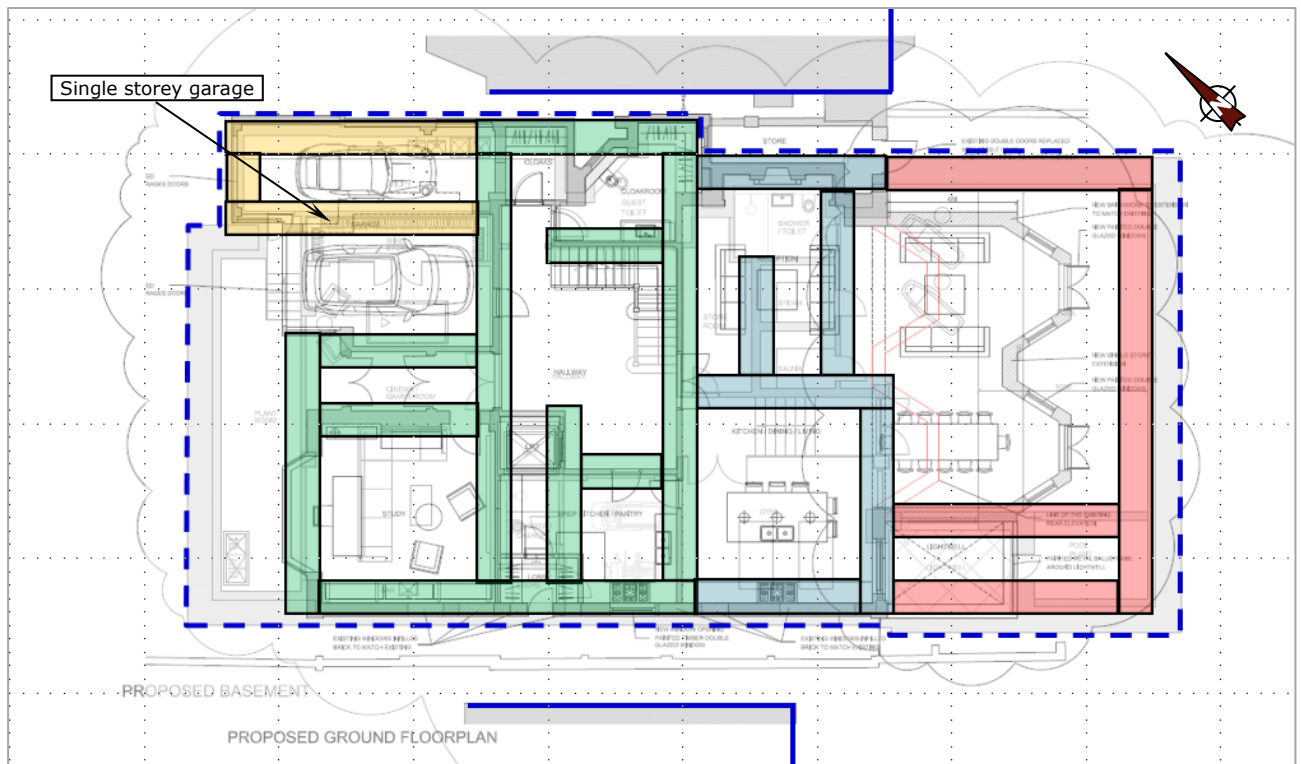
The analytical technique depends on the selection of appropriate rectangular areas to simulate loading by the new underpins. We have assumed that the following peripheral walls and internal walls will be underpinned and the new loaded areas are shown in the following drawing:

The analysis assumes that all elements equate to loads over a series of rectangular areas representing the foundations. The following loadings have been assumed:

Main house/hallway (green)	-	70kPa
Main house/pool area (blue)	-	70kPa
Single-storey garage (yellow)	-	30kPa
Pool/pool area (red)	-	20kPa

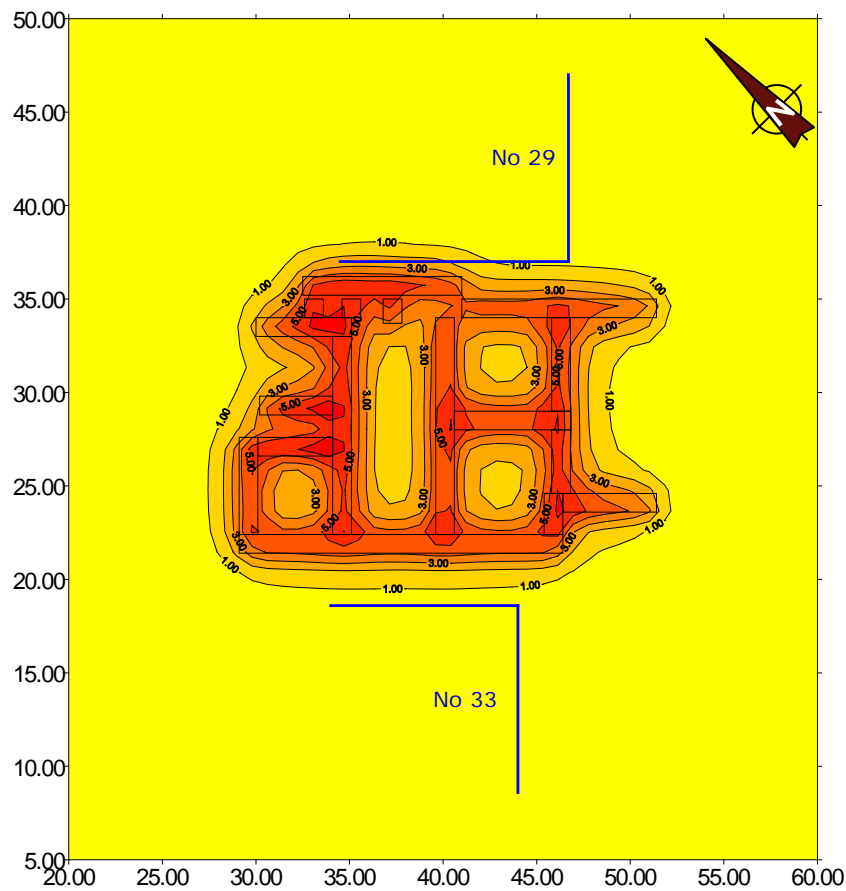
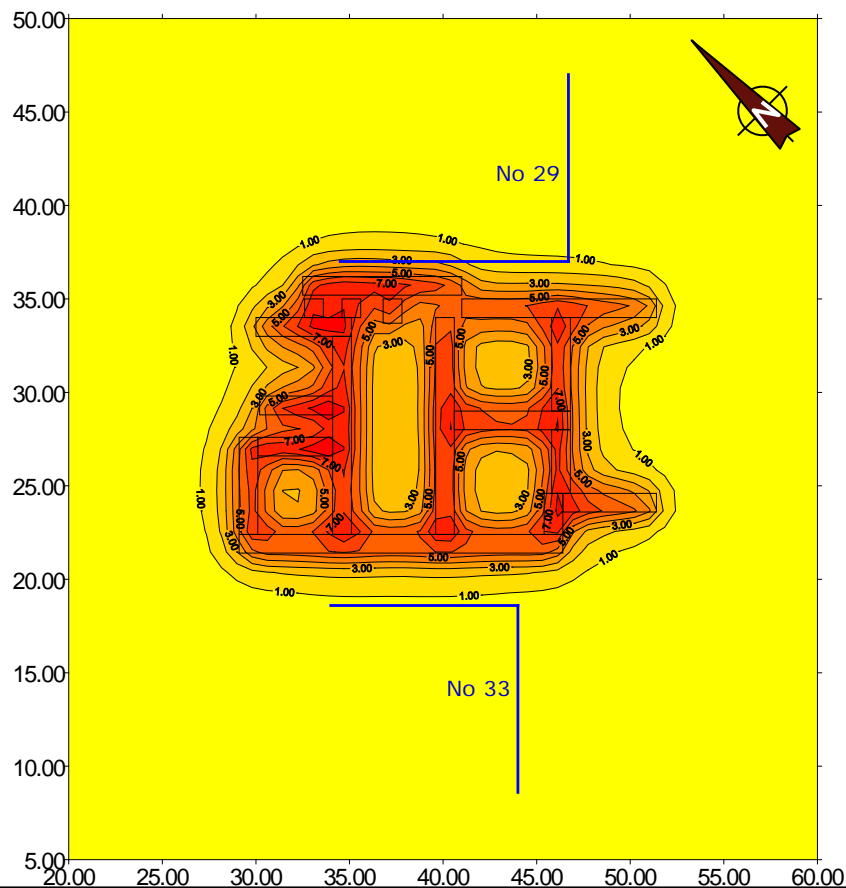
**FIGURE 2**

**End of construction (100% immediate and 20% long term)**

**Post construction (0% immediate and 80% long term)**

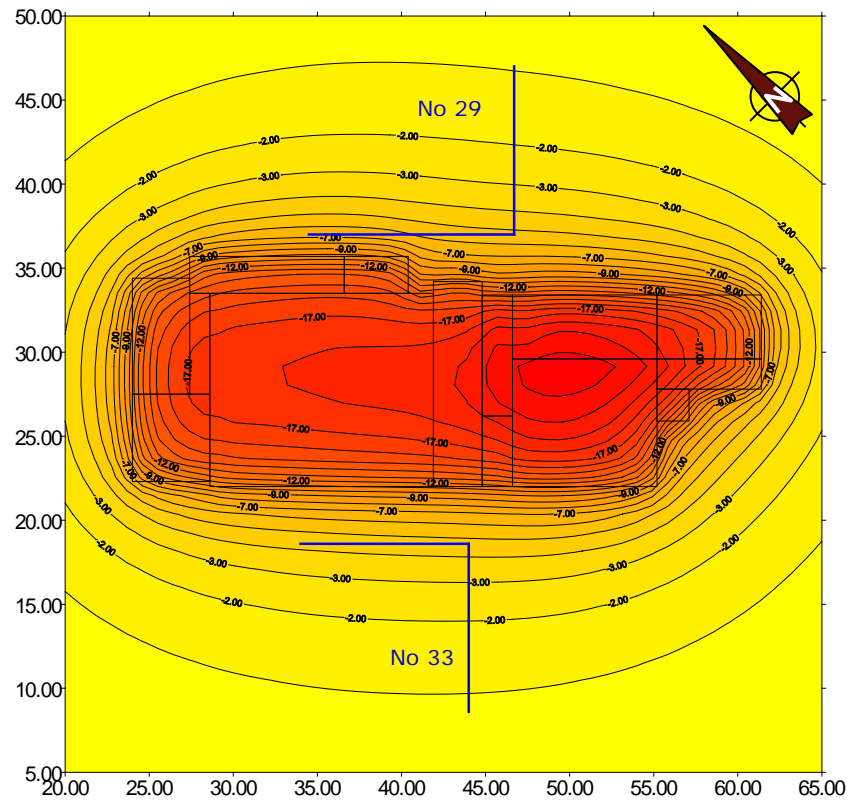
FIGURE 4

Post construction (0% immediate and 80% long term)

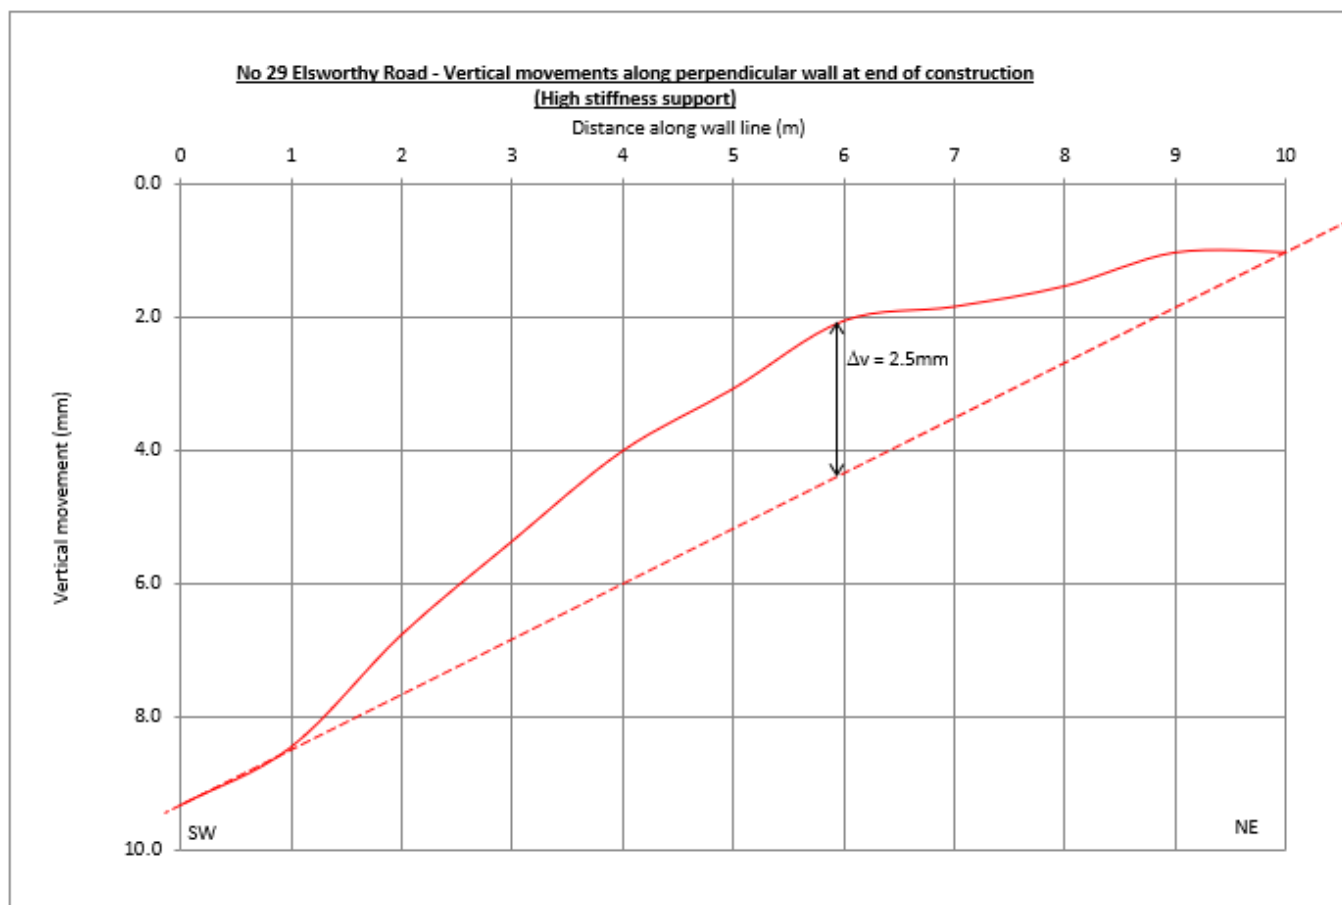
FIGURE 5

## Settlement profile – No 29 Elsworthy Road perpendicular wall (High stiffness)

End of construction

Perpendicular wall - vertical movement at end of construction HIGH				
Distance along wall line (m)	Installation	Settlement (loading)	Settlement (excavation)	Net vertical movement at end of construction (mm)
	Estimated from CIRIA chart	Due to foundations - from Bouss spreadsheet (mm)	Settlement due to basement excavation - estimated from CIRIA chart	
0.0	5.0	0.8	3.5	9.3
1.0	4.0	0.5	4.0	8.5
2.0	3.0	0.3	3.5	6.8
3.0	2.0	0.2	3.2	5.4
4.0	1.0	0.1	2.9	4.0
5.0	0.5	0.1	2.5	3.1
6.0	0.0	0.0	2.0	2.0
7.0	0.0	0.0	1.8	1.8
8.0	0.0	0.0	1.5	1.5
9.0	0.0	0.0	1.0	1.0
10.0	0.0	0.0	1.0	1.0

Profiles of the assessed vertical movement along the line of this wall are shown for both high and intermediate stiffness support in Figures 5 to 8. The  $\Delta v$  values obtained from these profiles are used in assessing vertical strains for damage assessment.

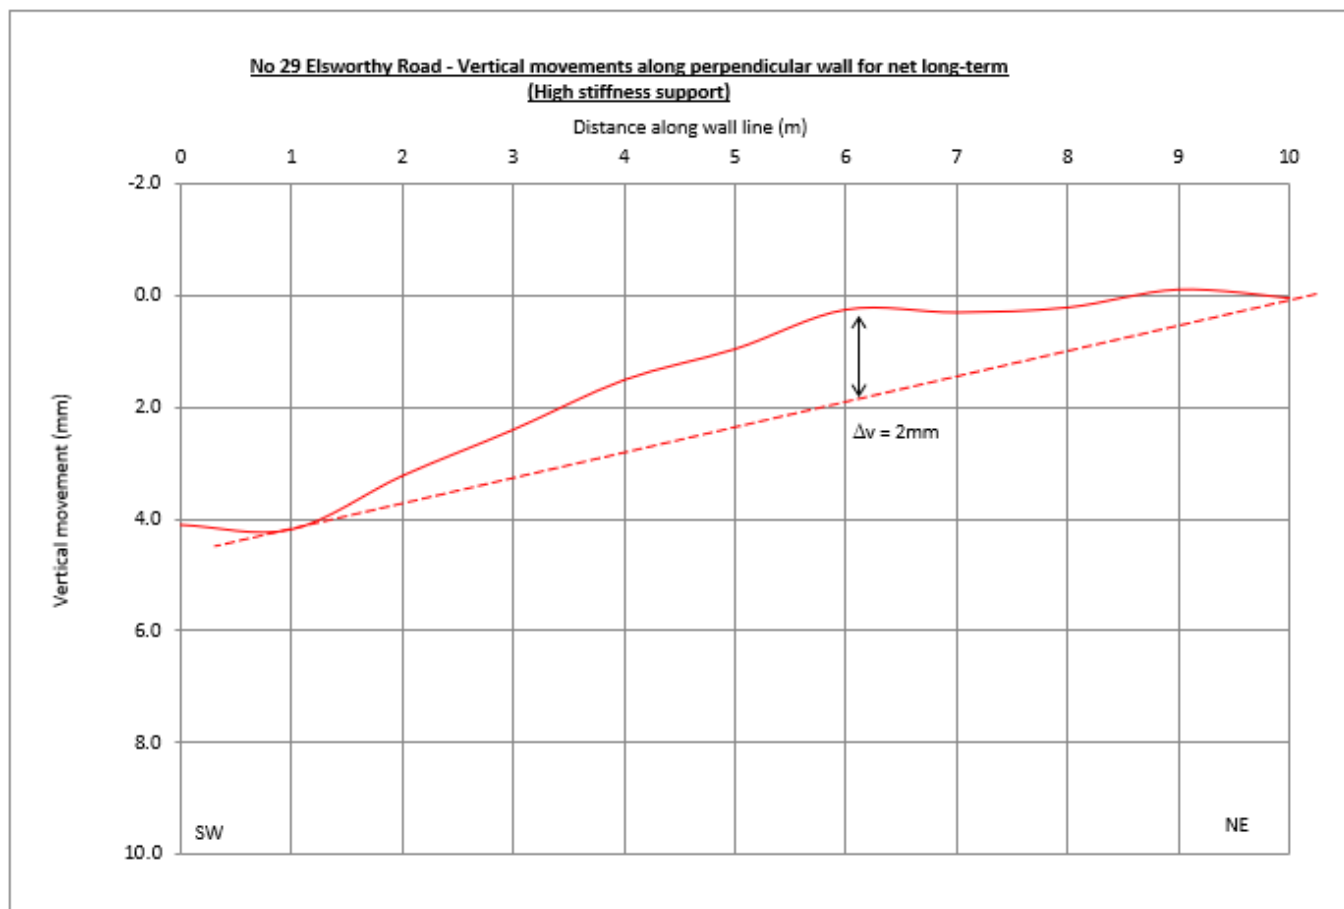
## Settlement profile – No 29 Elsworthy Road perpendicular wall (High stiffness)

Long term

Perpendicular wall - vertical movement long-term HIGH			
Distance along wall line (m)	Settlement (loading)	Heave (unloading)	Net total movement long-term (mm)
	Due to foundations - from Bouss spreadsheet (mm)	Post-construction heave - from Bouss spreadsheet (mm)	
0.0	1.1	-5.2	4.1
1.0	0.6	-4.3	4.2
2.0	0.4	-3.5	3.2
3.0	0.2	-3.0	2.4
4.0	0.1	-2.5	1.5
5.0	0.1	-2.1	1.0
6.0	0.1	-1.8	0.3
7.0	0.0	-1.5	0.3
8.0	0.0	-1.3	0.2
9.0	0.0	-1.1	-0.1
10.0	0.0	-1.0	0.1

(Note: total long term net is determined using the end of construction movement and the post construction movements)

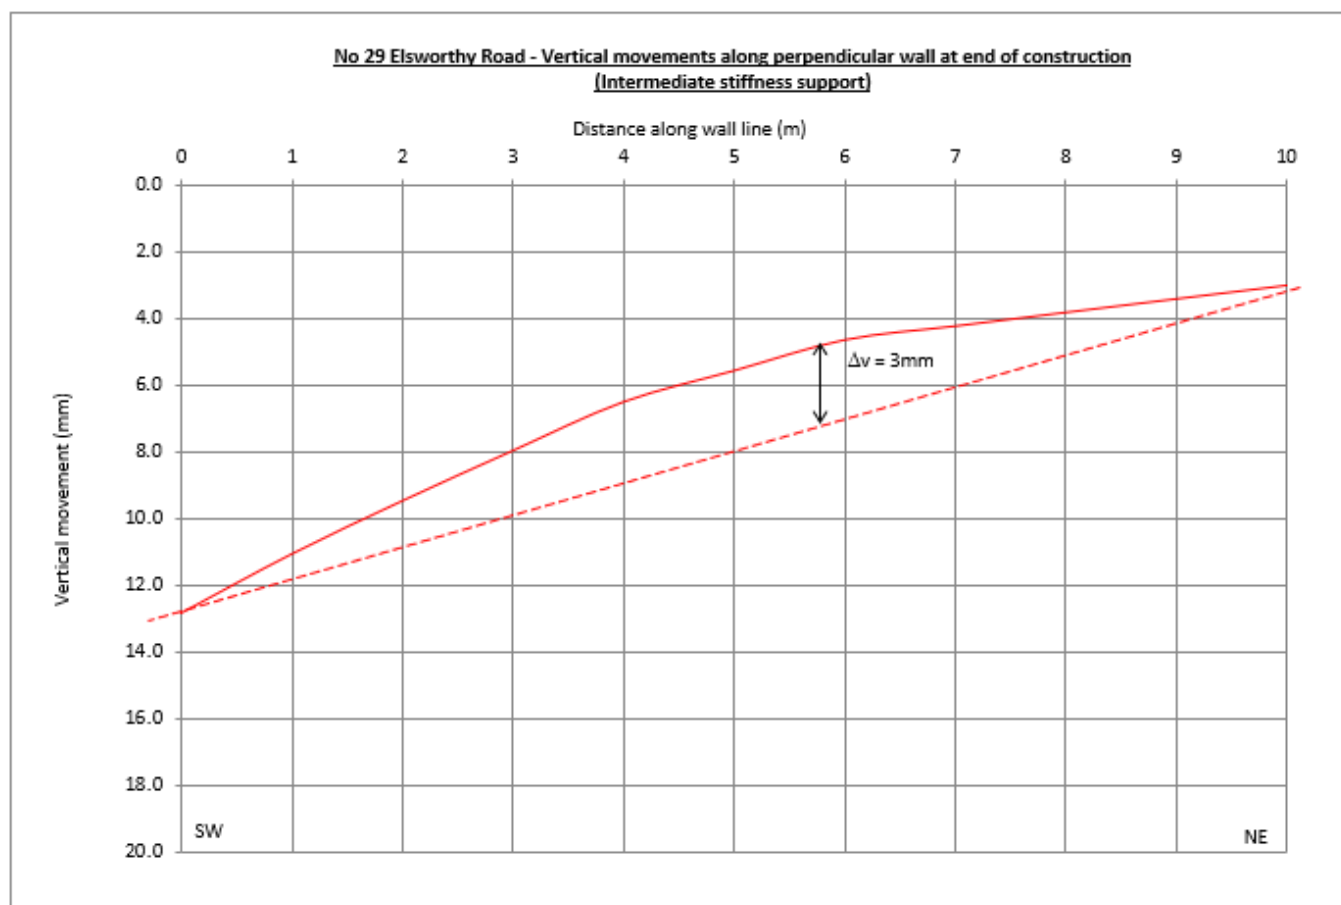
FIGURE 7

## Settlement profile – No 29 Elsworthy Road perpendicular wall (Intermediate stiffness)

End of construction

Perpendicular wall - vertical movement at end of construction INTERMEDIATE				
Distance along wall line (m)	Installation	Settlement (loading)	Settlement (excavation)	Net vertical movement at end of construction (mm)
	Estimated from CIRIA chart	Due to foundations - from Bouss spreadsheet (mm)	Settlement due to basement excavation - estimated from CIRIA chart	
0.0	5.0	0.8	7.0	12.8
1.0	4.0	0.5	6.6	11.1
2.0	3.0	0.3	6.2	9.5
3.0	2.0	0.2	5.8	8.0
4.0	1.0	0.1	5.4	6.5
5.0	0.5	0.1	5.0	5.6
6.0	0.0	0.0	4.6	4.6
7.0	0.0	0.0	4.2	4.2
8.0	0.0	0.0	3.8	3.8
9.0	0.0	0.0	3.4	3.4
10.0	0.0	0.0	3.0	3.0

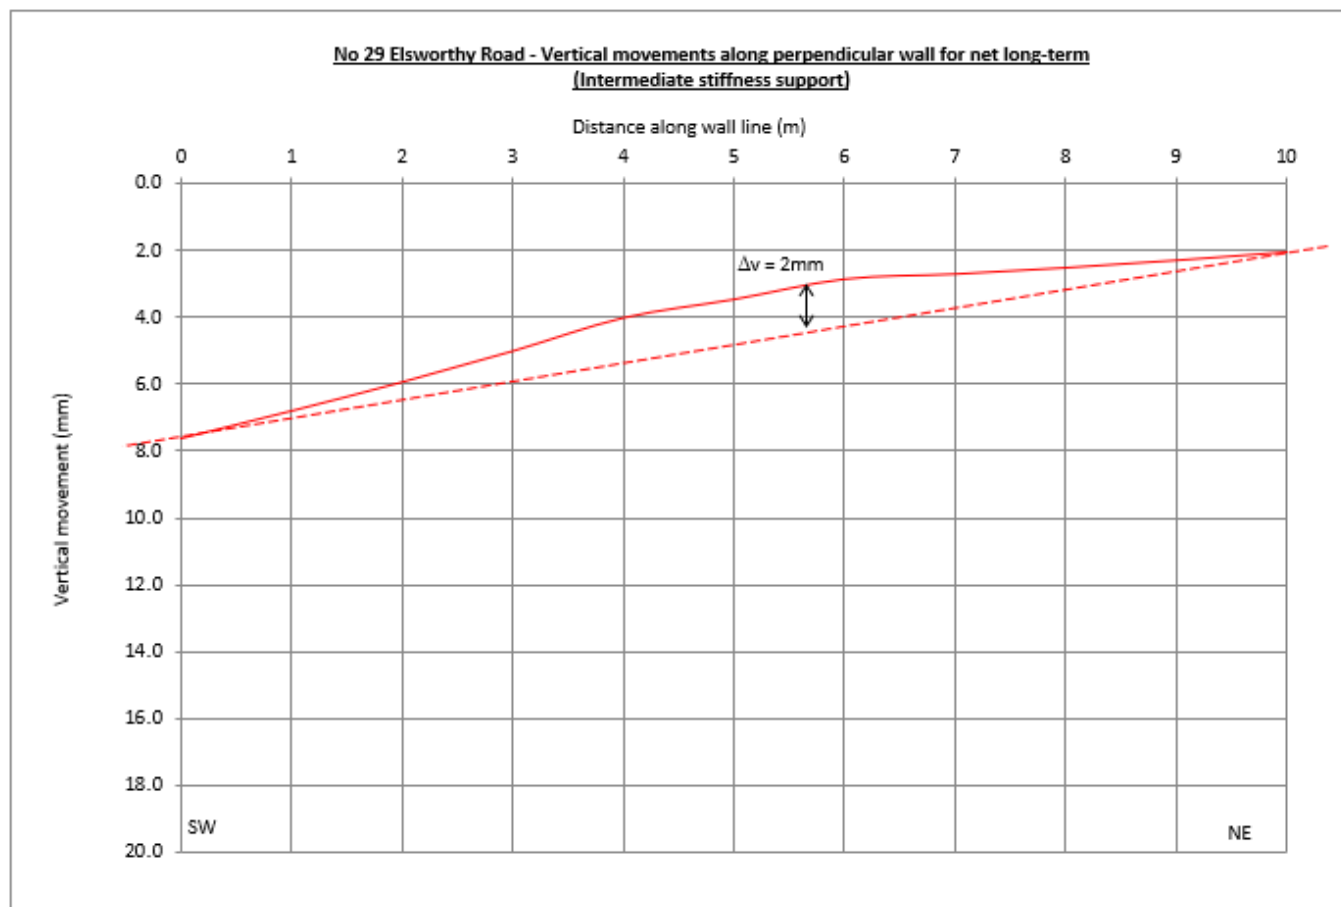
## Settlement profile – No 29 Elsworthy Road perpendicular wall (Intermediate stiffness)

Long term

Distance along wall line (m)	Perpendicular wall - vertical movement long-term INT		Net total movement long-term (mm)
	Settlement (loading) Due to foundations - from Bouss spreadsheet (mm)	Heave (unloading) Post-construction heave - from Bouss spreadsheet (mm)	
0.0	1.1	-5.2	7.6
1.0	0.6	-4.3	6.8
2.0	0.4	-3.5	5.9
3.0	0.2	-3.0	5.0
4.0	0.1	-2.5	4.0
5.0	0.1	-2.1	3.5
6.0	0.1	-1.8	2.9
7.0	0.0	-1.5	2.7
8.0	0.0	-1.3	2.5
9.0	0.0	-1.1	2.3
10.0	0.0	-1.0	2.1

(Note: total long term net movement is determined using the end of construction movement and the post construction movements)

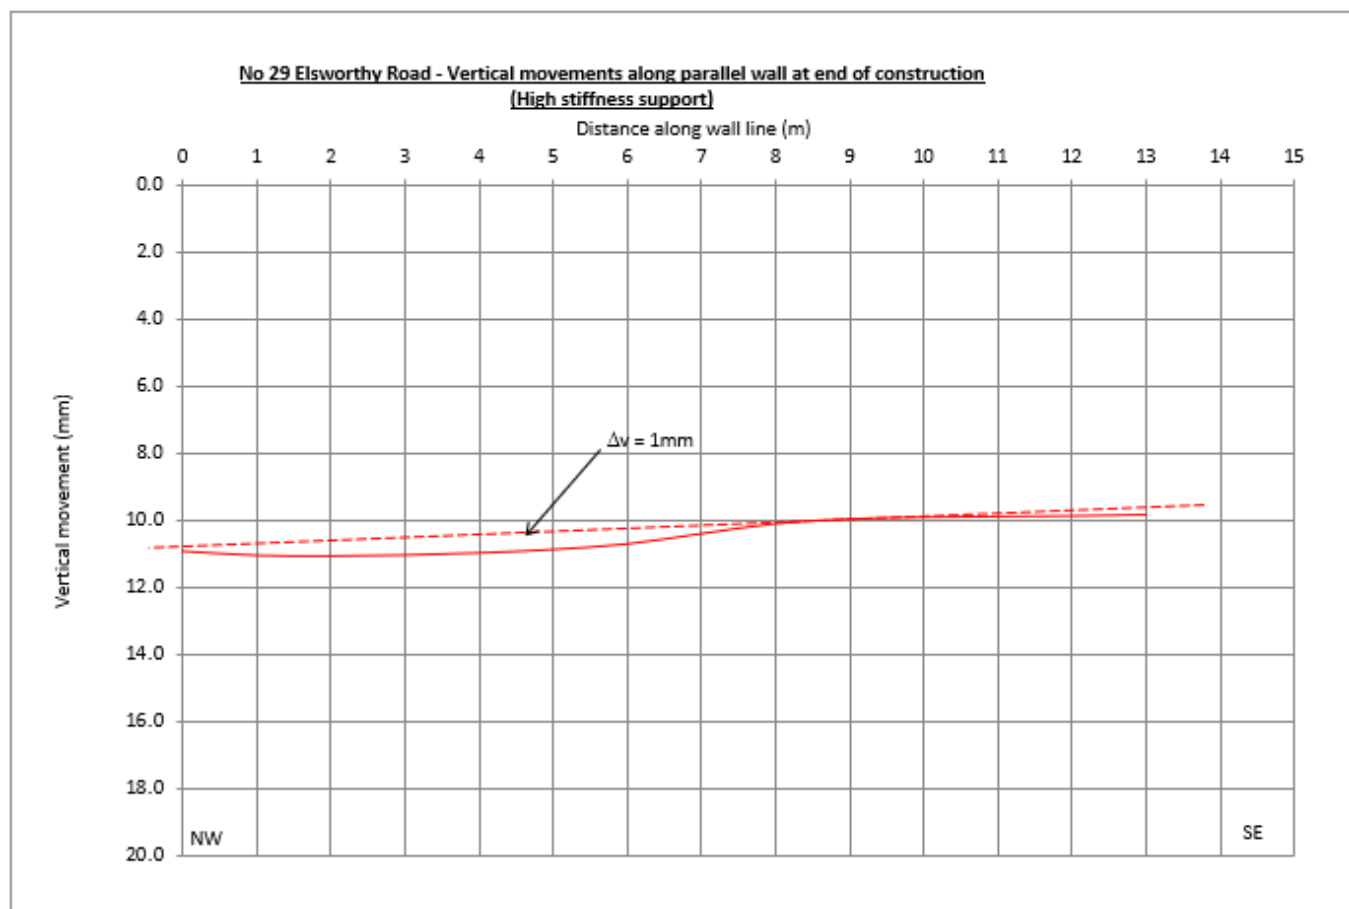
FIGURE 9

## Settlement profile – No 29 Elsworthy Road parallel wall (High stiffness)

End of construction

Parallel wall - vertical movement at end of construction HIGH				
Distance along wall line (m)	Installation	Settlement (loading)	Settlement (excavation)	Net vertical movement at end of construction (mm)
	Estimated from CIRIA chart	Due to foundations - from Bouss spreadsheet (mm)	Settlement due to basement excavation - estimated from CIRIA chart	
0.0	5.0	1.9	4.0	10.9
1.0	5.0	2.0	4.0	11.0
2.0	5.0	2.1	4.0	11.1
3.0	5.0	2.0	4.0	11.0
4.0	5.0	2.0	4.0	11.0
5.0	5.0	1.9	4.0	10.9
6.0	5.0	1.7	4.0	10.7
7.0	5.0	1.4	4.0	10.4
8.0	5.0	1.1	4.0	10.1
9.0	5.0	1.0	4.0	10.0
10.0	5.0	0.9	4.0	9.9
11.0	5.0	0.9	4.0	9.9
12.0	5.0	0.9	4.0	9.9
13.0	5.0	0.8	4.0	9.8

Profiles of the assessed vertical movement along the line of this wall are shown for both high and intermediate stiffness support in Figures 9 to 12. The  $\Delta v$  values obtained from these profiles are used in assessing vertical strains for damage assessment.

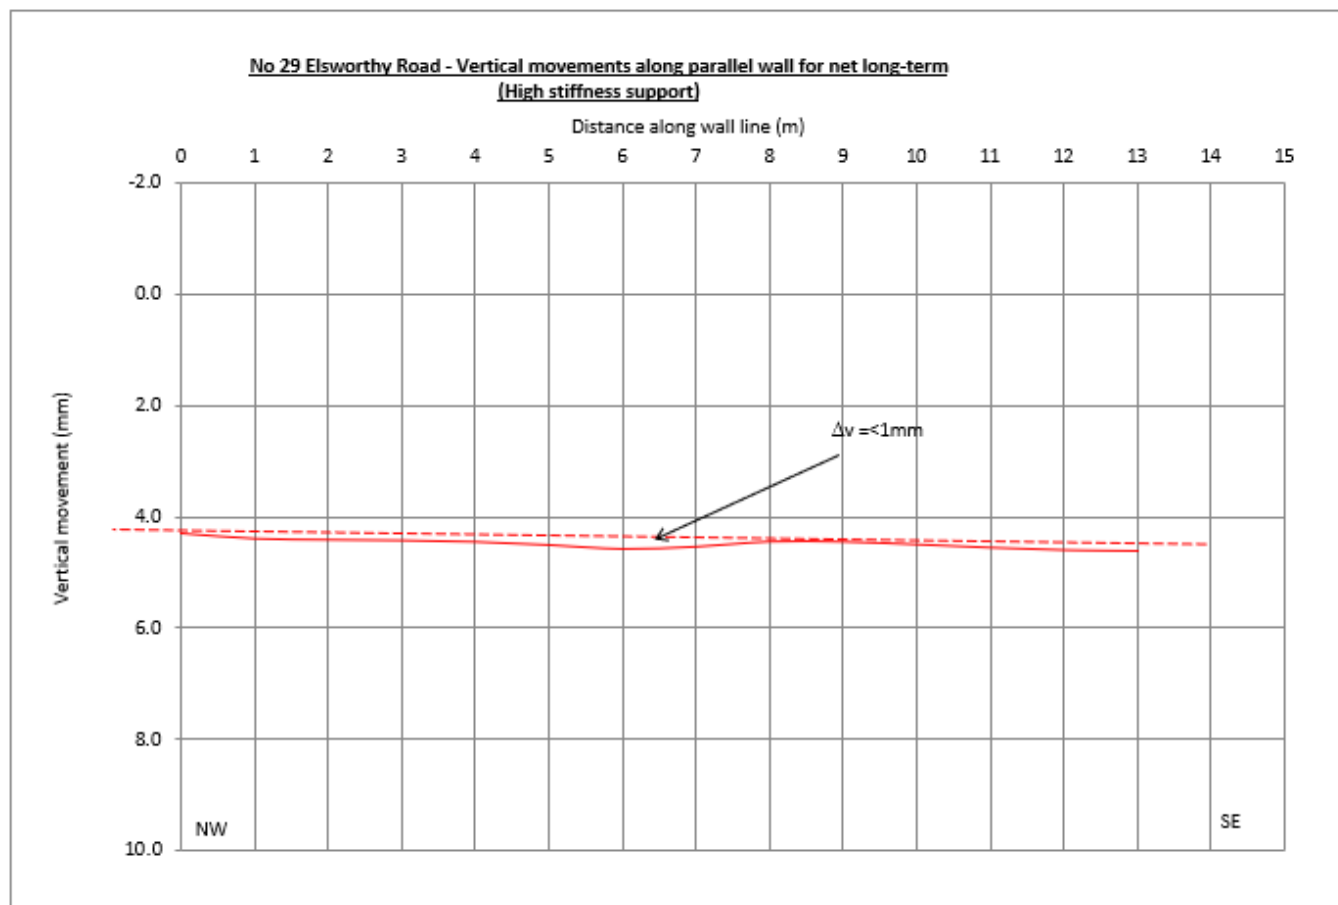
Long term

Distance along wall line (m)	Parallel wall - vertical movement long-term HIGH		
	Settlement (loading)	Heave (unloading)	Net total movement long-term (mm)
	Due to foundations - from Bouss spreadsheet (mm)	Post-construction heave - from Bouss spreadsheet (mm)	
0.0	2.5	-6.6	4.3
1.0	2.7	-6.6	4.4
2.0	2.7	-6.6	4.4
3.0	2.7	-6.6	4.4
4.0	2.6	-6.5	4.4
5.0	2.5	-6.4	4.5
6.0	2.2	-6.1	4.6
7.0	1.8	-5.9	4.5
8.0	1.4	-5.7	4.4
9.0	1.3	-5.5	4.4
10.0	1.2	-5.4	4.5
11.0	1.2	-5.3	4.5
12.0	1.1	-5.3	4.6
13.0	1.1	-5.2	4.6

(Note: total long term net is determined using the end of construction movement and the post construction movements)

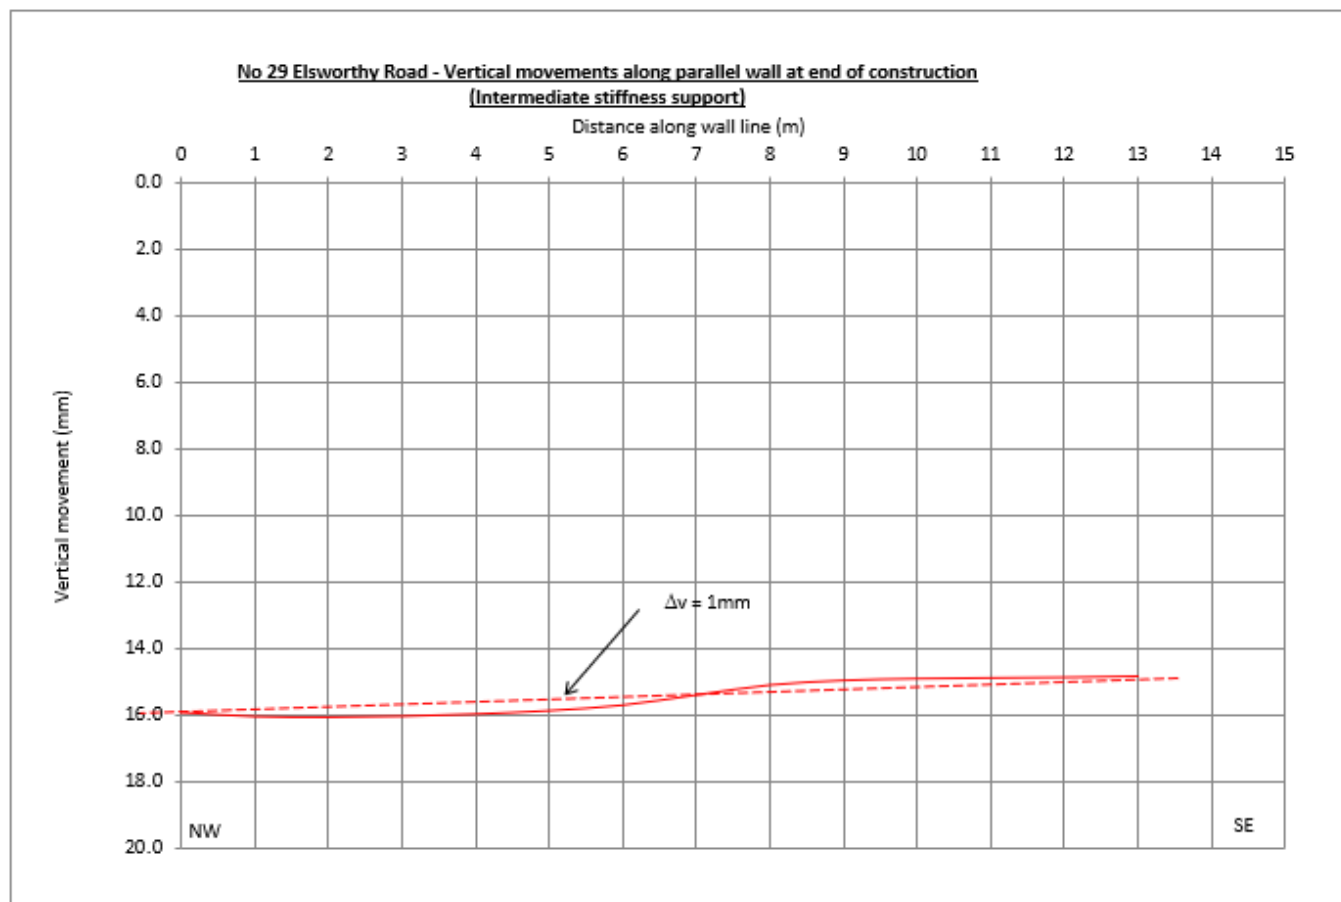
FIGURE 11

End of construction

Parallel wall - vertical movement at end of construction Intermediate				
Distance along wall line (m)	Installation	Settlement (loading)	Settlement (excavation)	Net vertical movement at end of construction (mm)
	Estimated from CIRIA chart	Due to foundations - from Bouss spreadsheet (mm)	Settlement due to basement excavation - estimated from CIRIA chart	
0.0	5.0	1.9	9.0	15.9
1.0	5.0	2.0	9.0	16.0
2.0	5.0	2.1	9.0	16.1
3.0	5.0	2.0	9.0	16.0
4.0	5.0	2.0	9.0	16.0
5.0	5.0	1.9	9.0	15.9
6.0	5.0	1.7	9.0	15.7
7.0	5.0	1.4	9.0	15.4
8.0	5.0	1.1	9.0	15.1
9.0	5.0	1.0	9.0	15.0
10.0	5.0	0.9	9.0	14.9
11.0	5.0	0.9	9.0	14.9
12.0	5.0	0.9	9.0	14.9
13.0	5.0	0.8	9.0	14.8

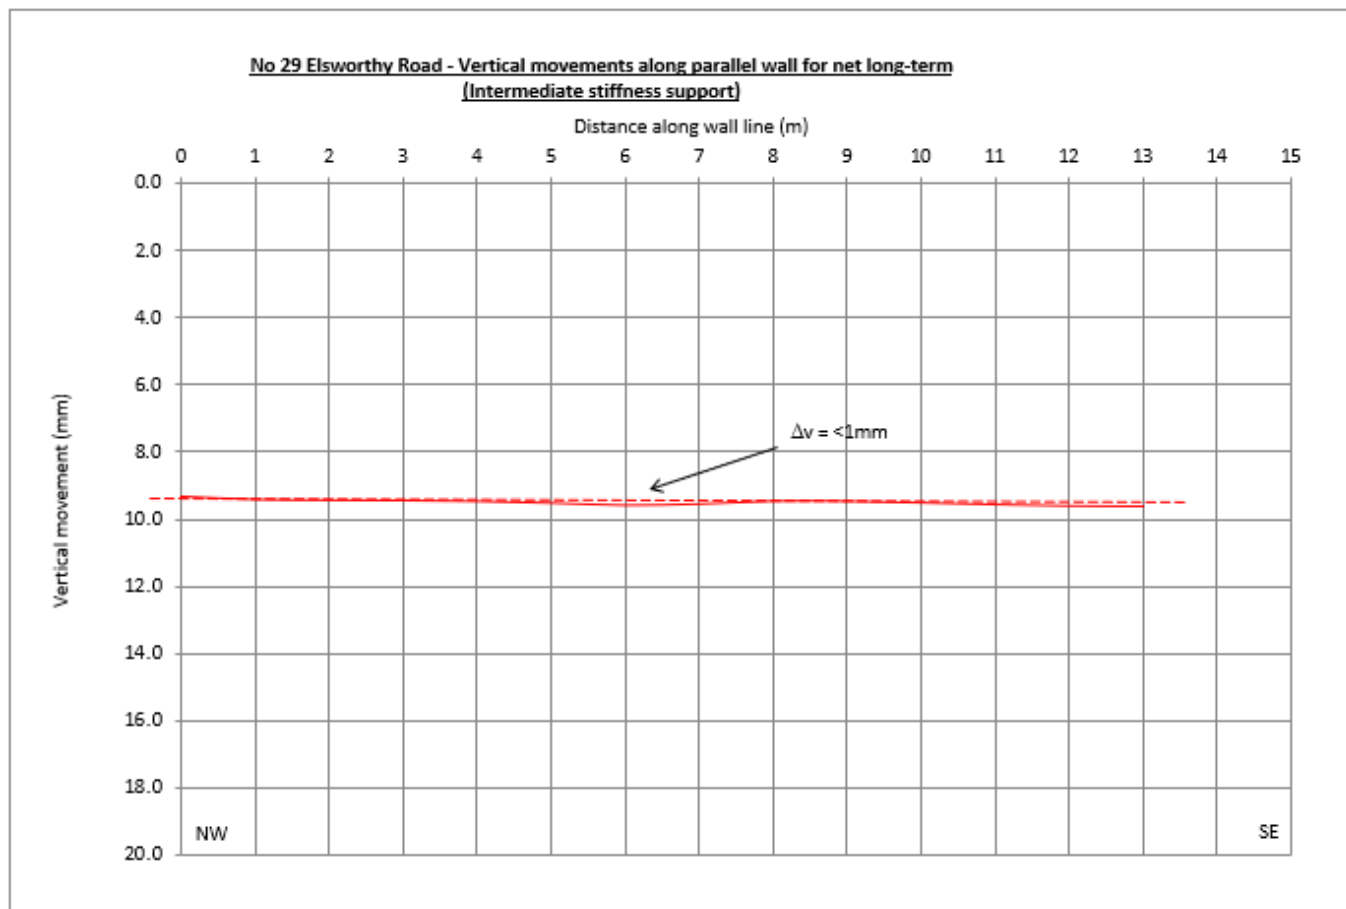
## Long term

Distance along wall line (m)	Parallel wall - vertical movement long-term Intermediate		
	Settlement (loading) Due to foundations - from Bouss spreadsheet (mm)	Heave (unloading) Post-construction heave - from Bouss spreadsheet (mm)	Net total movement long-term (mm)
0.0	2.5	-6.6	9.3
1.0	2.7	-6.6	9.4
2.0	2.7	-6.6	9.4
3.0	2.7	-6.6	9.4
4.0	2.6	-6.5	9.4
5.0	2.5	-6.4	9.5
6.0	2.2	-6.1	9.6
7.0	1.8	-5.9	9.5
8.0	1.4	-5.7	9.4
9.0	1.3	-5.5	9.4
10.0	1.2	-5.4	9.5
11.0	1.2	-5.3	9.5
12.0	1.1	-5.3	9.6
13.0	1.1	-5.2	9.6

(Note: total long term net movement is determined using the end of construction movement and the post construction movements)

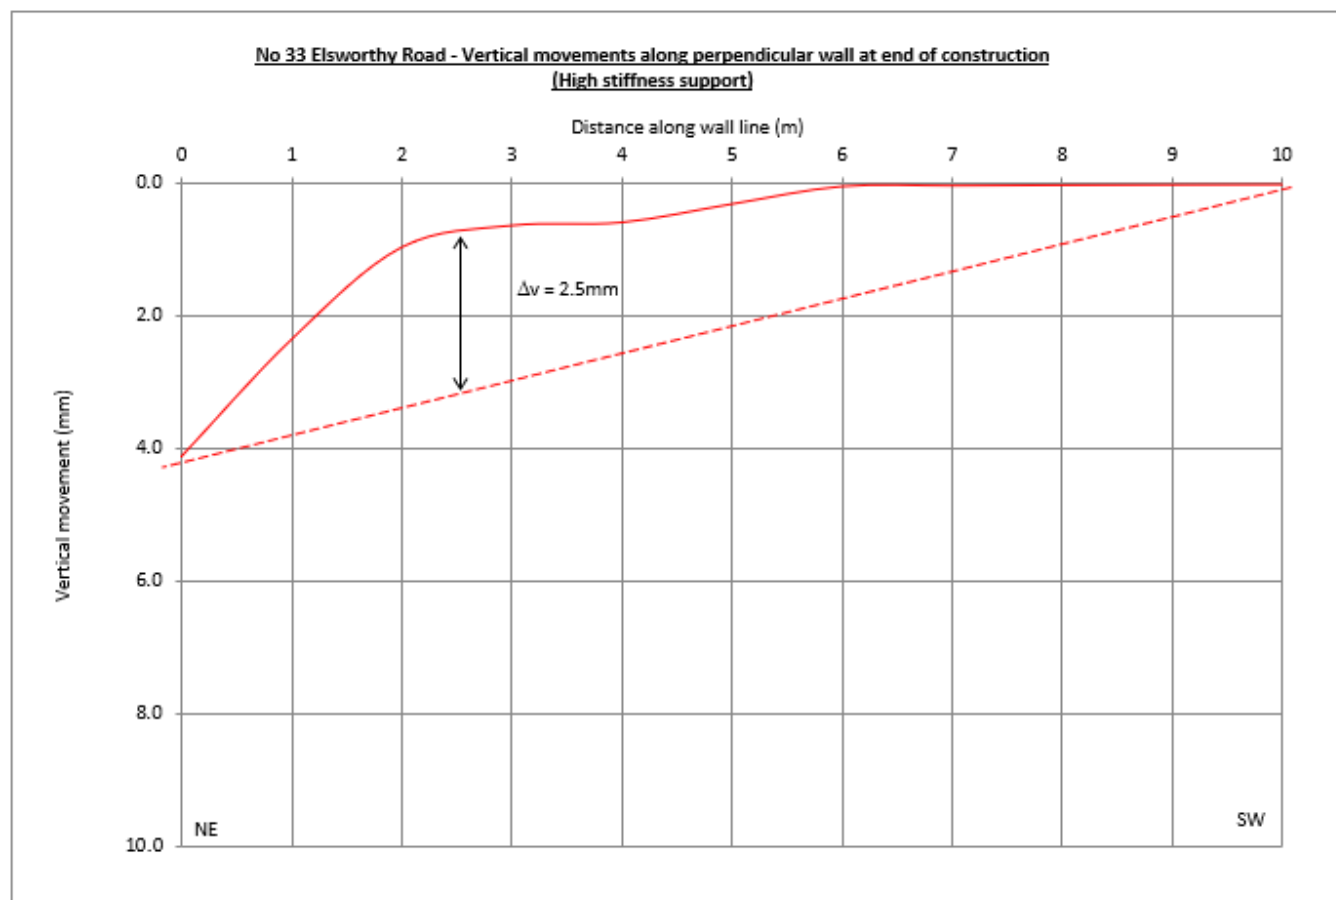
FIGURE 13

End of construction

Perpendicular wall - vertical movement at end of construction HIGH				
Distance along wall line (m)	Installation	Settlement (loading)	Settlement (excavation)	Net vertical movement at end of construction (mm)
	Estimated from CIRIA chart	Due to foundations - from Bouss spreadsheet (mm)	Settlement due to basement excavation - estimated from CIRIA chart	
0.0	2.0	0.6	1.5	4.1
1.0	1.0	0.4	1.0	2.4
2.0	0.0	0.2	0.8	1.0
3.0	0.0	0.1	0.5	0.6
4.0	0.0	0.1	0.5	0.6
5.0	0.0	0.1	0.3	0.3
6.0	0.0	0.0	0.0	0.0
7.0	0.0	0.0	0.0	0.0
8.0	0.0	0.0	0.0	0.0
9.0	0.0	0.0	0.0	0.0
10.0	0.0	0.0	0.0	0.0

Profiles of the assessed vertical movement along the line of this wall are shown for both high and intermediate stiffness support in Figures 13 to 16. The  $\Delta v$  values obtained from these profiles are used in assessing vertical strains for damage assessment.

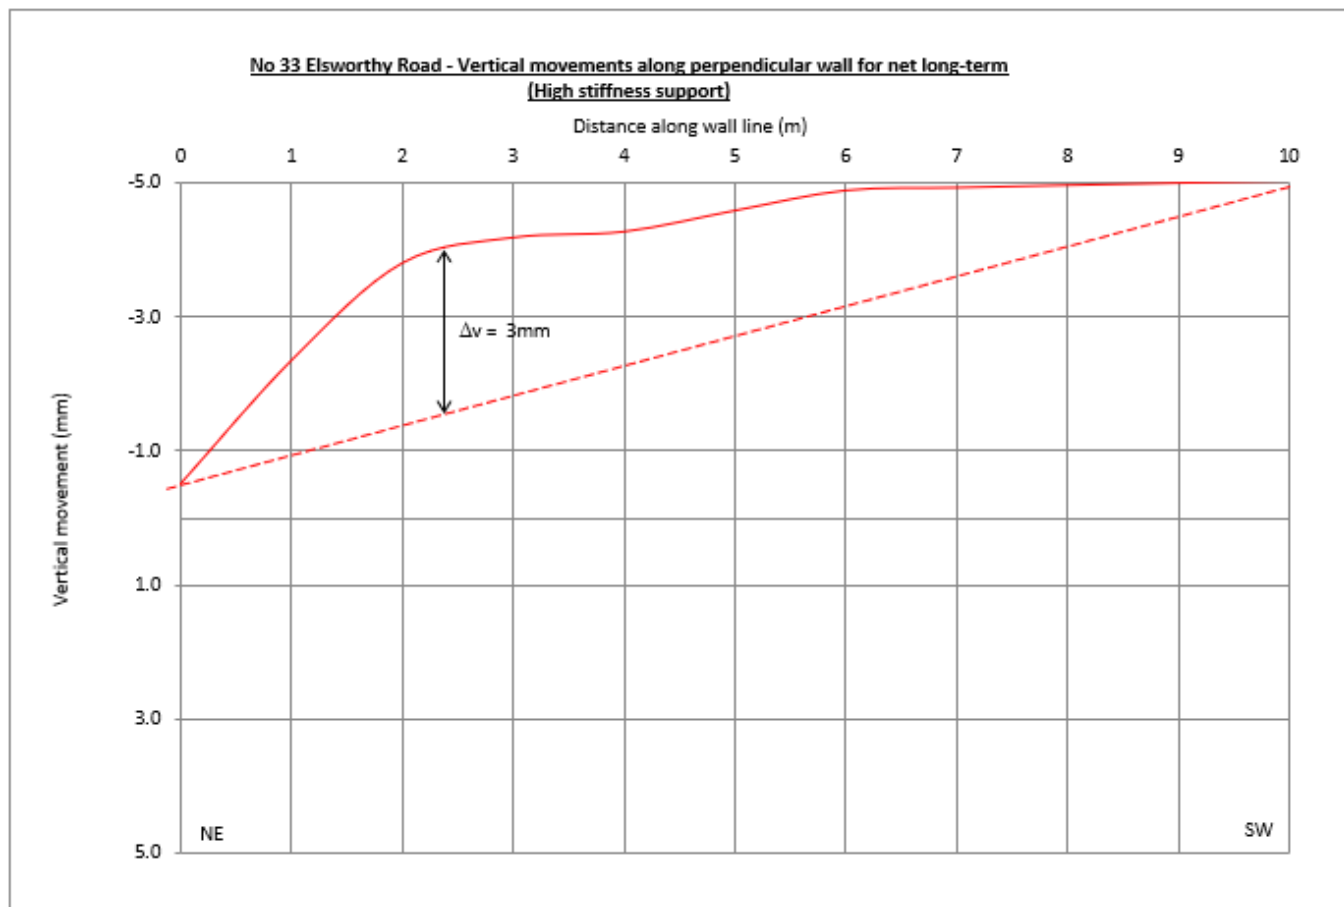
Long term

Perpendicular wall - vertical movement long-term HIGH			
Distance along wall line (m)	Settlement (loading)	Heave (unloading)	Net total movement long-term (mm)
	Due to foundations - from Bouss spreadsheet (mm)	Post-construction heave - from Bouss spreadsheet (mm)	
0.0	0.8	-4.7	-0.5
1.0	0.5	-4.7	-2.4
2.0	0.3	-4.8	-3.8
3.0	0.2	-4.8	-4.2
4.0	0.1	-4.9	-4.3
5.0	0.1	-4.9	-4.6
6.0	0.1	-4.9	-4.9
7.0	0.0	-5.0	-4.9
8.0	0.0	-5.0	-5.0
9.0	0.0	-5.0	-5.0
10.0	0.0	-5.0	-5.0

(Note: total long term net is determined using the end of construction movement and the post construction movements)
