**GROUND MOVEMENT ANALYSIS REPORT**

**PROPOSED BASEMENT CONSTRUCTION:  
31 ELSWORTHY ROAD, LONDON NW3 3BY**

**Report ref:** **10588A/JRCB/R2**

**Date:** **3<sup>rd</sup> February 2022**

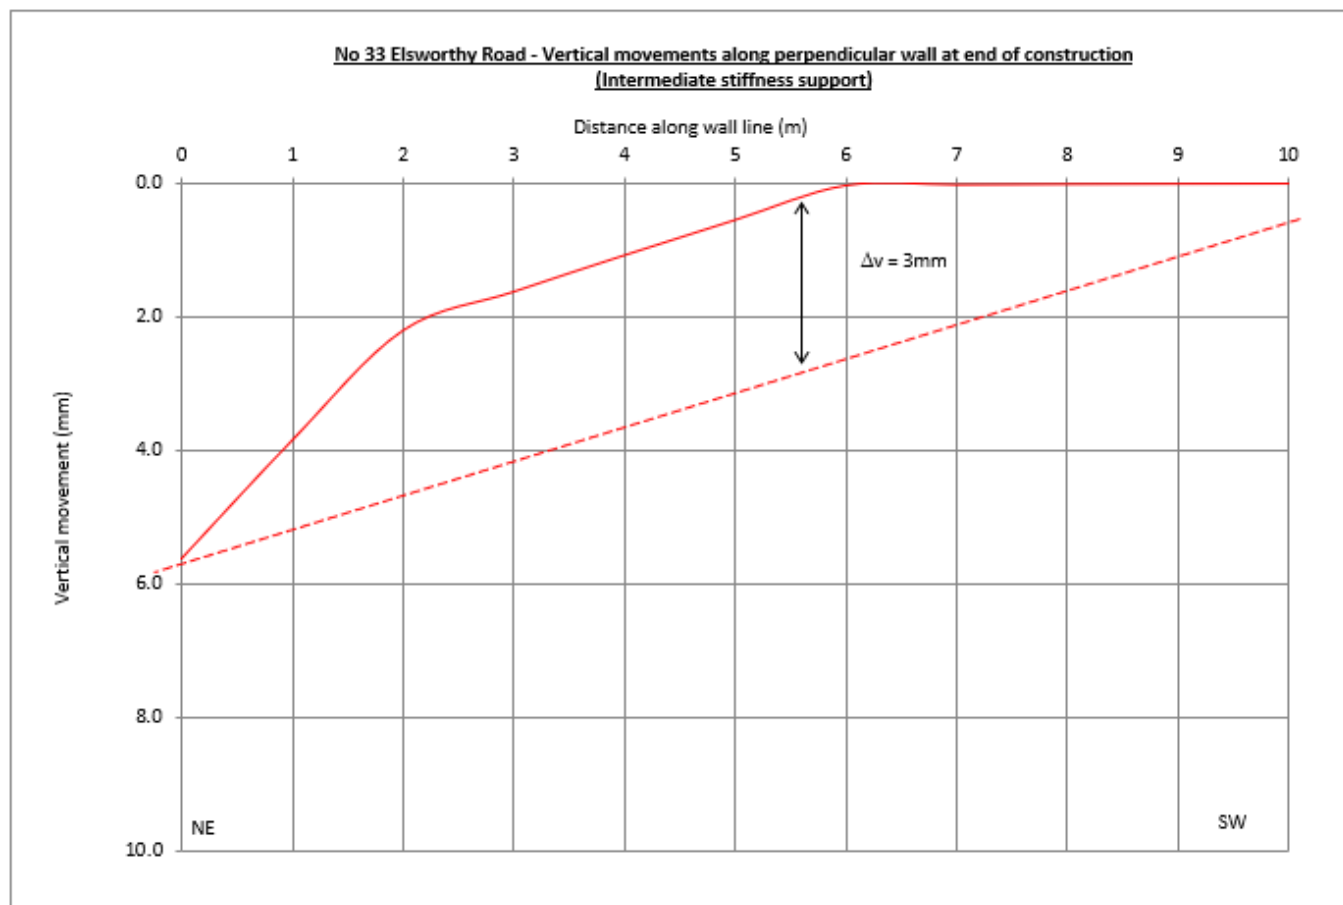
FIGURE 15

End of construction

Perpendicular wall - vertical movement at end of construction INTERMEDIATE				
Distance along wall line (m)	Installation	Settlement (loading)	Settlement (excavation)	Net vertical movement at end of construction (mm)
	Estimated from CIRIA chart	Due to foundations - from Bouss spreadsheet (mm)	Settlement due to basement excavation - estimated from CIRIA chart	
0.0	2.0	0.6	3.0	5.6
1.0	1.0	0.4	2.5	3.9
2.0	0.0	0.2	2.0	2.2
3.0	0.0	0.1	1.5	1.6
4.0	0.0	0.1	1.0	1.1
5.0	0.0	0.1	0.5	0.6
6.0	0.0	0.0	0.0	0.0
7.0	0.0	0.0	0.0	0.0
8.0	0.0	0.0	0.0	0.0
9.0	0.0	0.0	0.0	0.0
10.0	0.0	0.0	0.0	0.0

Profiles of the assessed vertical movement along the line of this wall are shown for both high and intermediate stiffness support in Figures 13 to 16. The  $\Delta v$  values obtained from these profiles are used in assessing vertical strains for damage assessment.

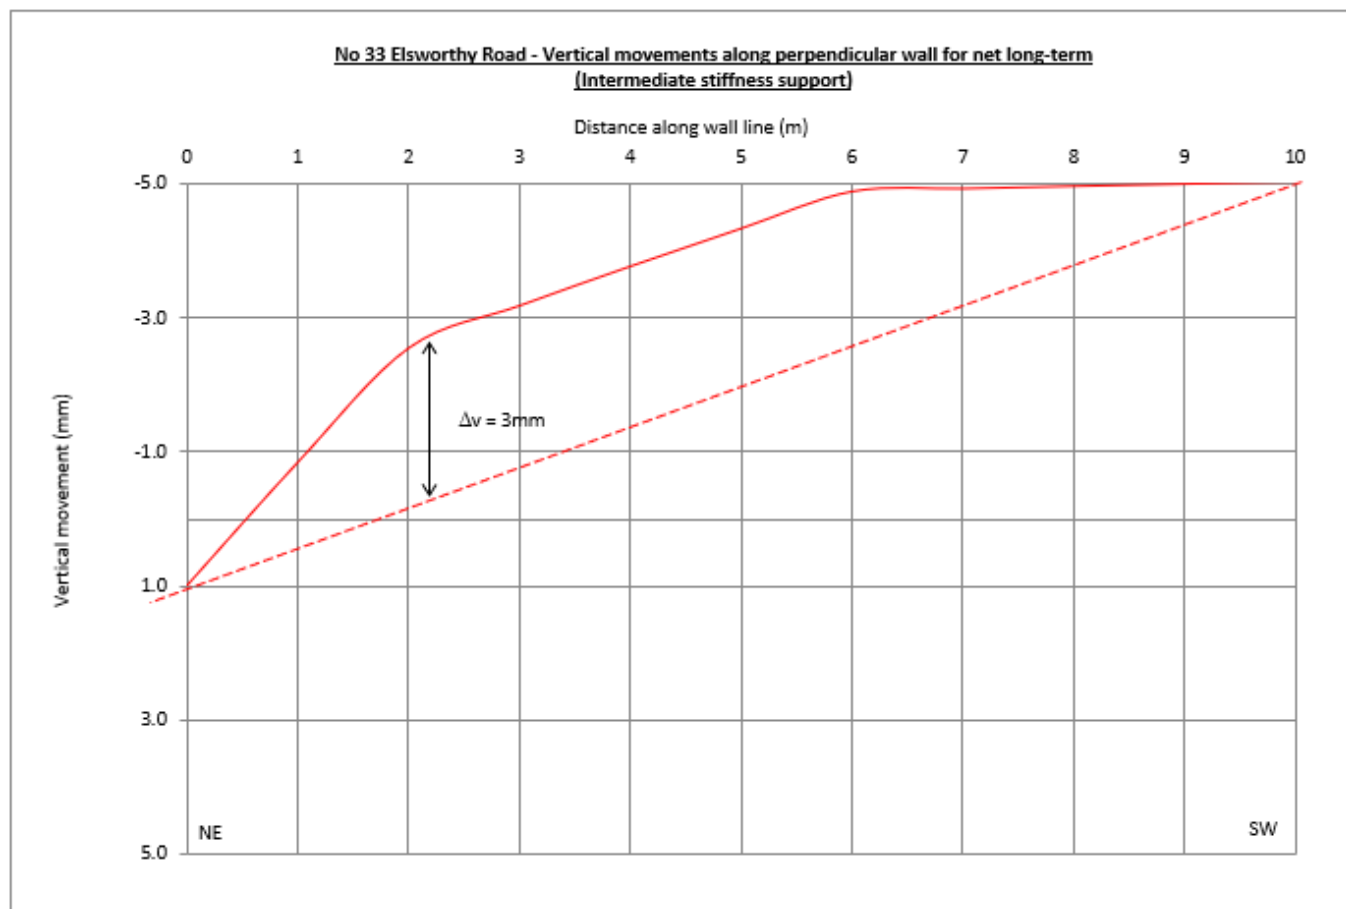
## Long term

Distance along wall line (m)	Perpendicular wall - vertical movement long-term INT		
	Settlement (loading)	Heave (unloading)	Net total movement long-term (mm)
	Due to foundations - from Bouss spreadsheet (mm)	Post-construction heave - from Bouss spreadsheet (mm)	
0.0	0.9	-4.7	1.0
1.0	0.9	-4.7	-0.9
2.0	0.9	-4.8	-2.6
3.0	0.9	-4.8	-3.2
4.0	0.9	-4.9	-3.8
5.0	0.9	-4.9	-4.3
6.0	0.9	-4.9	-4.9
7.0	0.9	-5.0	-4.9
8.0	0.9	-5.0	-5.0
9.0	0.9	-5.0	-5.0
10.0	0.8	-5.0	-5.0

(Note: total long term net movement is determined using the end of construction movement and the post construction movements)

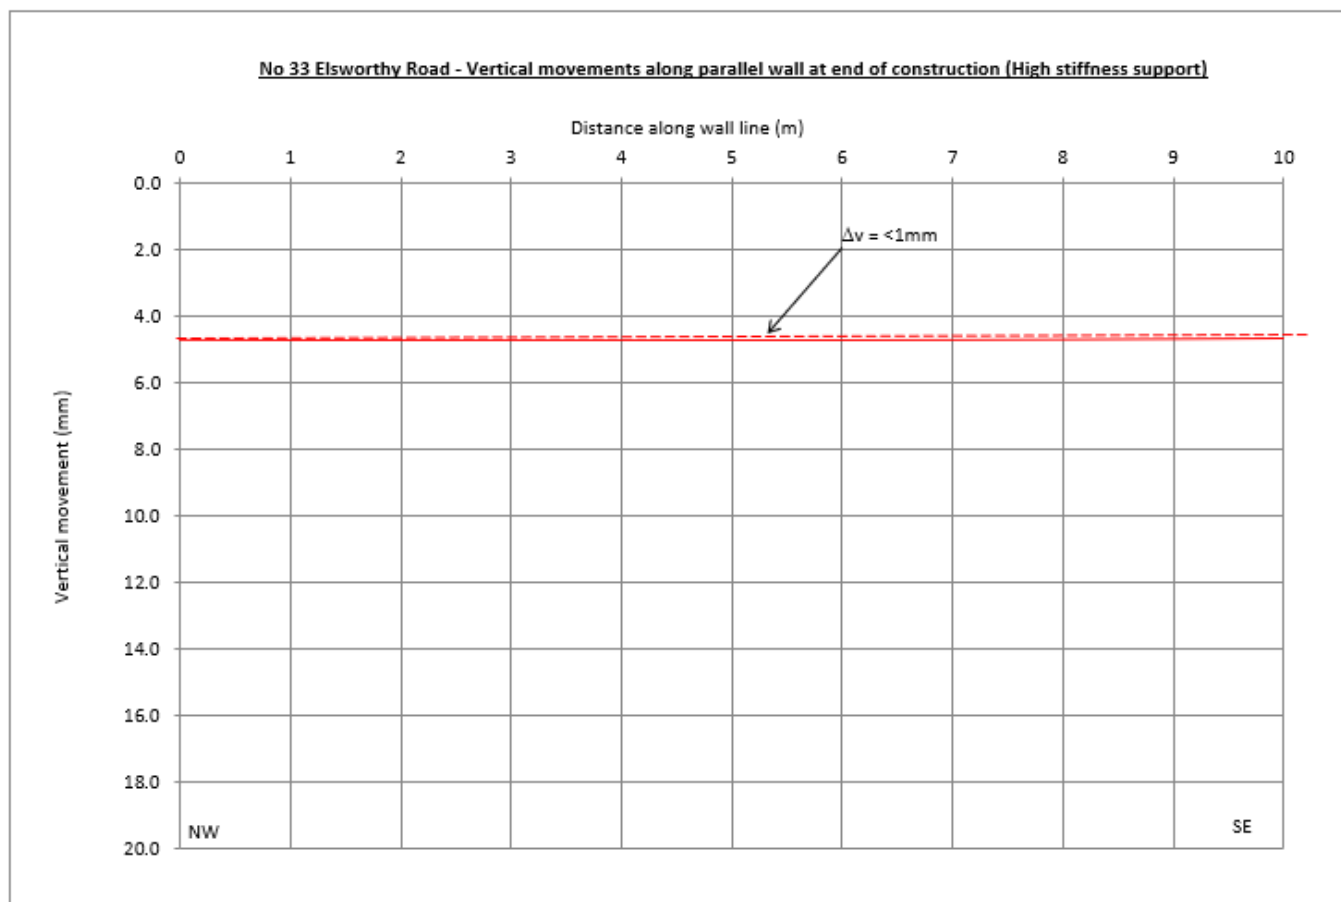
FIGURE 17

End of construction

parallel wall - vertical movement at end of construction HIGH				
Distance along wall line (m)	Installation	Settlement (loading)	Settlement (excavation)	Net vertical movement at end of construction (mm)
	Estimated from CIRIA chart	Due to foundations - from Bouss spreadsheet (mm)	Settlement due to basement excavation - estimated from CIRIA chart	
0.0	2.0	0.7	2.0	4.7
1.0	2.0	0.7	2.0	4.7
2.0	2.0	0.7	2.0	4.7
3.0	2.0	0.7	2.0	4.7
4.0	2.0	0.7	2.0	4.7
5.0	2.0	0.7	2.0	4.7
6.0	2.0	0.7	2.0	4.7
7.0	2.0	0.7	2.0	4.7
8.0	2.0	0.7	2.0	4.7
9.0	2.0	0.7	2.0	4.7
10.0	2.0	0.6	2.0	4.6

Profiles of the assessed vertical movement along the line of this wall are shown for both high and intermediate stiffness support in Figures 17 to 20. The  $\Delta v$  values obtained from these profiles are used in assessing vertical strains for damage assessment.

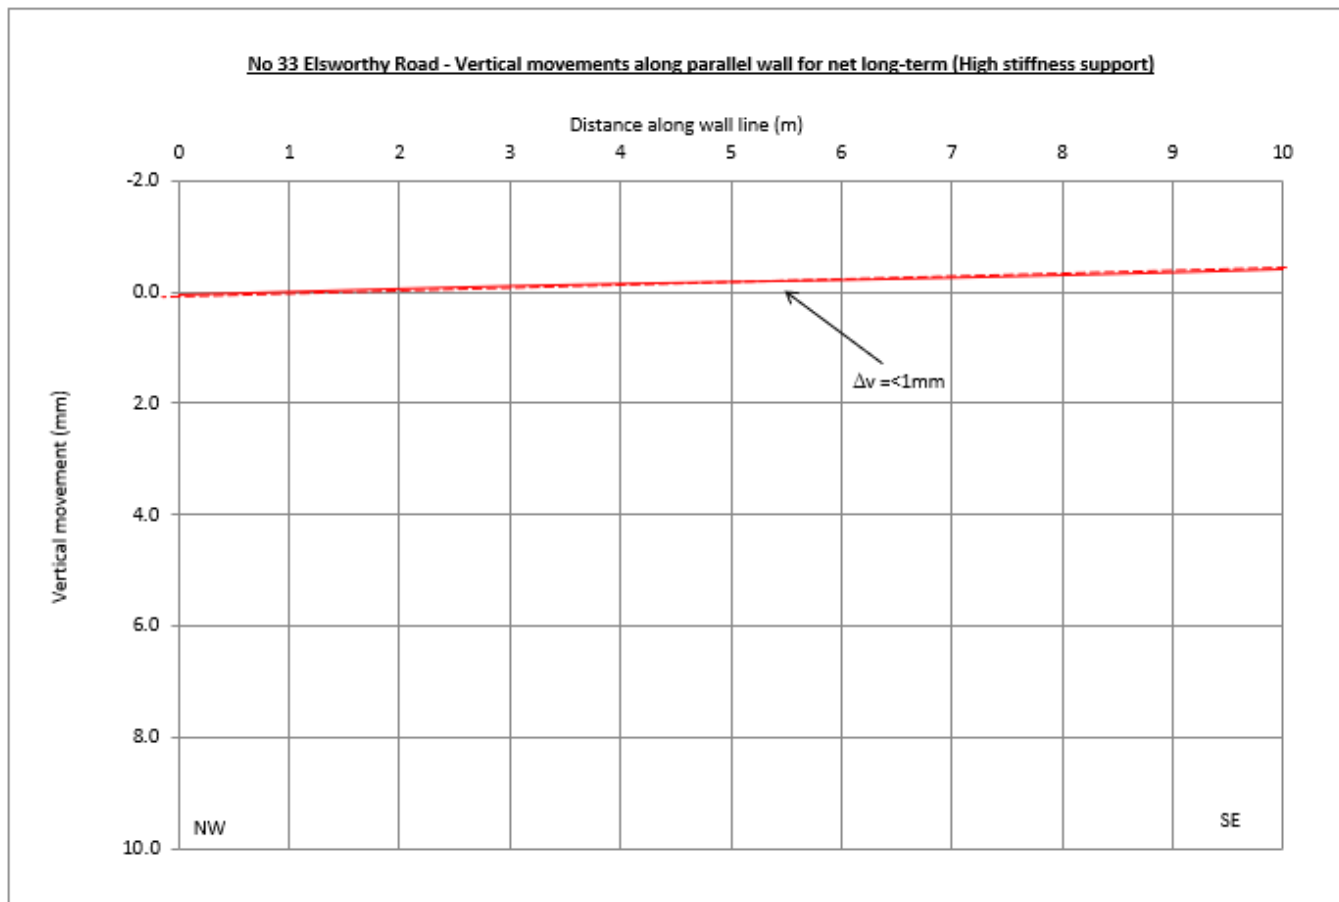
## Long term

Distance along wall line (m)	parallel wall - vertical movement long-term HIGH		
	Settlement (loading) Due to foundations - from Bouss spreadsheet (mm)	Heave (unloading) Post-construction heave - from Bouss spreadsheet (mm)	Net total movement long-term (mm)
0.0	0.9	-4.7	0.0
1.0	0.9	-4.7	0.0
2.0	0.9	-4.8	-0.1
3.0	0.9	-4.8	-0.1
4.0	0.9	-4.9	-0.2
5.0	0.9	-4.9	-0.2
6.0	0.9	-4.9	-0.2
7.0	0.9	-5.0	-0.3
8.0	0.9	-5.0	-0.3
9.0	0.9	-5.0	-0.4
10.0	0.8	-5.0	-0.4

(Note: total long term net is determined using the end of construction movement and the post construction movements)

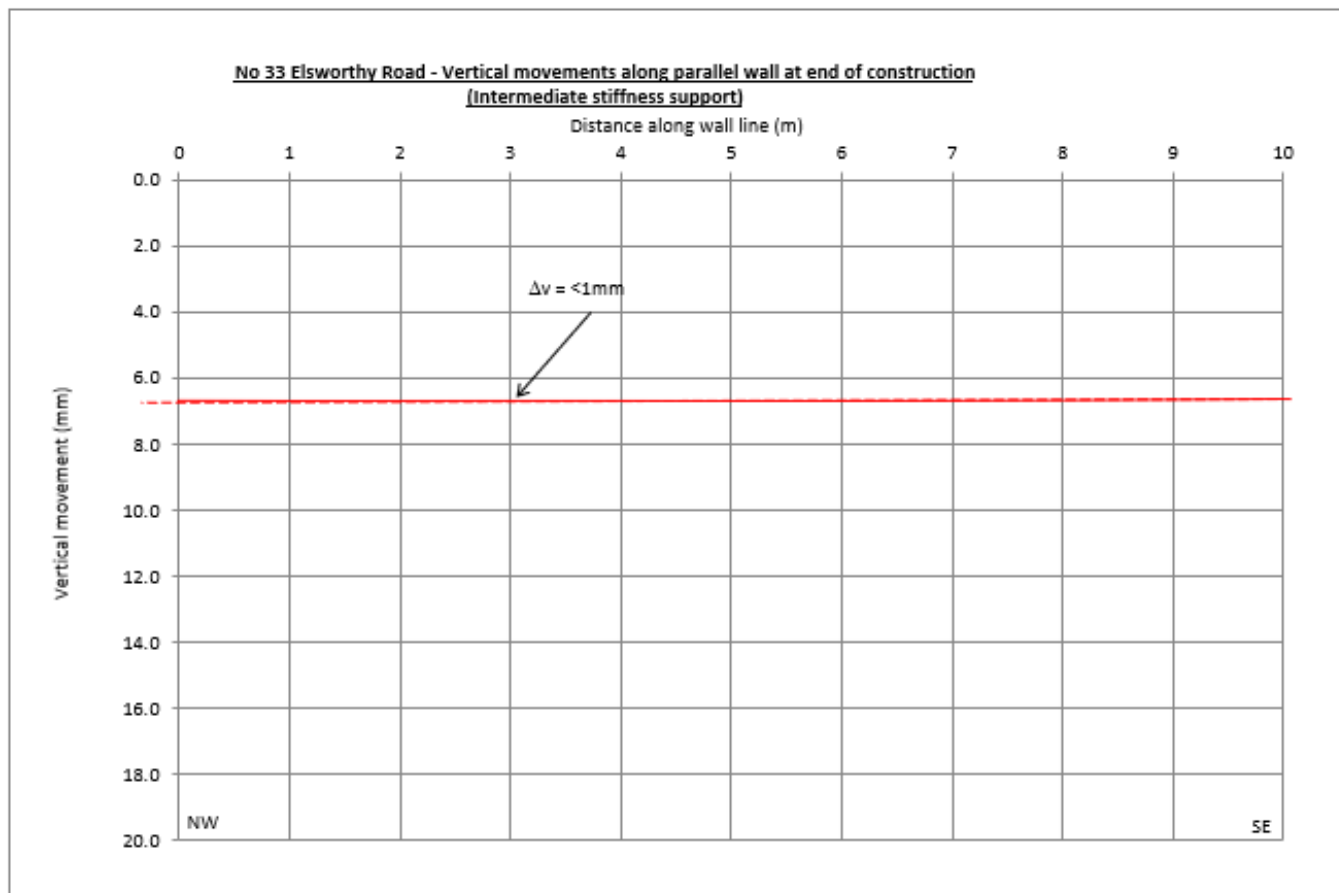
FIGURE 19

End of construction

Parallel wall - vertical movement at end of construction Intermediate				
Distance along wall line (m)	Installation	Settlement (loading)	Settlement (excavation)	Net vertical movement at end of construction (mm)
	Estimated from CIRIA chart	Due to foundations - from Bouss spreadsheet (mm)	Settlement due to basement excavation - estimated from CIRIA chart	
0.0	2.0	0.7	4.0	6.7
1.0	2.0	0.7	4.0	6.7
2.0	2.0	0.7	4.0	6.7
3.0	2.0	0.7	4.0	6.7
4.0	2.0	0.7	4.0	6.7
5.0	2.0	0.7	4.0	6.7
6.0	2.0	0.7	4.0	6.7
7.0	2.0	0.7	4.0	6.7
8.0	2.0	0.7	4.0	6.7
9.0	2.0	0.7	4.0	6.7
10.0	2.0	0.6	4.0	6.6

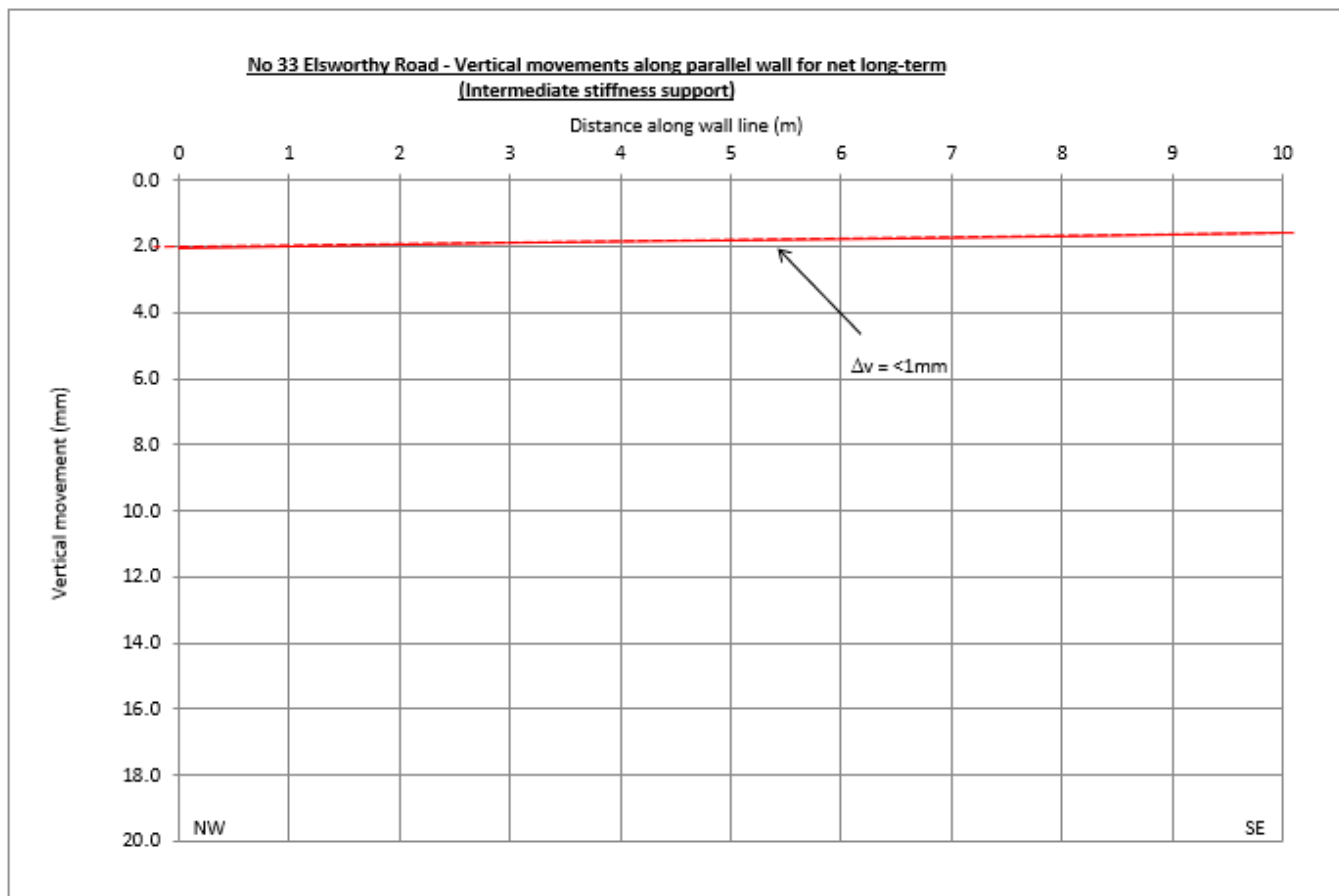
## Long term

Distance along wall line (m)	Parallel wall - vertical movement long-term Intermediate		
	Settlement (loading) Due to foundations - from Bouss spreadsheet (mm)	Heave (unloading) Post-construction heave - from Bouss spreadsheet (mm)	Net total movement long-term (mm)
0.0	0.9	-4.7	2.0
1.0	0.9	-4.7	2.0
2.0	0.9	-4.8	1.9
3.0	0.9	-4.8	1.9
4.0	0.9	-4.9	1.8
5.0	0.9	-4.9	1.8
6.0	0.9	-4.9	1.8
7.0	0.9	-5.0	1.7
8.0	0.9	-5.0	1.7
9.0	0.9	-5.0	1.6
10.0	0.8	-5.0	1.6

(Note: total long term net movement is determined using the end of construction movement and the post construction movements)

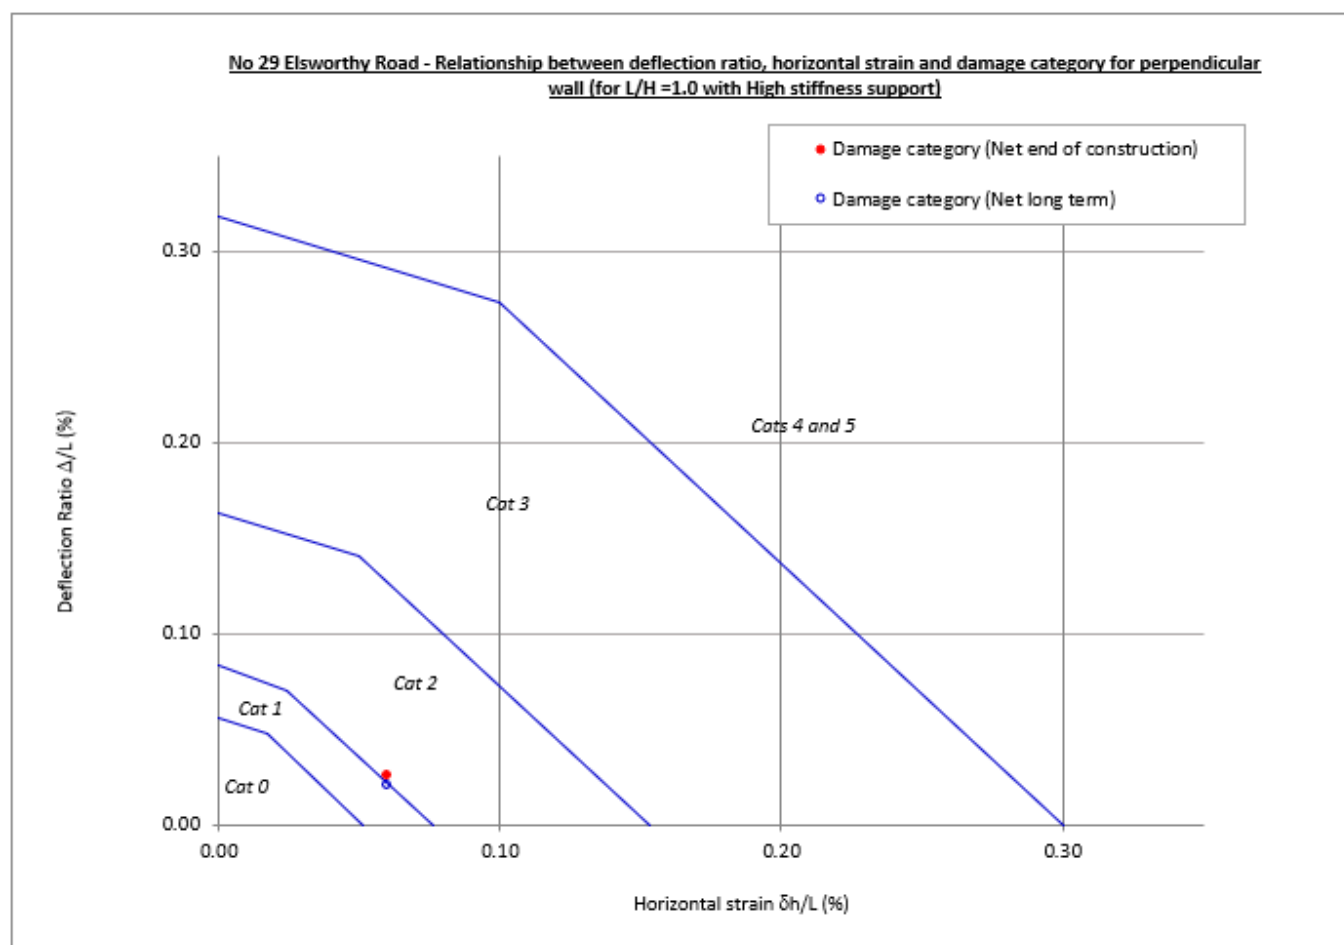
FIGURE 21

## Damage category assessment – No 29 Elsworthy Road perpendicular wall

**High stiffness**

Vertical/horizontal movement (mm)		Wall length (m)	DR/HS
End of construction			
$\Delta v =$	2.5	10.00	0.025
$\delta h =$	6.0	10.00	0.060
Long term			
$\Delta v =$	2.0	10.00	0.020
$\delta h =$	6.0	10.00	0.060

The graphical results are shown in Figures 21 to 28 appended. A summary of the assessed damage categories is shown overleaf:

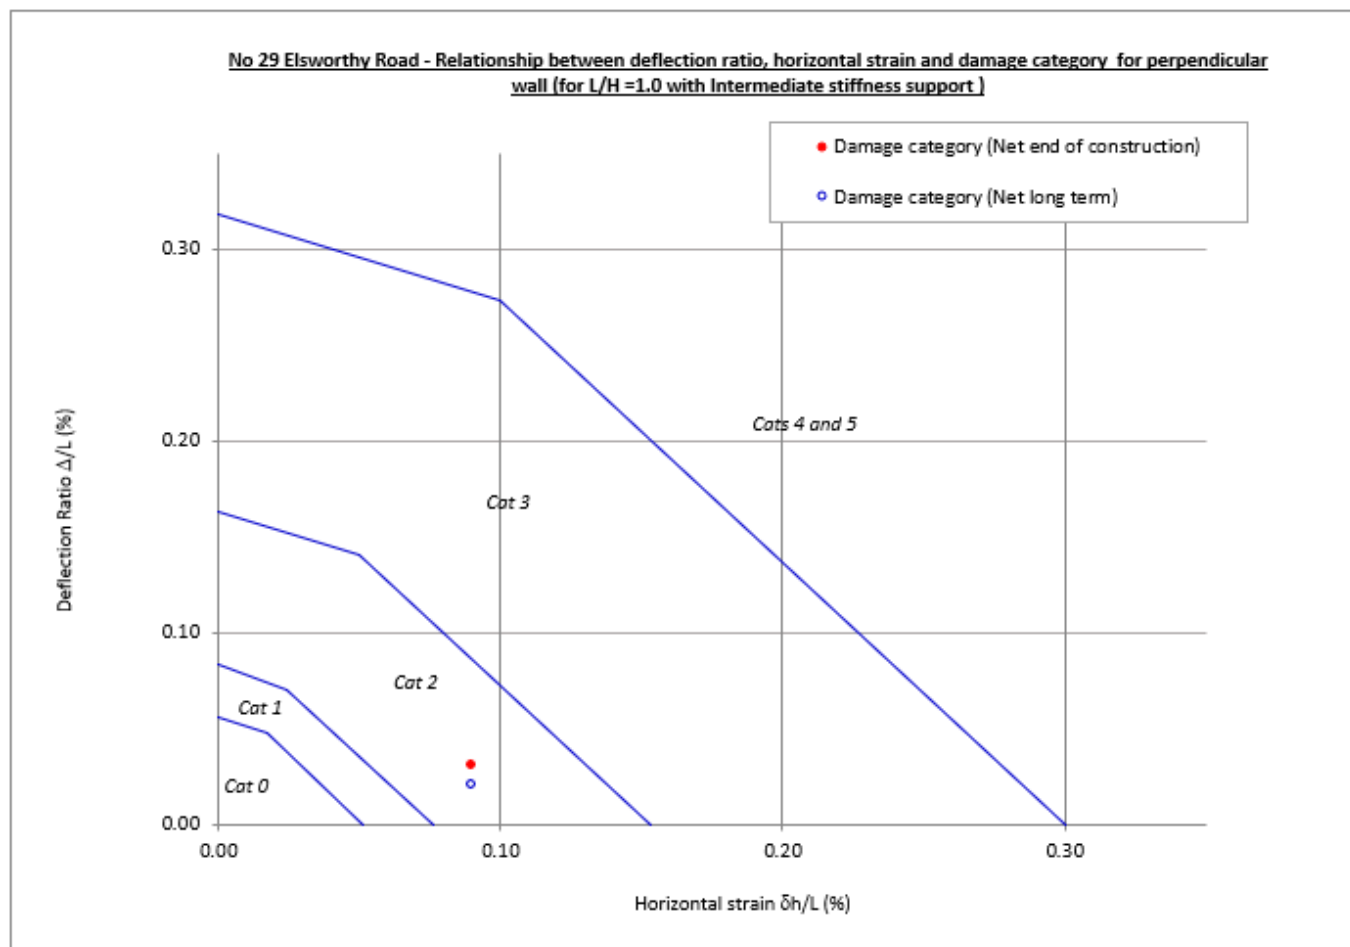
FIGURE 22

Intermediate stiffness

Vertical/horizontal movement (mm)		Wall length (m)	DR/HS
End of construction			
$\Delta v =$	3.0	10.00	0.030
$\delta h =$	9.0	10.00	0.090
Long term			
$\Delta v =$	2.0	10.00	0.020
$\delta h =$	9.0	10.00	0.090

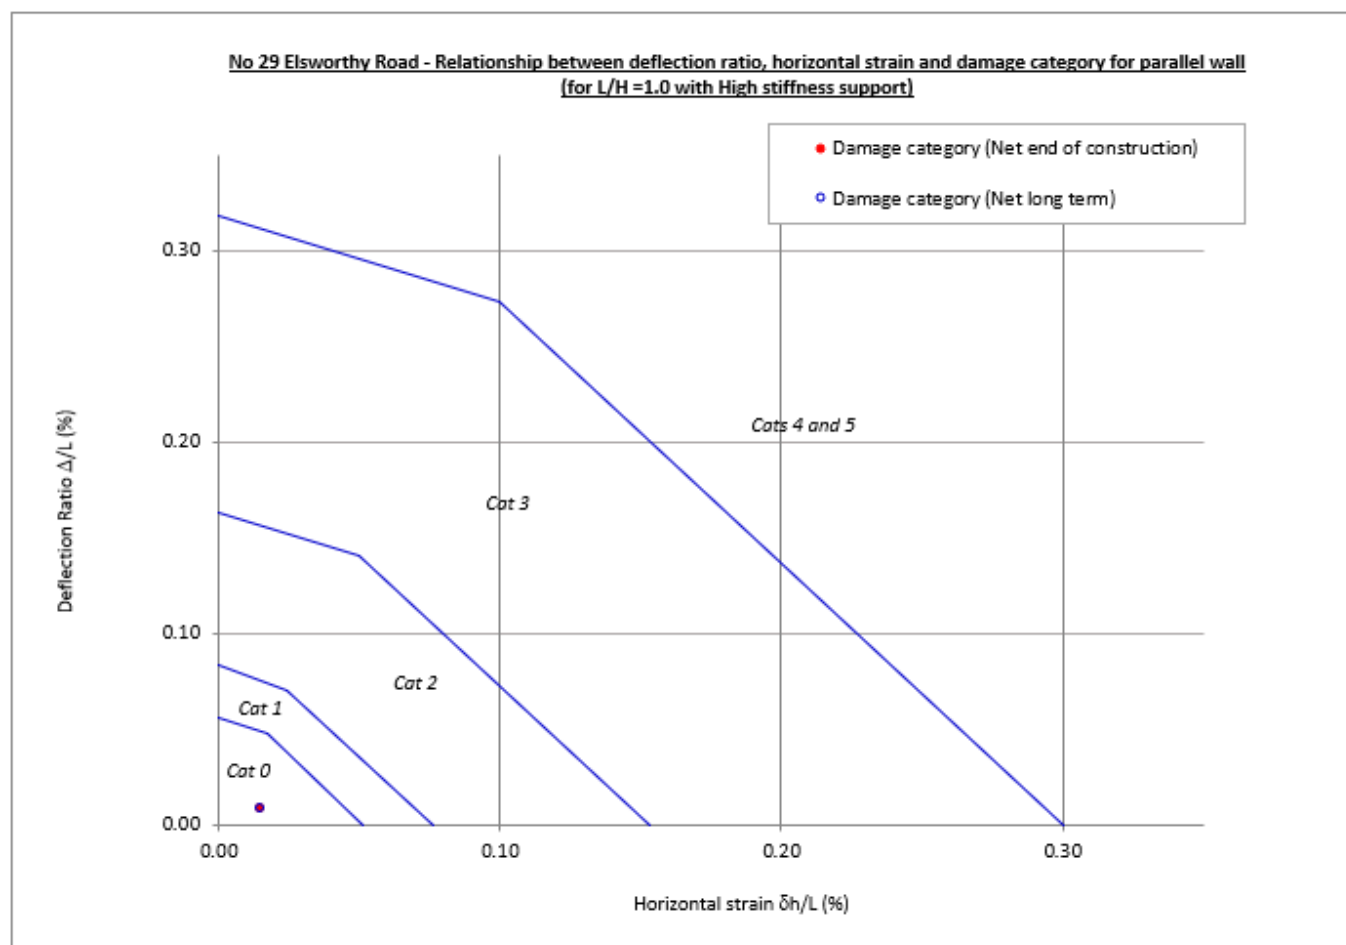
FIGURE 23

**High stiffness**

Vertical/horizontal movement (mm)		Wall length (m)	DR/HS
End of construction			
$\Delta v =$	1.0	13.00	0.008
$\delta h =$	2.0	13.00	0.015
Long term			
$\Delta v =$	1.0	13.00	0.008
$\delta h =$	2.0	13.00	0.015

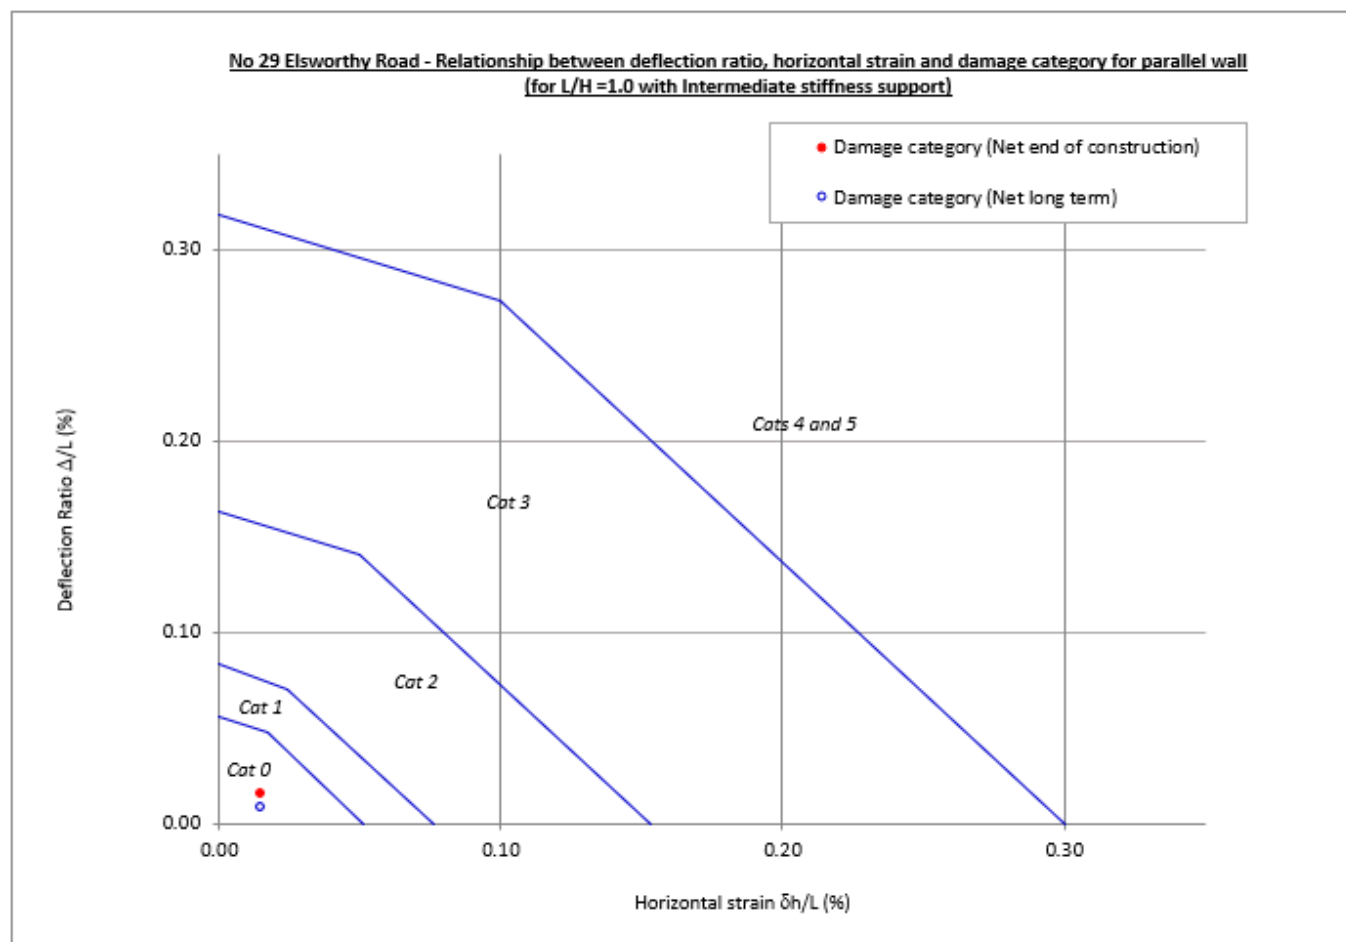
FIGURE 24

Intermediate stiffness

Vertical/horizontal movement (mm)		Wall length (m)	DR/HS
End of construction			
$\Delta v =$	2.0	13.00	0.015
$\delta h =$	2.0	13.00	0.015
Long term			
$\Delta v =$	1.0	13.00	0.008
$\delta h =$	2.0	13.00	0.015

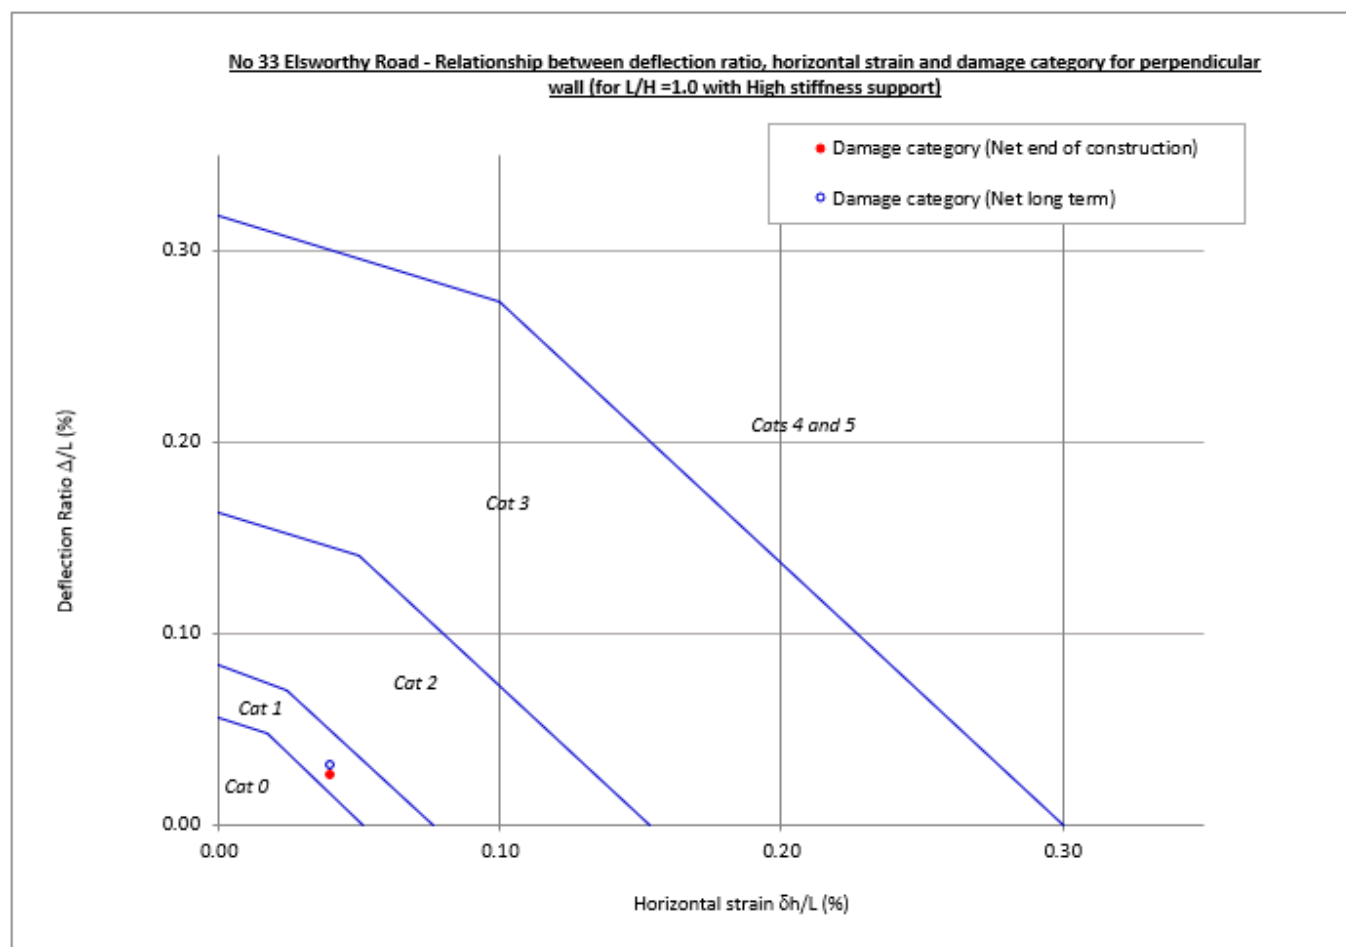
FIGURE 25

## High stiffness

Vertical/horizontal movement (mm)		Wall length (m)	DR/HS
End of construction			
$\Delta v =$	2.5	10.00	0.025
$\delta h =$	4.0	10.00	0.040
Long term			
$\Delta v =$	3.0	10.00	0.030
$\delta h =$	4.0	10.00	0.040

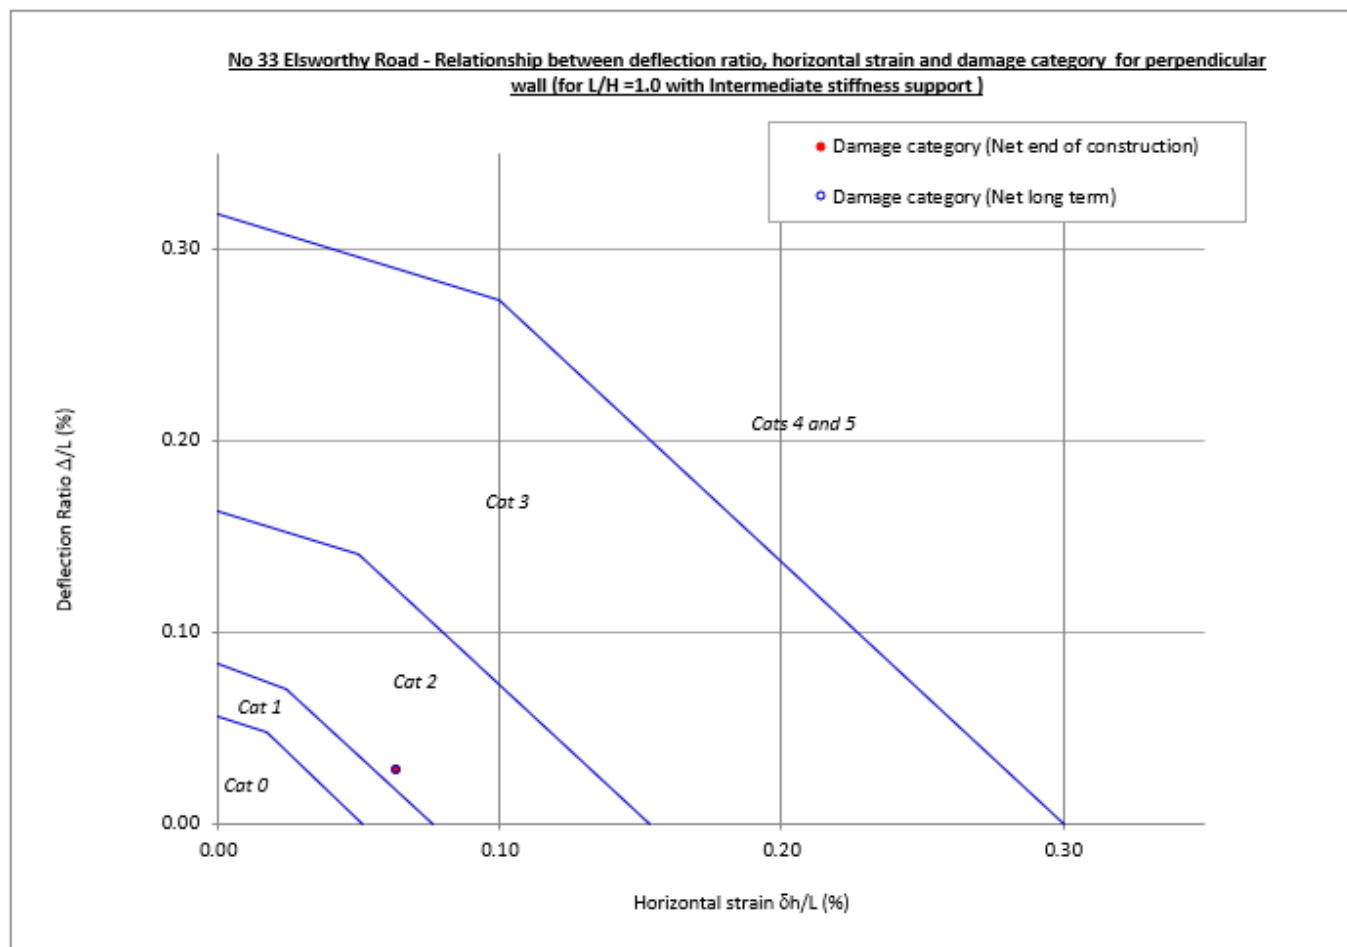
FIGURE 26

Intermediate stiffness

Vertical/horizontal movement (mm)		Wall length (m)	DR/HS
End of construction			
$\Delta v =$	3.0	11.00	0.027
$\delta h =$	7.0	11.00	0.064
Long term			
$\Delta v =$	3.0	11.00	0.027
$\delta h =$	7.0	11.00	0.064

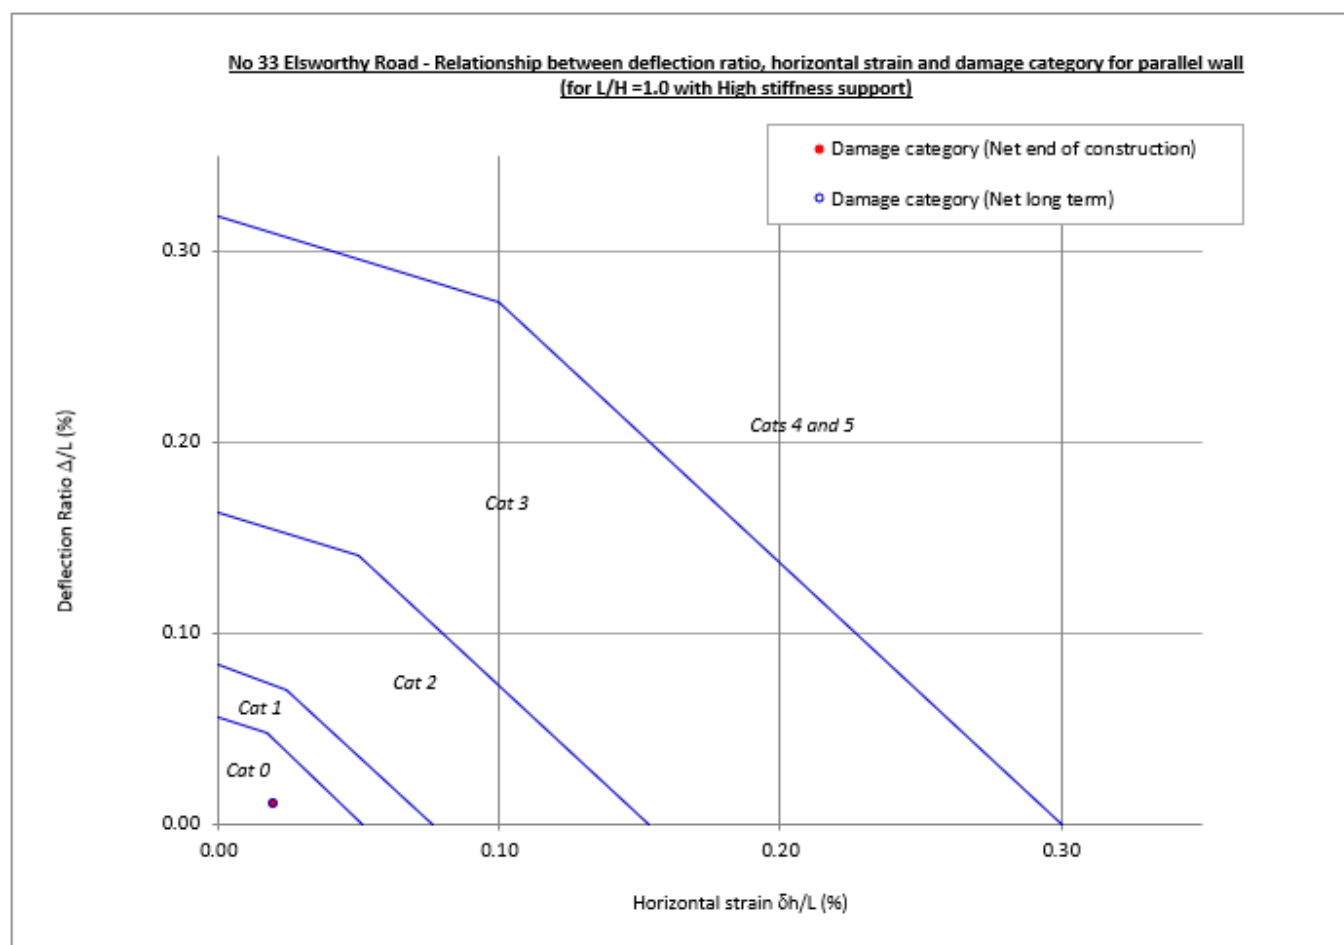
FIGURE 27

## High stiffness

Vertical/horizontal movement (mm)		Wall length (m)	DR/HS
End of construction			
$\Delta v =$	1.0	10.00	0.010
$\delta h =$	2.0	10.00	0.020
Long term			
$\Delta v =$	1.0	10.00	0.010
$\delta h =$	2.0	10.00	0.020

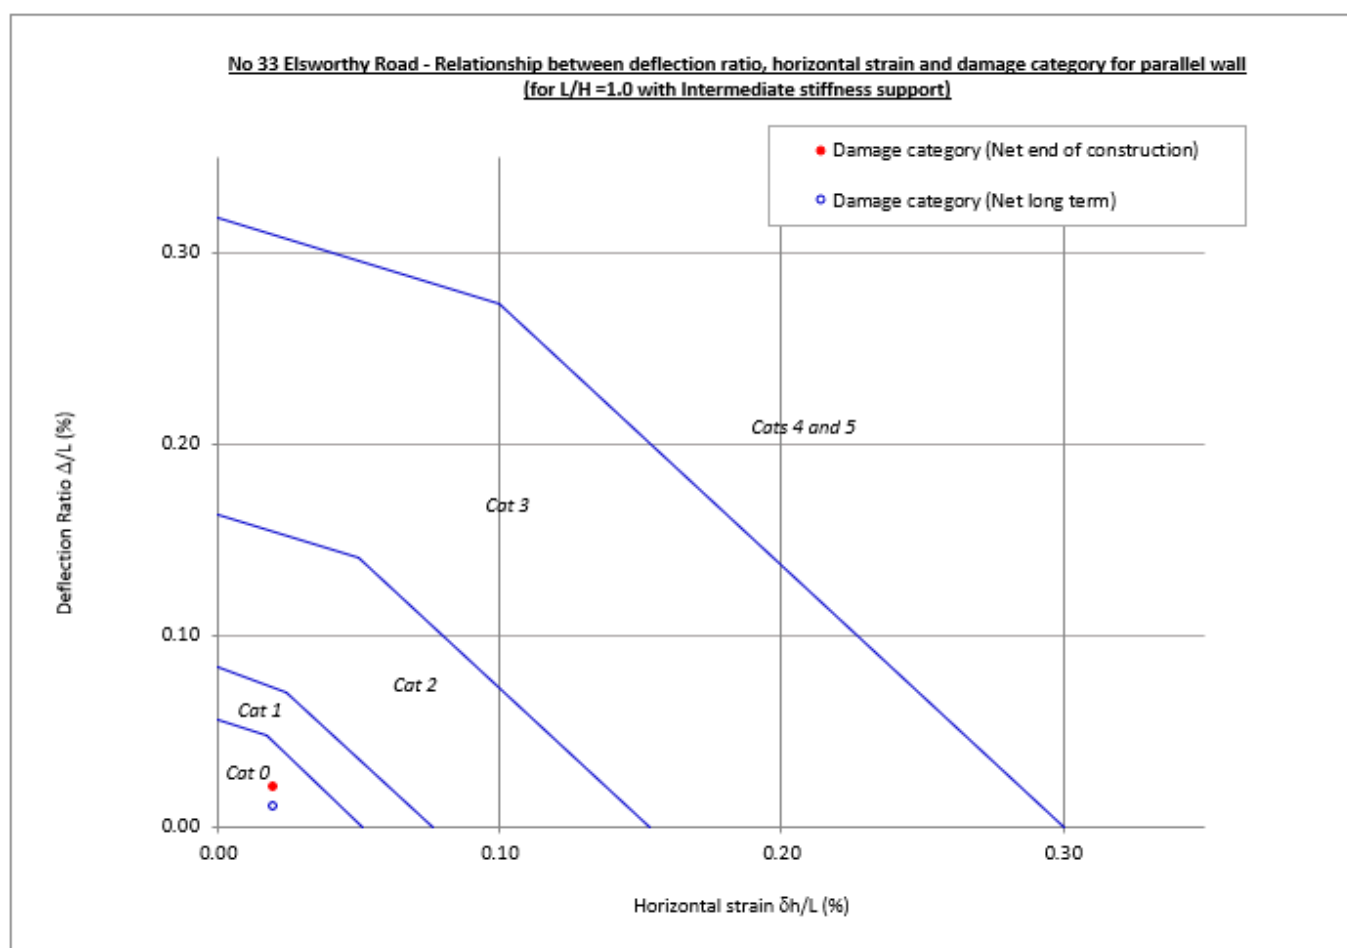
FIGURE 28

Intermediate stiffness

Vertical/horizontal movement (mm)		Wall length (m)	DR/HS
End of construction			
$\Delta v =$	2.0	10.00	0.020
$\delta h =$	2.0	10.00	0.020
Long term			
$\Delta v =$	1.0	10.00	0.010
$\delta h =$	2.0	10.00	0.020

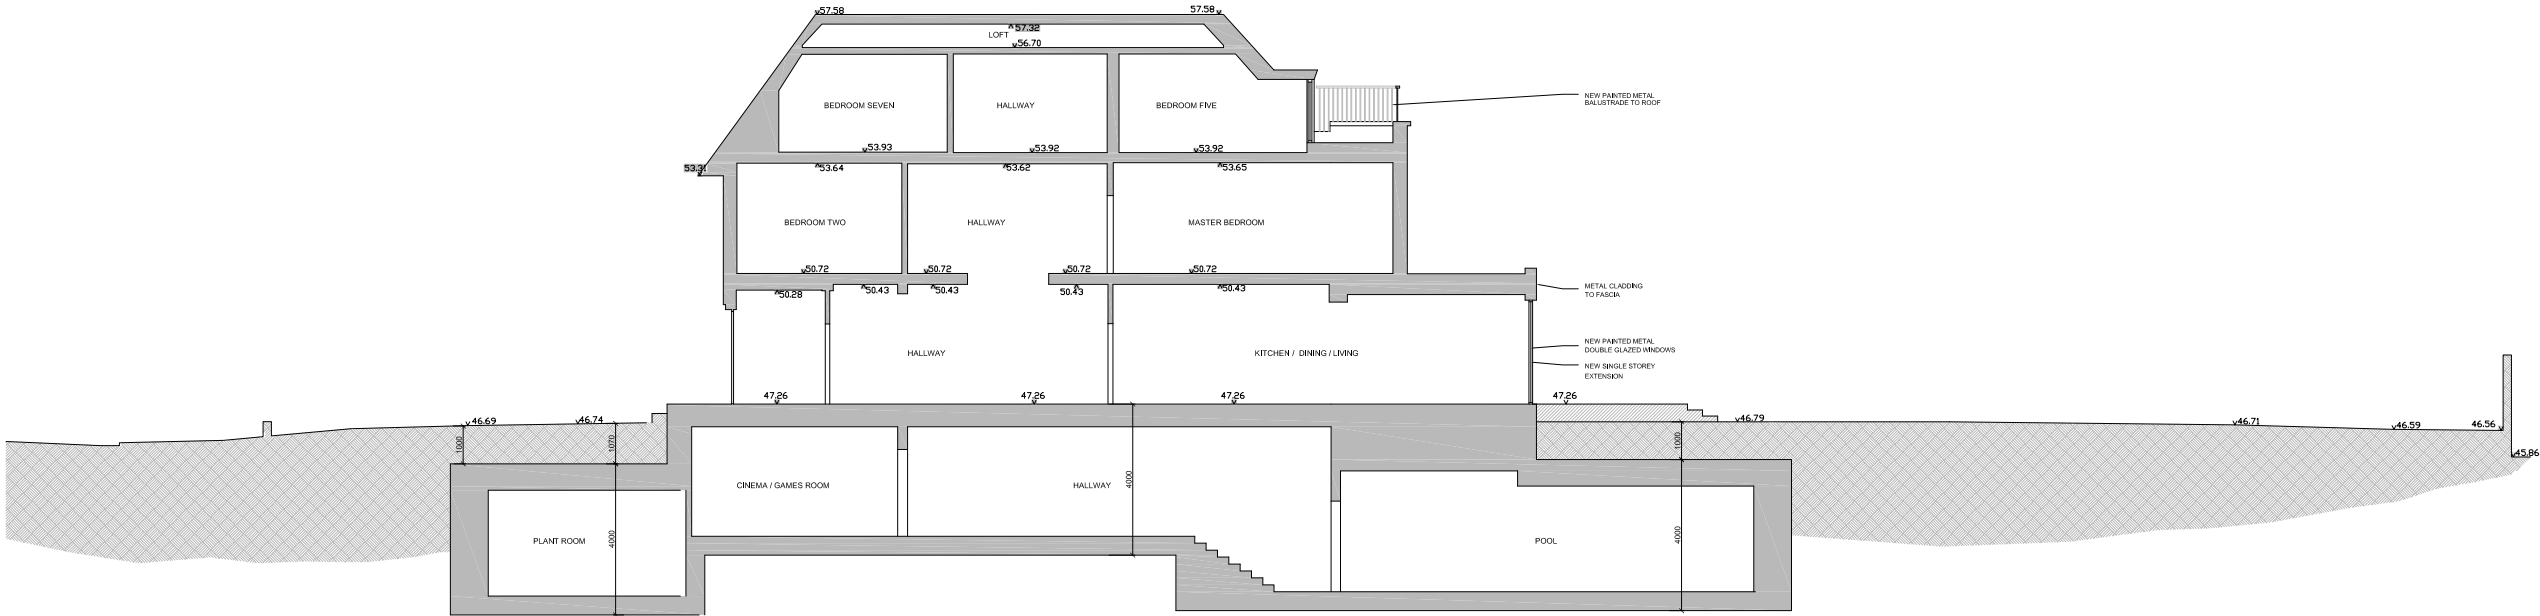
PROPOSED SECTION AA

Datum Line Level :40.00m

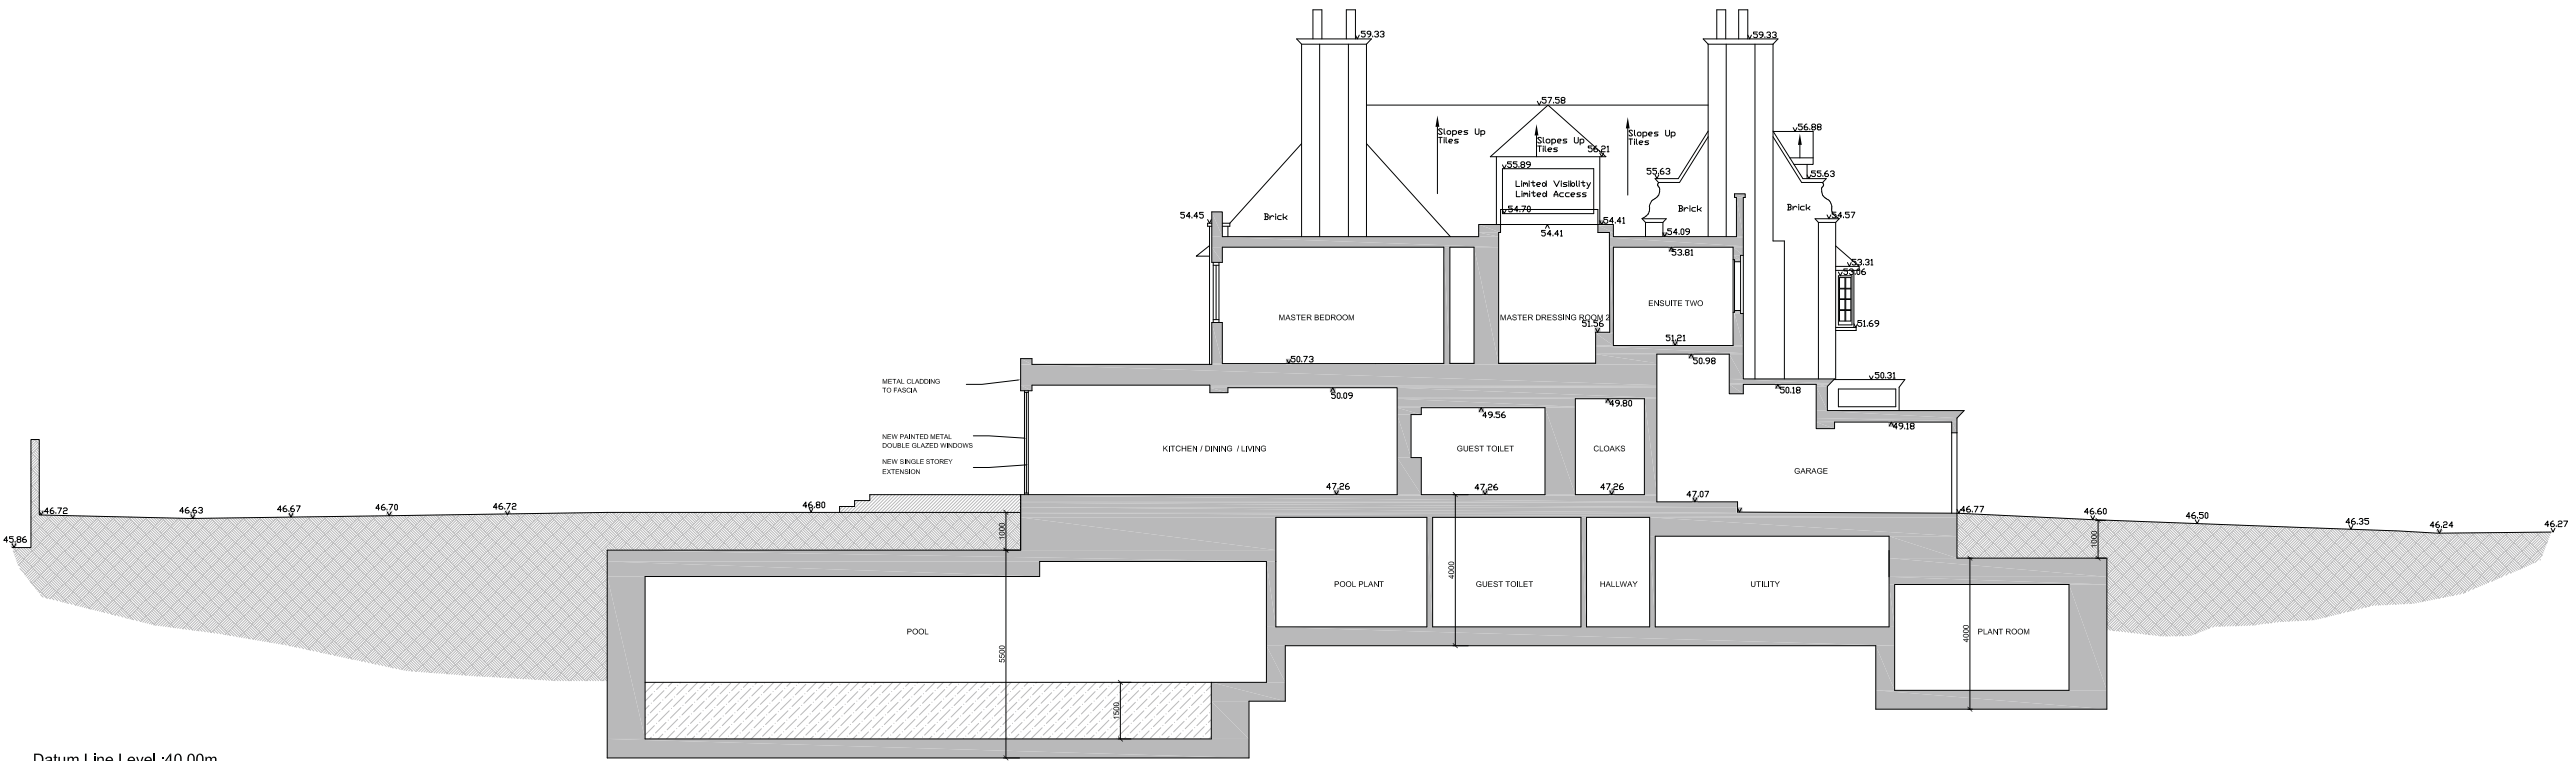
PROPOSED SECTION BB

Datum Line Level :40.00m
