## 18 Grove Terrace, NW5 1PH

Method Statements - Cleaning of Front and Rear Facade

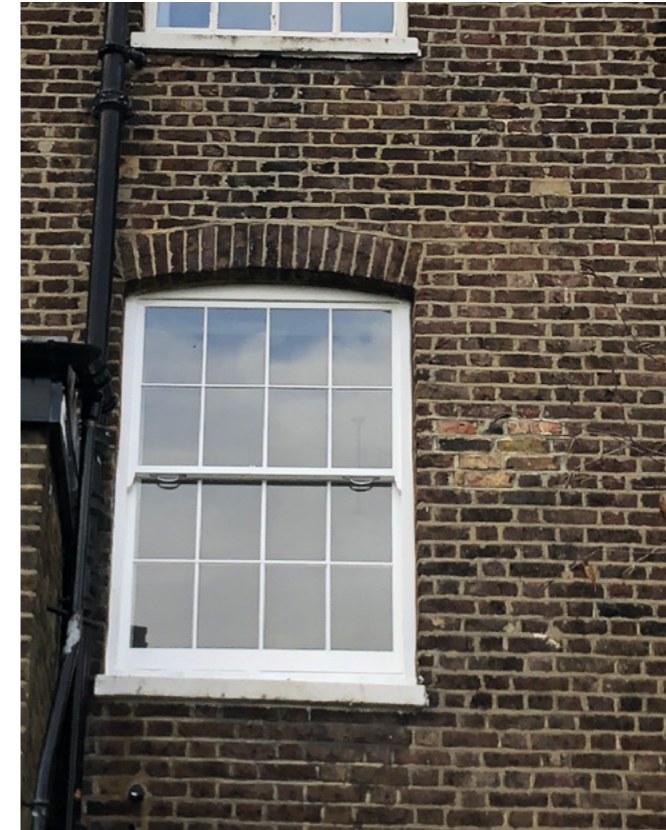
Images of rear exterior and existing pointing conditions - poor, weathered and dirty.

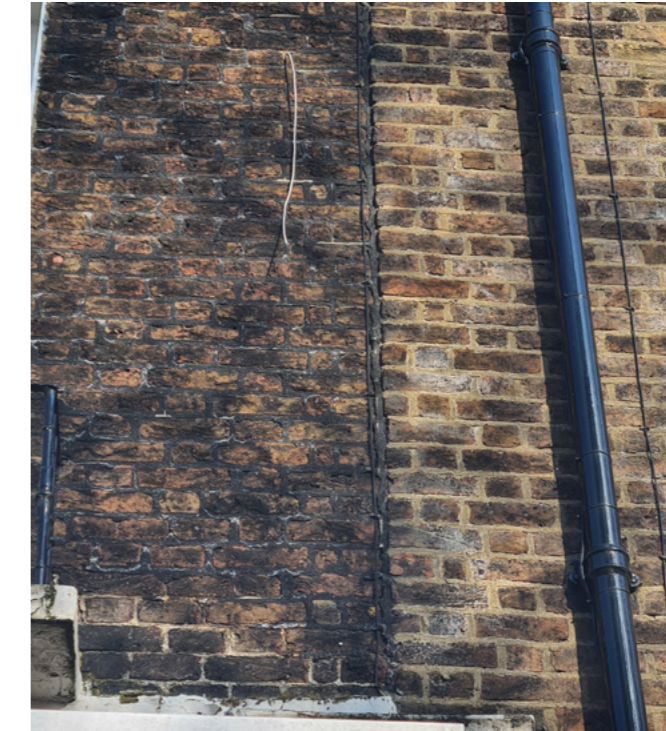
Existing Front Facade

The exterior of the building is in poor visual condition, years of soot and airbourne dirt has taken its toll on the facade.
