PROJECT:
62_Parliament Hill

DRAWING:
SIDE (SOUTH) ELEVATION 2
(TANZA ROAD ELEVATION)
2101/PL.22_B

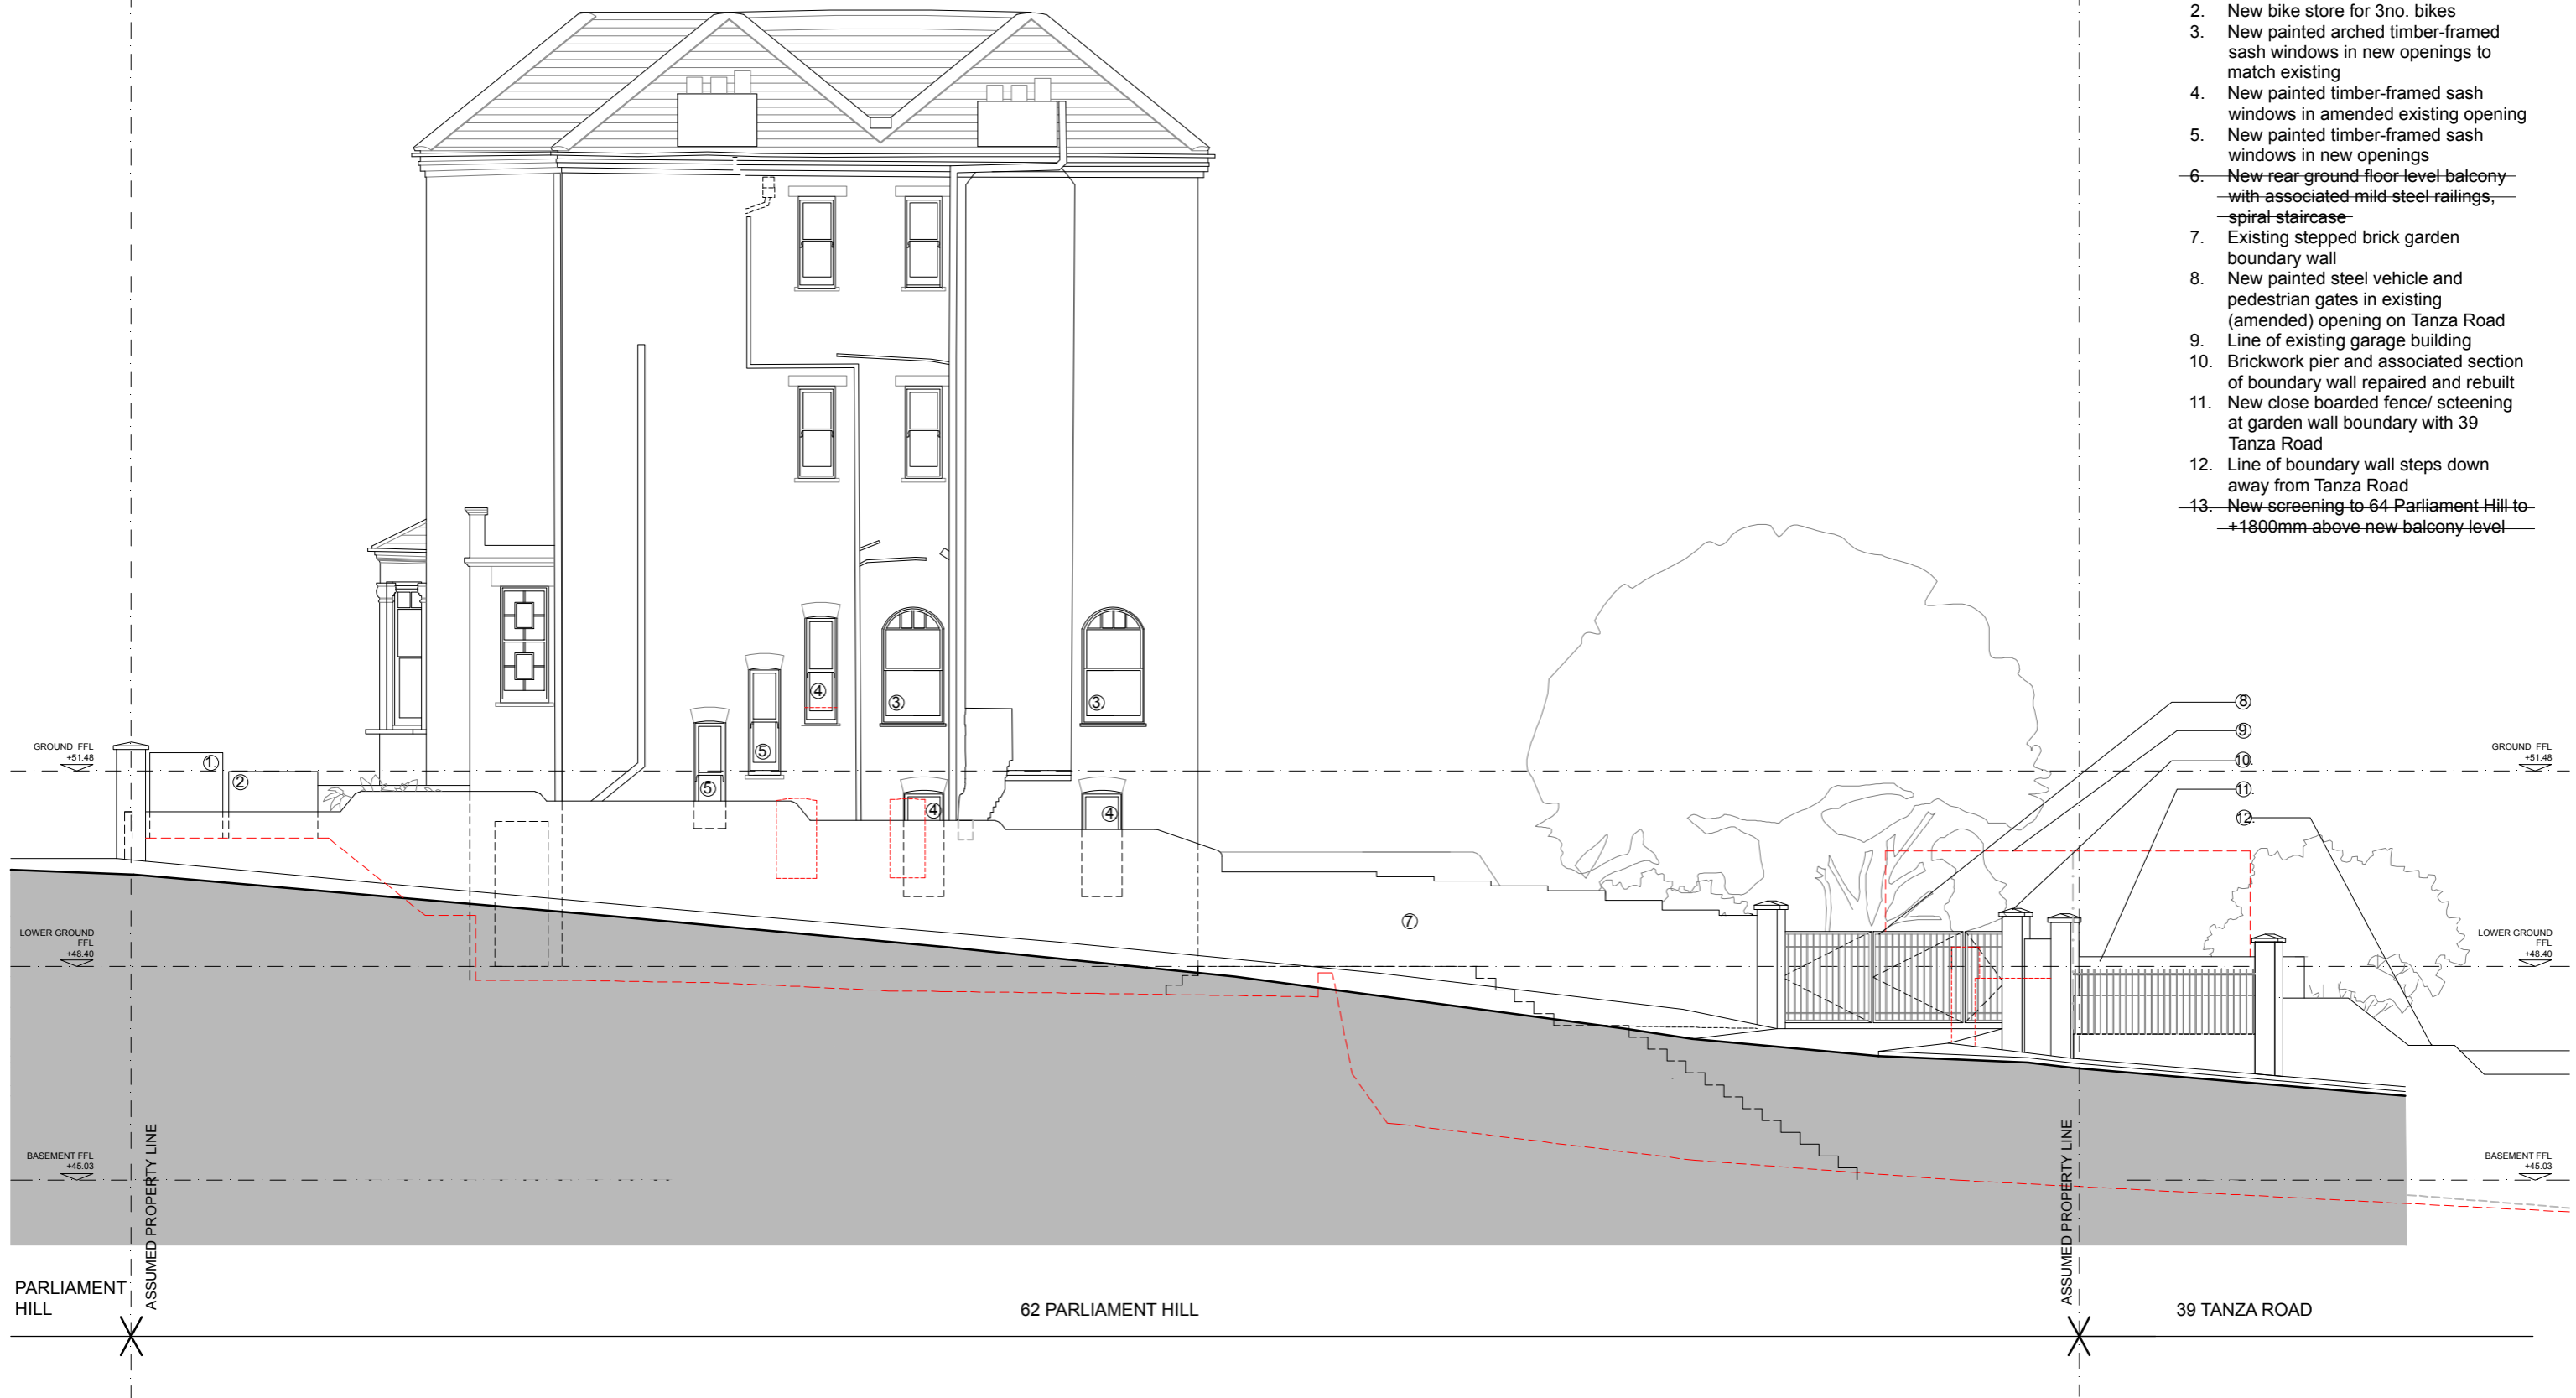
1. New bin store for 2no. wheelie bins
2. New bike store for 3no. bikes
3. New painted arched timber-framed sash windows in new openings to match existing
4. New painted timber-framed sash windows in amended existing opening
5. New painted timber-framed sash windows in new openings
- ~~6. New rear ground floor level balcony with associated mild steel railings, spiral staircase~~
7. Existing stepped brick garden boundary wall
8. New painted steel vehicle and pedestrian gates in existing (amended) opening on Tanza Road
9. Line of existing garage building
10. Brickwork pier and associated section of boundary wall repaired and rebuilt
11. New close boarded fence/ screening at garden wall boundary with 39 Tanza Road
12. Line of boundary wall steps down away from Tanza Road
- ~~13. New screening to 64 Parliament Hill to +1800mm above new balcony level~~

B 21.02.22 Balcony removed
