PROJECT:
62_Parliament Hill

DRAWING:
**SOUTH EAST
BOUNDARY ELEVATION 11
2101/PL.27_B**

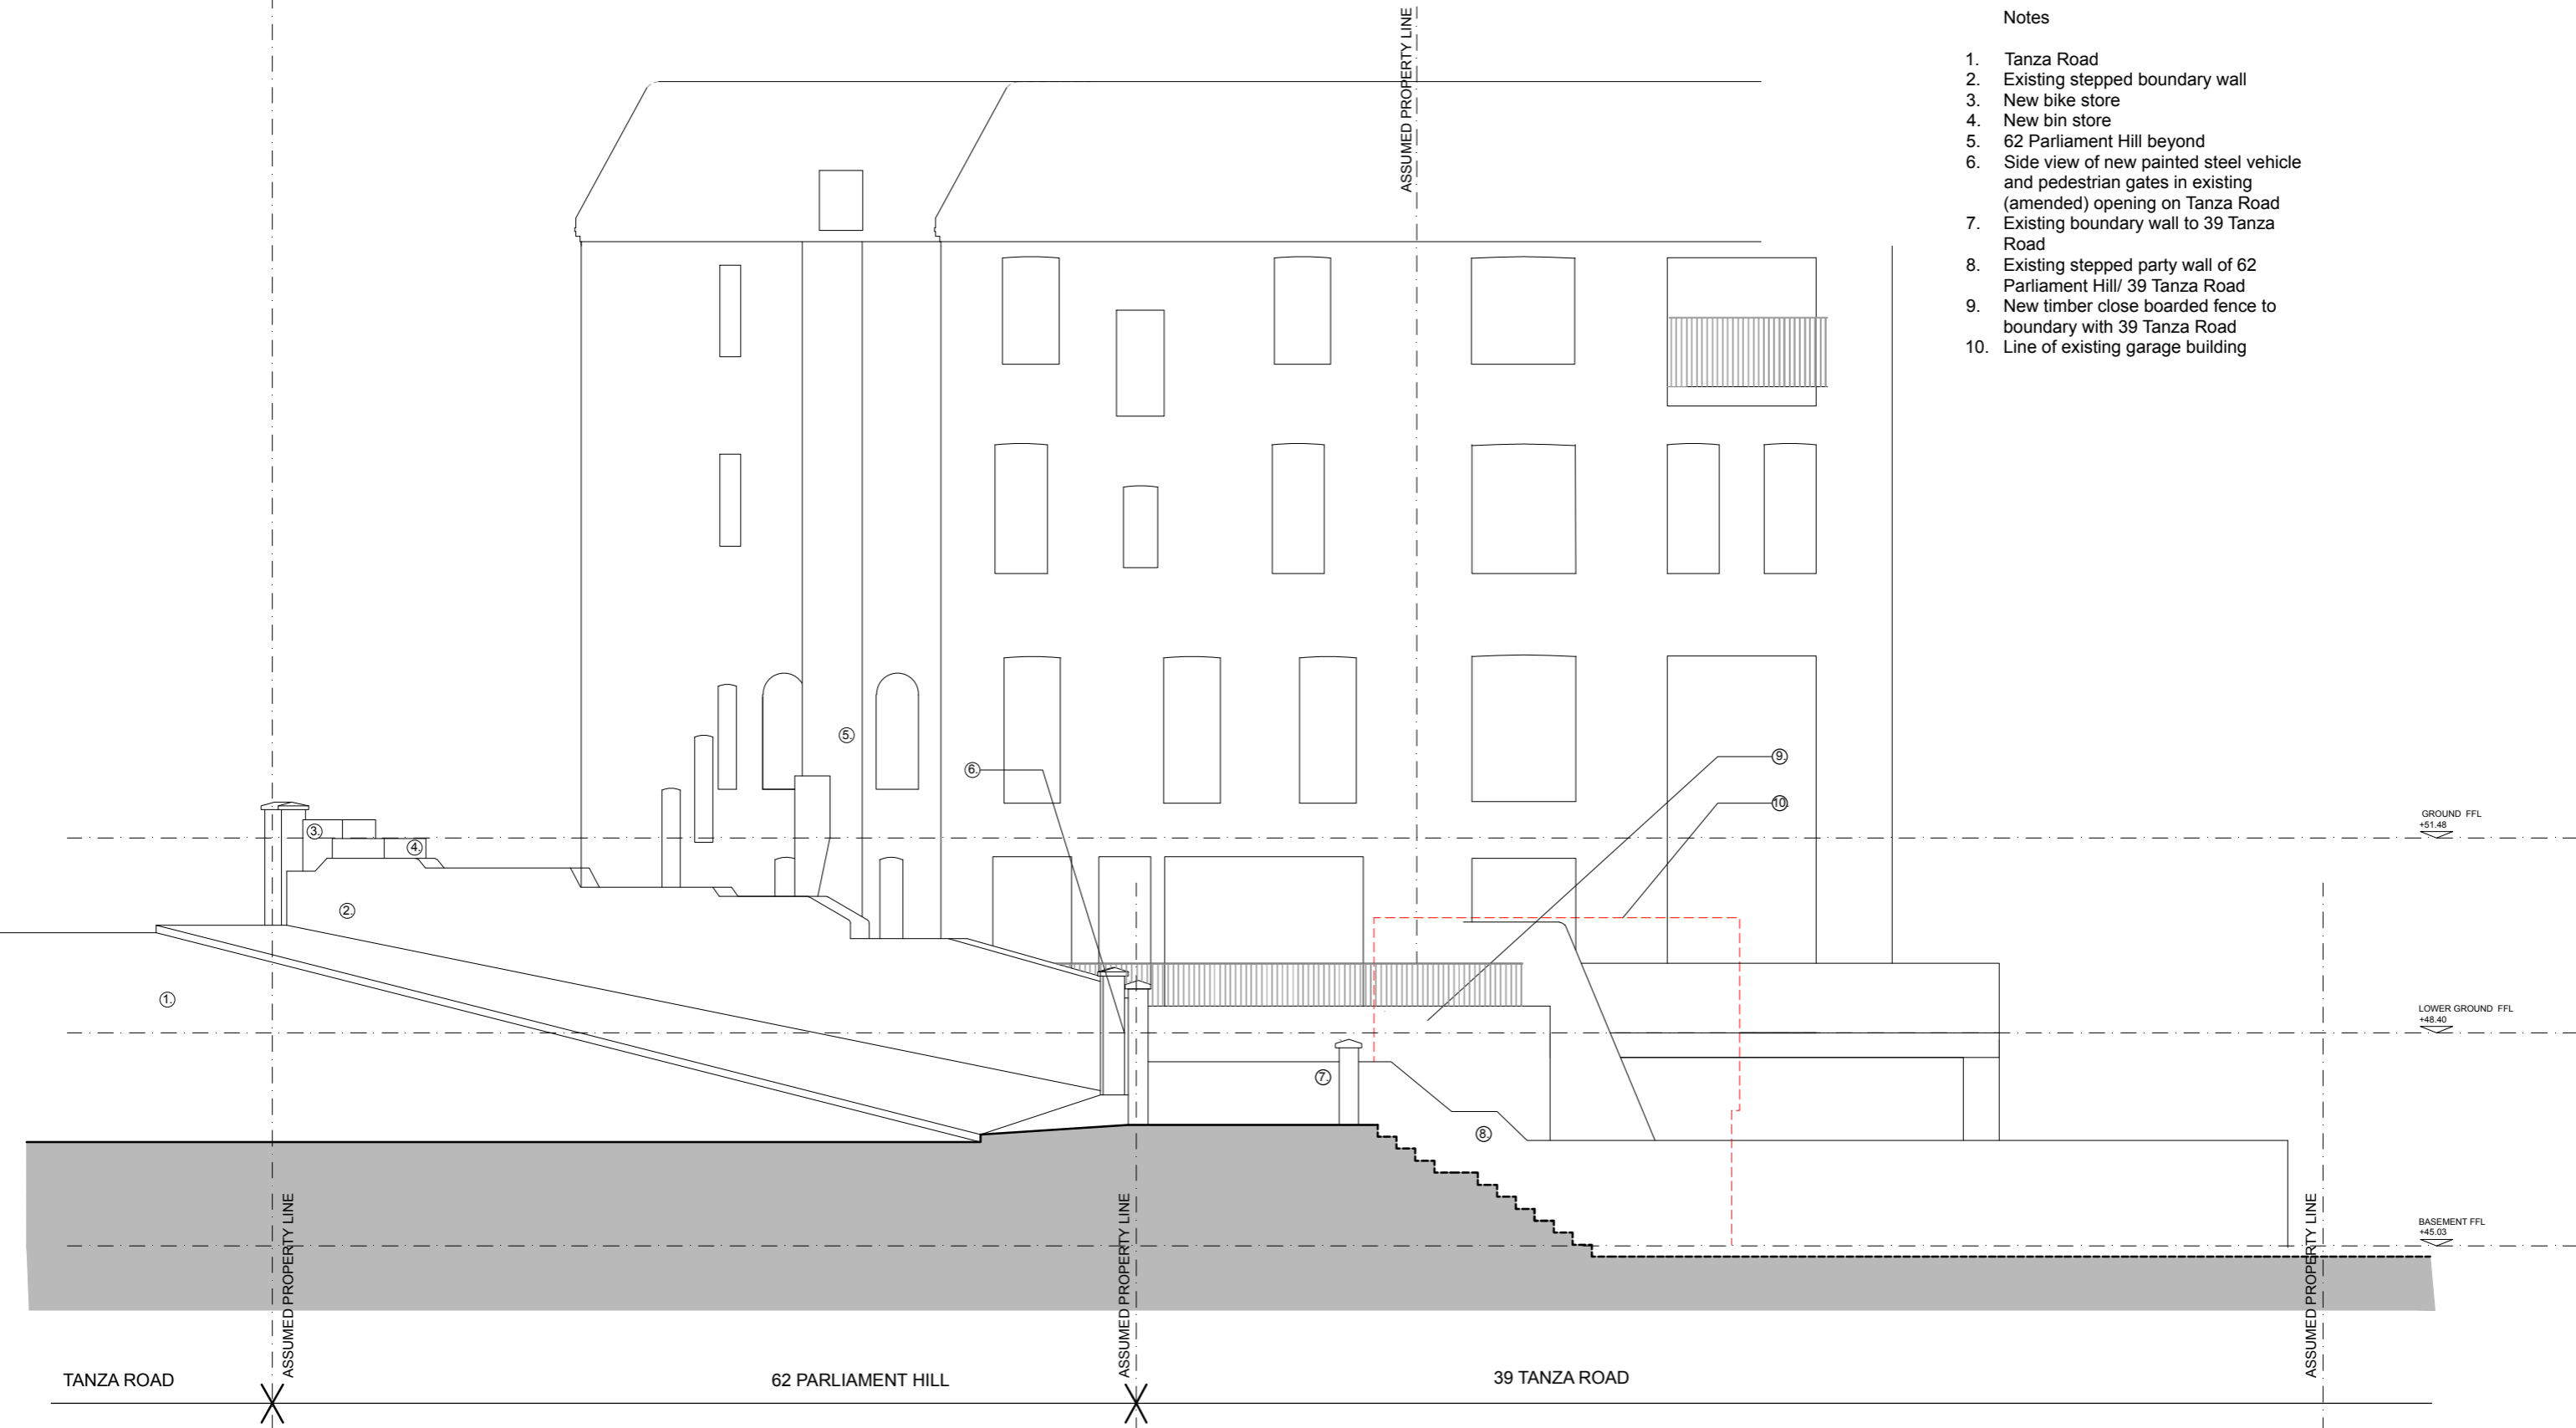
1. Tanza Road
2. Existing stepped boundary wall
3. New bike store
4. New bin store
5. 62 Parliament Hill beyond
6. Side view of new painted steel vehicle and pedestrian gates in existing (amended) opening on Tanza Road
7. Existing boundary wall to 39 Tanza Road
8. Existing stepped party wall of 62 Parliament Hill/ 39 Tanza Road
9. New timber close boarded fence to boundary with 39 Tanza Road
10. Line of existing garage building
