PROJECT:
62_Parliament Hill

DRAWING:
LONG SECTION A-A

2101/PL.28_B

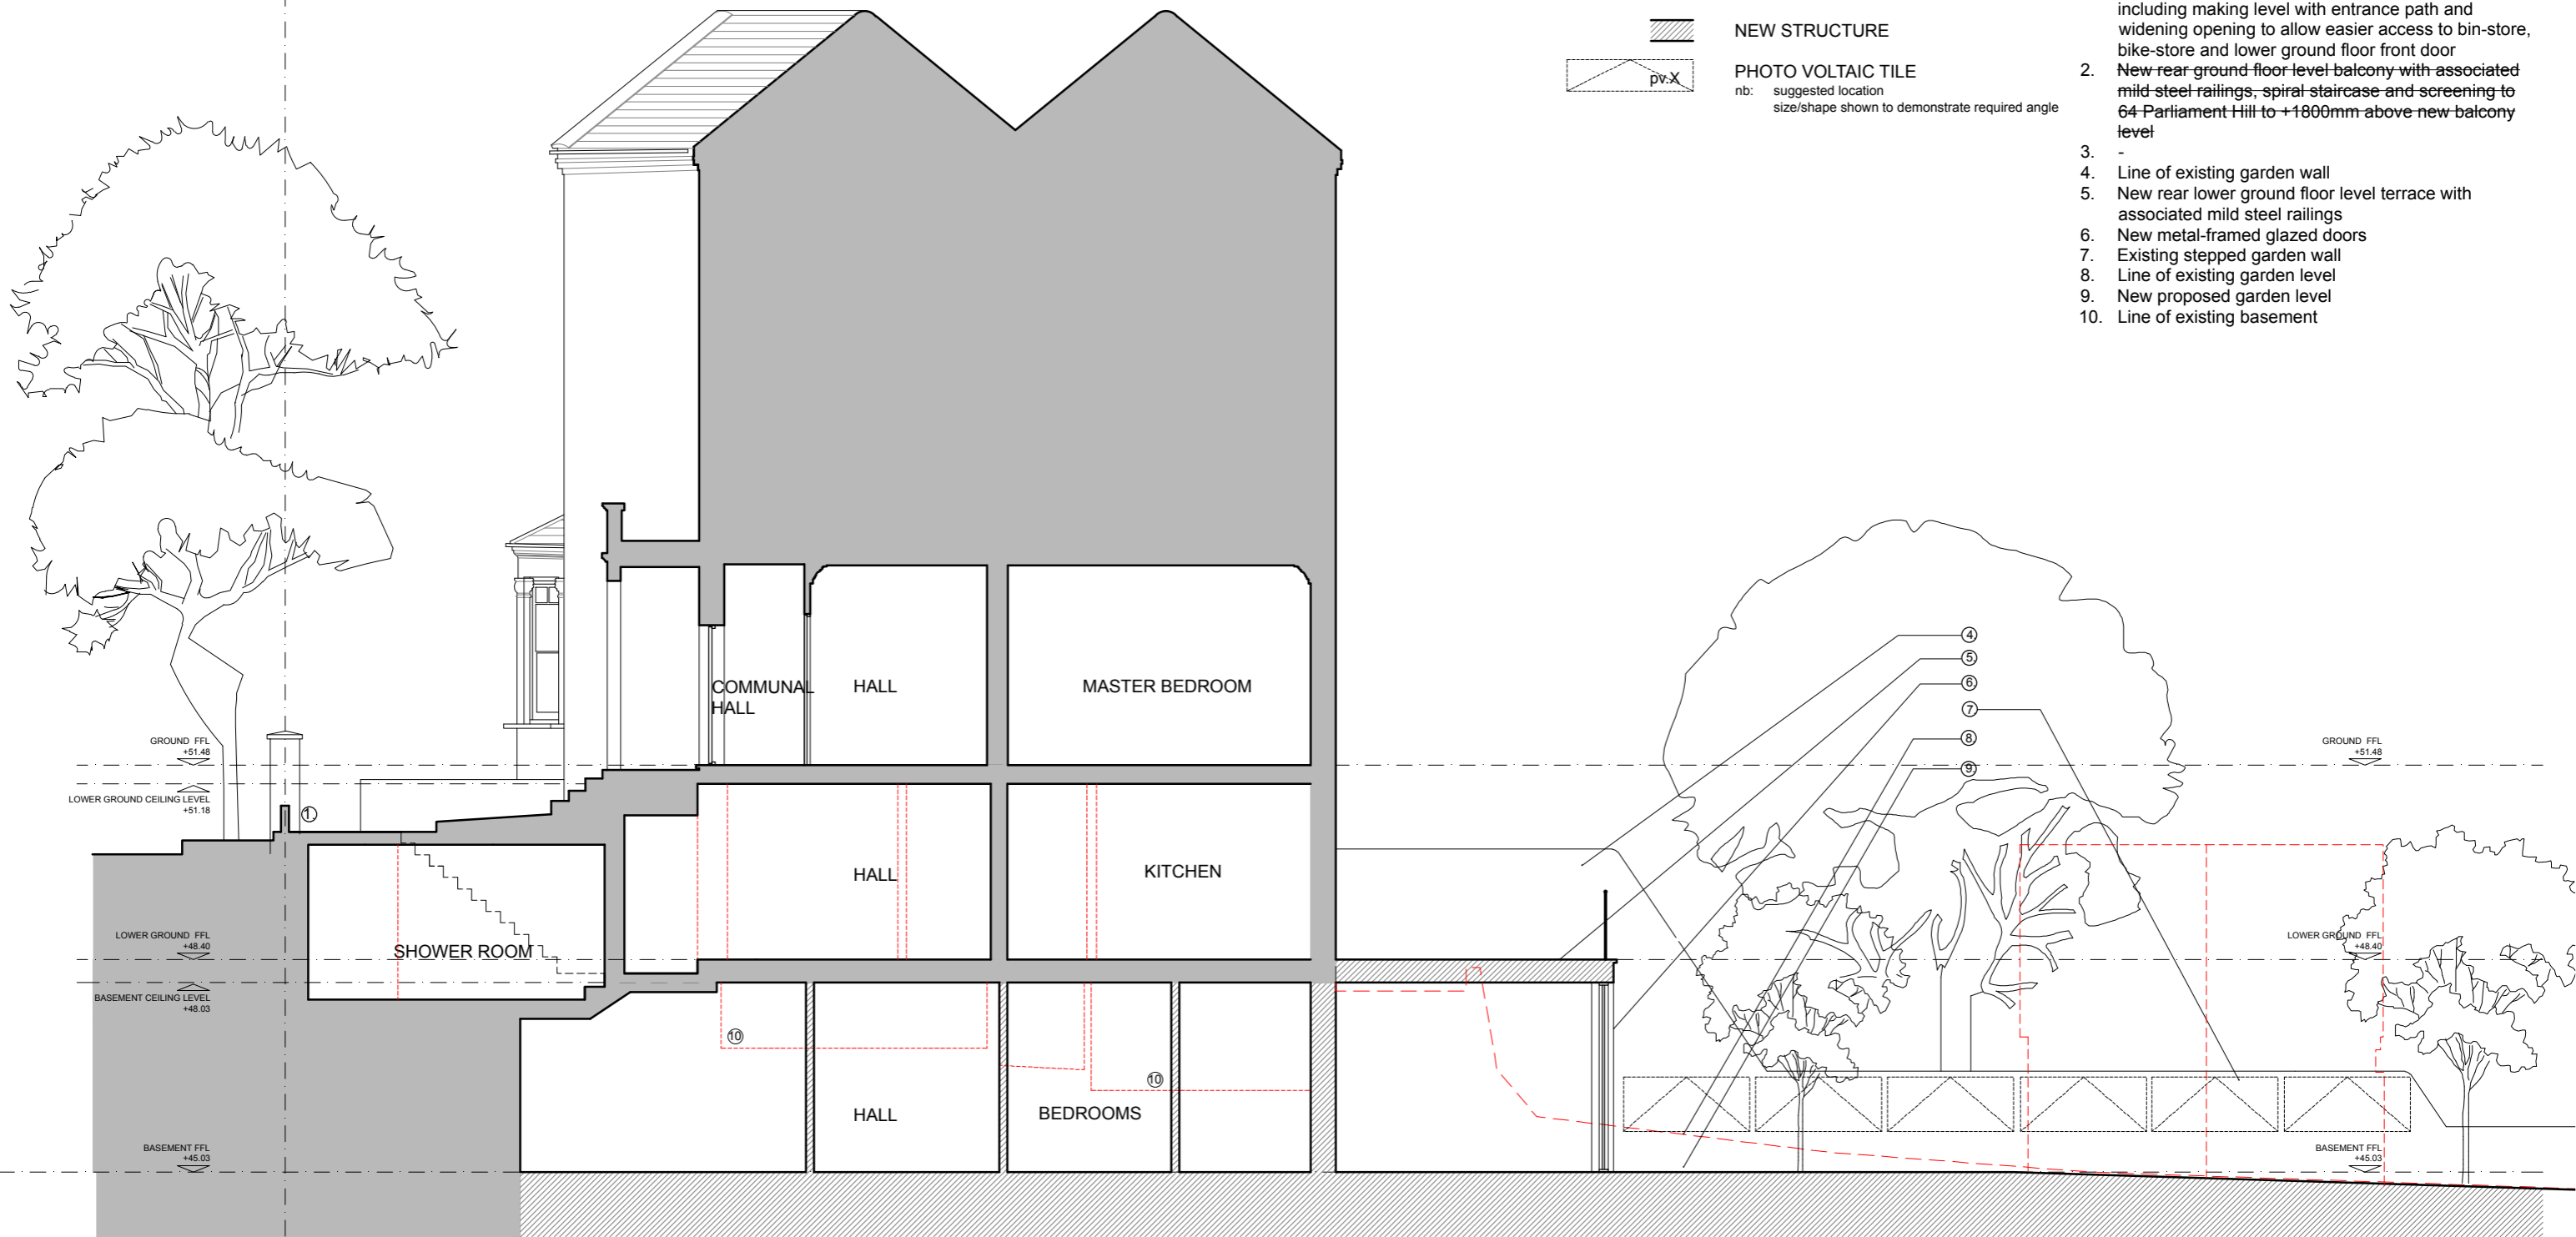
1. Alterations to front access and right side path including making level with entrance path and widening opening to allow easier access to bin-store, bike-store and lower ground floor front door
2. **New rear ground floor level balcony with associated mild steel railings, spiral staircase and screening to 64 Parliament Hill to +1800mm above new balcony level**
3. -
4. Line of existing garden wall
5. New rear lower ground floor level terrace with associated mild steel railings
6. New metal-framed glazed doors
7. Existing stepped garden wall
8. Line of existing garden level
9. New proposed garden level
10. Line of existing basement
