64-68 Millman Street, London, WC1N 3EG

Arboricultural Report, Tree Constraints Plan
&
Impact Assessment

Surveyor: John Crawshaw M.Arbor.A.

Survey Date: Wednesday, 2 March 2022

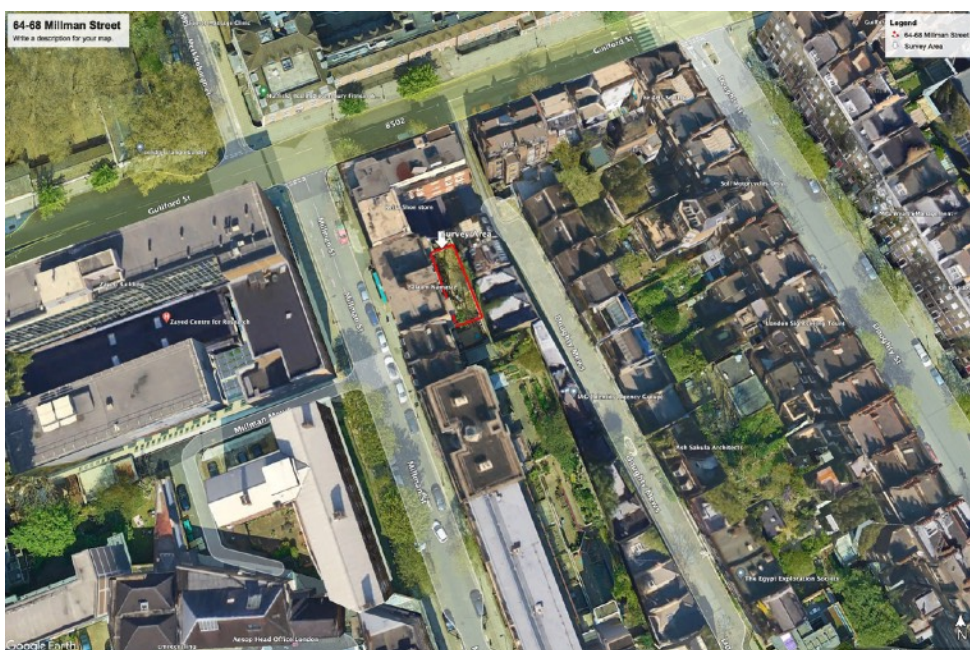
The survey site comprises an enclosed courtyard to the rear of the property.

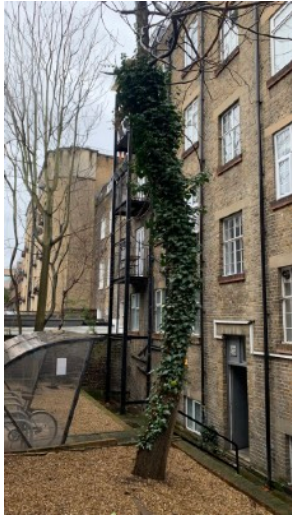
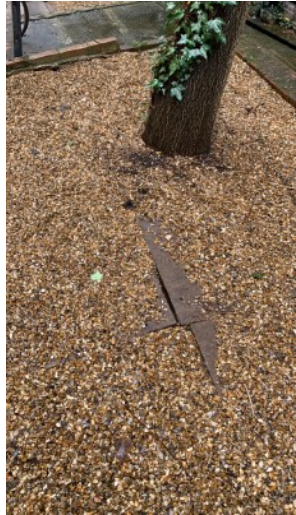
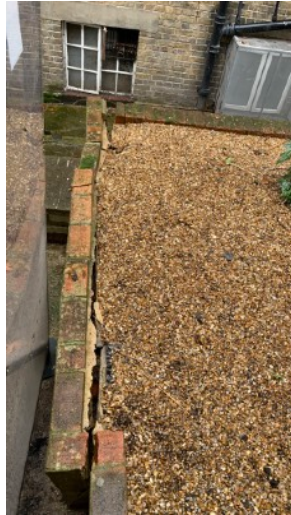
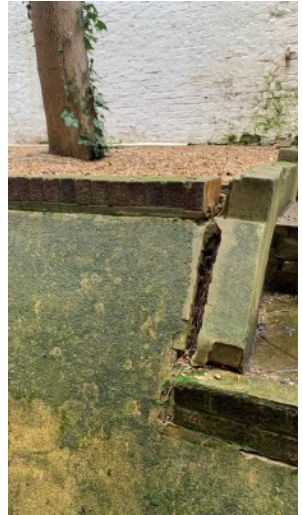
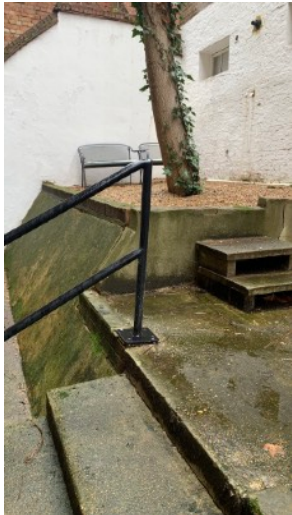
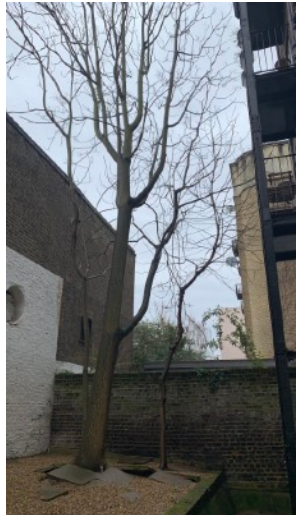
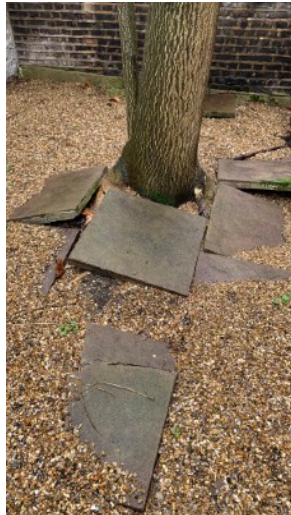
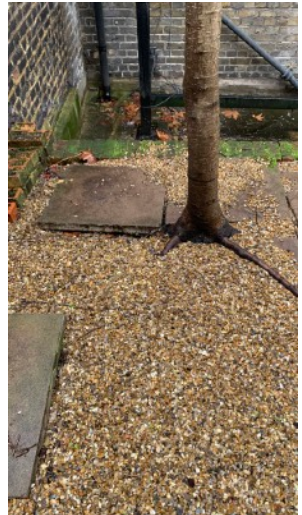
3. Photographs

| Ref | Species | H/T | Stems | Dia | Canopy | | | | First Branch | Crown H/T | Age | Yrs | Cat | Observations | Recommendations | RPA (r) | RPA (a) | TPO/CON |
|---|---|---|---|---|---|---|---|---|---|---|---|---|---|---|---|---|---|---|
| T1 | Tree of Heaven | 12 | 5 | 275 | 3 | 2 | 2 | 2 | 5N | 4 | Early Mature | 10 | C | Evidence of snapped out limbs. Ivy encroachment and severe physical damage to revetment walling | Monitor/possible removal | 3.3 | 34.2 | CON |
| T2 | Tree of Heaven | 14 | 5 | 325 | 2.5 | 2.5 | 2.5 | 2.5 | 5E | 3 | Early Mature | 20 | C | Good overall condition. Significant uplift of adjacent surfaces | None | 3.9 | 47.8 | CON |
| T3 | Cherry | 5 | 5 | 75 | 0.5 | 0.5 | 1 | 1 | 4S | 3 | Young | 10 | C | Poor quality specimen, crowded by T2. Significant uplift of adjacent surfaces | Monitor/possible removal | 0.9 | 2.5 | CON |

All trees within this report are causing direct physical damage to the structures within the courtyard. The trees have outgrown the viable space within the enclosed courtyard.

Repairing the damage with the trees in situ may be problematic without damage to root systems and as the trees continue to grow, may pose future pressure on the structures.

The trees could be removed to facilitate repair/development and replaced with smaller, suitable specimens to mitigate for immediate residents where possible.
