43 DOWNSHIRE HILL

21150 _ PRELIMINARY _ Published 25/02/22

PL220 rev- PR FRONT & REAR ELEVATIONS

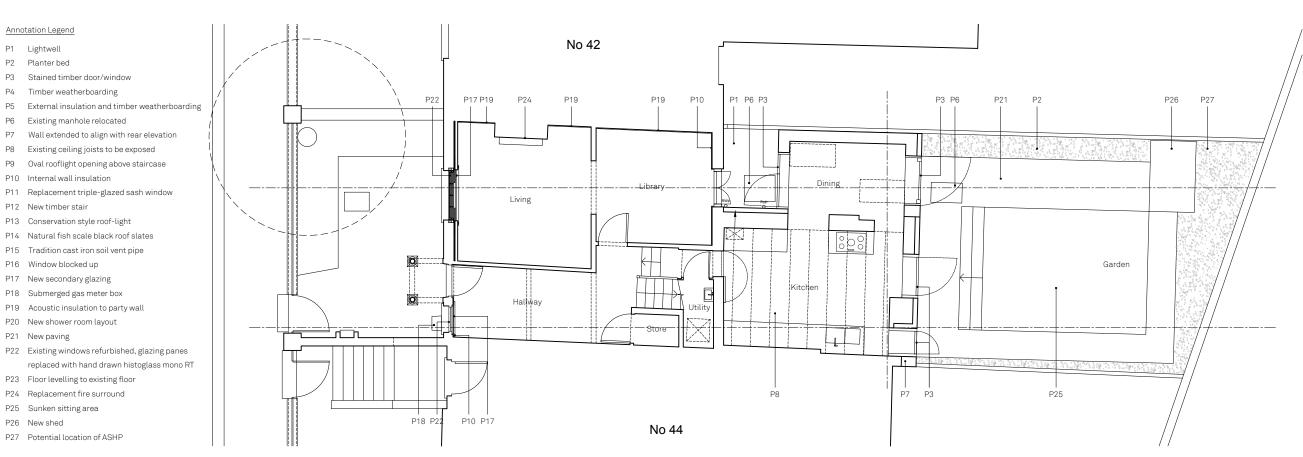
PROPOSED GROUND FLOOR PLAN

P6 Existing manhole relocated

P10 Internal wall insulation

P12 New timber stair P13 Conservation style roof-light

P16 Window blocked up

P17 New secondary glazing P18 Submerged gas meter box

P20 New shower room layout

P23 Floor levelling to existing floor

P24 Replacement fire surround

P27 Potential location of ASHP

P25 Sunken sitting area P26 New shed

P21 New paving

P1 Lightwell

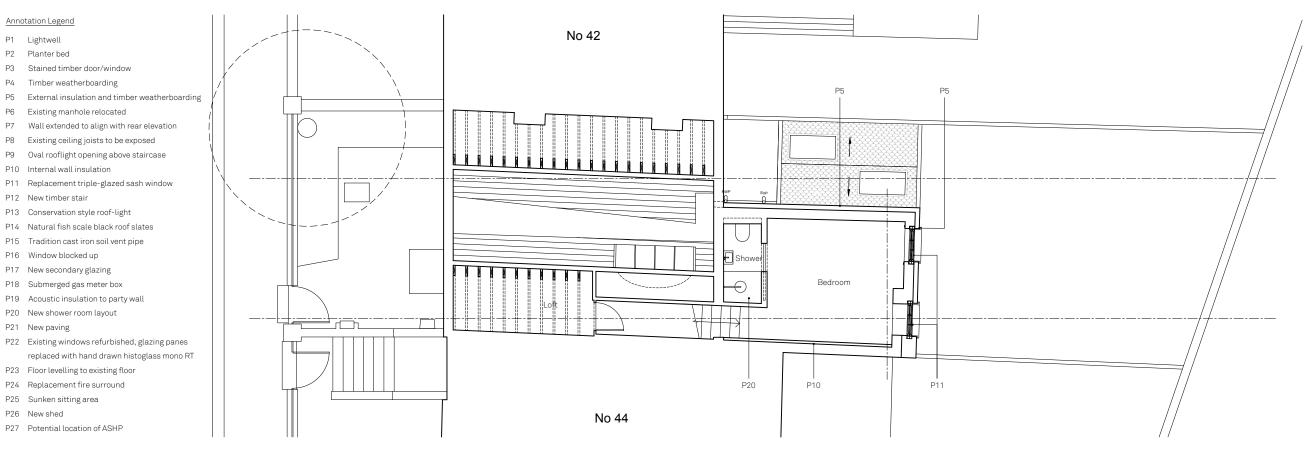
PROPOSED SECOND FLOOR PLAN

P4 Timber weatherboarding

P6 Existing manhole relocated

P10 Internal wall insulation

P15 Tradition cast iron soil vent pipe

P12 New timber stair P13 Conservation style roof-light

P16 Window blocked up

P21 New paving

P17 New secondary glazing

P18 Submerged gas meter box P19 Acoustic insulation to party wall P20 New shower room layout

P23 Floor levelling to existing floor P24 Replacement fire surround

P25 Sunken sitting area P26 New shed

P27 Potential location of ASHP

P1 Lightwell P2 Planter bed

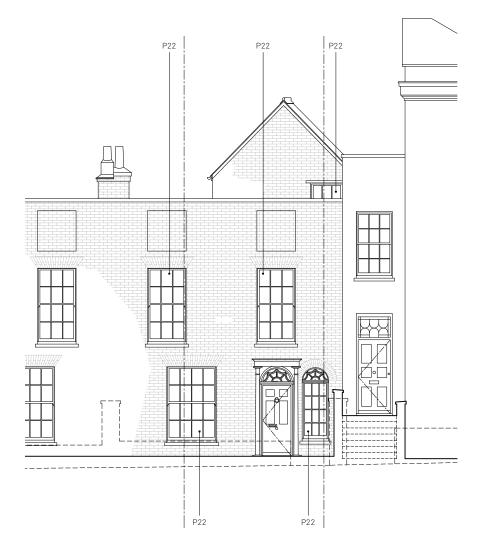
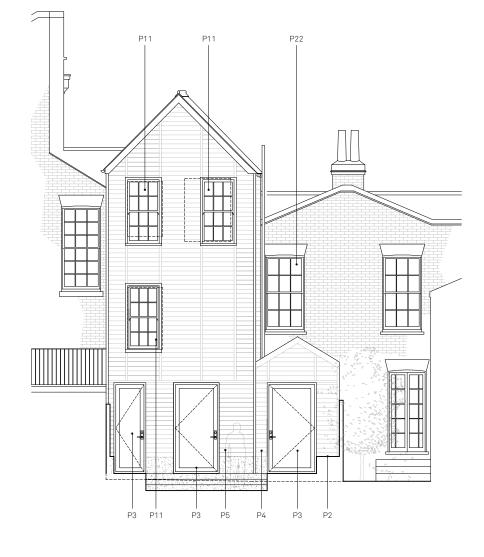
PROPOSED FRONT ELEVATION PROPOSED REAR ELEVATION

- P1 Lightwell
- P2 Planter bed
- P4 Timber weatherboarding
- P5 External insulation and timber weatherboarding
- P6 Existing manhole relocated
- P7 Wall extended to align with rear elevation

- P8 Existing ceiling joists to be exposed
- P9 Oval rooflight opening above staircase
- P10 Internal wall insulation
- P11 Replacement triple-glazed sash window

- P12 New timber stair
- P13 Conservation style roof-light
- P14 Natural fish scale black roof slates
- P15 Tradition cast iron soil vent pipe
- P16 Window blocked up

- P17 New secondary glazing
- P18 Submerged gas meter box
- P19 Acoustic insulation to party wall
- P20 New shower room layout
- P21 New paving
- P22 Existing windows refurbished, glazing panes replaced with hand drawn histoglass mono RT

- P23 Floor levelling to existing floor
- P24 Replacement fire surround
- P25 Sunken sitting area
- P26 New shed
- P27 Potential location of ASHP

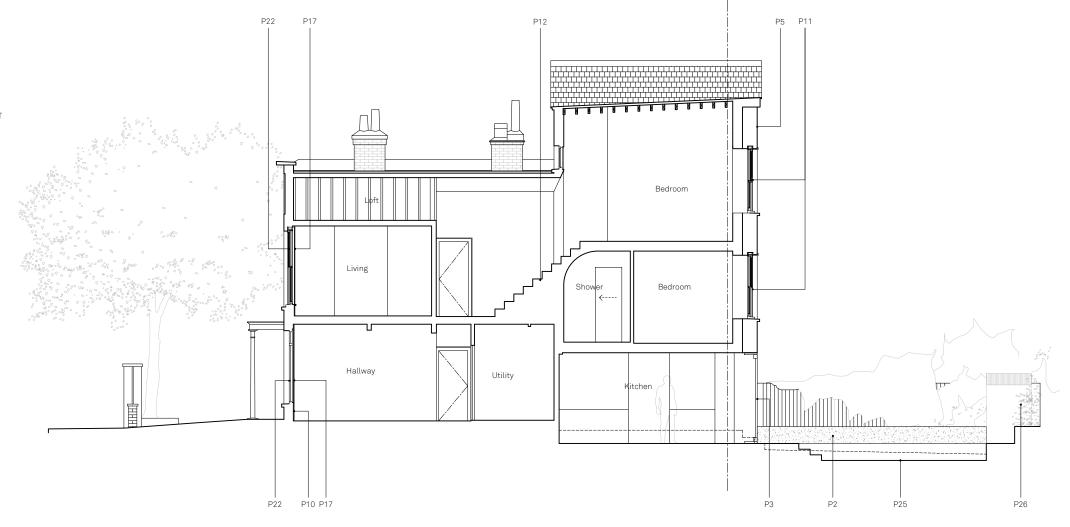
PROPOSED SECTION A-A

- P1 Lightwell
- P2 Planter bed
- P4 Timber weatherboarding
- P5 External insulation and timber weatherboarding
- P6 Existing manhole relocated
- P7 Wall extended to align with rear elevation

- P8 Existing ceiling joists to be exposed
- P9 Oval rooflight opening above staircase
- P10 Internal wall insulation
- P11 Replacement triple-glazed sash window

- P12 New timber stair
- P13 Conservation style roof-light
- P14 Natural fish scale black roof slates
- P15 Tradition cast iron soil vent pipe
- P16 Window blocked up

- P17 New secondary glazing
- P18 Submerged gas meter box
- P19 Acoustic insulation to party wall
- P20 New shower room layout
- P21 New paving
- P22 Existing windows refurbished, glazing panes replaced with hand drawn histoglass mono RT

- P23 Floor levelling to existing floor
- P24 Replacement fire surround
- P25 Sunken sitting area
- P26 New shed
- P27 Potential location of ASHP

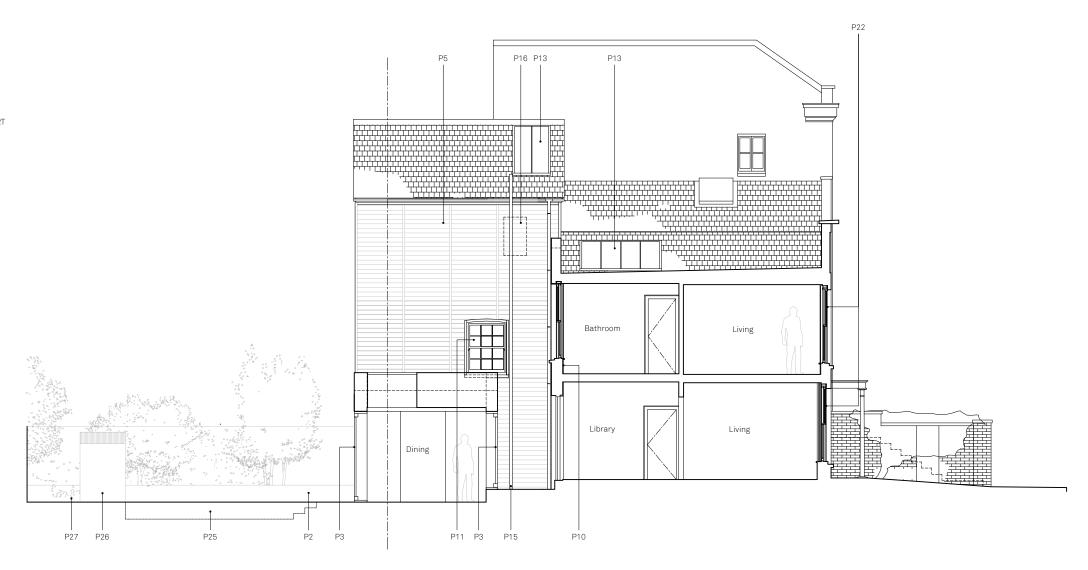
PROPOSED SECTION B-B

- P1 Lightwell
- P2 Planter bed
- P3 Stained timber door/window
- P4 Timber weatherboarding
- P5 External insulation and timber weatherboarding
- P6 Existing manhole relocated

- P7 Wall extended to align with rear elevation
- P8 Existing ceiling joists to be exposed
- P9 Oval rooflight opening above staircase
- P10 Internal wall insulation

- P11 Replacement triple-glazed sash window
- P12 New timber stair
- P13 Conservation style roof-light
- P14 Natural fish scale black roof slates
- P15 Tradition cast iron soil vent pipe

- P16 Window blocked up
- P17 New secondary glazing
- P18 Submerged gas meter box
- P19 Acoustic insulation to party wall
- P20 New shower room layout
- P21 New paving

- P22 Existing windows refurbished, glazing panes replaced with hand drawn histoglass mono RT
- P23 Floor levelling to existing floor
- P24 Replacement fire surround

- P25 Sunken sitting area
- P26 New shed
- P27 Potential location of ASHP
