24 Constantine Road

Ridgeline alignment | 24 Constantine Road and 22 Constantine Road

10 September 2021

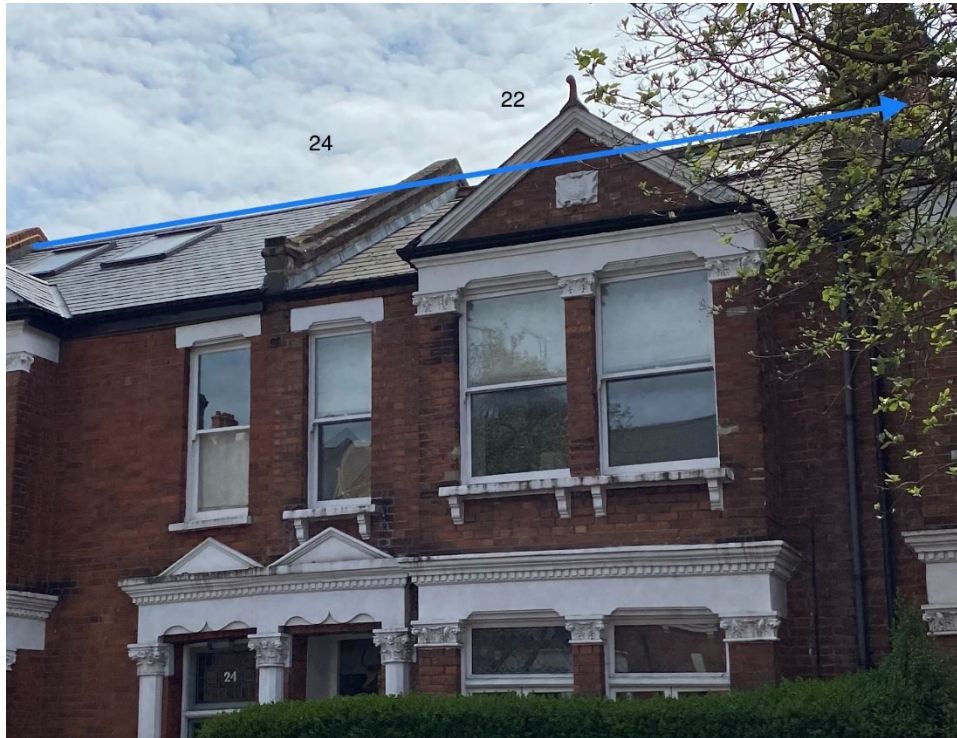
- Party wall between 22 and 24 Constantine Road unaltered.
- Ridgeline of 22 Constantine Road is sagging and not level.
- Most houses in Constantine Road have a lower party wall to the east end (downhill) due to differential movement over many years resulting in ridgeline not level.
- Ridgeline of 24 Constantine Road installed level, aligns with western end of ridgeline to 22 Constantine Road.
