Elevation 3 - West Wall

0	0.	5	1		2	<u>3</u> m
P02	21/03/22		SP No	SP Notation amended			
P01	09/03/22		SP Pro	Production Information Stage 4 Draft			
No Date		By Co	/ Comments				
Issued							
Status		Purpose of Issue					
- Production Information							
BRITISH MUSEUM ROOM 35 REFURBISHMENT JOSEPH HOTUNG TEMPORARY GALLERY							
Dannatt Johnson Architects							
Unit 1 The Wireworks 77 Great Suffolk Street London SE1 0BU Tel (020) 7357 7100 Email dja@djarchitects.co.uk							
Title							
Proposed Internal Elevation of Room 35 - West Wall							
Drawing Number							Revision
631-BM-DJA-DR-A-30002 P0							P02
RIBA	Stage	DJA R	ef	Scale(s	5)		ι
2	1	631		1:50	A3		
				1

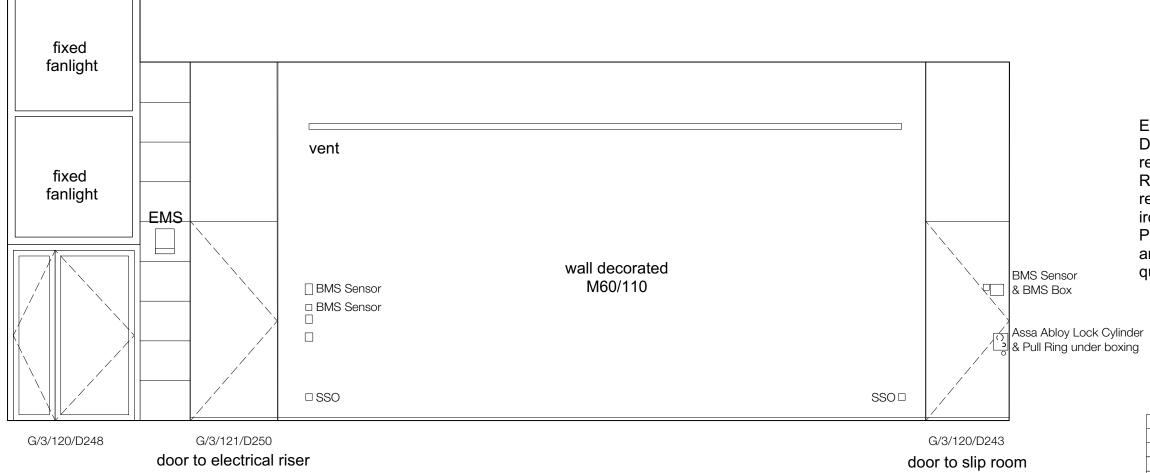
Existing flush timber fire doors D250 and D243 are to be carefully removed and overhauled. Remove existing ironmongery and repair door ready to receive new ironmongery.

Prepare and refurbish door leafs and frames to achieve a high quality painted finish as M60/110
