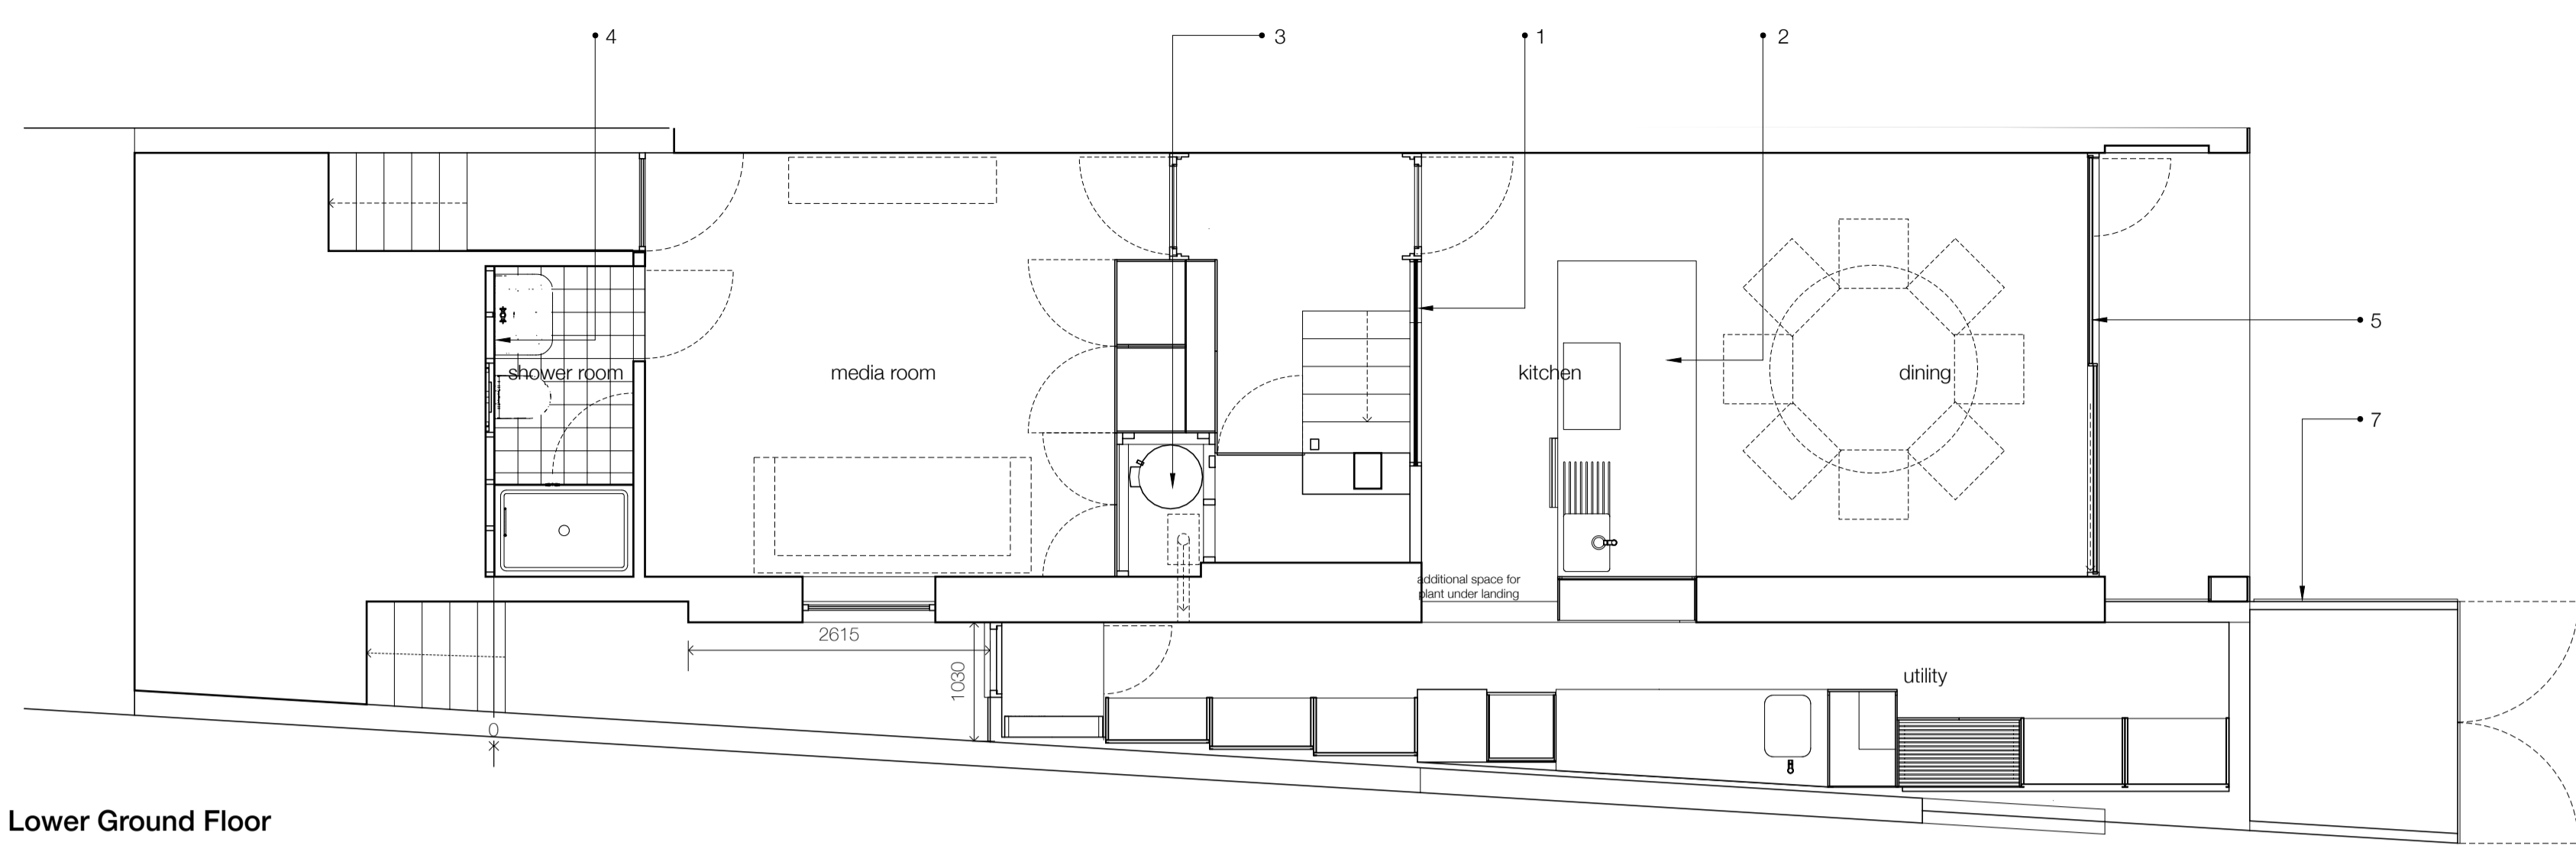
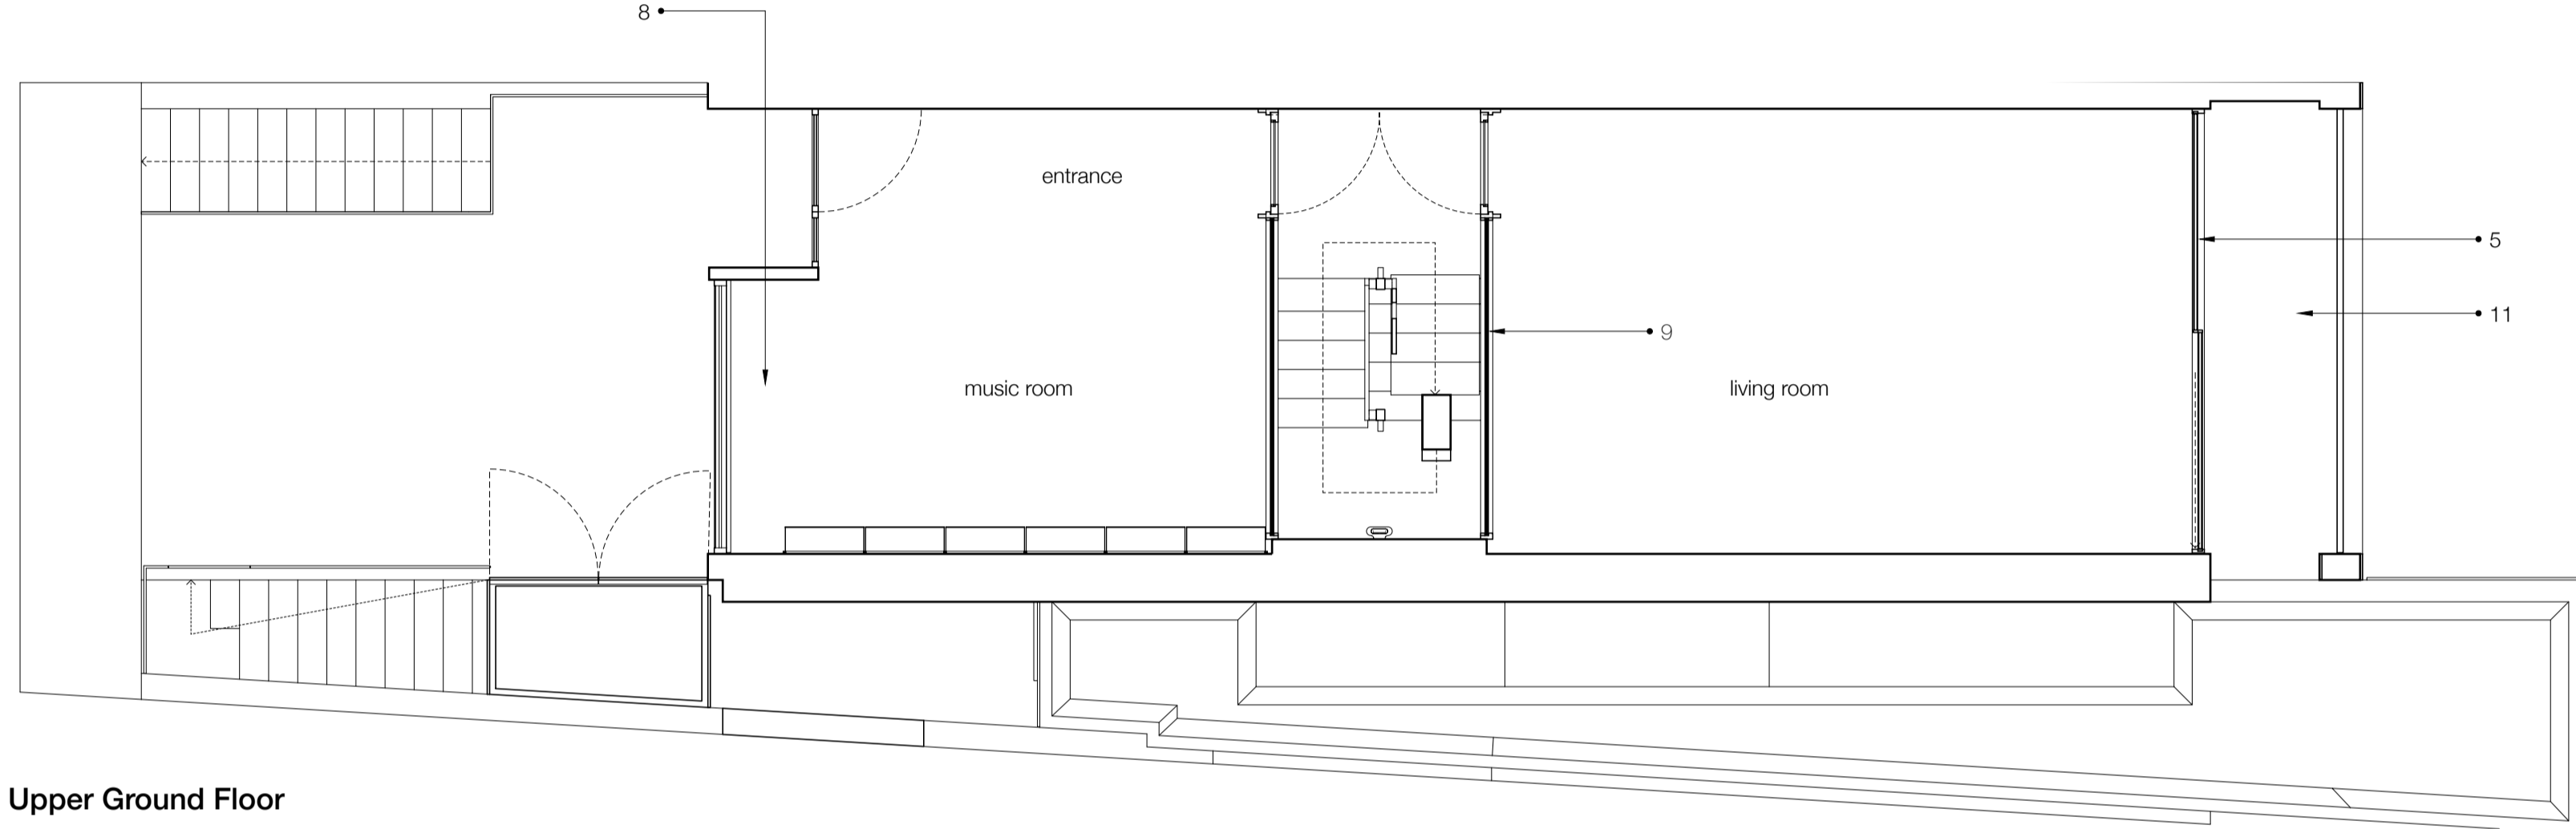
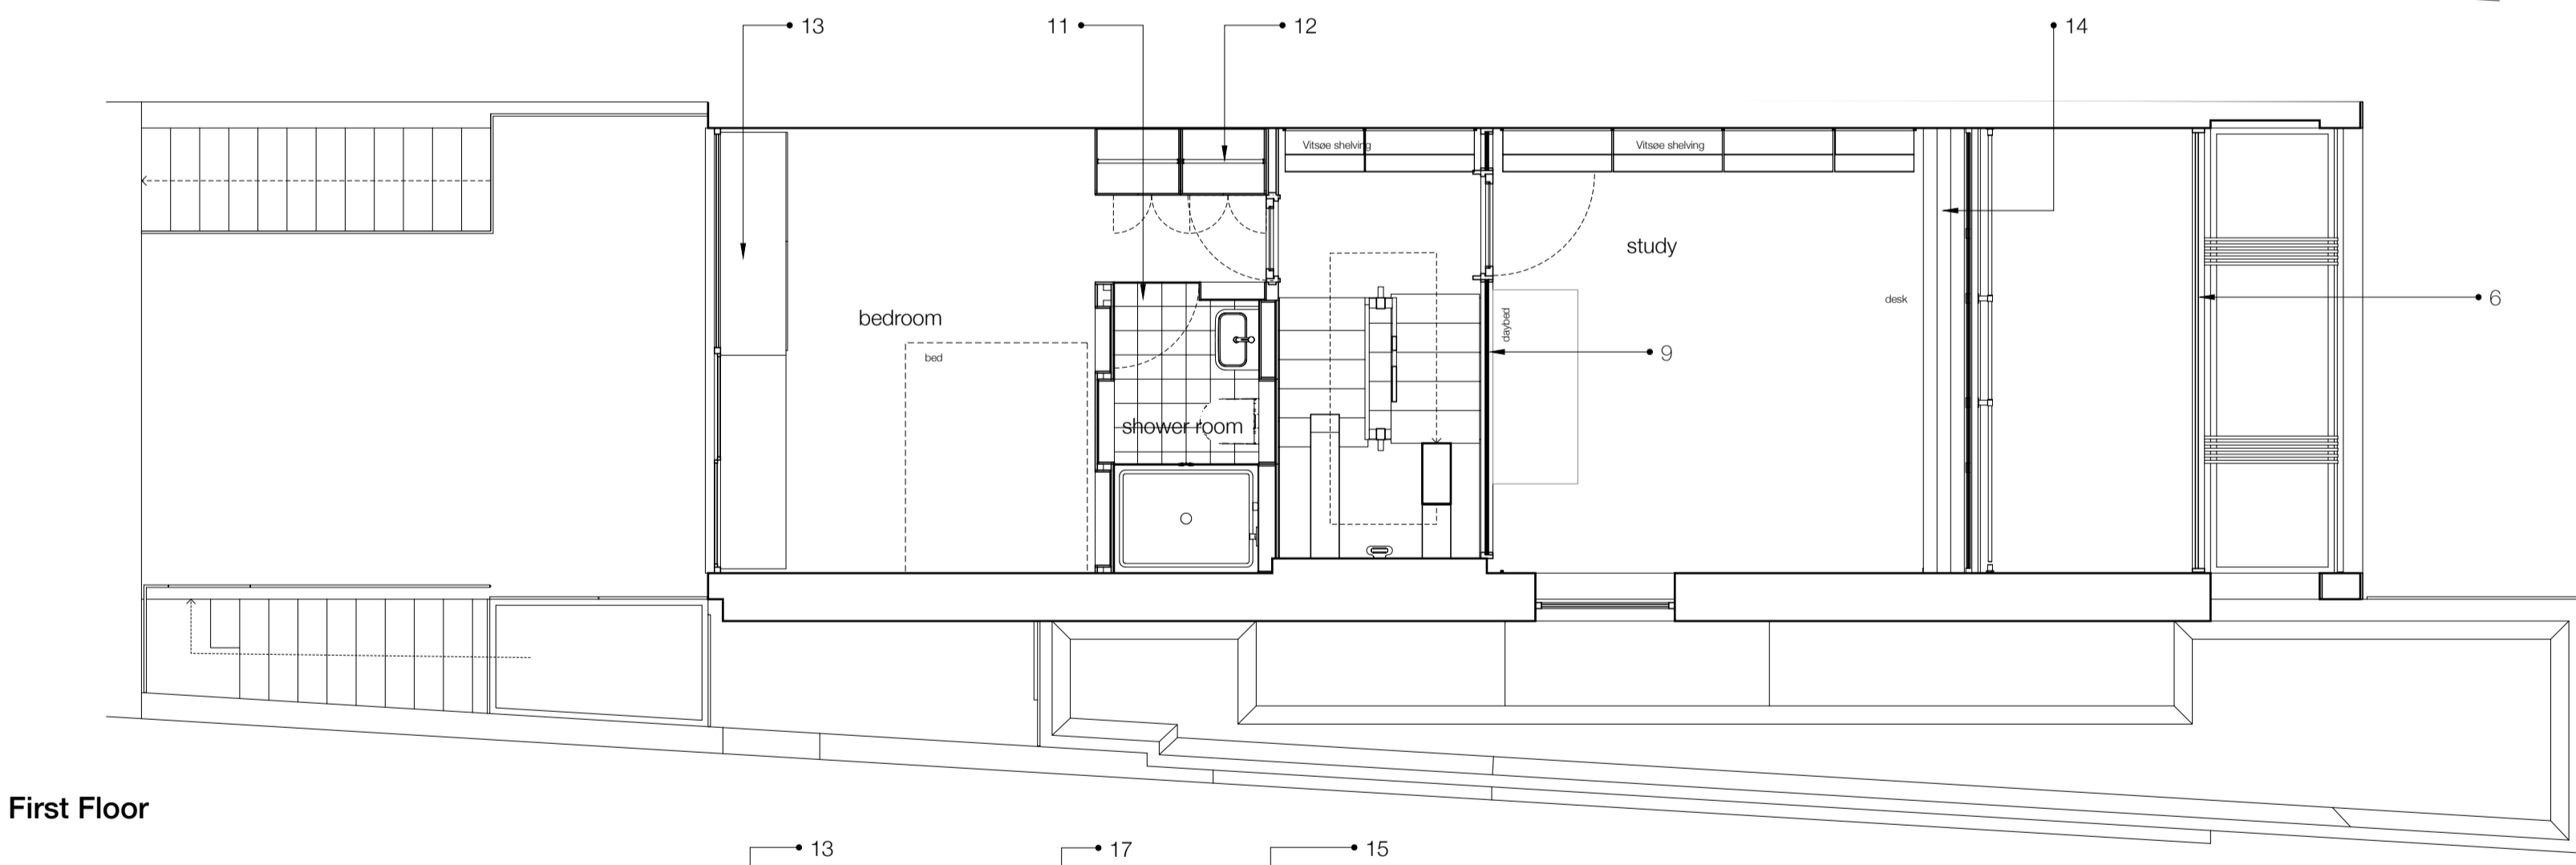
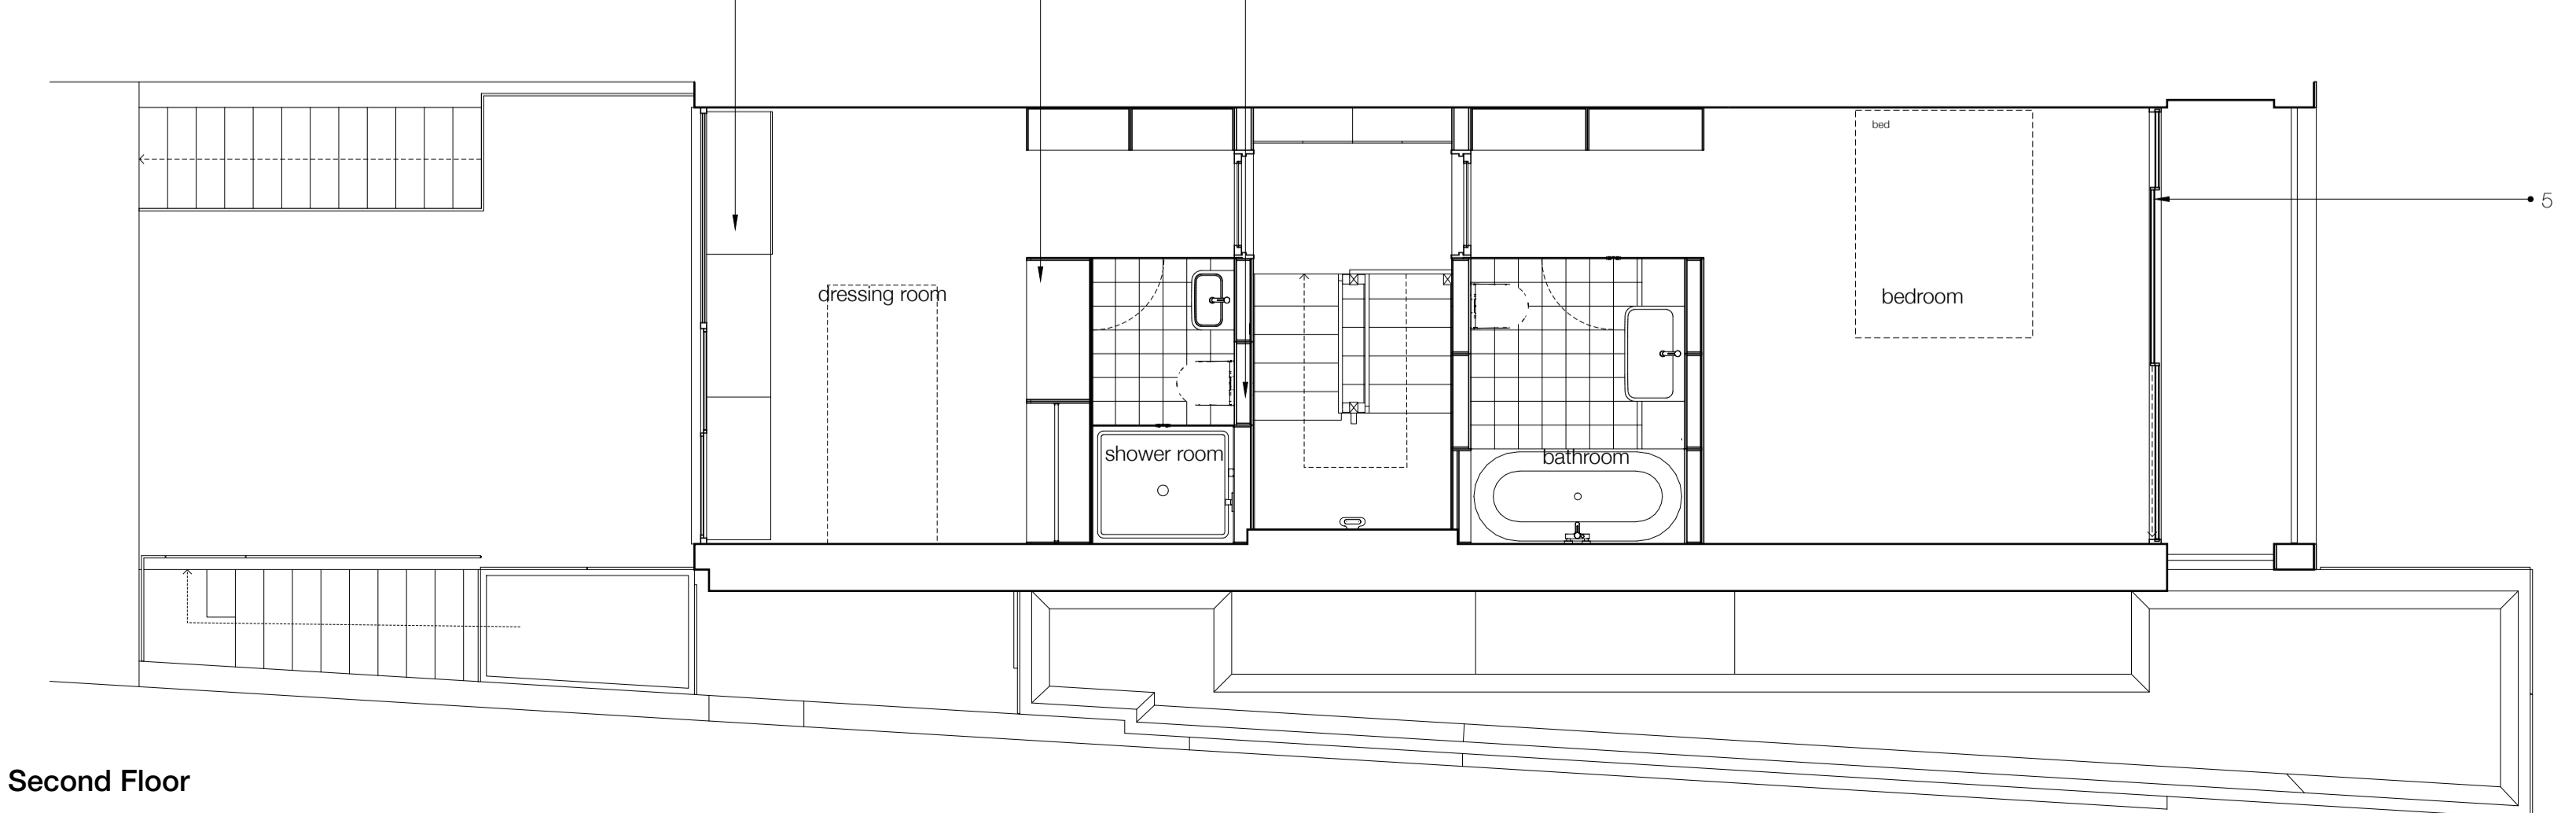
- 1 30 minute fire rated partition with glazed upper panel
- 2 kitchen joinery
- 3 stud framed enclosure for central heating and hot water plant
- 4 lining to conceal services to shower room
- 5 sliding doors
- 6 fixed glazing
- 7 garden shed with western red cedar cladding
- 8 window seat
- 9 30 minute fire rated glazed screen with solid timber fire rated door
- 10 existing balcony refurbished
- 11 shower room constructed in joinery
- 12 utility room joinery
- 13 window set and drawers
- 14 existing bench refurbished
- 15 combined vanity unit and bath enclosure
- 16 cupboard unit
- 17 wardrobe joinery
