# Construction/ Demolition Management Plan

pro forma

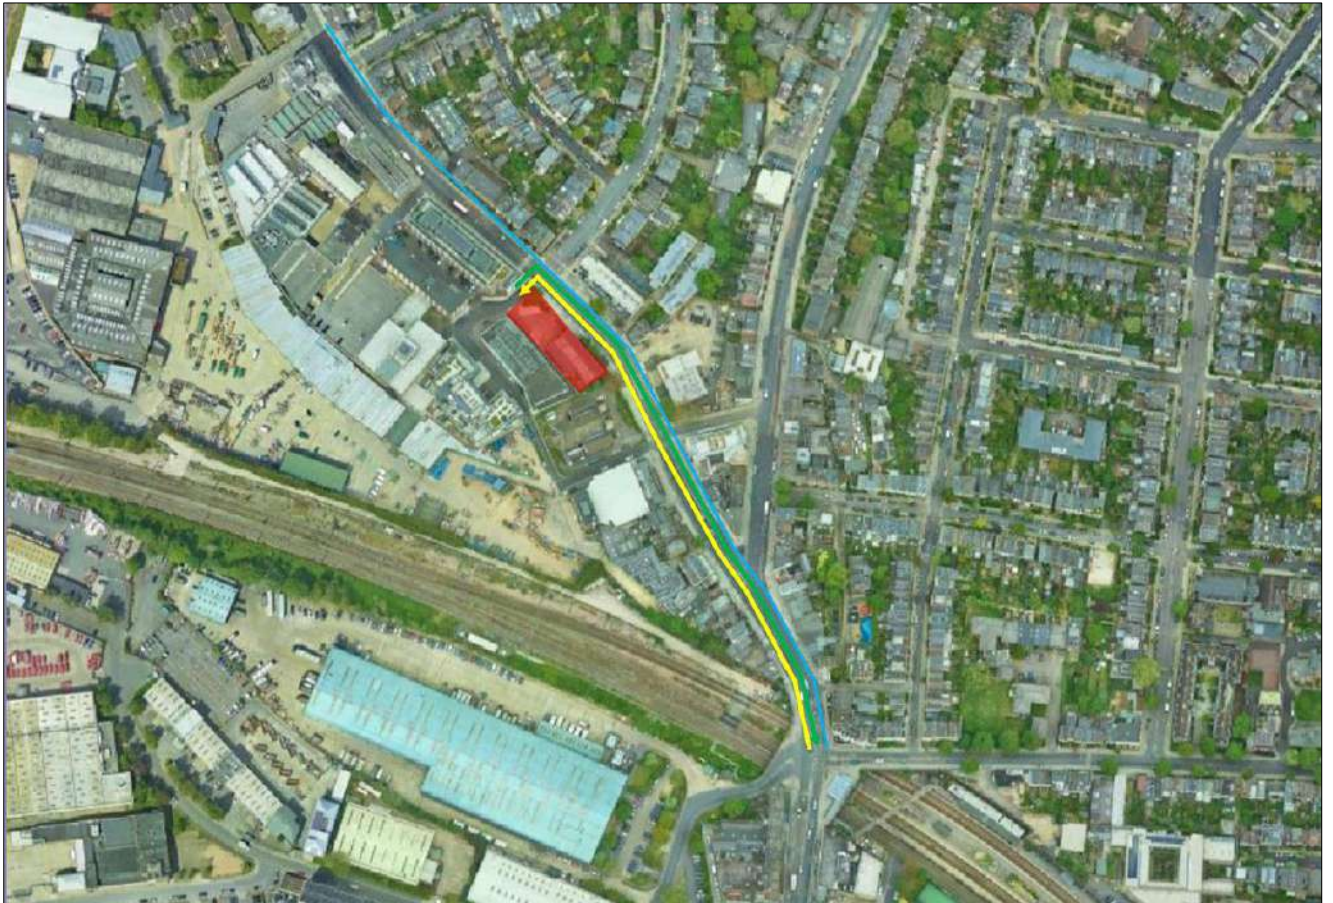
Figure 3: Site Access and Egress Routes (Route A)

3. Exit site in a forward gear and turn right into Greenwood Place.
4. Continue to the junction with to Highgate Road (B518).
5. At the junction with Highgate Road (B518) turn right into Highgate Road (B518) and continue away from site in a south easterly direction.

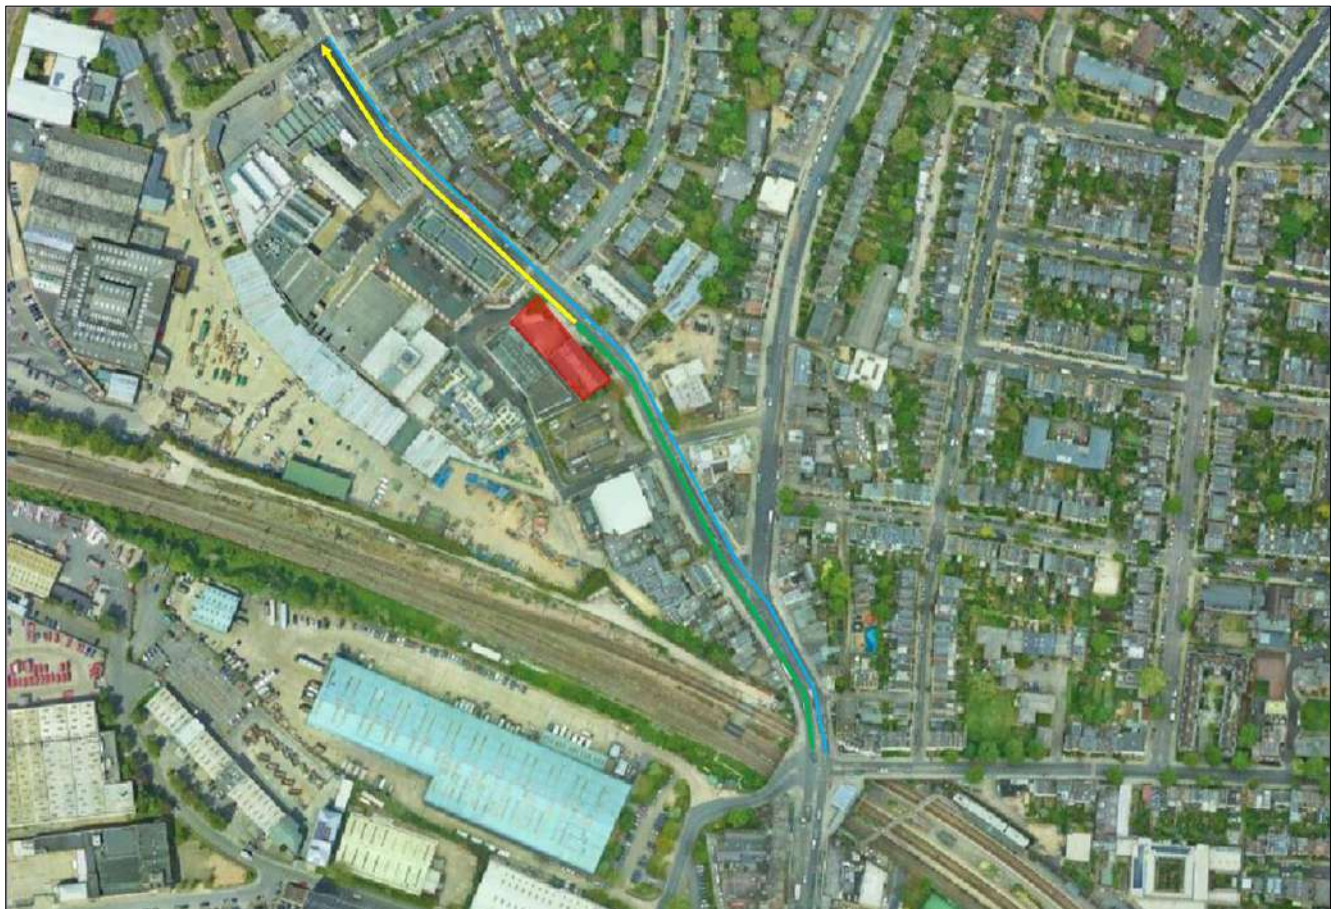
Figure 4: Site Access and Egress Routes (Route B)

Site Access: Yellow Arrow

3. Exit the managed set down area and continue away from site in a north westerly direction on Highgate Road (B518).

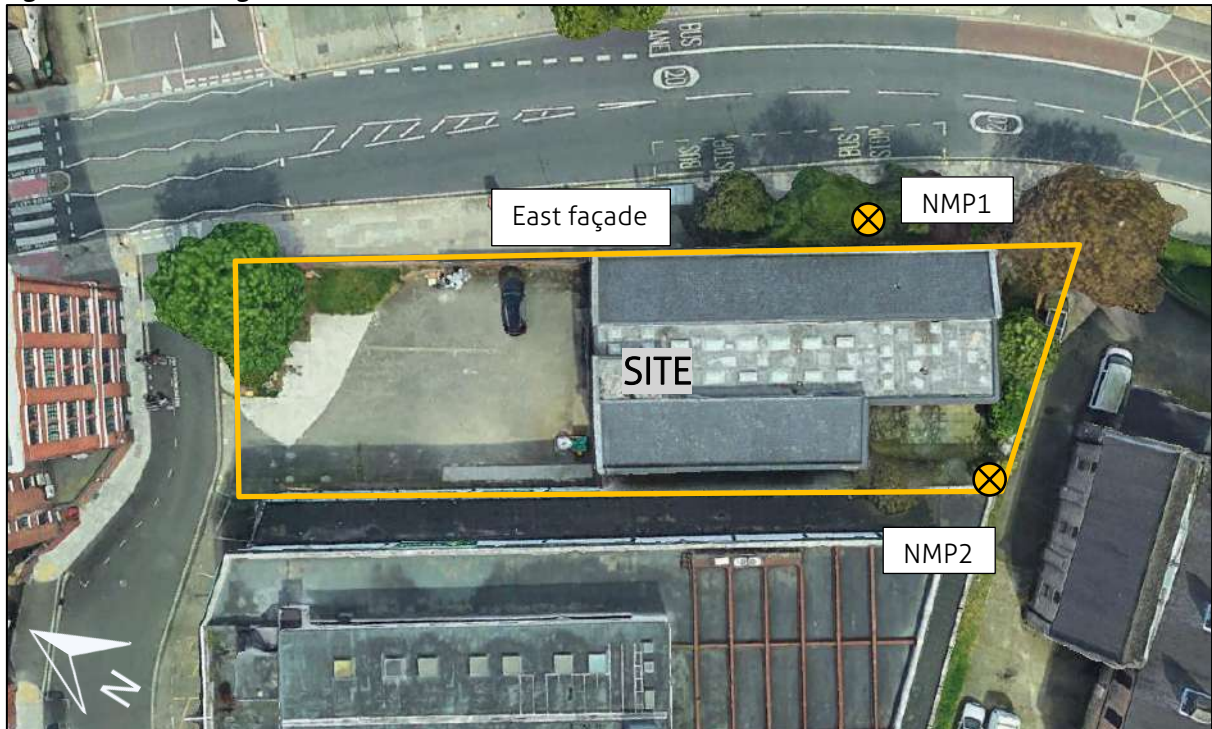
**Figure 4.1: Monitoring Locations**

The prevailing noise conditions in the area were determined by a detailed environmental noise survey undertaken over a 7-day period at two measurement locations, between Tuesday 2<sup>th</sup> and Tuesday 9<sup>th</sup> November 2021. Full details of the survey can be found in Appendix A.

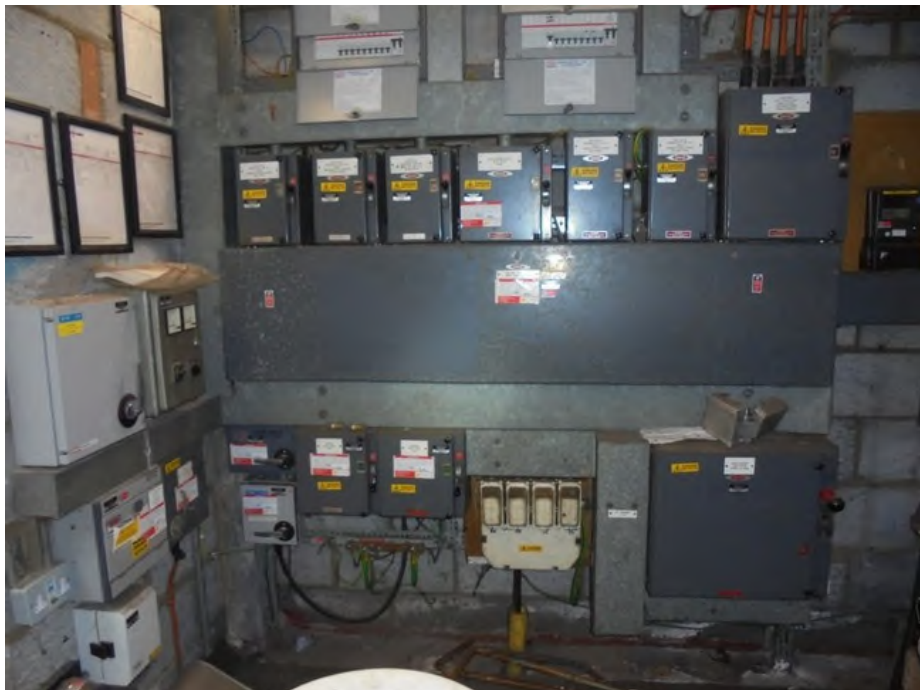
Action: Apply Warning Labels

Material Comments: No access was gained to inspect within the electrics due to being live. Presume ACMs present until proven otherwise.

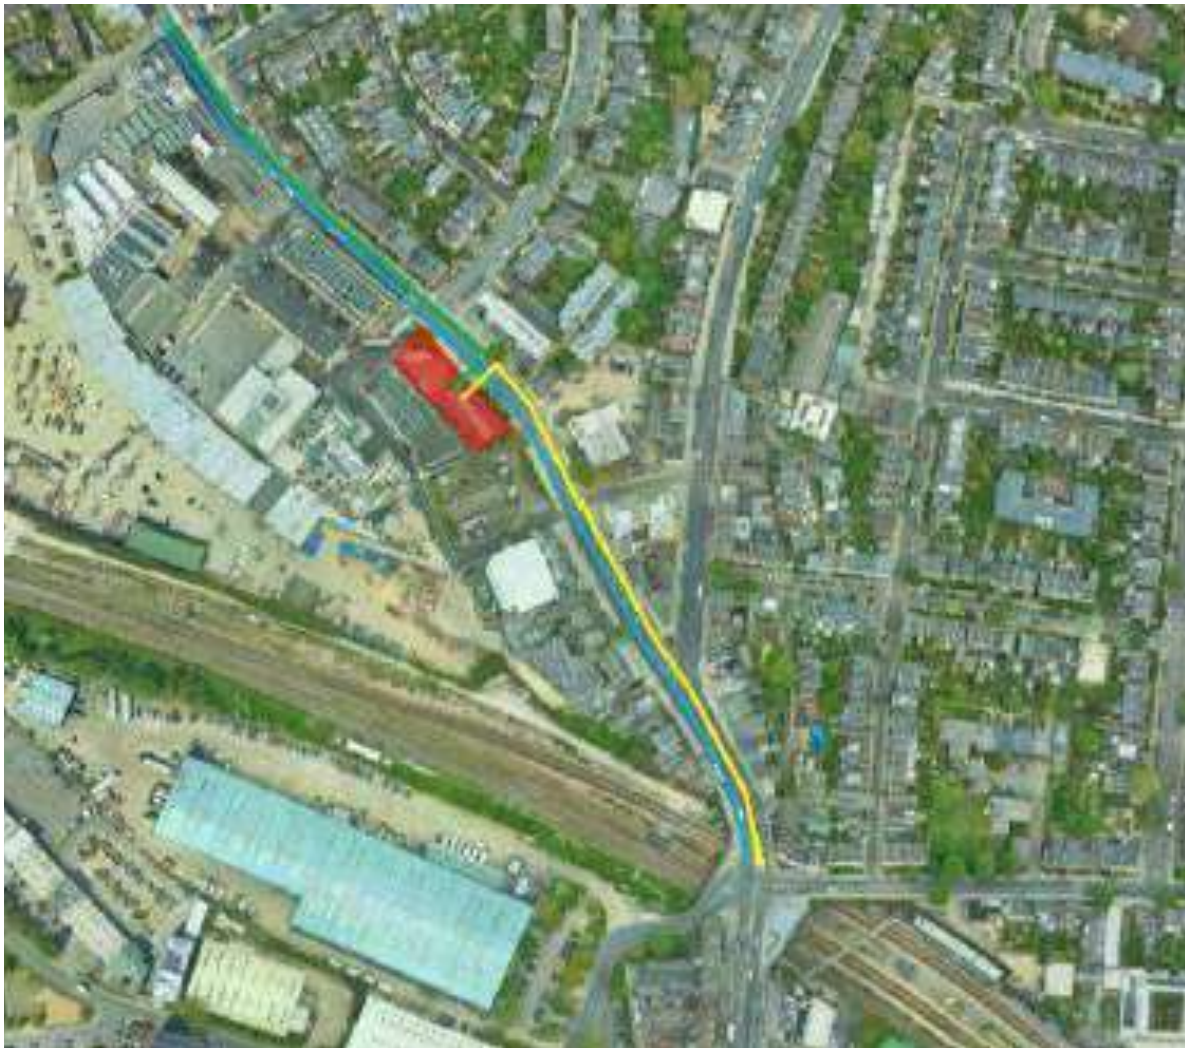
3. Exit site in a forward gear and turn right onto Highgate Road (B518)
4. Continue away from site on Highgate Road (B518) in a south easterly direction
