ARBORICULTURAL IMPACT ASSESSMENT AND METHOD STATEMENT

BS5837:2012

Report Reference: AAAIA12EL

Report re: Proposed development at 12a Ellerdale Road, Hampstead

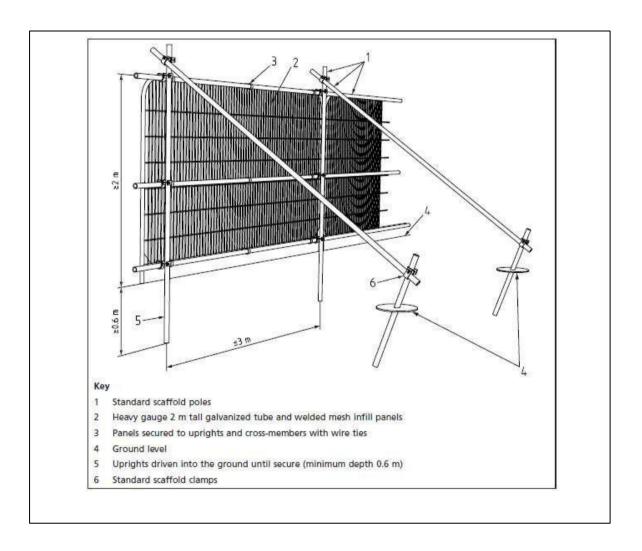
APPENDIX 2 – Protective Fencing

'Fencing should be established at the minimum distance set out in British Standard 5837:2012 'Trees in relation to design, demolition and construction - Recommendations'. Excavations should not encroach into the fence position and it is appropriate to keep atleast 0.5m between the fence and any changes in level.

Tree protection barriers: Protective fencing will be installed prior to the commencement of any development activity and will be retained in the positions shown on the tree protection plan (AATPP12EL). The fencing will be to the BS 5837:2012 'Trees in relation to design, demolition and construction – recommendations' (section 6.2) i.e. preformed galvanised steel mesh panels ('Heras' or similar) facings on a driven braced scaffold pole framework. It will be retained at the locations shown until construction is completed. It may be moved or removed only with notice to and consent from the local planning authority.

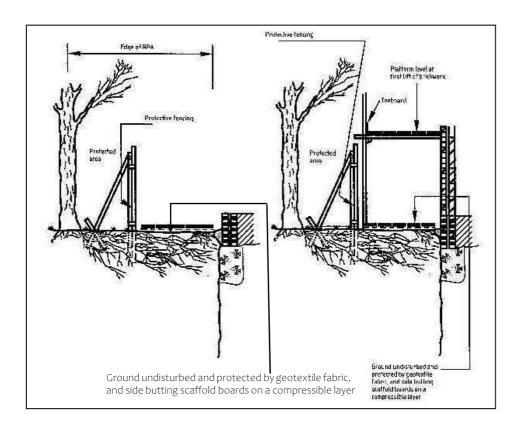
Where ground protection measures are necessary, they can be provided by laying a geotextile mat onto the existing ground level and adding to this compressible materials, such as bark mulch or sharp sand to form a safe, level surface. Onto this surface is laid scaffold boards which become the working surface for the duration of the construction phase.

Where scaffolding is proposed above the area requiring protection the footway can be suspended above ground level using the upright scaffold poles onto which horizontal supports can be attached and then boards used to form the footway surface. A geotextile mat should be laid on the ground beneath to prevent contamination from materials dropped through the footway.

Ground protection: Temporary ground protection to be installed within RPA's of T1 and T2 should be capable of supporting pedestrian movements only, a single thickness of scaffold boards placed either on top of a driven scaffold frame, so as to form a suspended walkway, or on top of a compression-resistant layer (e.g. 100 mm depth of woodchip), laid onto a geotextile membrane.
