Arboricultural assessment & method statement

Whittington Hospital (Camden & Islington Trust), Magdala Avenue, London N19 5NF

19165-AA6-PB

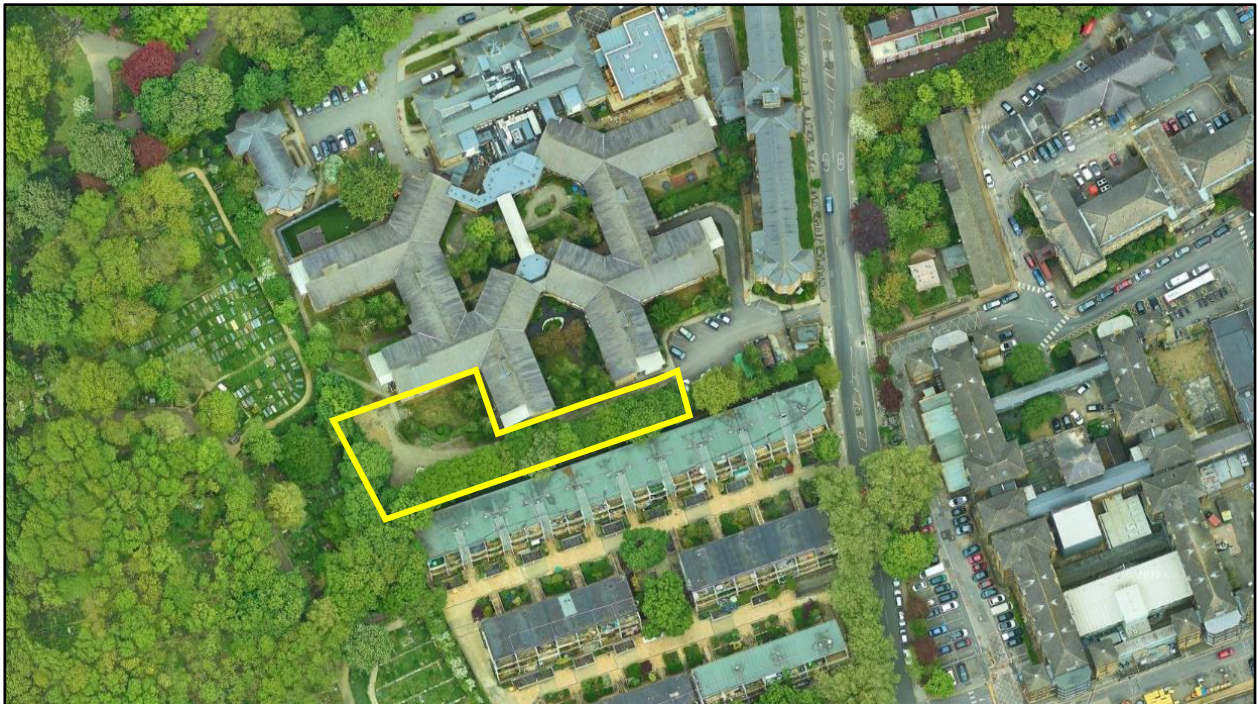
Site location

This aerial image is supplied courtesy of Google. The yellow line shows the approximate area within which the proposed temporary construction compound will be formed. This detail is for illustrative purposes only and must not be scaled from.
