RIDGE
PROPERTY & CONSTRUCTION CONSULTANTS

SICK CHILDRENS TRUST

ELECTRICAL CUPBOARD RELOCATION

EXISTING AND PROPOSED
FRONT ELEVATION

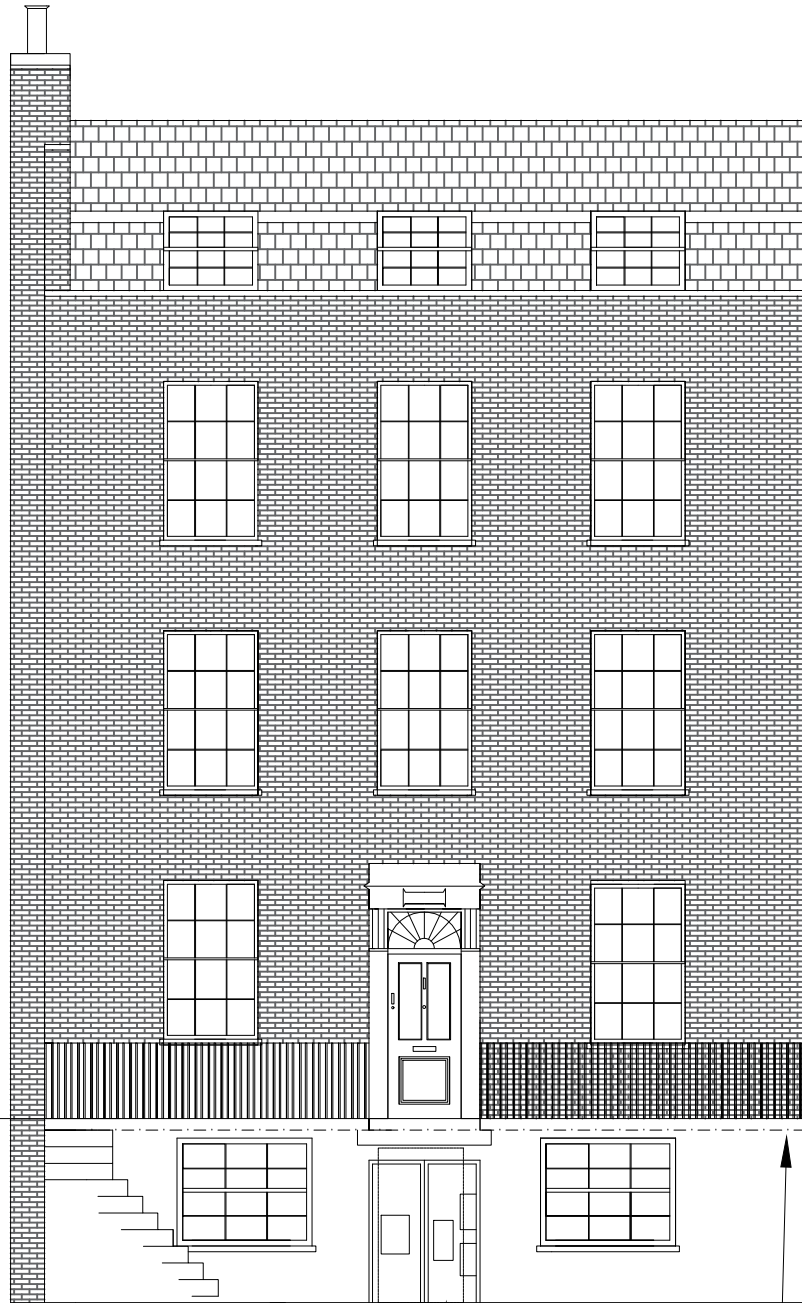
Existing Elevation

Existing electrical cupboard location

Street level

Currently the existing electrical cupboard is situated underneath the existing pathway above. The cupboard has been subject to water ingress despite multiple attempts at damp proofing repairs. The water ingress regularly shorts out the electrics within in the cupboard which interferes with the operational use of the building. It is proposed to relocate the cupboard to the end of the walkway at basement level to remedy the water ingress issue. The cupboard will be below street level and not visible from any public highway. The elevations to the rear and sides are not to be altered from this application and will remain the same.

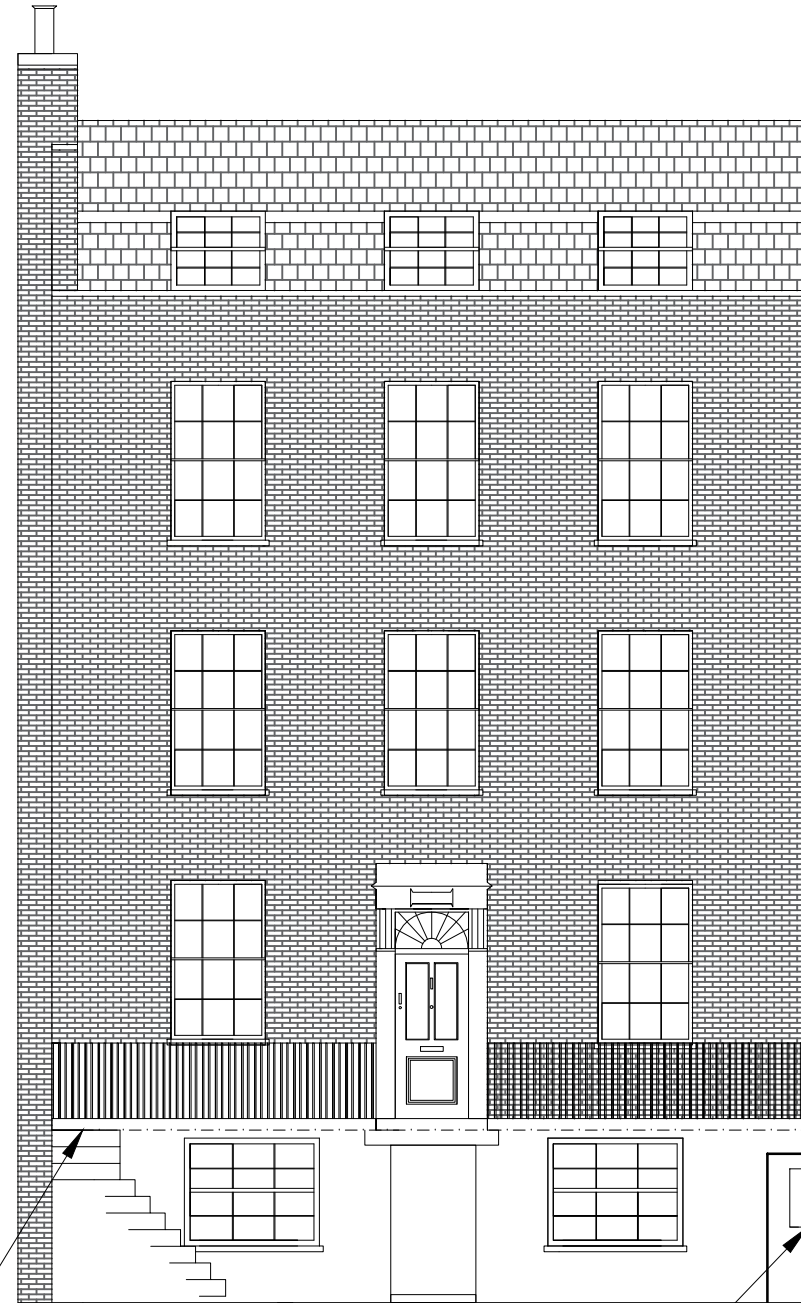
Proposed Elevation

Proposed electrical cupboard location
