**Level and Crack Monitoring**

Occupier:	
Address:	37C Westbere Road
Address:	
Town:	London
County:	
Post Code:	NW2 3SP
Contact Name

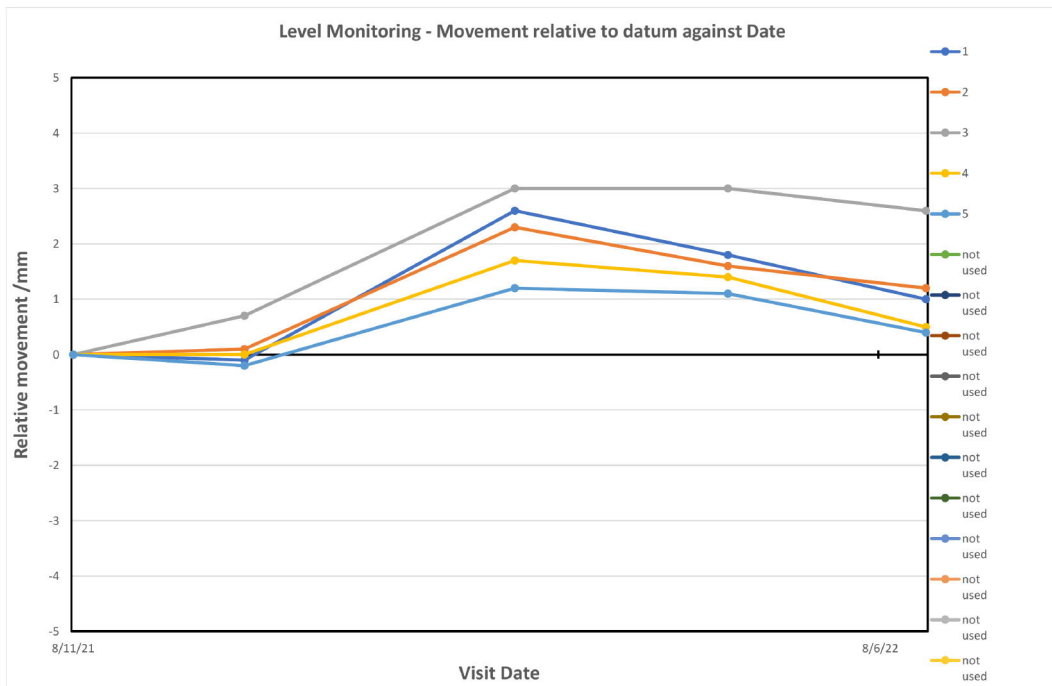
**Level Monitoring - Reduced Levels (in metres)**

Reading Date	8/11/21	23/12/21	4/3/22	29/4/22	20/6/22							
Point / Reading	1	2	3	4	5	6	7	8	9	10	11	12
1	10.8245	10.8244	10.8271	10.8263	10.8255							
2	10.8782	10.8783	10.8805	10.8798	10.8794							
3	10.6471	10.6478	10.6501	10.6501	10.6497							
4	10.9430	10.9430	10.9447	10.9444	10.9435							
5	11.2139	11.2137	11.2151	11.2150	11.2143							
not used												
not used												
not used												
not used												
not used												
not used												
not used												
not used												
not used												
not used												
Tech Initials	RH	RH	BA	BA	BA							
Level S/N.	524015	524015	522888	522888	521856

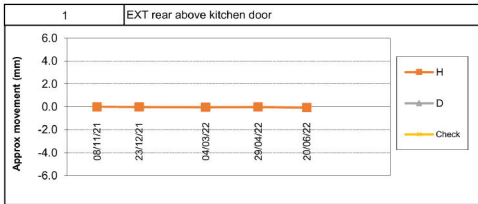
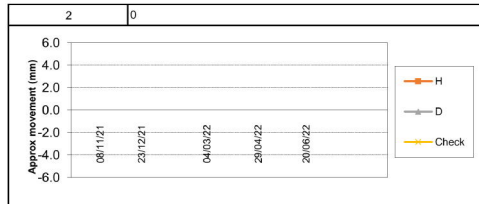
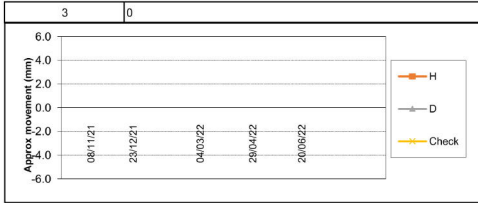
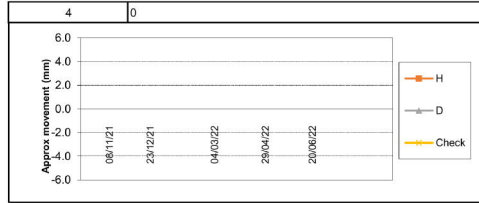
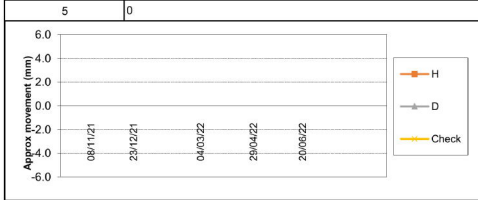
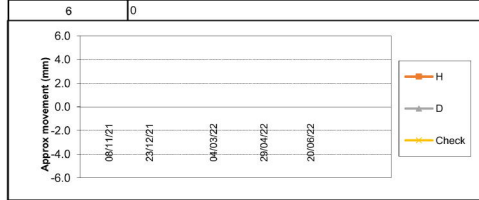
**Crack Monitoring - Movement Against Time**

1	EXT rear above kitchen door
2	
3	
4	
5	
6

Studs nos	Align-ment	Visit Date	08/11/21	Visit Date	23/12/21	Visit Date	04/03/22	Visit Date	29/04/22	Visit Date	20/06/22	Visit Date	
		Reading	Current c/w	Reading	Current c/w	Reading	Current c/w	Reading	Current c/w	Reading	Current c/w	Reading	Current c/w
1	H	67.01	2.59	66.99	3.24	66.98	3.64	66.99	3.50	66.94	3.71		
1	D												
1	Check												
2	H												
2	D												
2	Check												
3	H												
3	D												
3	Check												
4	H												
4	D												
4	Check												
5	H												
5	D												
5	Check												
6	H												
6	D												
6	Check												
Caliber nos		6883		6883		9171		9171		9171			
Technician		RH		RH		BA		BA		BA
