Material Details - Lift Overrun

Client	
City of London Corporation	
Project	
City Junior School	
Title	
Details	
Lift Overrun - Section

Scale @ A2 1:20, 1:3.18	Date 18/07/22	Drawn CS
Purpose of Issue Issued for Planning		
Drawing Code 21040-LSI-A1-XX-DR-A-1451	Suit. S2	Rev. P01

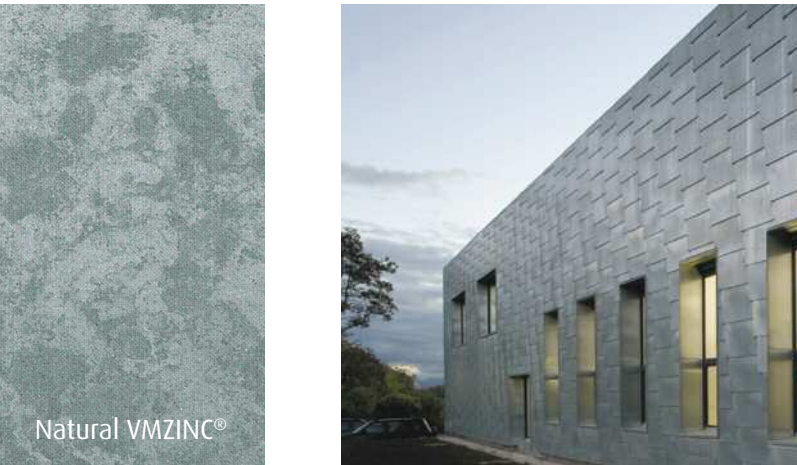
Product: VMZinc Plus

Finish: Natural VMZinc to match existing
Standing seam spacing max. 600 mm centres

Above Left: Zinc swatch

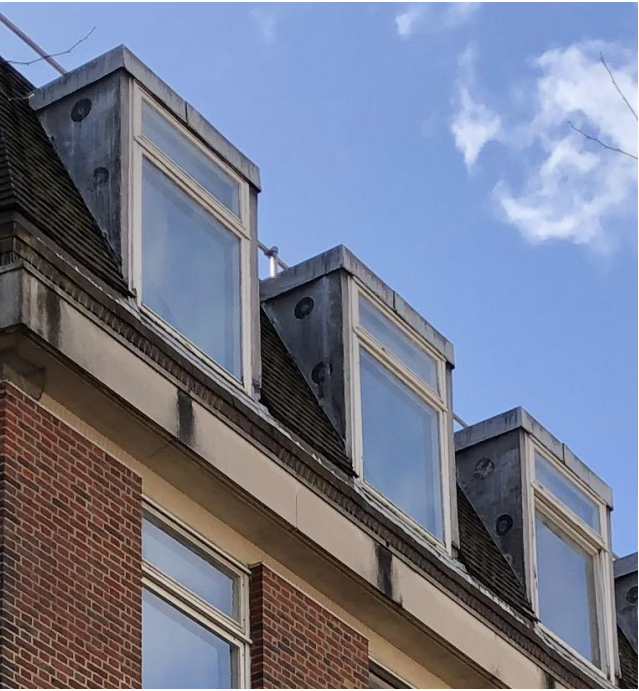
Lift overrun material and spacing to match existing dormer windows as much as reasonably possible.

Above Right: Example of zinc swatch installed
