**FLITCROFT STREET**  
**1 - 5 FLITCROFT STREET, LONDON**

**Proposed Elevation A**

project ref	scale(s)	original paper size
1707		A1
name :		
project	originator	volume level type role number
FLITC	CA	00 - ZZ - DR - A - 3005
status : suitability description :		
S2	SUITABLE FOR INFORMATION	
revision : revision description :		
P03	PRELIMINARY

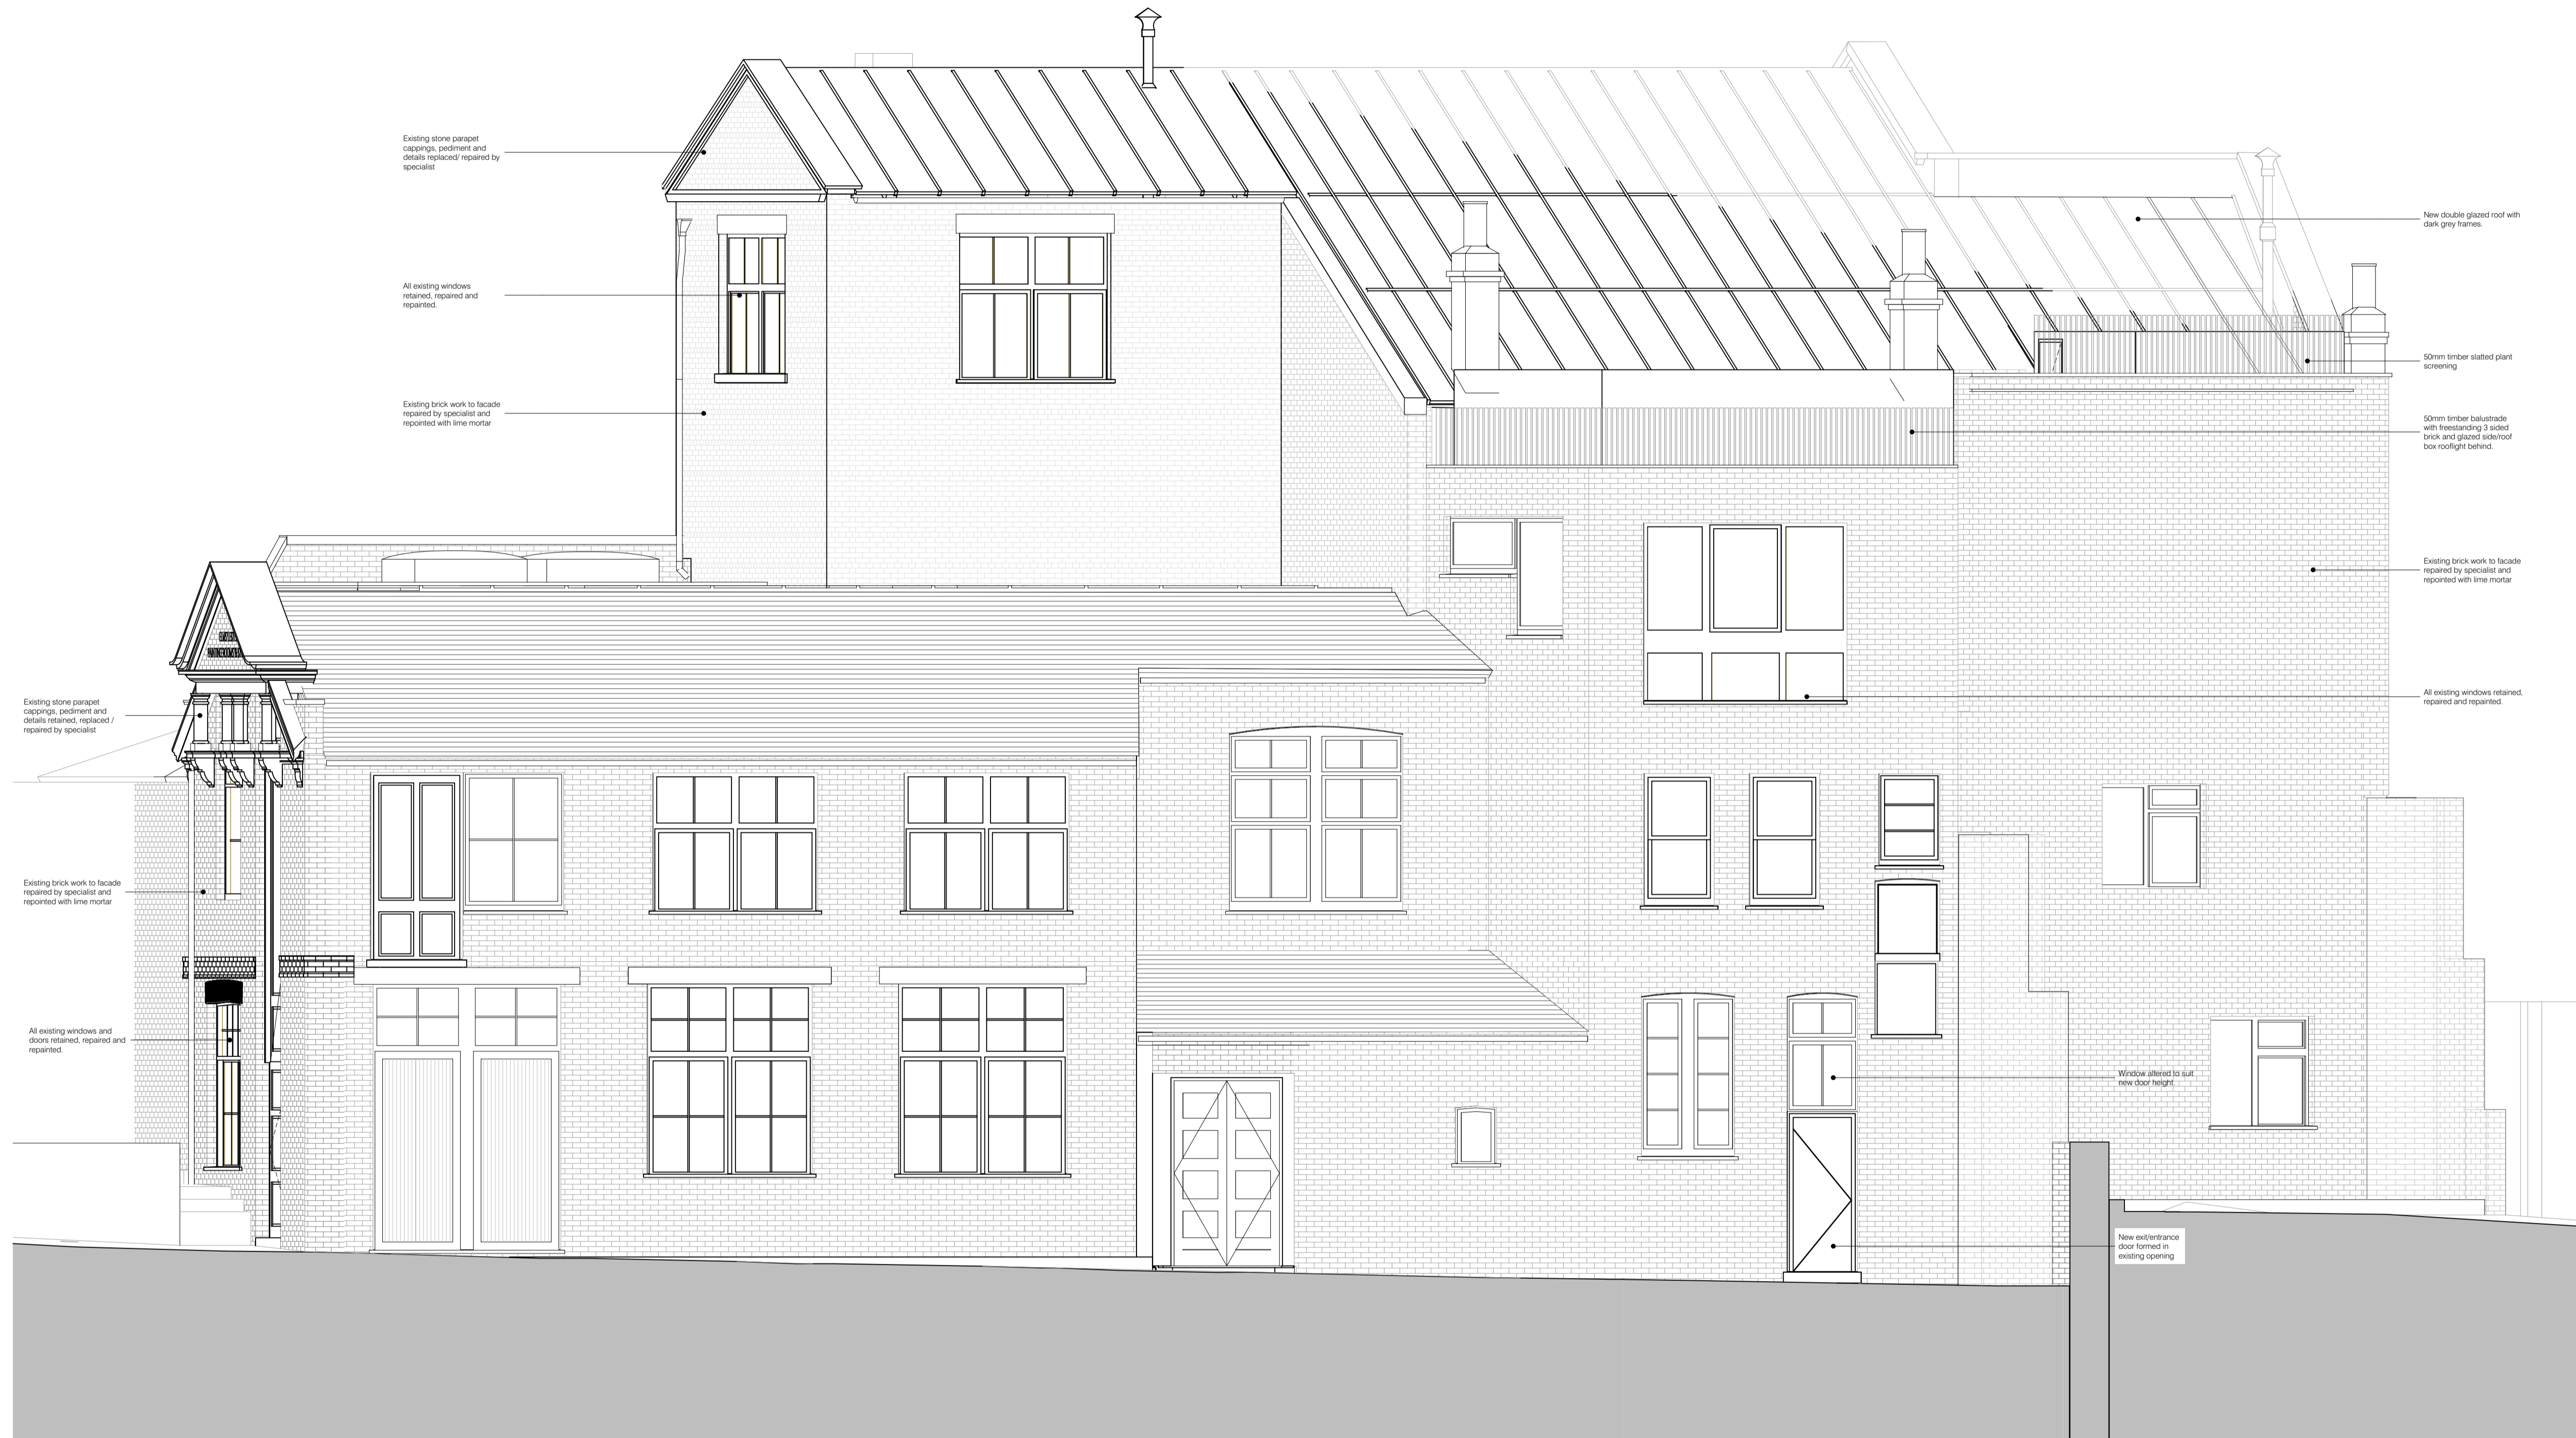
Proposed Elevation A  
1:50 at A1

Existing stone parapet coping, pediment and details retained, replaced / repaired by specialist

All existing windows retained, repaired and replaced

Existing brick work to facade repaired by specialist and replaced with lime mortar

New double glazed roof with dark grey frames

50mm timber slatted plant screening

50mm timber balustrade with freestanding 3 sided brick and glazed side/roof box rooflight behind

All existing windows and doors retained, repaired and replaced

Window altered to suit new door height

New entrance door formed in existing opening
