Job: 2201 Ambassadors Theatre  
Client: Ambassador Theatre Group

Drawing: Existing LGF - RCP  
Drawing no: 2201-3-044  
Scale: 1:50@A1, 1:100@A3

Rev: C  
Status: Stage 3  
Date: 10/06/22

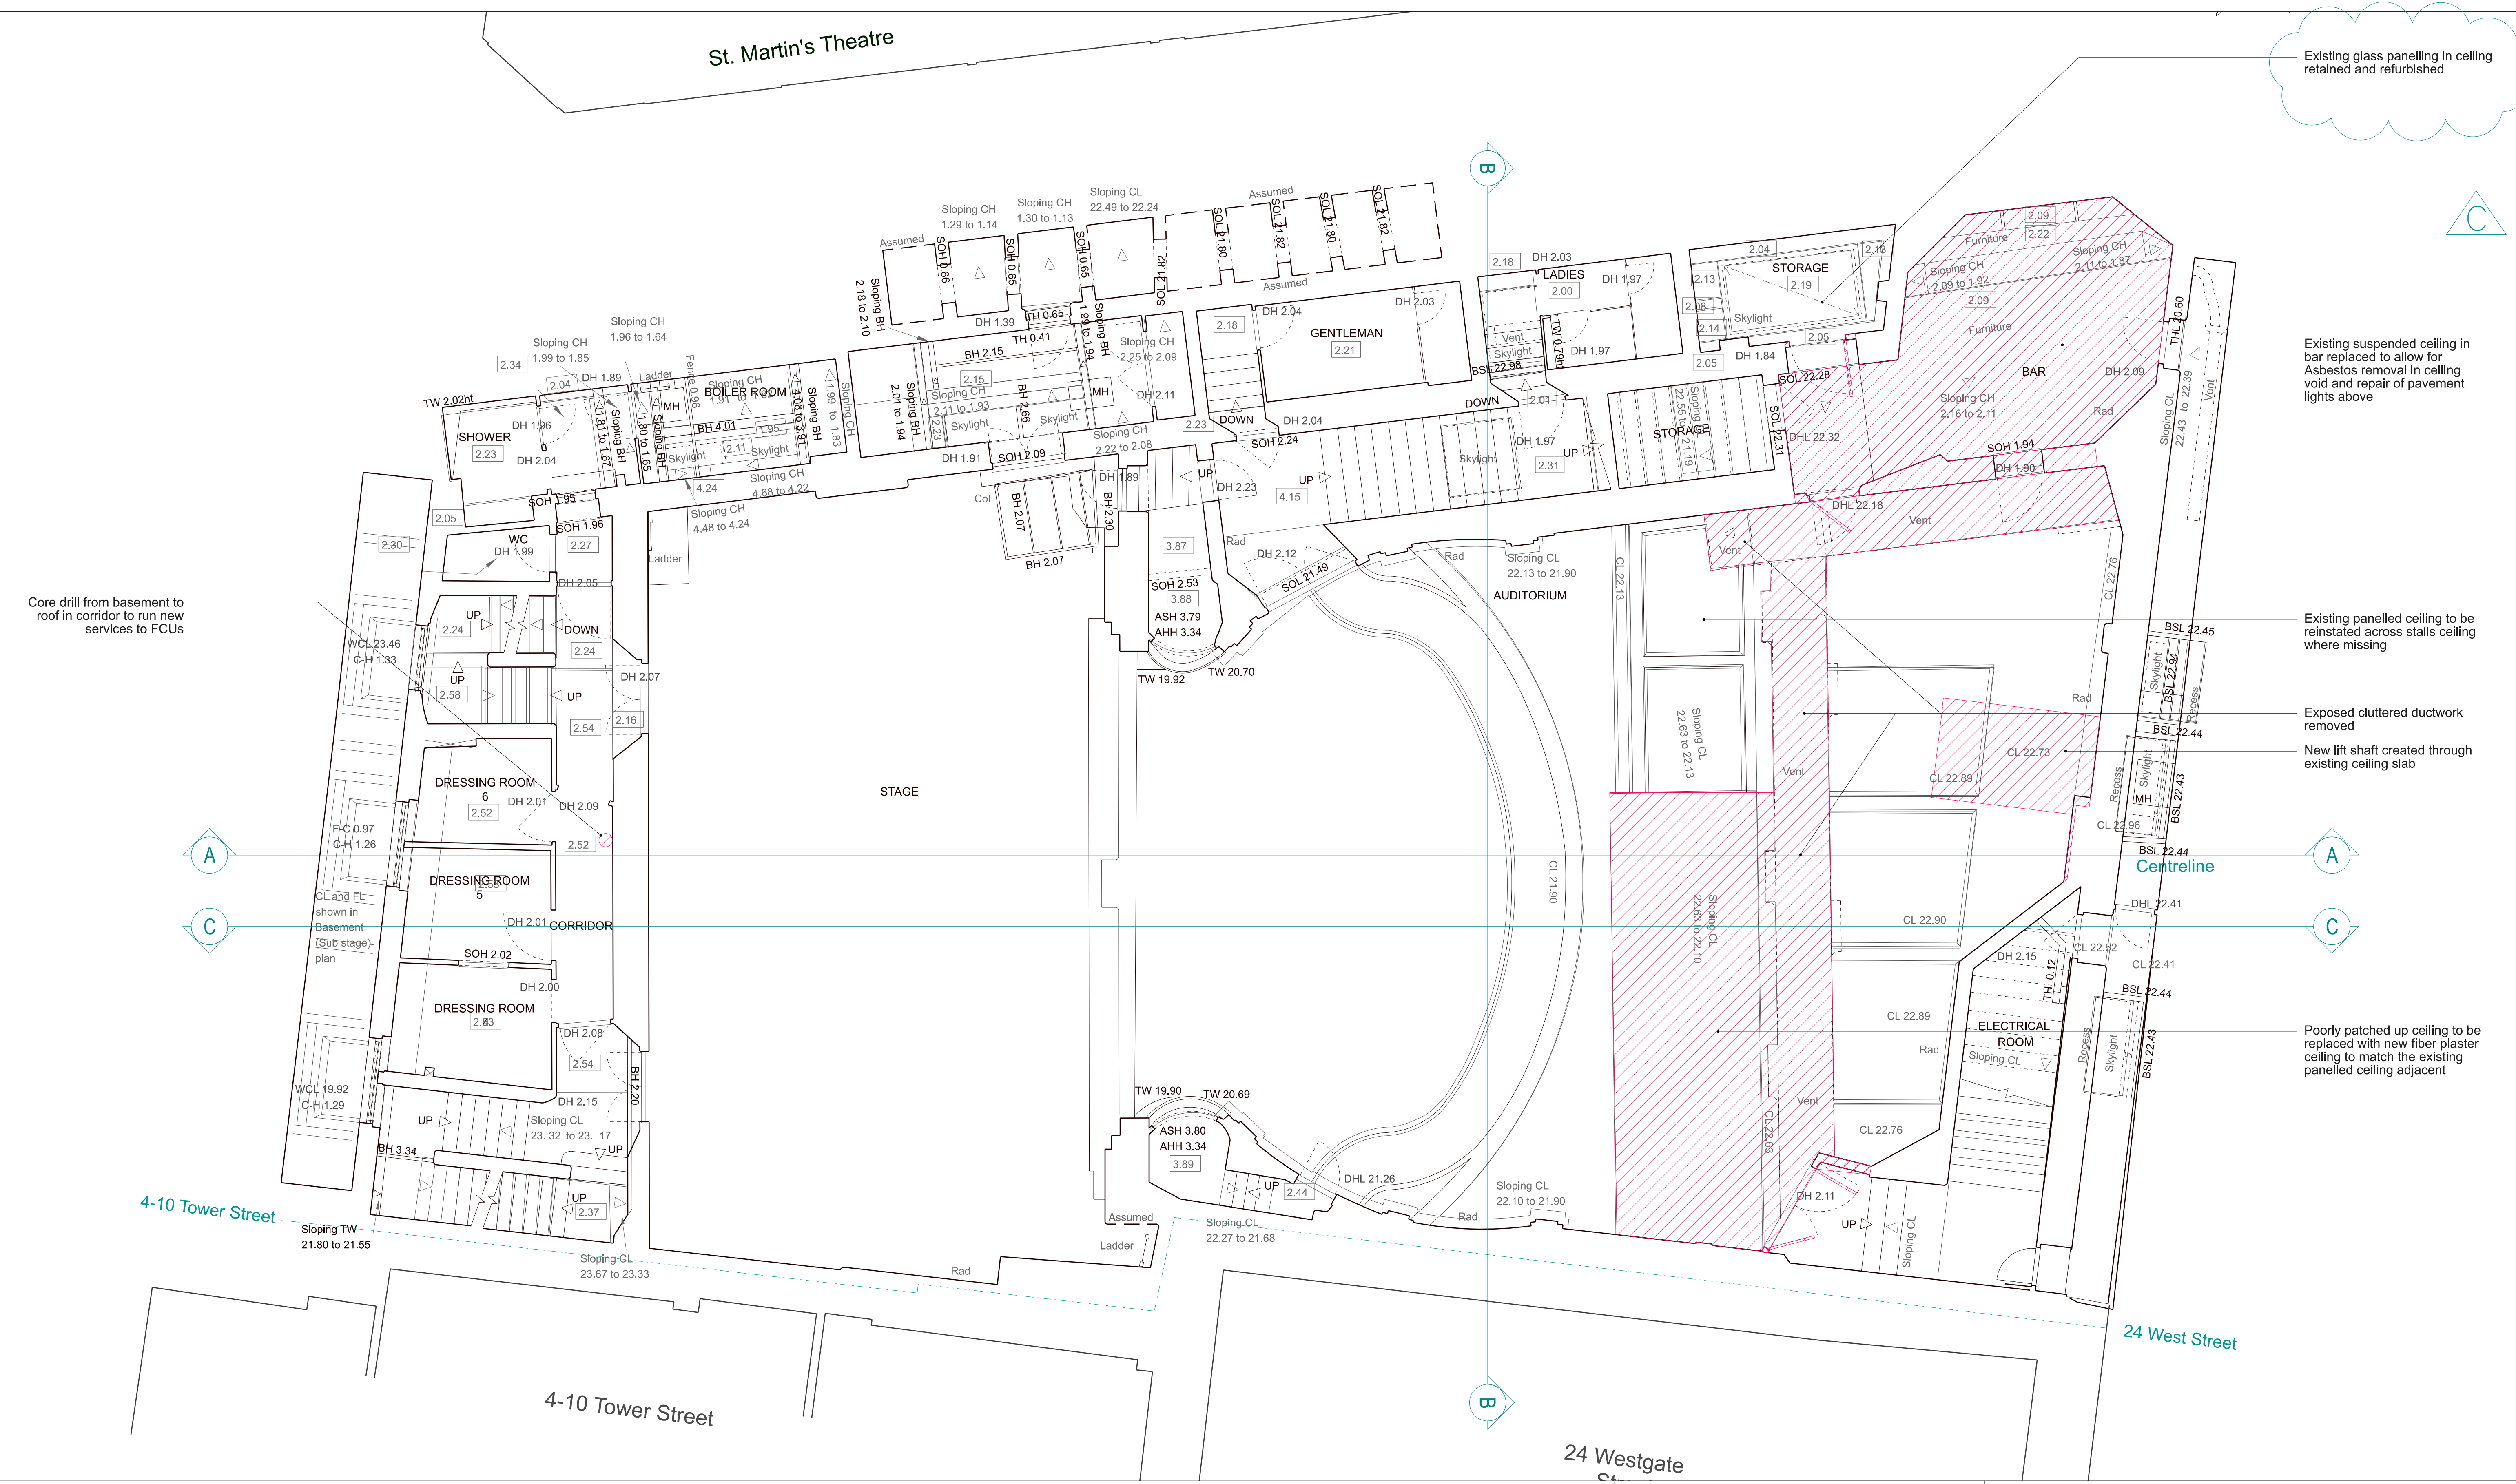
- Existing
- Proposed demolition
- Remove existing dilapidated ceiling to underside of circle and reinstate ceiling pattern to match existing
- Refer to M+E specifications for the proposed lighting, heating and ventilation strategy details.

Existing glass panelling in ceiling retained and refurbished

Existing suspended ceiling in bar replaced to allow for Asbestos removal in ceiling void and repair of pavement lights above

Existing panelled ceiling to be reinstated across stalls ceiling where missing

Exposed cluttered ductwork removed

New lift shaft created through existing ceiling slab

Poorly patched up ceiling to be replaced with new fiber plaster ceiling to match the existing panelled ceiling adjacent
