Job: 2201 Ambassadors Theatre
Client: Ambassador Theatre Group

Drawing: External Front Lobby
Drawing no: 2201-3-705
Rev: Status: Stage 3
Scale: 1:20@A3, 1:10@A1
Date: 20/09/22

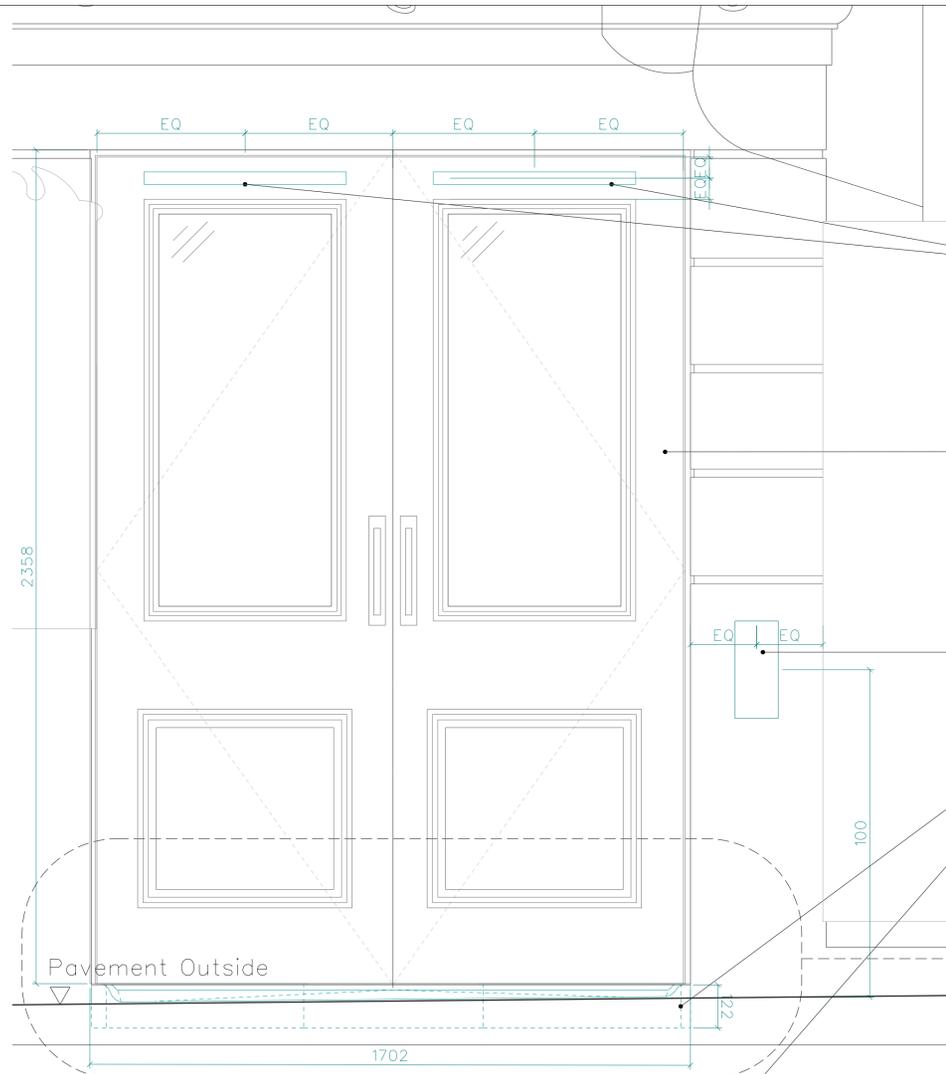
1
750 New door cill and automatic door openers to front door
External Elevation

New internally wired PIR safety sensors installed to existing door leaves, centred on door frame/ glass panels

Existing external door retained

New intercom and push to open button installed

New matching marble cill and recessed door openers installed
See drawing 700 for details
Door opener face plates to be PPC RAL1036 Pearl Gold

Existing marble cill is currently broken in different locations. New marble cill to match existing.
Automatic door openers to be installed within cill depth - see also drawing 700 for new cill details.
PIR safety sensors to be installed at door head and to be internally wired.
Push to open door access controls to be installed internally and externally to this door
