London Industrial Archaeology Society

**Application Nos. 2022/3853/P and 2022/3940/L
Camden Lock Market West Yard and East Vaults, NW1 8NH**

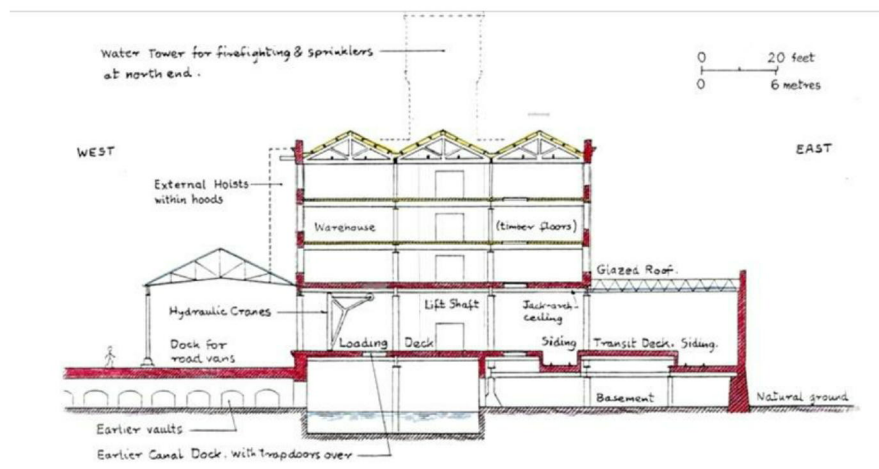
4) I append for information a sketch cross-section of the warehouse, indicating the arrangement of structure, railway tracks and cranes. I would draw it to the developer's attention that the former railway siding near the centre of the East Vaults ('basement') is above the party floor division between the East Vaults and the leasehold tenancy above, and that may alter the feasibility of the ducts shown crossing that feature in section 4.1.9 of the DAS.
