Project 29 Great James Street

Code QA202

Date 23rd June 2022

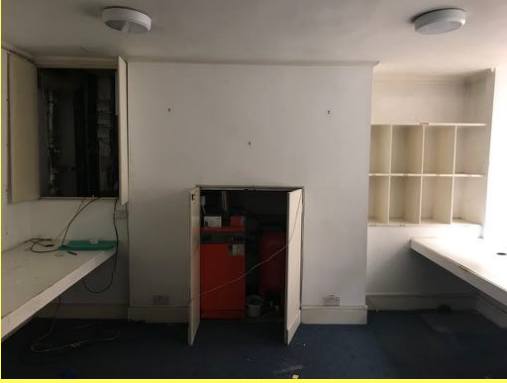
Code	Location	Existing Condition	Photo	Proposed Condition
Basement				
FB.01	Bed (B04)	<ul style="list-style-type: none">No fireplace. Interior used as cupboard to house boiler.

<ul style="list-style-type: none">No fireplace. Opening to be closed up and vent installed.
FG.01	Dining (G01)	<ul style="list-style-type: none">Non-original stone surround and interiorHearth concealed, condition unknown

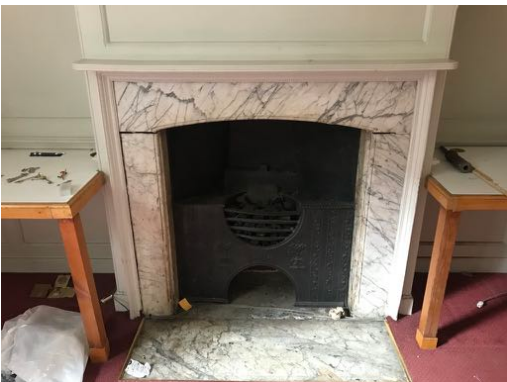
<ul style="list-style-type: none">New stone surround, early Georgian styleCast iron slipsExposed brick firebackHearth to be assessed. If not salvageable, install new stone hearth.
FG.02	Reception (G12)	<ul style="list-style-type: none">Simple moulded mantelpieceCast iron fireboxMarble hearth

<ul style="list-style-type: none">Surround appears correct period and style. To be retained and refurbished.Basket removed.New cast iron slipsExposed brick firebackFunctioning open fire in cast iron basket

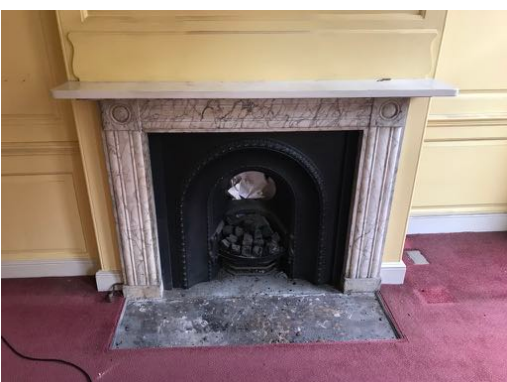
F1.01	Living (101)	<ul style="list-style-type: none">Stone regency style surround (too late for period of house)Metal slipsCast iron firebox and integrated basketStone hearth

<ul style="list-style-type: none">New stone surround, early Georgian styleCast iron slipsExposed brick firebackNew wood burning insertHearth to be assessed. If not salvageable, install new stone hearth.Functioning open fire in cast iron basket
F1.02	Office (103)	<ul style="list-style-type: none">Stone regency style surround (too late for period of house)Metal slipsCast iron firebox and integrated basketHearth obscured by finishes - condition unknown

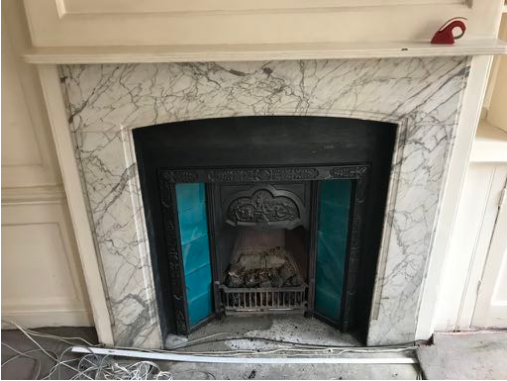
Code	Location	Existing Condition	Photo	Proposed Condition
F2.01	Bedroom (201)	<ul style="list-style-type: none">• Simple moulded mantelpiece• Metal slips• Cast iron firebox with tiled sides and integrated basket• Hearth obscured by finishes - condition unknown

<ul style="list-style-type: none">• Surround appears of the correct period and style. To be retained and refurbished.• New cast iron slips.• Exposed brick fireback• New basket with biofuel burner
F2.02	Bathroom (205)	<ul style="list-style-type: none">• Simple moulded mantelpiece• Metal slips• Cast iron firebox• Hearth obscured by finishes - condition unknown

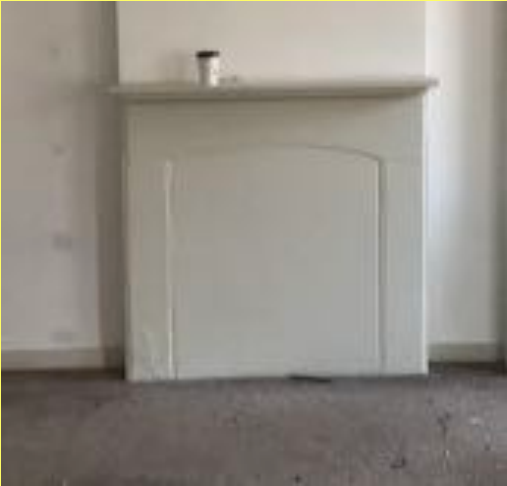
<ul style="list-style-type: none">• Surround and interior appear of the correct period and style. All to be retained and refurbished.• Hearth to be assessed. If missing, install new slate hearth.• New basket with biofuel burner
F3.01	Ensuite (309)	<ul style="list-style-type: none">• Plain faced surround, painted - potentially stone. Appears correct for the period.• Interior blocked

<ul style="list-style-type: none">• Surround appears of the correct period and style. To be retained and refurbished.• New cast iron slips.• Hearth to be assessed. If missing, install new stone hearth.• Exposed brick fireback• New basket with biofuel burner
