Briefing Note

Subject **The Hoo, 17 Lyndhurst Gardens, Hampstead – Heritage Impact Assessment for the works to the southern boundary wall**

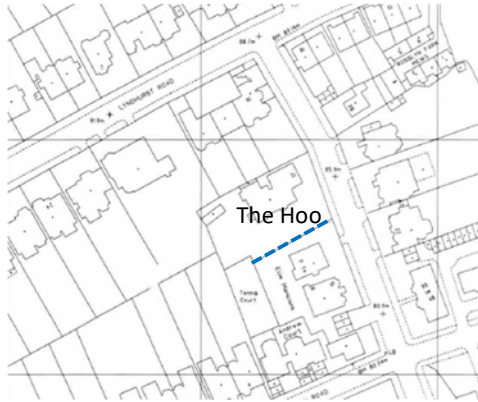
Figure 1 1990 OS map showing The Hoo and its surroundings; the south wall is indicated in blue.

3.2 Figure 1 shows the location of the southern boundary wall to be rebuilt, as identified on the 1990 Ordnance Survey map.

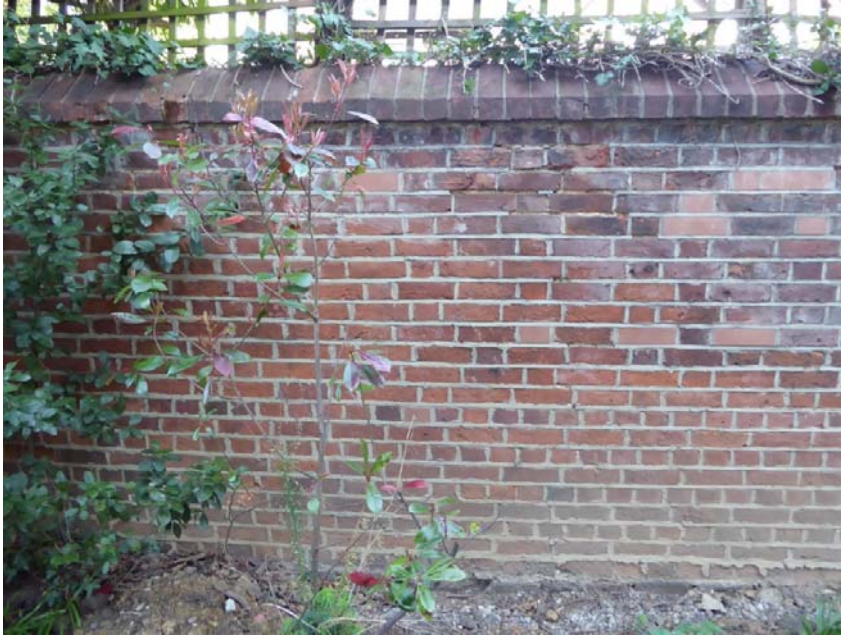
Figure 2 South boundary wall as seen from the grounds of Elim Mansions

- 3.6 The south boundary wall is constructed of what appear to be handmade red bricks, of imperial size (approximately 9" x 4 1/4" x 2 5/8"); the lowest c. 10 courses (as seen from the grounds of Elim Mansions) are of English bond, while the upper courses are set in a different bond, indicating the upper portion may have been rebuilt/extended. The bricks appear similar to those in the piers of No. 15, and also the bricks on the elevation of No. 17, The Hoo.

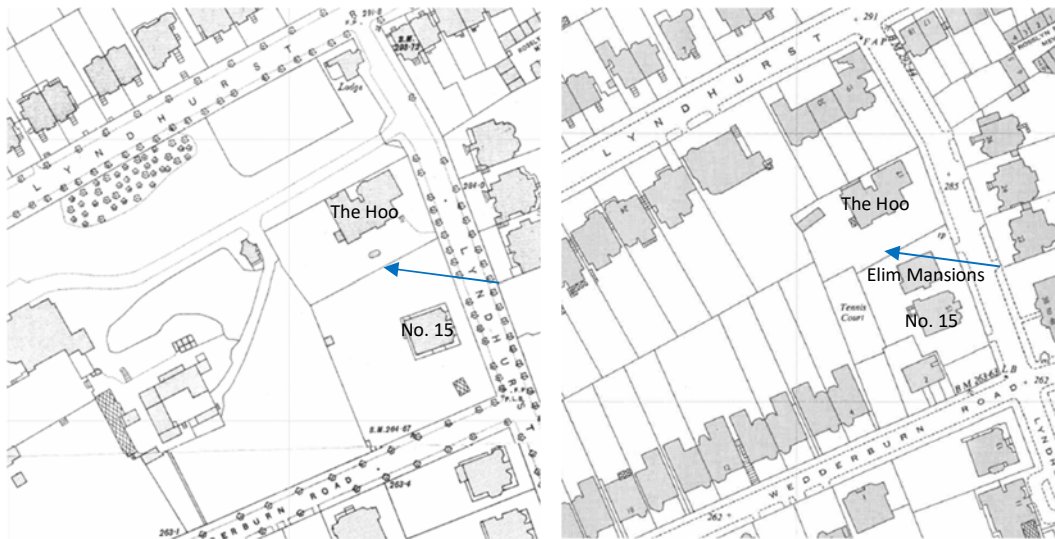
Figure 3 1896 OS map (left) and 1952-53 OS map (right)

- 3.3 The 1896 OS map (see Figure 3) shows the boundary between The Hoo and the villa at No. 15 Lyndhurst Gardens was established in its current location by the late 19th century, when both of these buildings were constructed. There likely would have been a boundary wall between the two buildings constructed at this time for privacy though it is unclear whether the existing wall is original (see Figure 2).
- 3.4 Subsequently, in the early-mid 20th century, a block of flats, the Elim Mansions, was built north of No. 15 (see Figure 3). At or around this time, a small part of the south-west corner of The Hoo's gardens, along with a large portion of No. 15's gardens, appears to have been sold off to create a tennis court (see Figure 3).

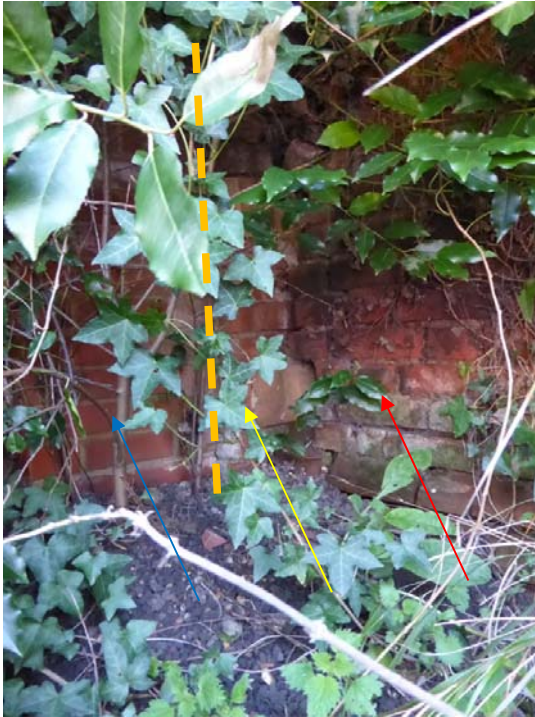
Figure 4 The south boundary wall to The Hoo is indicated in red; the historic brick pier of No. 15/Elim Mansions is indicated in yellow; and the modern brick pier of The Hoo is indicated in blue; and the division between the pier of The Hoo and the pier/ wall of No. 15/Elim Mansions is shown by a dashed orange line

- 3.5 Inspection of the south boundary wall from inside the grounds of The Hoo shows that the wall aligns with the northernmost brick pier to the street frontage of No. 15 Lyndhurst Gardens/Elim Mansions. The brick pier of No. 15 is historic and assumed to be original to the house (it matches those piers continuing south along the street frontage of the original extent of the grounds). It would seem that, being aligned with the pier of No. 15 Lyndhurst Gardens/Elim Mansions, it forms part of their land rather than the land of The Hoo. However, the south boundary wall does not appear to be tied into the pier of No. 15 (n.b. a close inspection was not possible due to foliage) (see Figure 4).

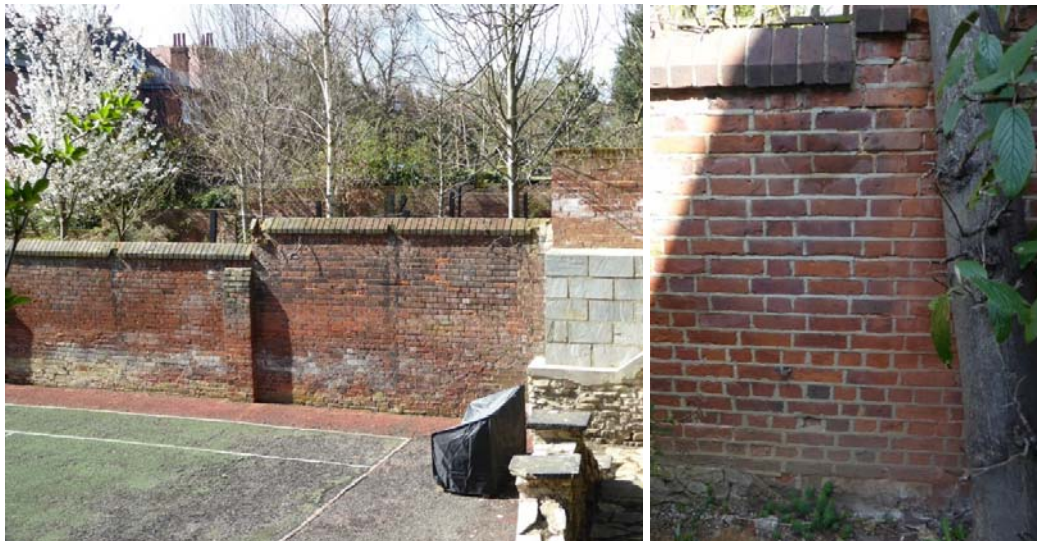
Figure 5 Brick boundary wall at the west edge of the tennis court built in the rear garden of No. 15 (left) and south boundary wall of The Hoo (right)

- 3.7 The copings of the south boundary wall appear to match the boundary wall of the at the far west edge of the tennis court, which would originally have been the edge of the grounds of No. 15. The bricks on the west wall to the tennis court also appear similar to those on the south boundary wall to The Hoo, though close inspection of the tennis court wall was not possible (see 5).
