49 Downshire Hill. Hampstead . NW3 1NX

22005. Tree survey. December 2022.

Arboricultural implications assessment.

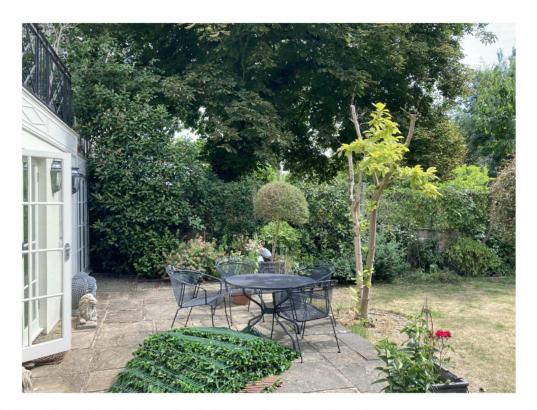
T4 is a Horse Chestnut growing in the garden of number 48.

Spot levels on the TSP show a brick wall of 1 metre height forming the boundary between numbers 49 & 48. There is a significant contour drop into the garden of number 48. The brick wall is buttressed in the garden of number 48 in order to retain the garden of number 49.

Due to change in levels and the historically deep founded boundary wall it is unlikely that there are roots of the Horse Chestnut that are essential for the normal functioning of the tree growing in the garden of number 49.

The minimal excavations required to build the small extension and to prepare the ground for the patio extension will not impact the Horse Chestnut at all. (The new patio is at the same level as existing and the adjacent lawn is lower).

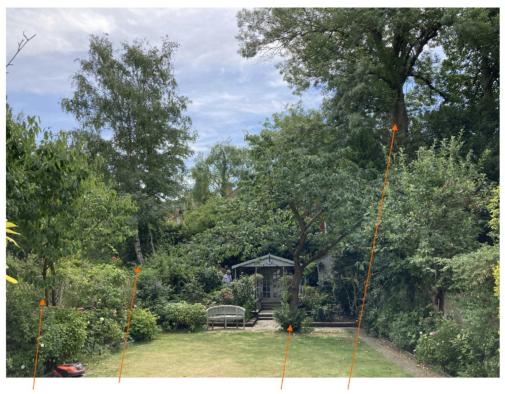
T8 Cherry T5 Silver Birch T3 Cherry T7 Ash

The garden design removes the small Cherry T8. This Cherry cannot be seen from anywhere the public have unrestricted access.

The proposal replaces the existing garden room with a slightly larger room with an asymmetrical footprint. This will involve minimal excavation adjacent to the boundary wall with number 48. The same logic applies to the neighbours Silver Birch T5 as to the Horse Chestnut T4. The drop in contour and existing boundary wall preclude significant Birch roots this side of the boundary. The garden room proposal will not impact the Birch.

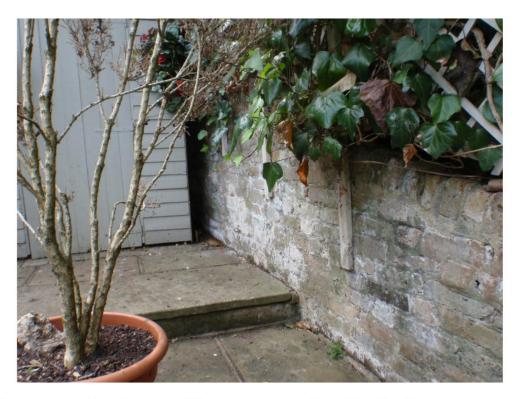
There is also a historic brick wall between number 49 and Hopkins House. It is a considered opinion that this wall is less of a root barrier than the one adjacent to number 48.

This end of the garden gives an indication of the original contour prior to any levelling to create gardens on Downshire Hill and the adjacent gardens at Hampstead Hill.

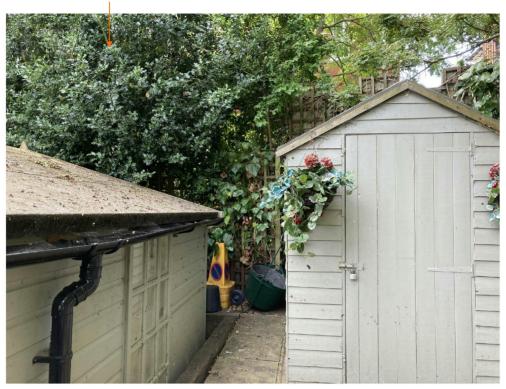
There was excavation to construct the existing garden room. The pad on which the garden shed is standing and the land adjacent to Hampstead Hill Gardens is retained by railway sleepers (sleeper wall). These retained areas will remain undisturbed by the proposal.

Slight excavation will take place adjacent to the boundary of number 48 for landscape planting next to the new garden building however this will not impact the Holly T6 or the Ash T7.

The Holly T6 is not really big enough to have put down substantial new roots after the excavation for the existing garden building. The existing garden building must to a certain extent be a rain shadow. Logic dictates the Holly would root towards Hampstead Hill Gardens rather than all of the way down the sleeper wall and under the building.

Similar logic applies to the Ash T7, however the Ash is big enough to put roots down the sleeper wall after excavation for the existing garden building. There is however no visible evidence of this.

These Ash roots however would have had to have come under the foundations of the historic brick wall many years ago and a lot of these would be through intractable London clay.

Aerial images indicate the Ash has significant root offset in its own and other adjacent gardens.

It is becoming difficult to see Ash as a planning constraint due to the increasingly common appearance of the fungus Hymenoscyphus fraxineus. This causes die back in the crown and rapid degradation of timber. Should the Ash T7 at Hopkins House show confirmed symptoms of Ask dieback it would become an actionable nuisance due to gardens within falling distance of branches and stems. It would have to be dismantled whilst it is still safe to climb. The impact of Ash dieback on Ash populations is becoming similar to the impact of Dutch Elm disease to Elm populations in the 1970s.

It proposed to leave the sleeper wall in place just in case there are Ash roots here.
