Existing Internal Elevations Window Stack 02

BW125 - BW - ## - XX - DR - E3002

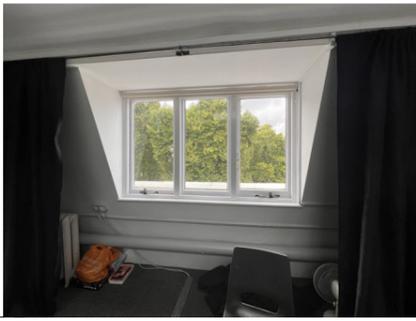
W.03.05

Modern casement
Post condition

Modern casement window.
Lowest significance.
No related detail of interest.
No related detail of interest.
Non original dormer (widened pre-existing).

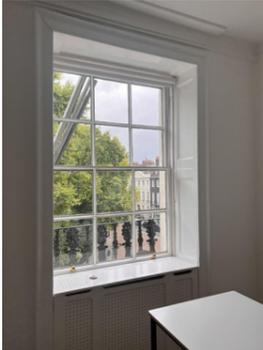
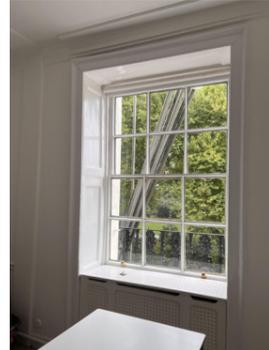
W.02.08

Weighted sash
6 panel sashes
Shutter box non functioning
Concealed radiator below
OK condition
Manually operated blinds

Good quality historic window without horns. Historic shutters much painted over. Reasonable condition. Radiator box below obscuring window details. Highest significance.

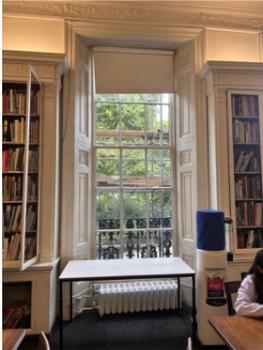
W.01.08

Weighted sash
6 over 9 panel sashes
Shutters historic and probably original
Painted shutters
Manually operated blinds shut
Pipework through the panel

Chamfered reveals and shutters original although in a poor condition. Left hand side shutter one of few openable shutters. High significance. Windows have no horns and appear to be original to the building although the glazing is later and sources record that the windows of the first floor were 'lown out (including glazing bars) during WWII. In addition, it has been reported that the windows to no. 34 were replaced in the 1920s to match those at no. 35 (the windows to no. 34 having been replaced in the 19th century). Given the importance of the first floor windows and appropriate detailing these are considered to be of the highest significance.

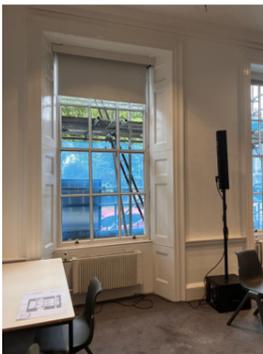
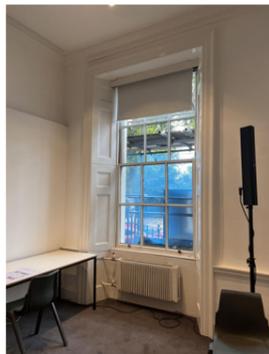
W.00.06

Weighted sash
6 panel sashes
OK condition
Pipes through panelling
Electric operated blinds

Chamfered reveals and shutters original with evidence of past repair. Reasonable condition but fixed shut and painted over. Highest significance. Windows have horns and glazing bars that lack the finesse of original windows suggesting post late Victorian date. Glazing bar pattern matches the 1919 front door suggesting all of the windows at ground floor were altered to match.

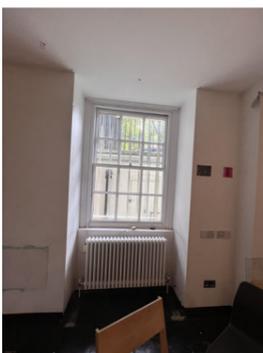
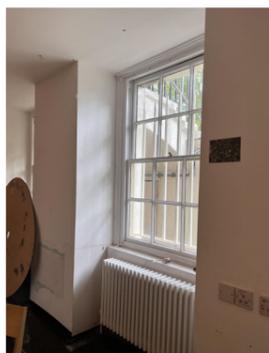
W.B1.05

New radiator

Historic window possibly 20th century but without horns. Very modest detailing. Medium significance.
