CONDITION 3

EXTERNAL MATERIALS - FRONT

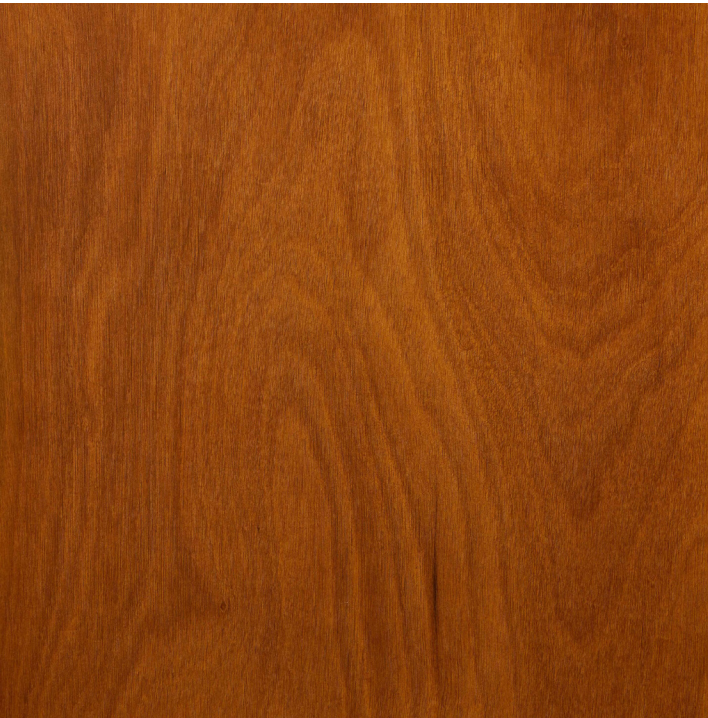
Parklex Veneered High pressure laminate cladding to new shopfronts - Finish Rustik Matte

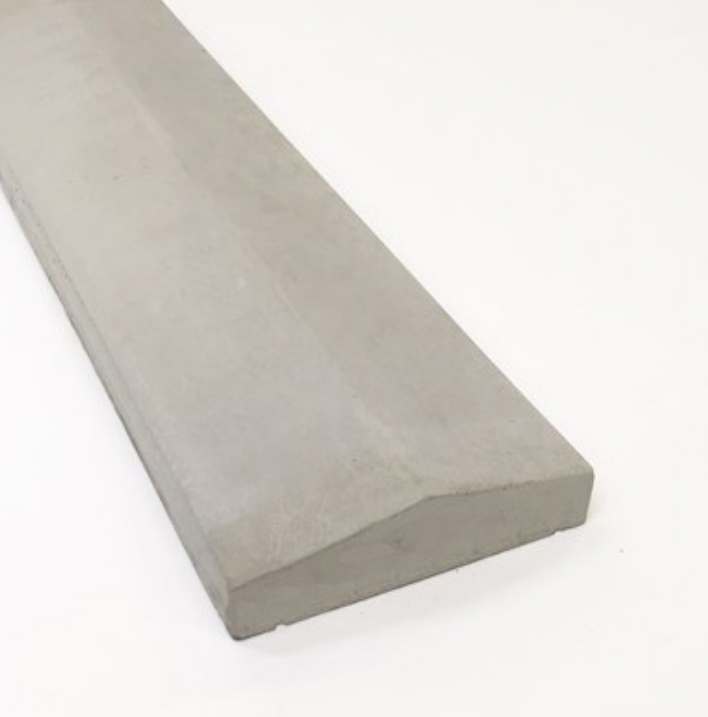
Concrete coping replacement

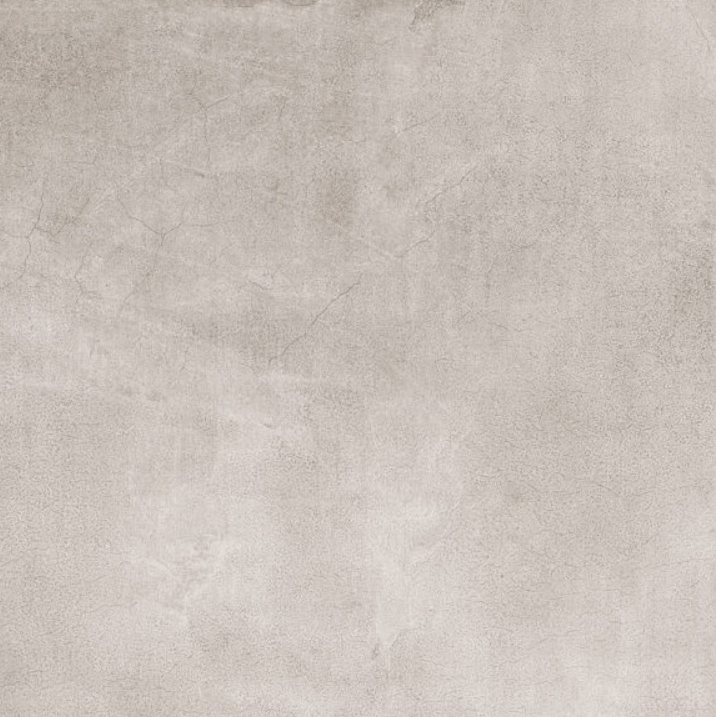
Porcelain tile to upstands - Set Concrete Pearl

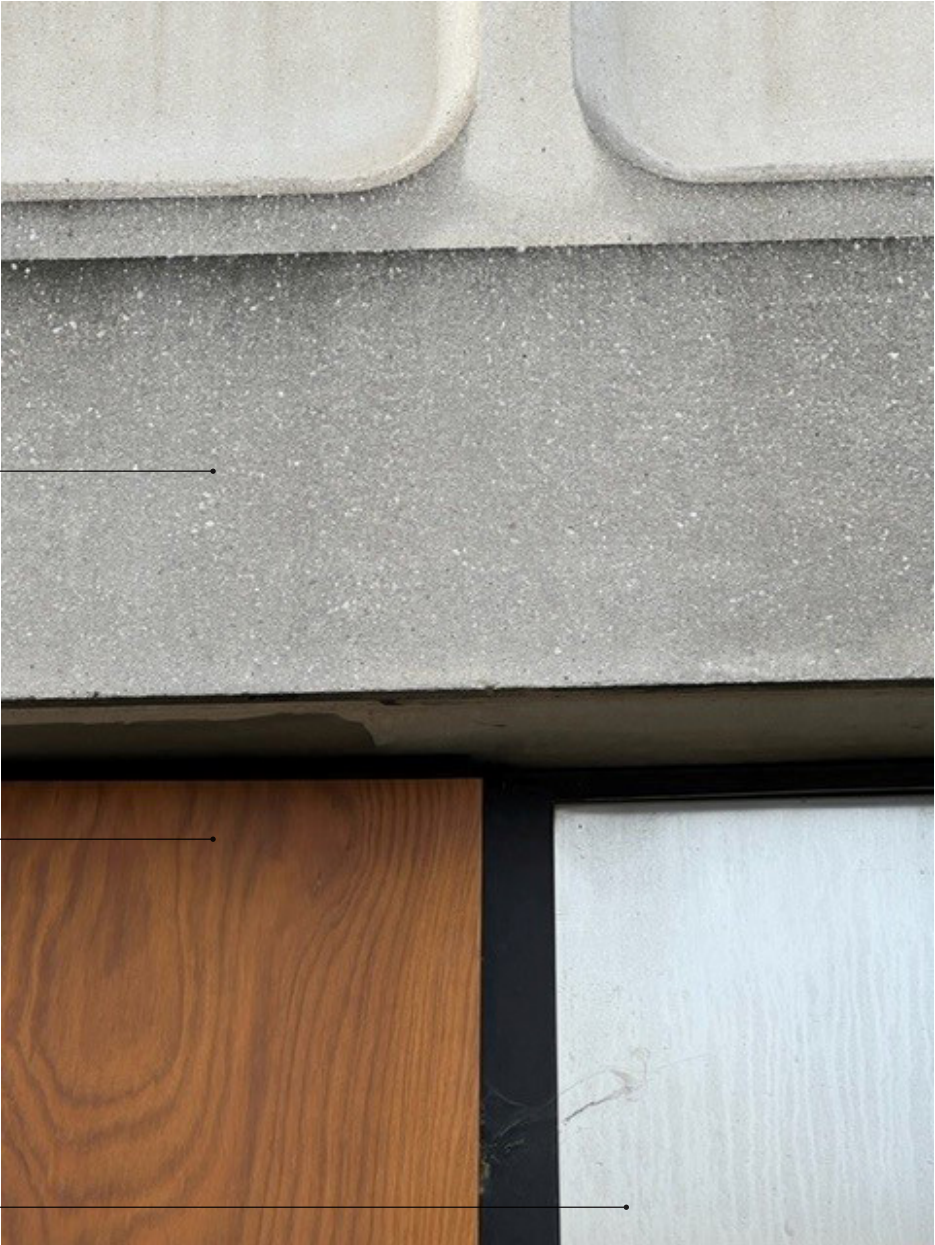
Existing concrete facade

New Parklex Veneered High pressure laminate cladding

Existing aluminum facade

Photo of sample taken on site

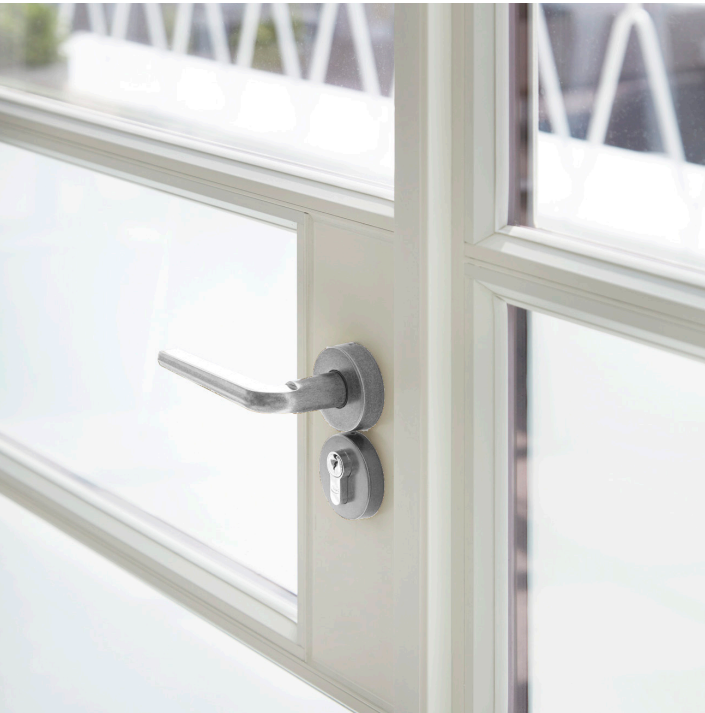
W40 Steel Window and Steel Door frames - RAL 9010

Stainless Steel ironmongery

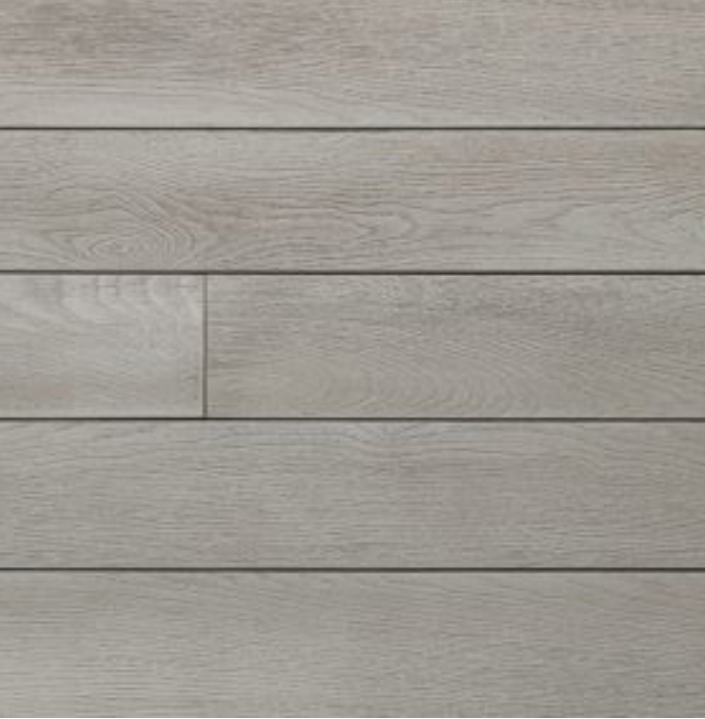
Composite timber decking - Smoked Oak

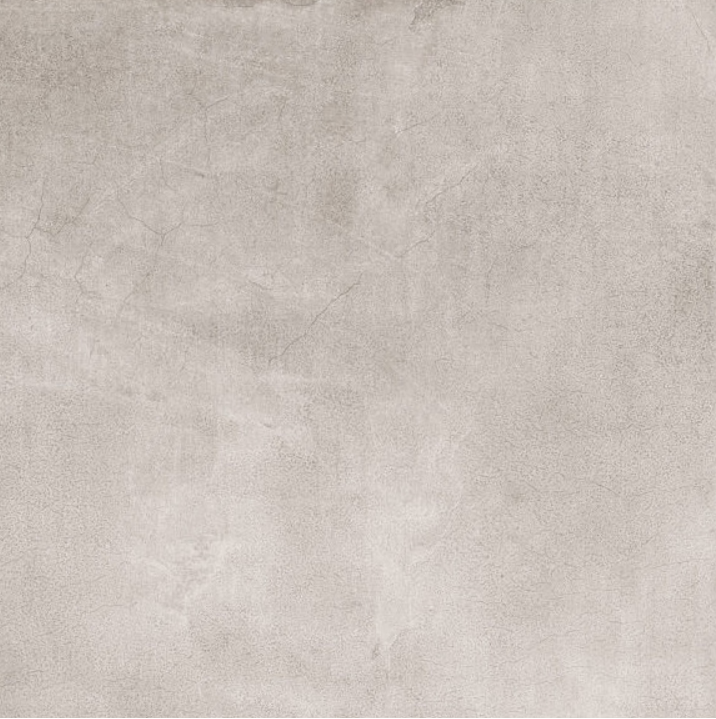
Porcelin tile to upstand - Set Concrete Pearl

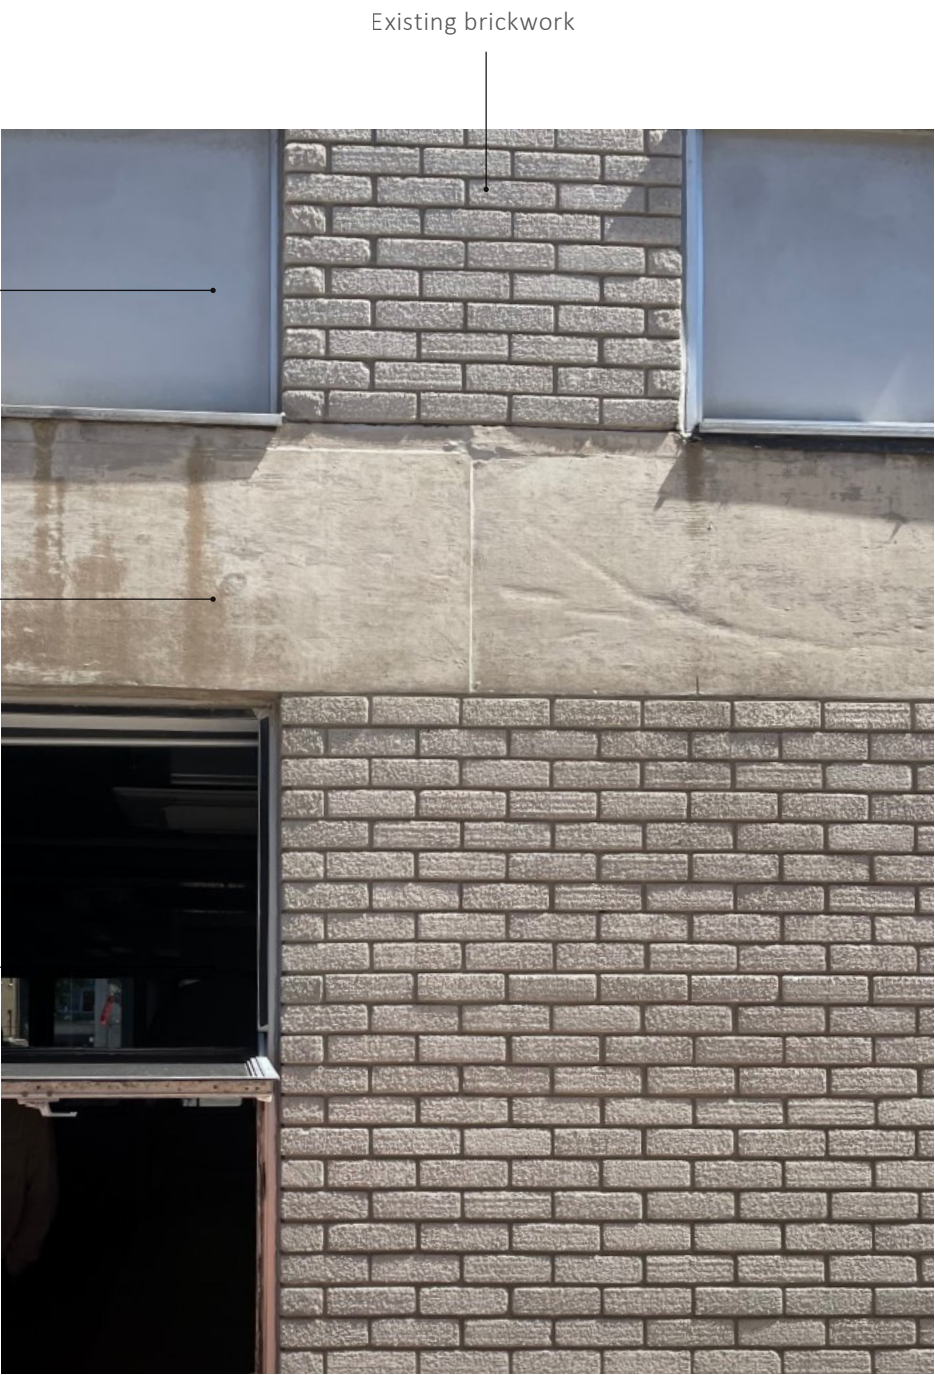
Existing aluminium  
window panels

Existing concrete facade  
panel

Existing aluminium  
windows

Photo of existing rear facade
