Pre-Redevelopment and Pre-Demolition Audit Report

Project 200 East Development – University College School

University College School Hampstead

08/12/2023

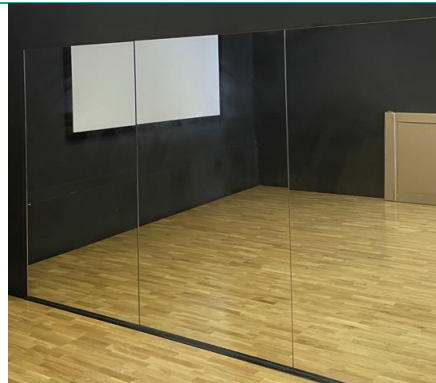
8.16 Glass found on-site was noted to be in reasonable condition.

Image 50 Fives Court - Wall Mirror

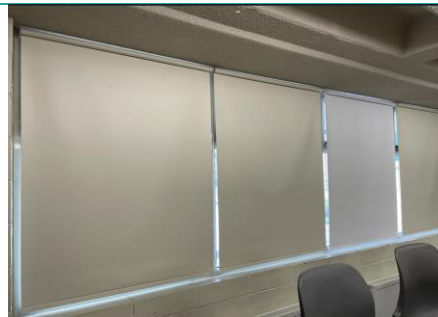
8.20 Plastics found on-site were noted to be in fair condition.

Image 60 GS Wing - Plastic Blinds

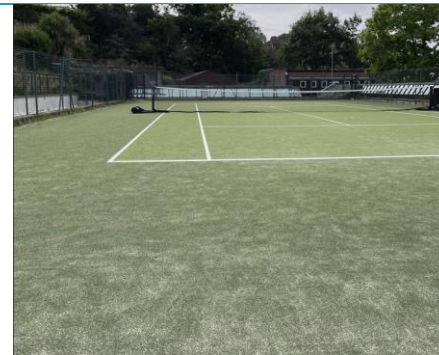
Image 61 External Areas - Astroturf

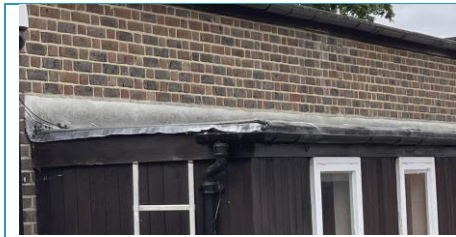
**Image 65 Fives Courts -
Mineral Roof Felt**

All bituminous mixtures (including mineral roof felt) will be sent off-site for recycling.

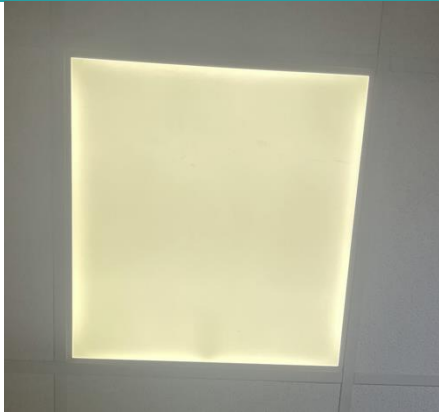
Image 67 Fivers Courts -
Luminaries

All luminaries that cannot be reused on and off-site will be sent off-site for recycling.

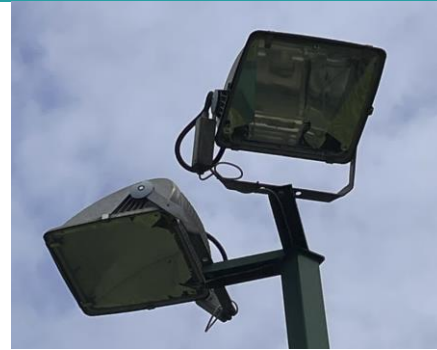
Image 69 External Areas -
Luminaries

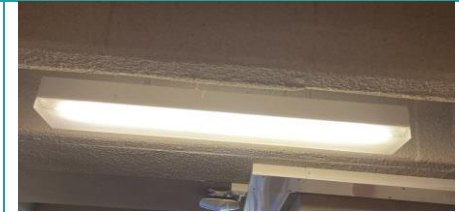
Image 70 GS Wing -
Luminaries

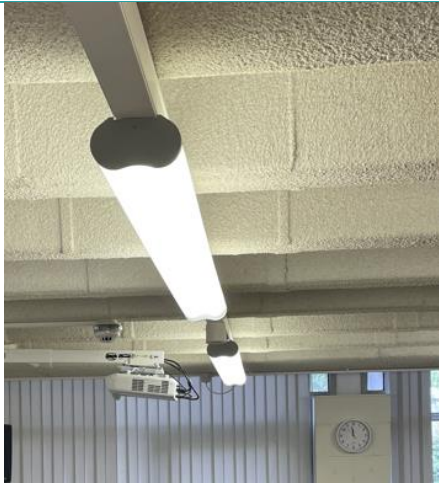
Image 71 GS Wing -
Luminaries
