**Clarifications and  
Responses on Demolition  
Justification including Pre-  
Redevelopment Audit and  
Retention options appraisal**

October 2023

This document relates to planning application 2023/2510/P and has been compiled in response to feedback from the GLA Stage 1, LB Camden officers and their 3rd Party technical reviewers. In particular the queries relate to how the proposals address the requirements of specific policies;

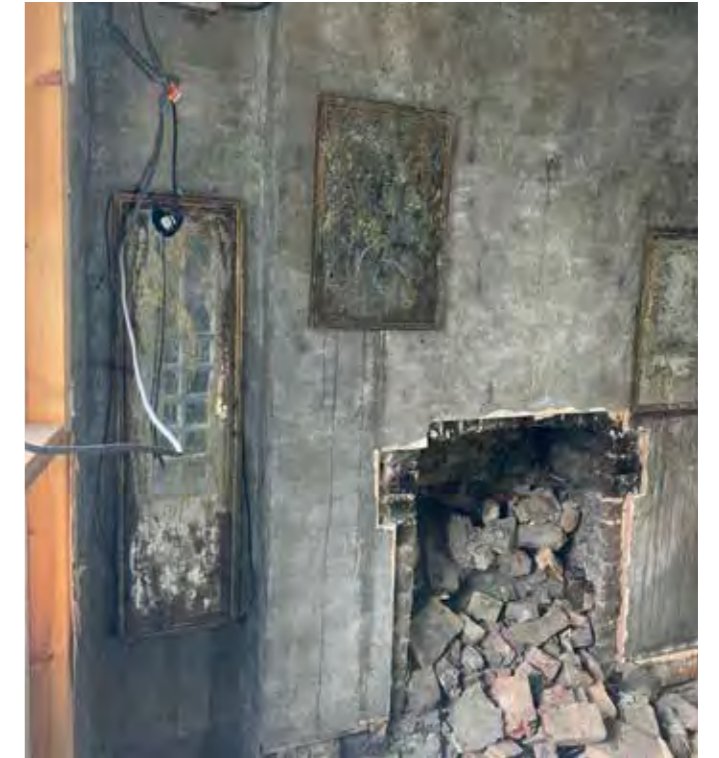
Modern joinery and lost fireplace. (35 NOST.)

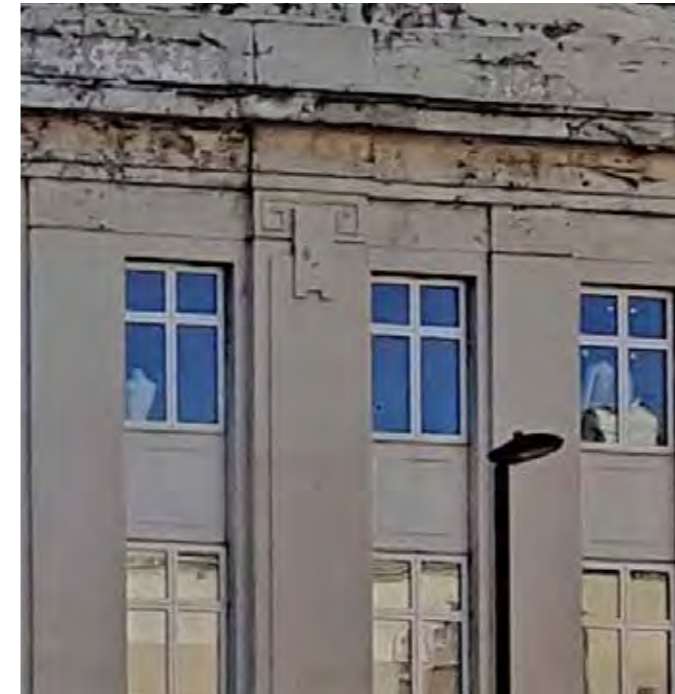
On upper floors while the main body of the facade and ornament is in good condition, it requires repainting. The current windows however are poor quality PVC windows in poor condition and their appearance do not resemble the more filligree multi-paned aluminium style window which would be expected of this period of architecture. The aperture sizes and locations relative to finished floor levels are well suited to create a good level of daylight/sunlight and aspect expected for residential accommodation. The building is topped by the characterful pitched pediment which is in a state of disrepair.

Existing Paintwork

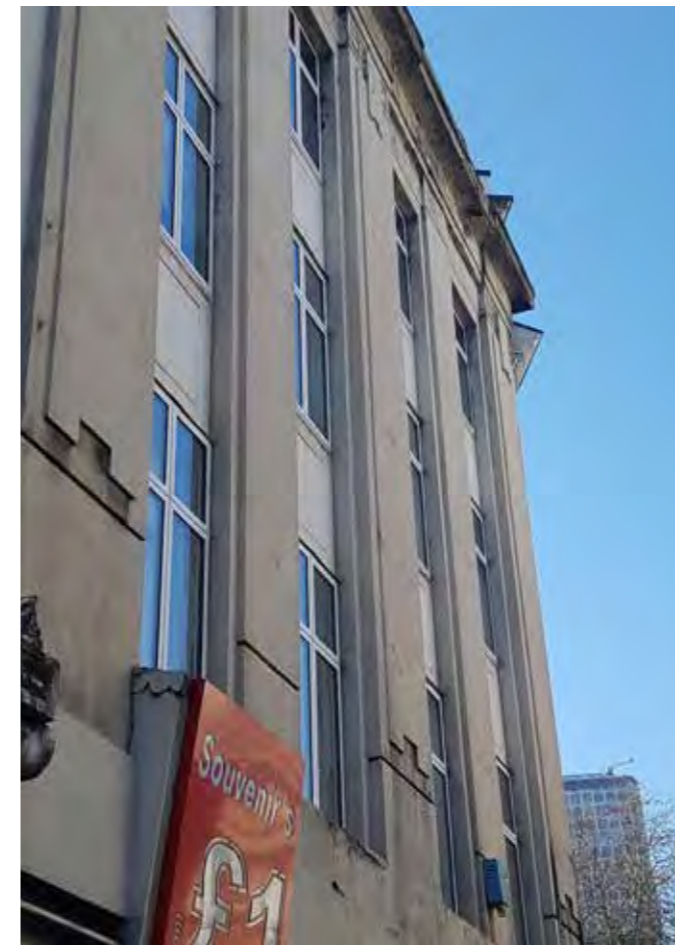
Existing Windows
