Project Name: Highgate Cemetery

Project Date: 06/03/2024

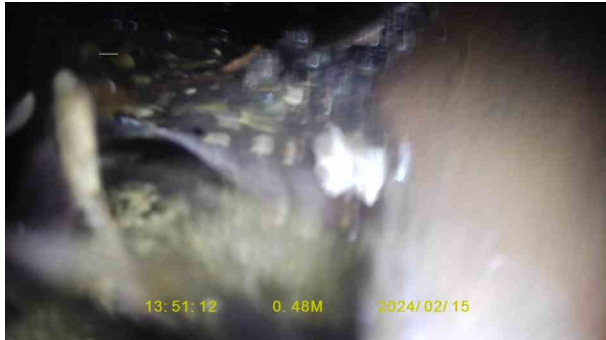
20c95e4e-6e9c-4eee-b96d-9d31401beb11.jpg, 00:00:22, 0.48 m
Settled deposits, fine, 25% cross-sectional area loss, start

Recommendations: Recommend HPWJ/Resurvey

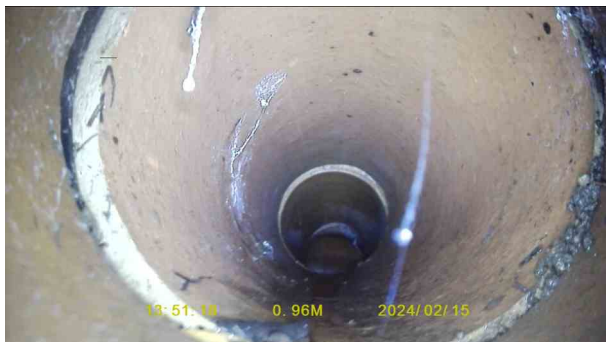
7b959420-30df-46fe-8b1c-021aa6c8dd4c.jpg, 00:00:28, 0.96 m
Joint displaced, medium

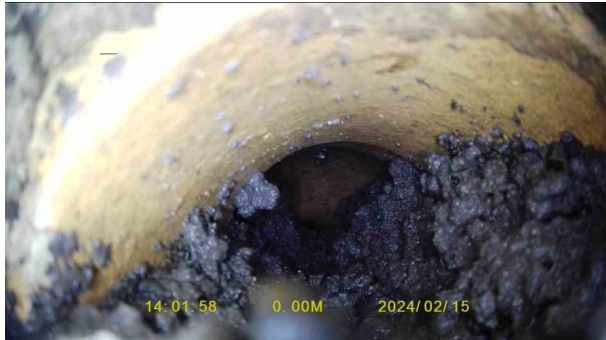
7ba87c9a-6b39-42d4-ae10-ec3c1a5078b6.jpg, 00:00:19, 0.01
m
Settled deposits, fine, 30% cross-sectional area loss

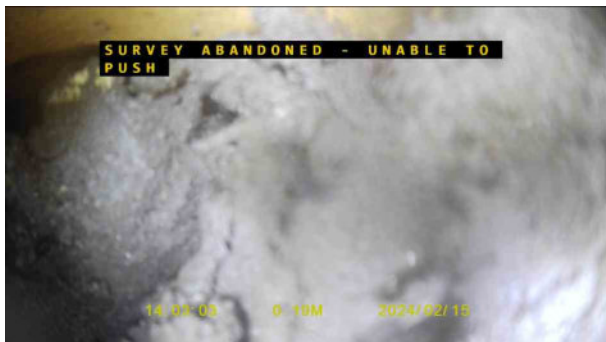
b3d517be-2c67-4ef1-a381-ccbc479d77ed.jpg, 00:00:58, 0.19
m
Survey abandoned, Camera unable to pass debris

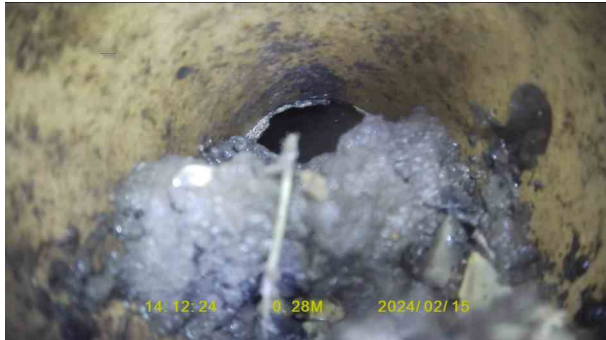
0b747a0b-873a-46c3-b4fc-464612ea82f8.jpg, 00:00:22, 0.28 m
Settled deposits, fine, 75% cross-sectional area loss

Recommendations: Recommend HPWJ/Resurvey

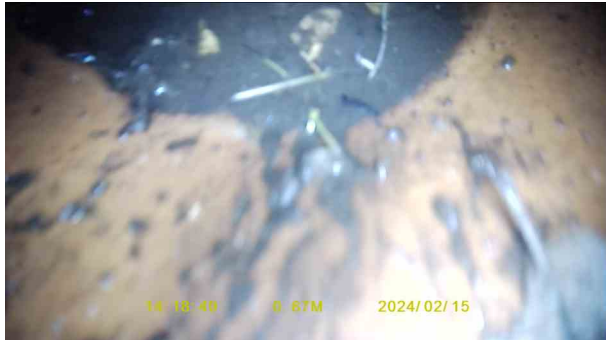
ccde89bb-de1f-44ef-bd98-8822d6aa2ec0.jpg, 00:00:28, 0.67
m
Settled deposits, fine, 25% cross-sectional area loss, start

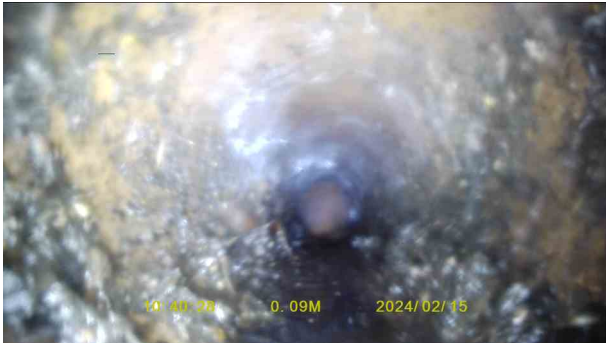
7d9258fa-146f-4850-be93-c5bf5397d76f.jpg, 00:00:10, 0.09 m
Settled deposits, fine, 20% cross-sectional area loss, start

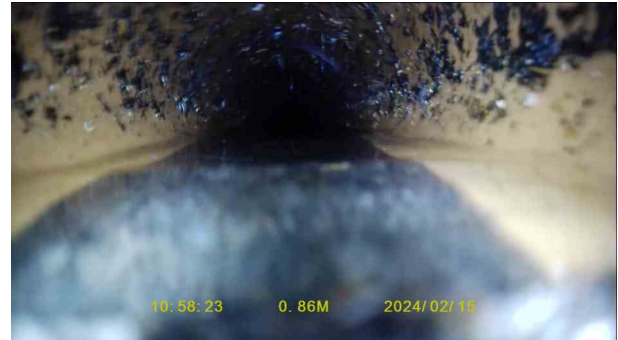
9139b476-f04d-427c-b933-e8b7d94a1fc7.jpg, 00:00:24, 0.86
m
Settled deposits, fine, 20% cross-sectional area loss, start

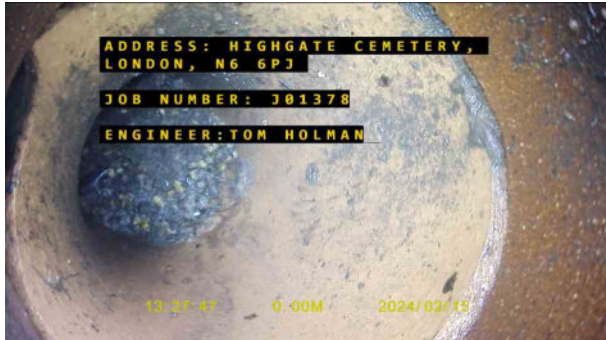
Section	PLR	Grade	Description
9	RWG6X	4	Broken pipe at joint from 8 o'clock to 11 o'clock
42	Branch BX	4	Broken pipe at joint from 9 o'clock to 4 o'clock
51	Branch AX	5	Hole in drain or sewer from 8 o'clock to 12 o'clock
52	Branch BX	4	Broken pipe at joint from 10 o'clock to 2 o'clock
92	RWG75X	4	Multiple defects
96	Branch AX	5	Hole in drain or sewer from 10 o'clock to 2 o'clock
98	UpstreamX	4	Broken pipe at joint from 12 o'clock to 12 o'clock
103	MH22X	4	Fractures, multiple at joint from 12 o'clock to 12 o'clock
110	Branch CX	4	Displaced bricks, single brick false from 7 o'clock to 8 o'clock
114	RWG89X	4	Broken pipe at joint from 10 o'clock to 3 o'clock

397b982f-a76e-453f-83c7-2e7946c7e29a.jpg, 00:00:01, 0.01
m
Broken pipe at joint from 8 o'clock to 11 o'clock

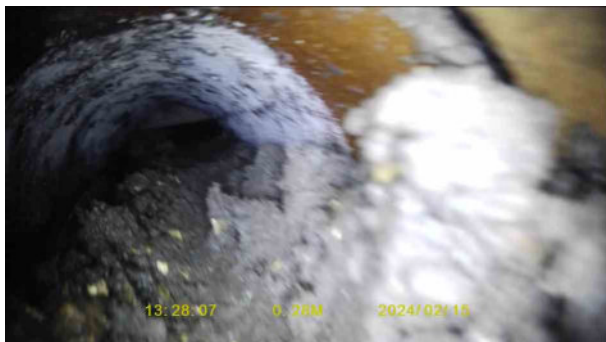
506d008a-a4ca-4920-9f11-68f6314c14b6.jpg, 00:00:21, 0.29
m
Joint displaced, medium

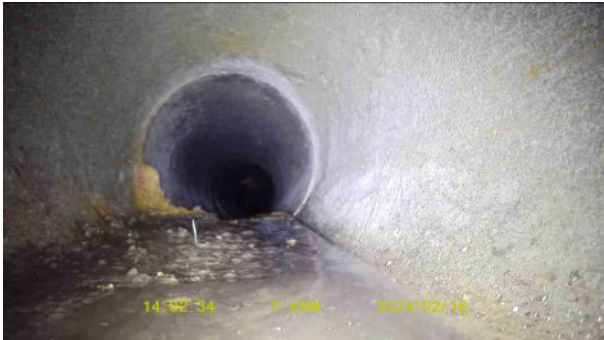
3d1525e2-dcc1-4be8-9519-7761d187d133.jpg, 00:01:04, 7.49
m
Settled deposits, fine, 20% cross-sectional area loss, start

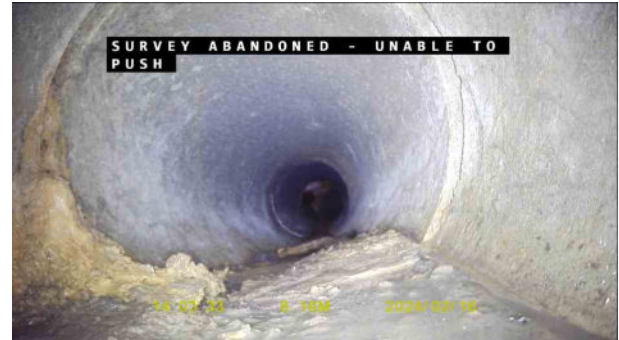
a0e355cb-3626-4767-b647-5fba654fe9cd.jpg, 00:01:59, 8.16
m
Survey abandoned, Camera unable to pass debris

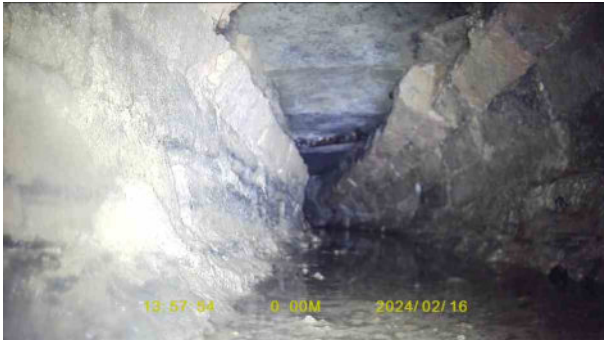
fe6ca740-4cf9-47e2-9136-ef9903ed7e3e.jpg, 00:00:09, 0.01
m
Hole in drain or sewer from 10 o'clock to 2 o'clock, start

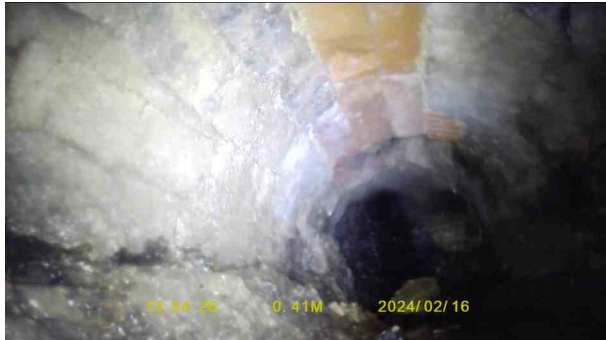
4ef6300e-2f9d-4306-95ef-b6cd0994d147.jpg, 00:00:14, 0.41
m
Broken pipe from 8 o'clock to 9 o'clock, start

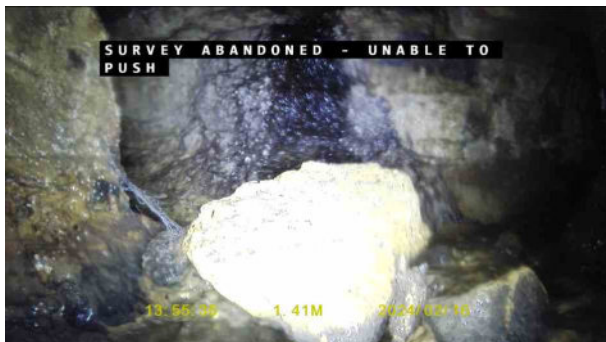
0231ad88-5588-41bb-b1e0-f9aa52024e8c.jpg, 00:01:04, 1.41
m
Settled deposits, coarse, 30% cross-sectional area loss

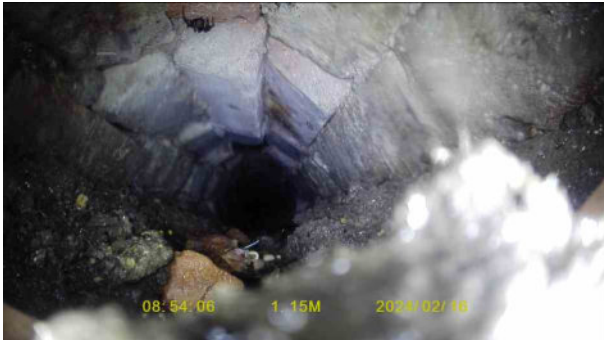
84b0b716-2f8d-4276-9b3f-552035c7ef7e.jpg, 00:00:19, 1.15 m
Settled deposits, coarse, 20% cross-sectional area loss, start

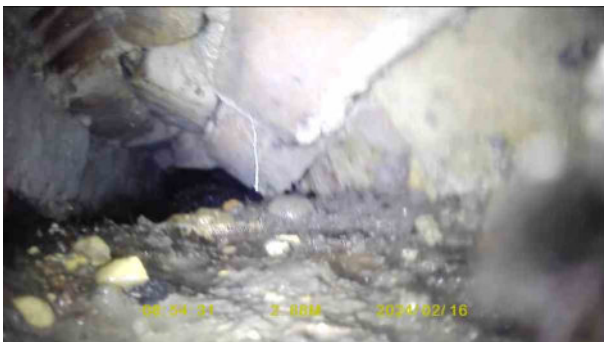
e31a2e52-a6f1-4f0a-b689-c60b44c4b2d1.jpg, 00:00:44, 2.69 m
Settled deposits, coarse, 40% cross-sectional area loss,

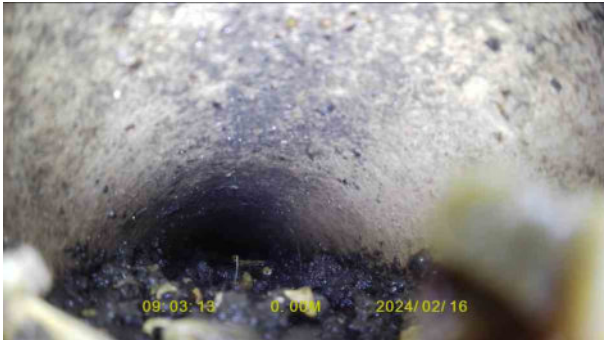
ba401d94-9d63-4eab-954e-07c8f4bf1f0e.jpg, 00:00:10, 0.01
m
Settled deposits, fine, 60% cross-sectional area loss, start

Town or Village:	Highgate	Inspection Direction:	Downstream	Upstream Node:	RWG13
Road:	Swains Lane	Inspected Length:	0.19 m	Upstream Pipe Depth:	0.900 m
Location:		Total Length:	0.19 m	Downstream Node:	DOWNSTREAM
Surface Type:		Joint Length:		Downstream Pipe Depth:	
Use:	Surface water	Pipe Shape:	Circular		
Type of Pipe:		Dia/Height:	100 mm		
Flow Control:		Material:	Vitrified clay		
Year Constructed:	Not Specified	Lining Type:	No Lining		
Inspection Purpose:		Lining Material:	No Lining		
Comments:					
Recommendations:	Recommend HPWJ/Resurvey

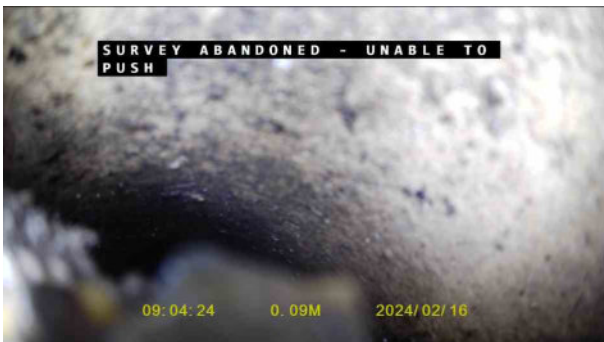
73afe08c-7a2a-4d40-8ce3-037b55db0272.jpg, 00:00:41, 0.19
m
Survey abandoned, Camera unable to pass debris

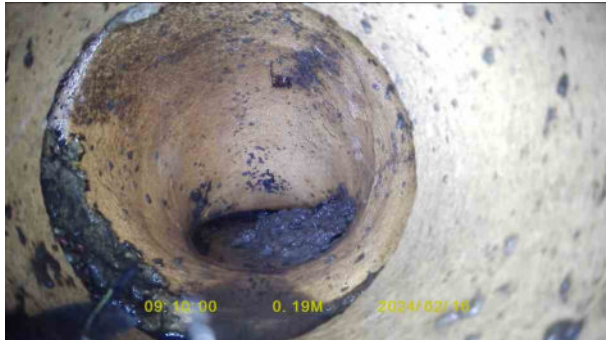
8f0bf5e6-2d78-4aa6-8b3c-8a2c8bcc296.jpg, 00:00:20, 0.19
m
Joint displaced, medium

Recommendations: Recommend HPWJ/LSR/Possible excavation

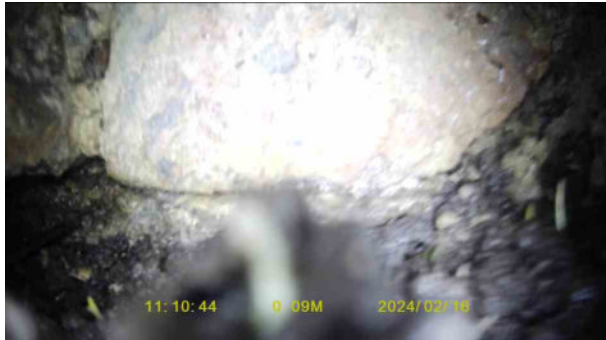
f02a77e9-e2f1-4c09-8064-3d1f006b46ec.jpg, 00:00:26, 0.09
m
Settled deposits, fine, 30% cross-sectional area loss

Recommendations: Further investigation required

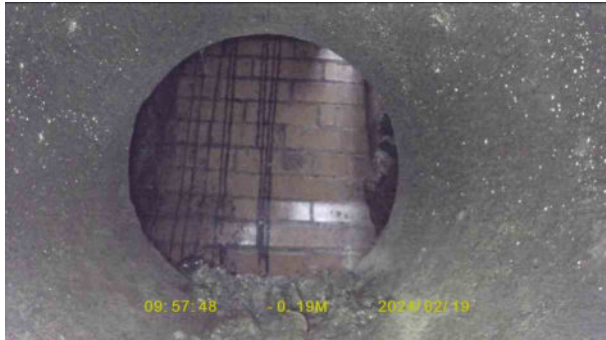
a193fc46-fa23-471b-ba4e-6ba2f7f41d1e.jpg, 00:00:14, 0.19 m
Settled deposits, fine, 15% cross-sectional area loss

Comments:	
Recommendations:	Recommend HPWJ

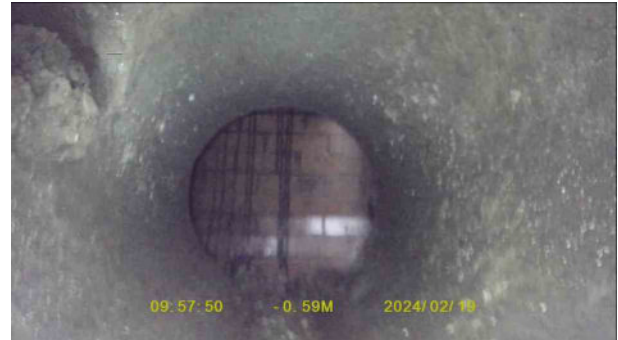
7d35edb2-a981-4e3e-9490-ae5dee594a66.jpg, 00:00:16, 0.59 m
Junction, blocked at 10 o'clock, 150mm dia

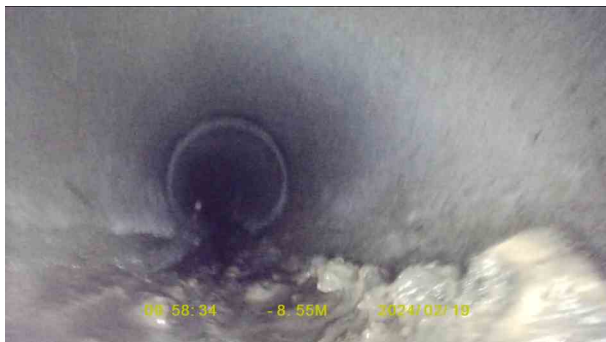
1cdcae68-ac06-4b81-8169-bb18b55dd423.jpg, 00:01:00, 8.55 m
Settled deposits, fine, 20% cross-sectional area loss, start

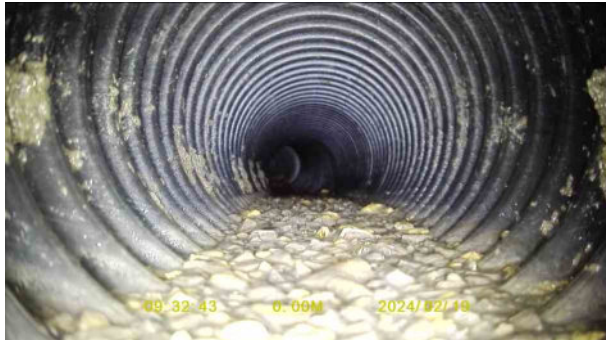
a2dc3797-f61a-4ba7-bb9a-1e1d3a959971.jpg, 00:00:11, 0.01
m
Settled deposits, fine, 20% cross-sectional area loss, start

Recommendations: Recommend HPWJ

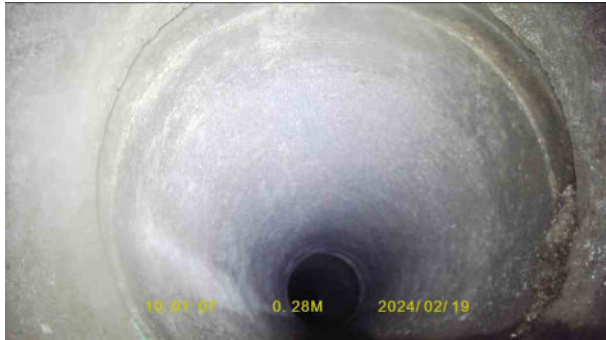
665fee94-ec28-4250-ae46-7b492f39d699.jpg, 00:00:39, 0.28
m
Joint displaced, medium

Recommendations: Recommend HPWJ/LSR/Resurvey

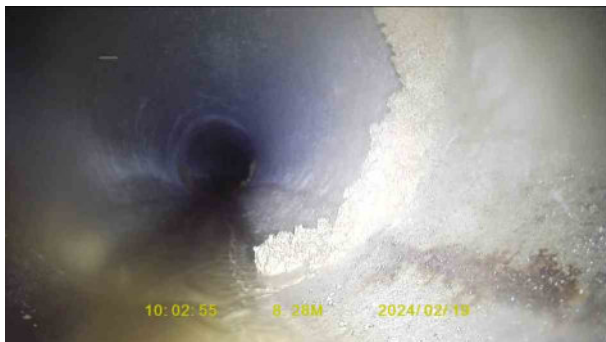
40adf8c3-9121-4654-9bc3-ba28ca5e23bb.jpg, 00:02:26, 8.28
m
Attached deposits, encrustation at joint from 12 o'clock to 5

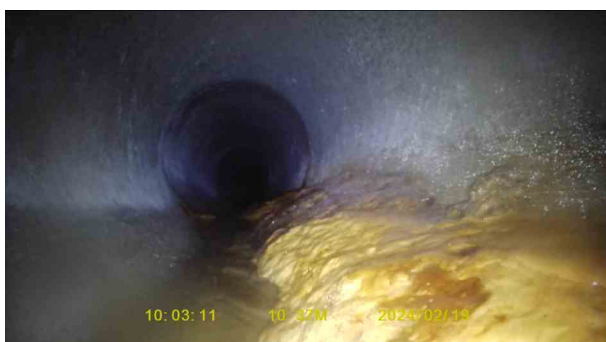
4af5cef2-5db1-4131-aa13-0ebe6428aa7f.jpg, 00:02:43, 10.00
m
Attached deposits, encrustation from 3 o'clock to 6 o'clock,

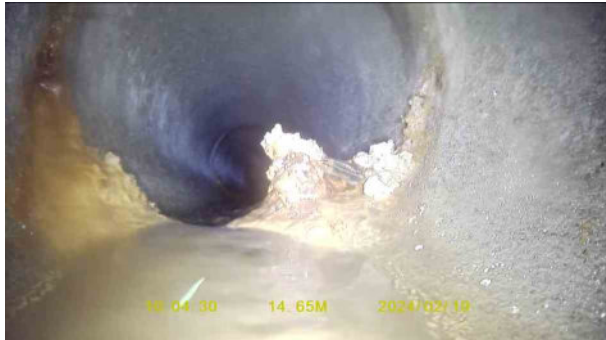
9b1df465-ba5a-4281-bed4-713f3c375753.jpg, 00:04:53, 14.65
m
Attached deposits, encrustation at joint from 3 o'clock to 7

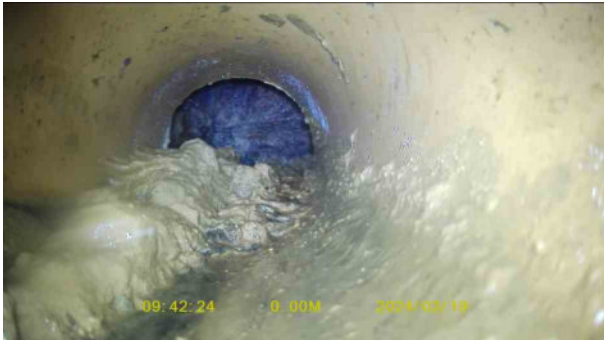
bd3cb6e8-d3e1-4268-9cfc-2e375bdc3a05.jpg, 00:00:11, 0.01
m
Settled deposits, fine, 30% cross-sectional area loss, start

Recommendations: Recommend HPWJ/Further investigation required

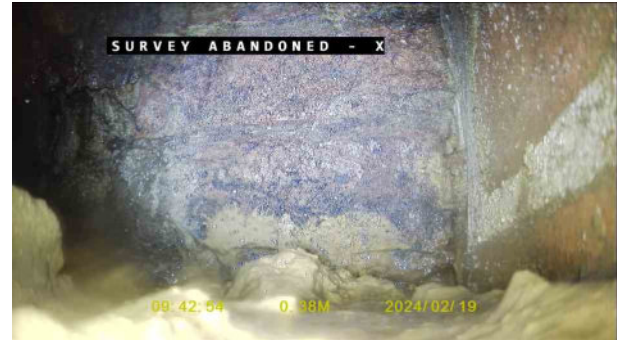
3c00efde-69b7-42c1-98b3-cf335e25a556.jpg, 00:00:26, 0.38
m
Survey abandoned, Further investigation required

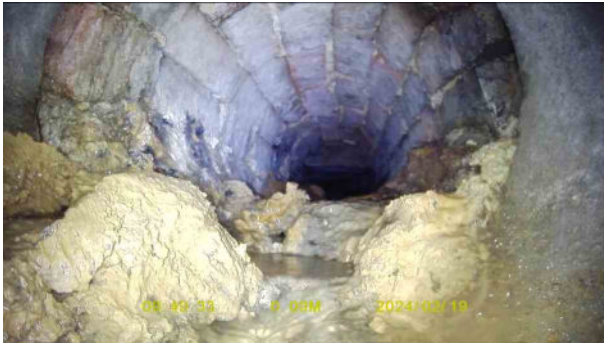
2749778e-e127-4fee-85d2-547ac9196837.jpg, 00:00:14, 0.09
m
Settled deposits, coarse, 40% cross-sectional area loss, start

Recommendations: Recommend HPWJ/Further investigation required

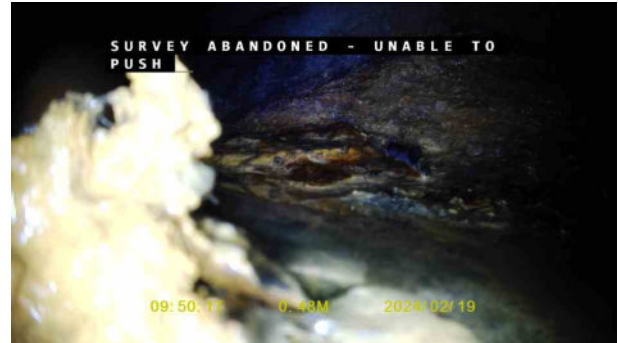
d284b3ad-28d3-422e-9f95-585843d0d021.jpg, 00:00:39, 0.48
m
Survey abandoned, Camera unable to pass debris

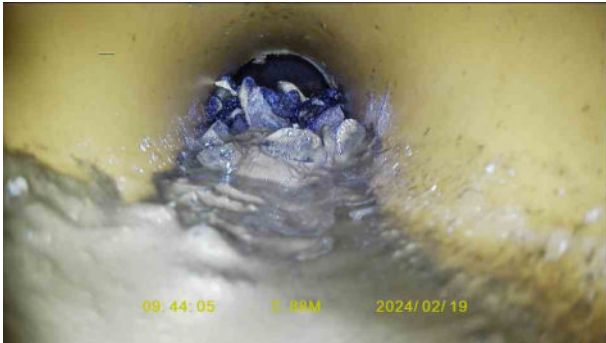
f4d6a904-8467-4fc3-94f9-5545c6fd43c2.jpg, 00:00:36, 2.88 m
Settled deposits, coarse, 70% cross-sectional area loss

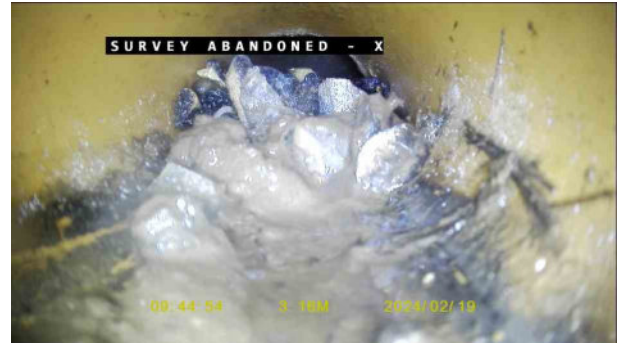
0f000214-7f3c-4309-82b6-efbfe00a12e8.jpg, 00:00:49, 3.16 m
Survey abandoned, Camera unable to pass debris

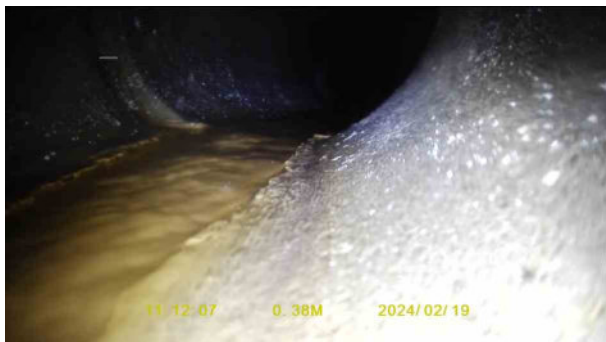
43fb38b2-6110-4a95-8fd4-09d5dc22a300.jpg, 00:00:13, 0.38
m
Joint displaced, medium

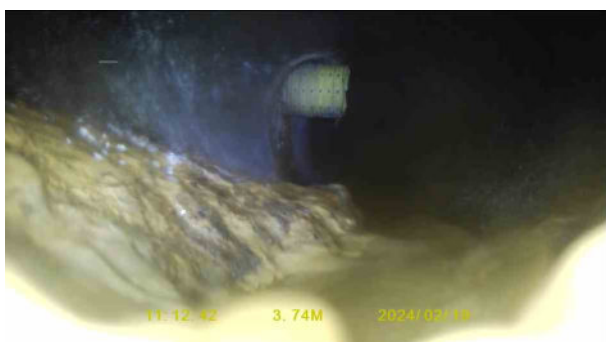
3.74	S02	DEE	Attached deposits, encrustation from 6 o'clock to 9 o'clock, 30% cross-sectional area loss, start	00:00:48		
	3.74	CXI		Connection defective, connecting pipe is intruding at 10 o'clock, 150mm dia, intrusion: 20%	00:00:53		4

e94015b3-ed59-45f9-848b-a6e22f99c630.jpg, 00:00:48, 3.74
m
Attached deposits, encrustation from 6 o'clock to 9 o'clock,

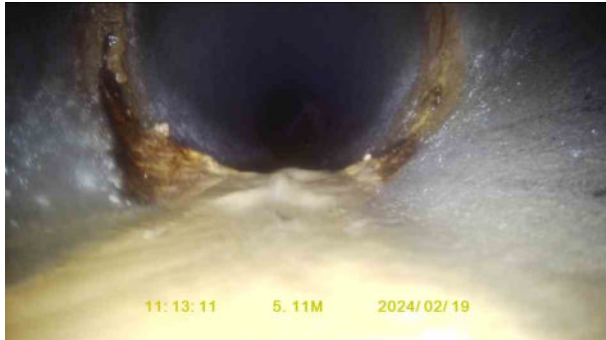
5.11	DEEJ		Attached deposits, encrustation at joint from 12 o'clock to 12 o'clock, 10% cross-sectional area loss	00:01:17		3
	6.80	CXI		Connection defective, connecting pipe is intruding at 1 o'clock, 150mm dia, intrusion: 50%	00:01:37		4

d7657106-80da-4f98-885f-3660c731a98d.jpg, 00:01:17, 5.11
m
Attached deposits, encrustation at joint from 12 o'clock to 12

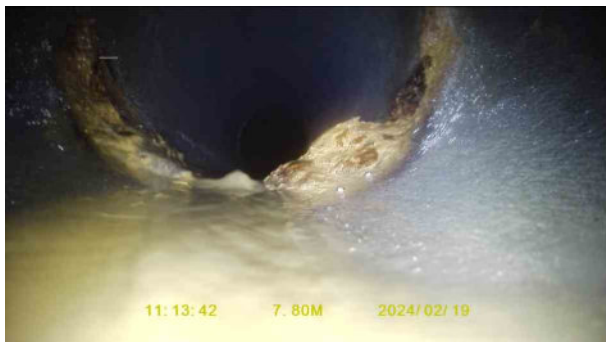
2e4e80b4-c8d3-4cd7-ae00-f610bb2f986c.jpg, 00:01:49, 7.80
m
Attached deposits, encrustation at joint from 12 o'clock to 12

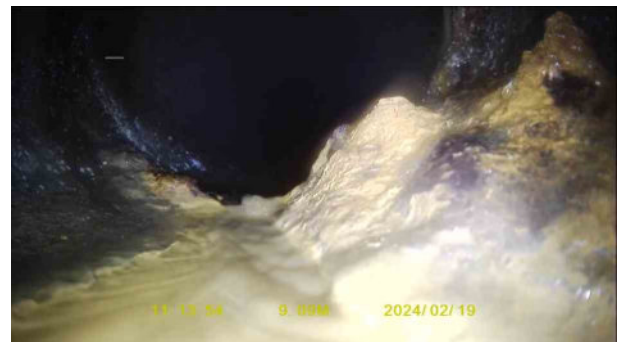
25845356-a660-487b-aea4-d6a70e377d5f.jpg, 00:02:00, 9.09
m
Attached deposits, encrustation at joint from 4 o'clock to 8

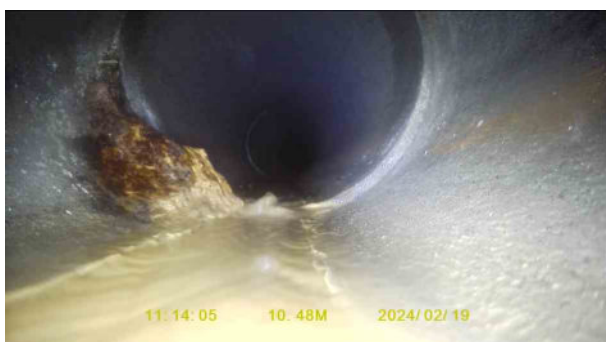
974cc9ab-f178-4677-8b46-f403d2fa1616.jpg, 00:02:11, 10.48
m
Attached deposits, encrustation at joint from 7 o'clock to 9

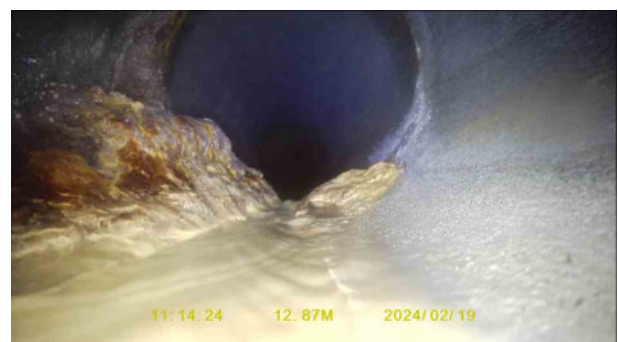
22f12925-390f-4c45-80db-538b3d662c09.jpg, 00:02:31, 12.87
m
Attached deposits, encrustation at joint from 4 o'clock to 11

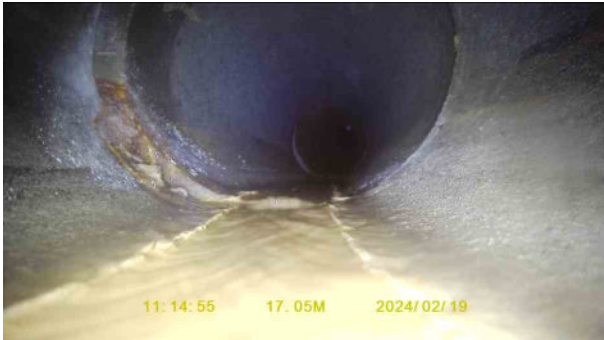
26c73e70-8711-4829-a15d-ed0453455f97.jpg, 00:03:02,
17.05 m
Joint displaced, medium

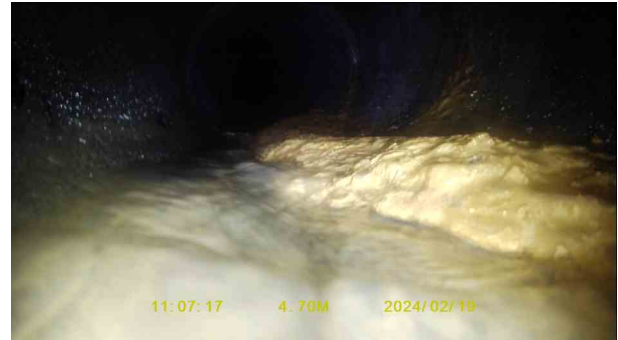
ac3e9b83-6581-407c-a00c-a1c81769c22a.jpg, 00:01:01, 4.70
m
Attached deposits, encrustation from 3 o'clock to 5 o'clock,

Recommendations: Recommend HPWJ/Resurvey

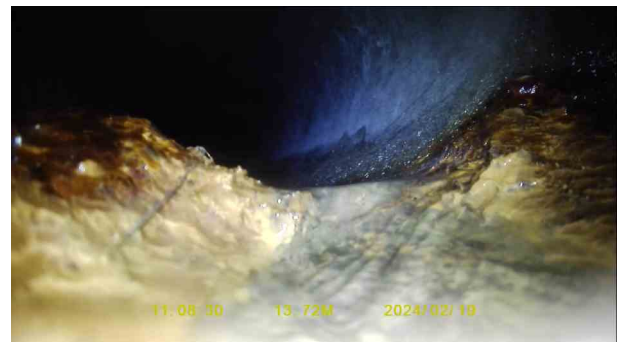
73255367-82f0-46a0-ae9f-d90a988d73ae.jpg, 00:02:14, 13.72
m
Attached deposits, encrustation from 3 o'clock to 5 o'clock,

Recommendations: Recommend HPWJ/Further investigation required

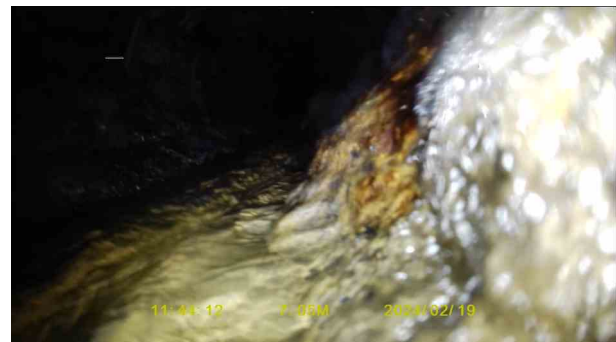
ed780d85-16dd-4e26-8e1c-0f15d63ba222.jpg, 00:02:16, 7.05
m
Attached deposits, encrustation from 3 o'clock to 7 o'clock,

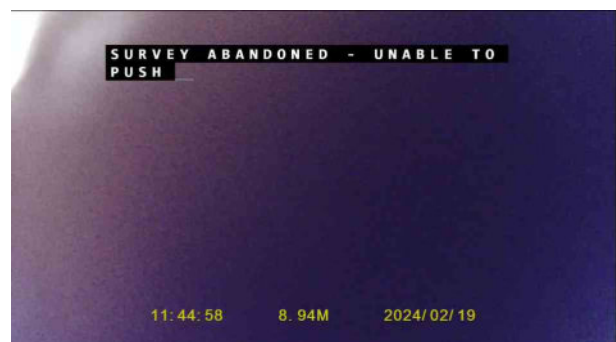
68a5d1b3-0594-4ad7-8c6b-f537cc0fd414.jpg, 00:02:56, 8.94
m
Survey abandoned, Loss of vision due to debris

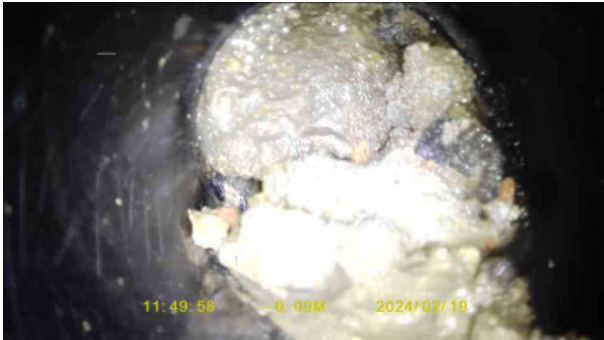
63c30535-253e-4492-9378-4942cecf6de7.jpg, 00:00:10, 0.09
m
Settled deposits, coarse, 90% cross-sectional area loss

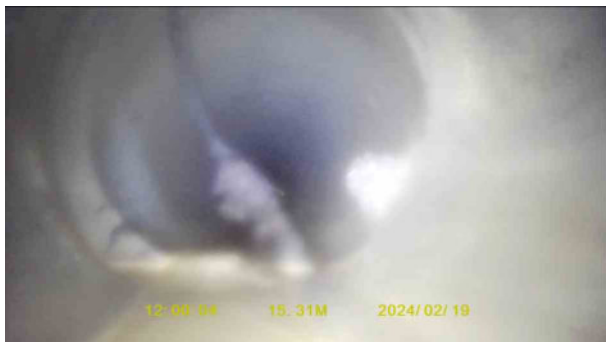
cfd37089-f5b5-48ce-ac96-437949ebdf9e.jpg, 00:01:44, 15.31 m
Roots, tap at joint

Recommendations: Recommend HPWJ/Root cut/Relining

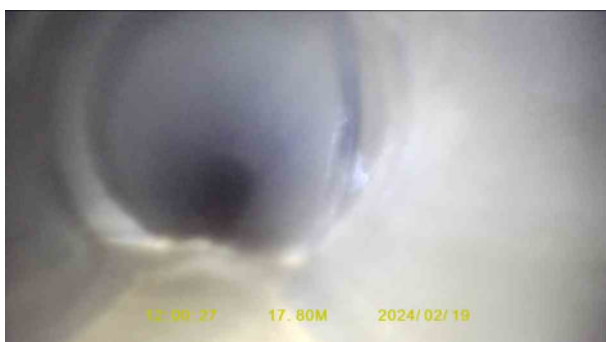
6aaf9e92-ed2e-4459-af05-5463ec3b53e4.jpg, 00:02:08, 17.89 m
Roots, tap at joint

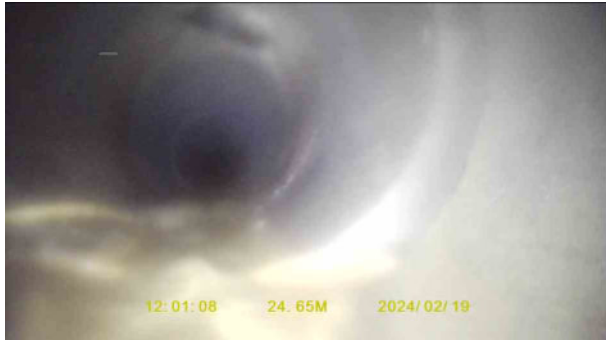
48778814-9246-4c73-ba73-c912ead5b075.jpg, 00:02:49,
24.65 m
Joint displaced, large

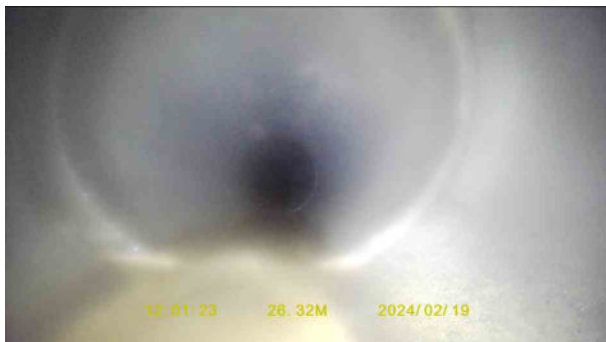
510d2746-6122-4fdc-ac3b-1094141f82cf.jpg, 00:03:03, 26.32
m
Joint displaced, large

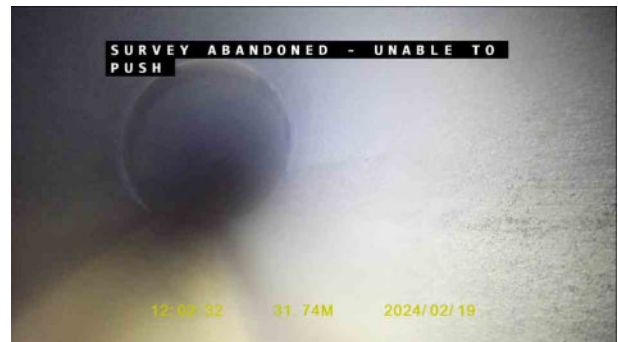
fad08eb9-8ce5-4b49-812a-45c4178156dd.jpg, 00:03:44,
31.74 m
Survey abandoned, Camera unable to push further

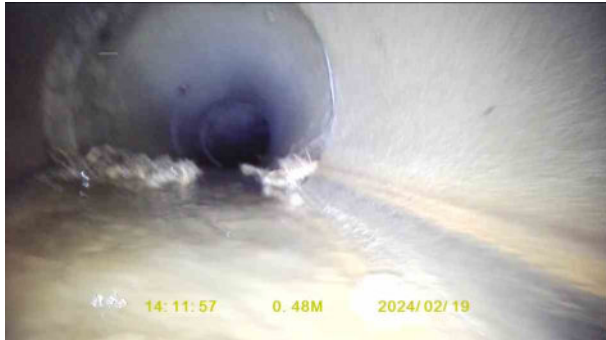
9ef8f719-6f34-4061-9c71-530c3ecf69fb.jpg, 00:00:12, 0.48 m
Joint displaced, large

Recommendations: Recommend HPWJ/Relining/Resurvery

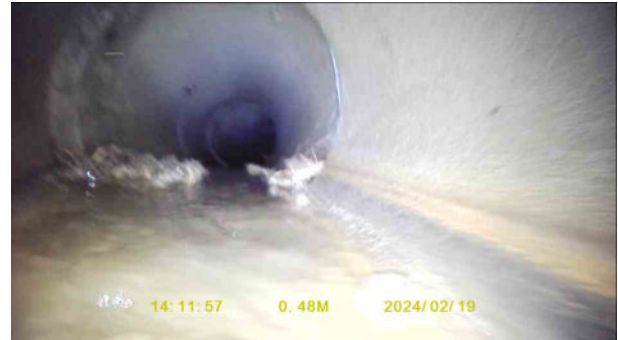
66386fb9-964f-40e2-b990-b4504dcca0eb.jpg, 00:00:12, 0.48 m
Attached deposits, encrustation at joint from 5 o'clock to 8

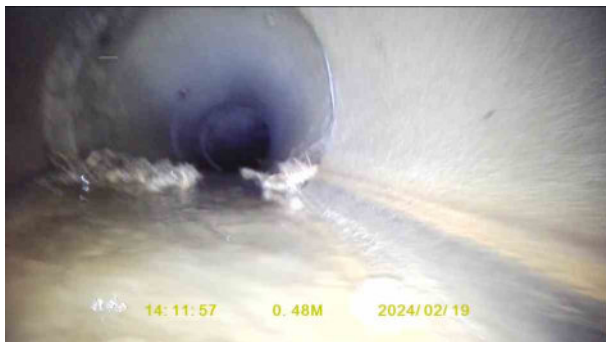
2e89adef-f018-4708-8a79-ba4d7296c35f.jpg, 00:00:12, 0.48 m
Roots, mass at joint, 20% cross-sectional area loss, start

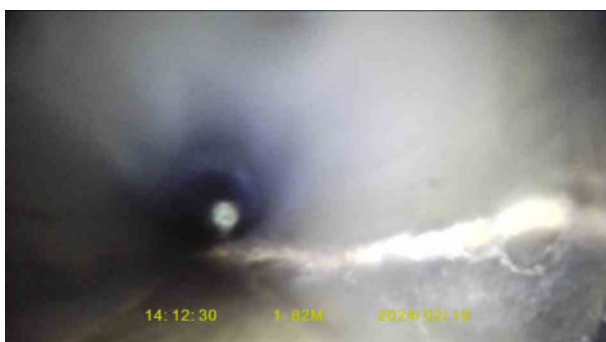
5769829f-e1f7-44b6-84d6-26706f8fbbf2.jpg, 00:00:46, 1.82 m
Roots, tap at joint

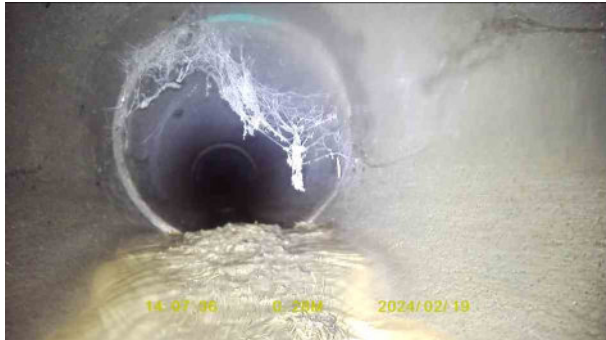
c90c49cb-90c8-4c29-b9e6-25c9edb953bc.jpg, 00:00:15, 0.28
m
Settled deposits, fine, 20% cross-sectional area loss

Comments:	
Recommendations:	Recommend HPWJ

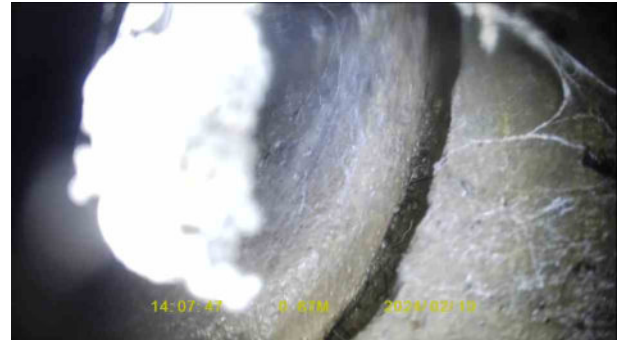
ef996390-ddfa-4960-9671-61ea9d940e87.jpg, 00:00:24, 0.67
m
Joint displaced, medium

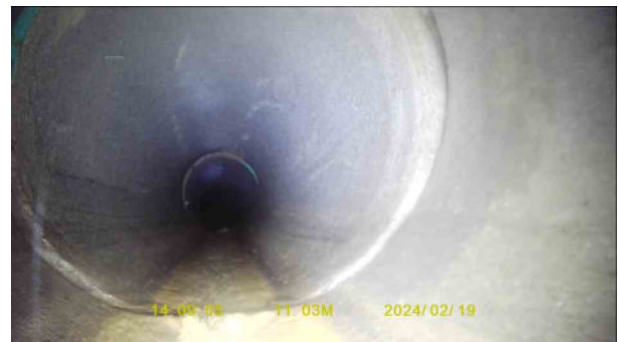
c0b29321-b805-4a0e-ad8a-f4155bcd4b7.jpg, 00:01:41,
11.03 m
Joint displaced, medium

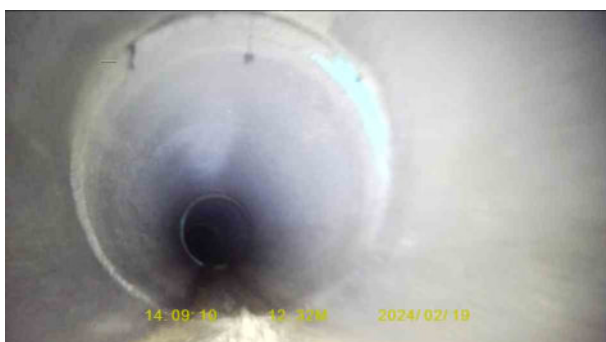
e3ef380b-964e-4a72-a3f0-f538712dbf1e.jpg, 00:01:47, 12.32
m
Joint displaced, medium

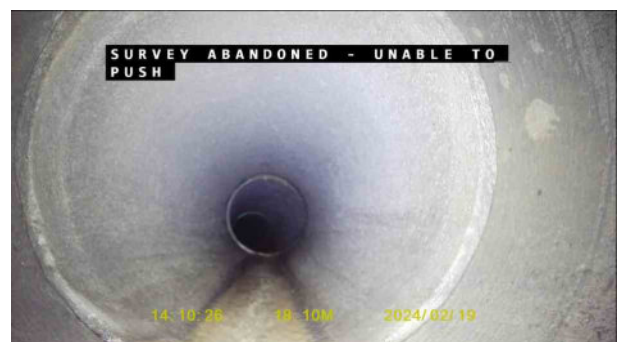
bd9add86-3620-47fd-a734-39fc3966ba3d.jpg, 00:02:29, 18.10
m
Survey abandoned, Camera unable to push further

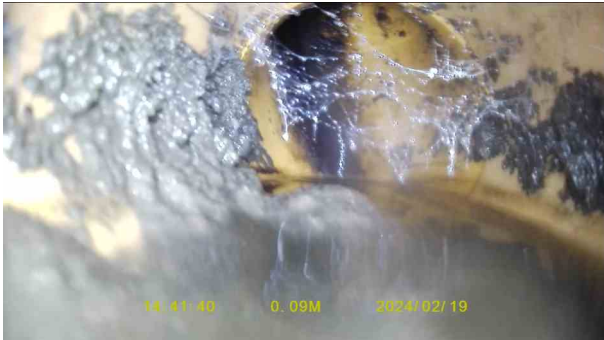
f07e7265-1a78-4885-83d7-e3071f993674.jpg, 00:00:10, 0.09 m
Settled deposits, fine, 15% cross-sectional area loss

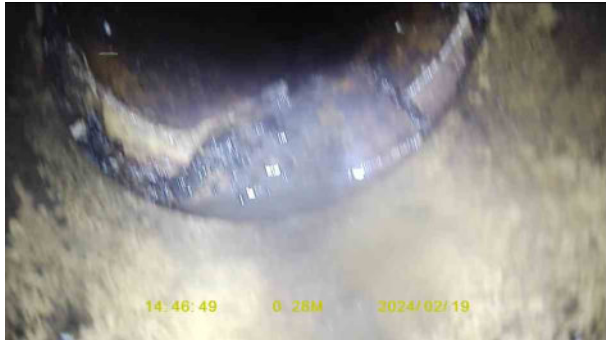
19414010-d444-4786-ba73-fbb897affb06.jpg, 00:00:18, 0.28
m
Joint displaced, large

Town or Village:	Highgate	Inspection Direction:	Downstream	Upstream Node:	MH9
Road:	Swains Lane	Inspected Length:	0.38 m	Upstream Pipe Depth:	0.600 m
Location:		Total Length:	0.38 m	Downstream Node:	DOWNSTREAM
Surface Type:		Joint Length:		Downstream Pipe Depth:	
Use:	Surface water	Pipe Shape:	Circular		
Type of Pipe:		Dia/Height:	100 mm		
Flow Control:		Material:	Polyvinyl chloride		
Year Constructed:	Not Specified	Lining Type:	No Lining		
Inspection Purpose:		Lining Material:	No Lining		
Comments:					
Recommendations:	Recommend LSR/Resurvey

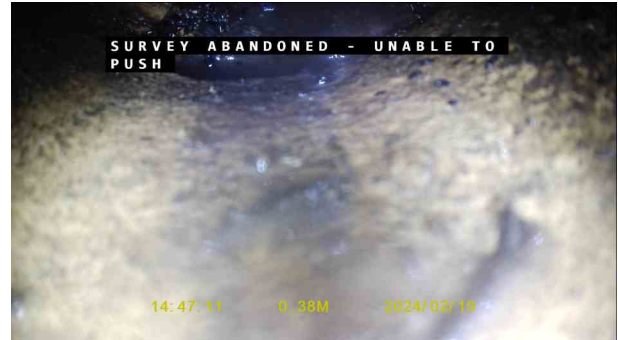
dc8cd36c-e0e8-45ce-b8dd-c6d740336fe6.jpg, 00:00:29, 0.38
m
Survey abandoned, Camera unable to pass JDL

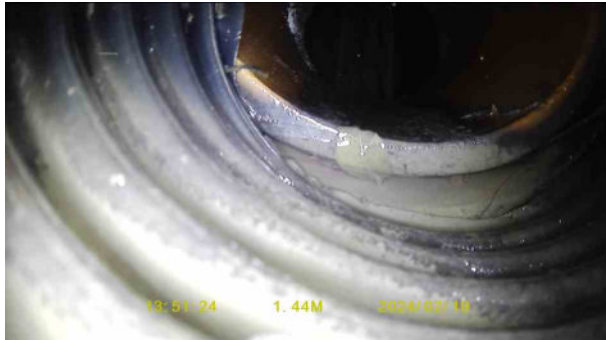
77433b44-5b3a-43c0-89b1-d2bb0d35f7f7.jpg, 00:00:17, 1.44
m
Joint displaced, large

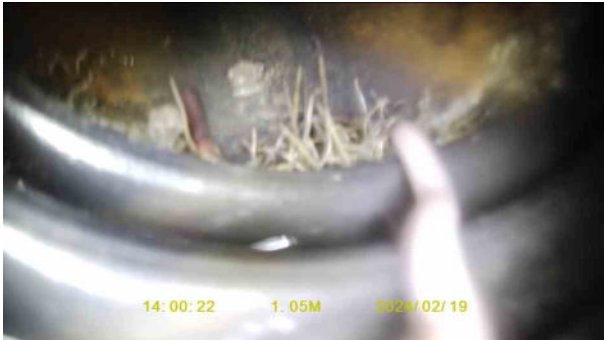
75738fd2-057a-42e3-8af6-84ea17b29526.jpg, 00:00:21, 1.05
m
Roots, fine at joint

Comments:	
Recommendations:	Recommend root cut/LSR

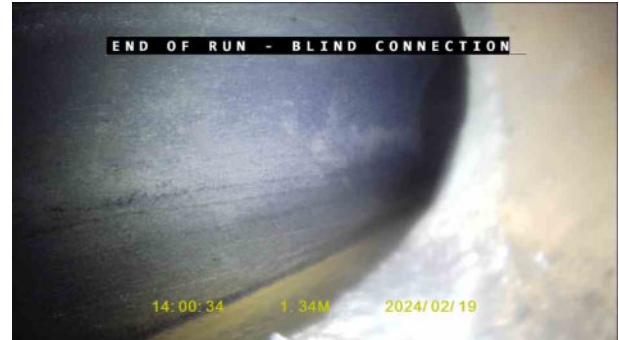
baeccc9c-6492-4e2f-8d1a-066f5c7e8907.jpg, 00:00:29, 1.34
m
Finish node, manhole, reference: Downstream, Blind junction

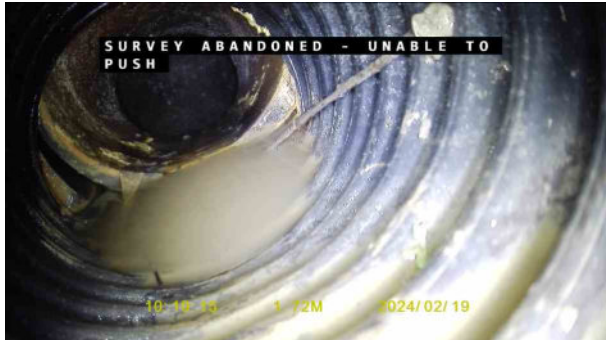
46a9c229-a384-4b90-8825-e392ff907ccf.jpg, 00:00:21, 1.72 m
Pipe material changes to vitrified clay at this point

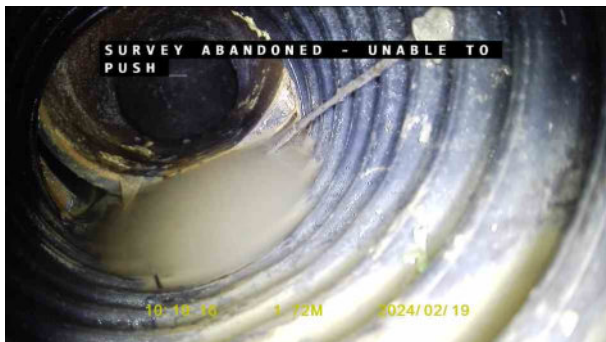
a12f9621-363e-4716-a179-4259851e7146.jpg, 00:01:00, 1.72 m
Open joint, large

Recommendations: Recommend excavation/Resurvey

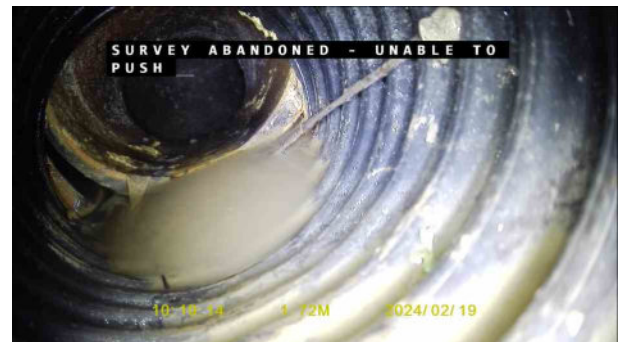
644f0a5a-3b8e-45d1-9ddd-94a4859114db.jpg, 00:00:58, 1.72 m
Survey abandoned, Camera unable to pass OJL/JDL

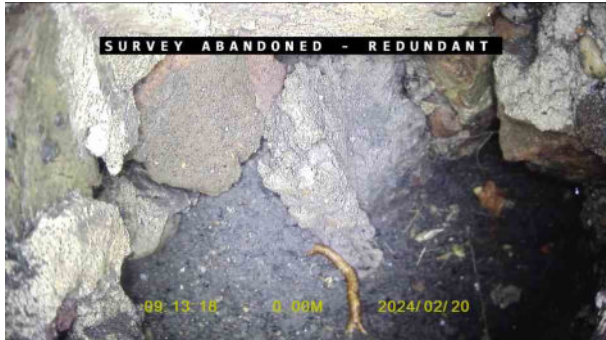
35029dbd-931a-4a6e-b368-7022e0edb8a7.jpg, 00:00:33, 0.01
m
Survey abandoned, Redundant

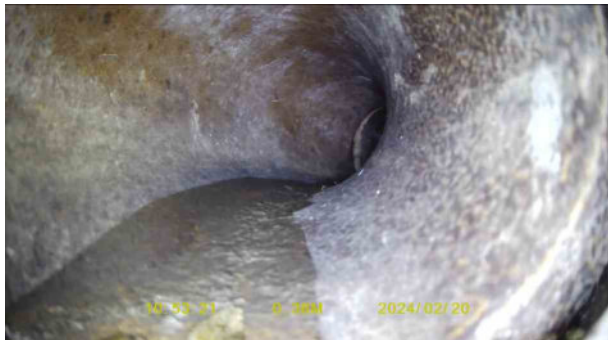
94c4cd49-8989-4d64-ba70-694f6b00c783.jpg, 00:00:15, 0.38
m
Joint displaced, medium

Recommendations: Recommend HPWJ/LSR/Resurvey

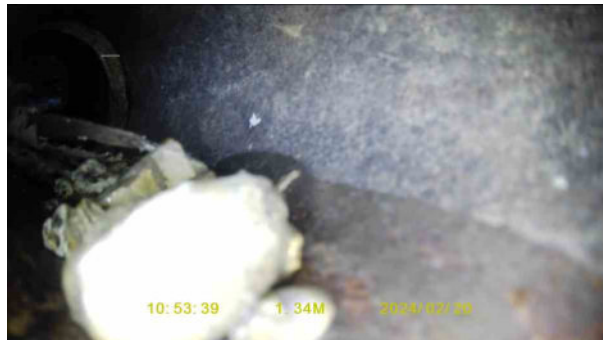
b1ec5c73-cb1b-4989-bafa-742fbe4b7188.jpg, 00:00:39, 1.15
m
Settled deposits, fine, 20% cross-sectional area loss

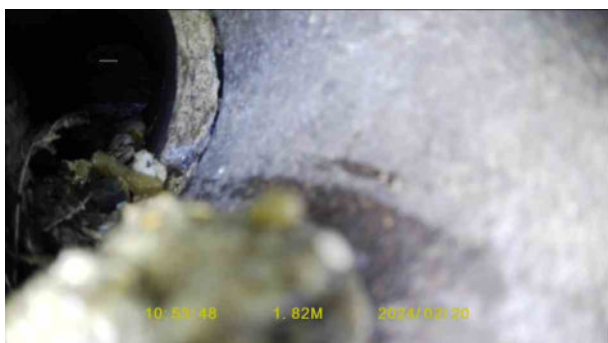
d2831d65-8e38-403f-8a5f-c8cc4d858d74.jpg, 00:00:42, 1.82
m
Joint displaced, medium

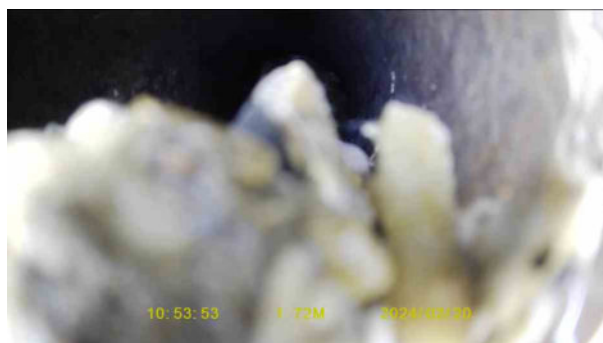
2972d6b0-2d48-4596-bb9a-7648fd527920.jpg, 00:00:47, 1.82
m
Settled deposits, coarse, 30% cross-sectional area loss, start

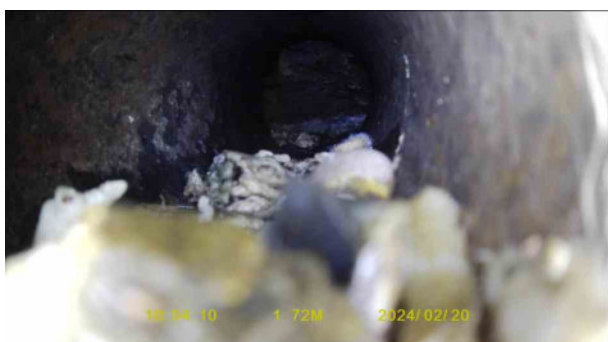
1dff81b8-6366-44e7-99e8-c7580857e882.jpg, 00:01:04, 1.82
m
Survey abandoned, Camera unable to pass debris

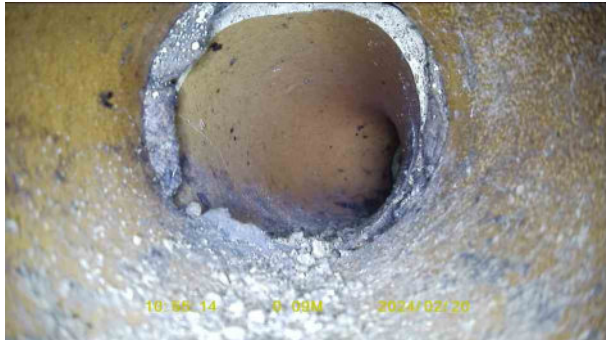
c9179bda-0f0a-4f25-a2db-2d0fef5be277.jpg, 00:00:13, 0.09 m
Attached deposits, encrustation at joint from 7 o'clock to 11 o'clock, 15% cross-sectional area loss

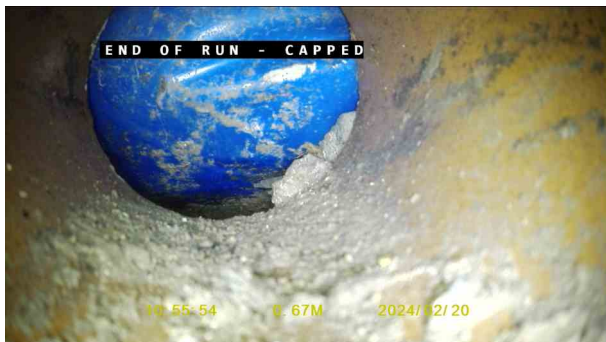
aea4d164-a499-4ccc-8d45-8b070c3022a0.jpg, 00:00:36, 0.67 m
Finish node, manhole, reference: Branch B, Capped

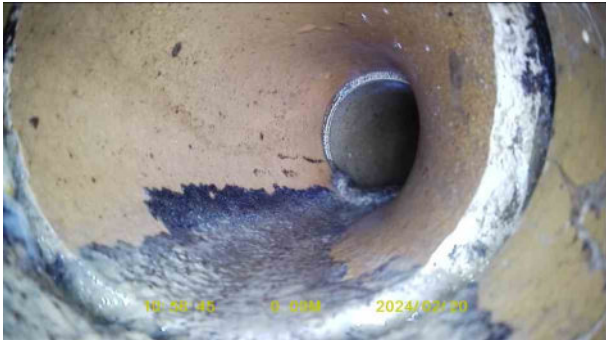
7076801a-6240-41d9-a416-603246e932b2.jpg, 00:00:10, 0.09 m
Joint displaced, medium

Town or Village:	Highgate	Inspection Direction:	Upstream	Upstream Node:	BRANCH C
Road:	Swains Lane	Inspected Length:	2.11 m	Upstream Pipe Depth:	
Location:		Total Length:	2.11 m	Downstream Node:	MH10
Surface Type:		Joint Length:		Downstream Pipe Depth:	
Use:	Surface water	Pipe Shape:	Circular		
Type of Pipe:		Dia/Height:	100 mm		
Flow Control:		Material:	Vitrified clay		
Year Constructed:	Not Specified	Lining Type:	No Lining		
Inspection Purpose:		Lining Material:	No Lining		
Comments:					
Recommendations:	Recommend HPWJ/LSR

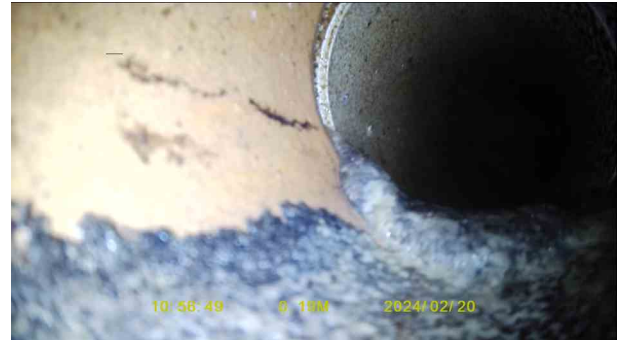
4bff65e0-e500-4552-8682-5a6f3d023944.jpg, 00:00:14, 0.19 m
Attached deposits, encrustation at joint from 4 o'clock to 8

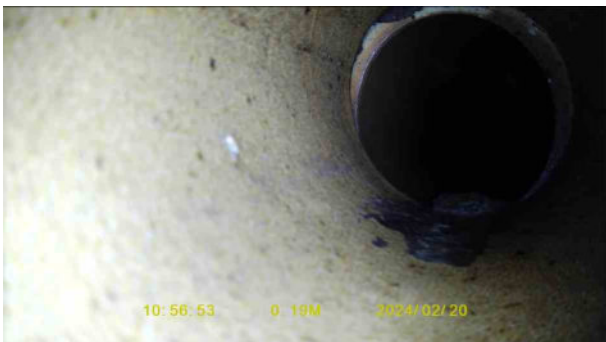
205e2d51-6137-455f-aa65-6f6f489f32b0.jpg, 00:00:18, 0.28 m
Joint displaced, medium

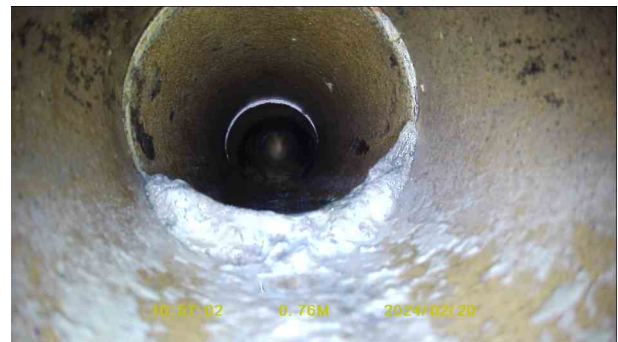
c49eab87-a58d-4fd3-9800-c705466255a4.jpg, 00:00:26, 0.76 m
Attached deposits, encrustation at joint from 4 o'clock to 7

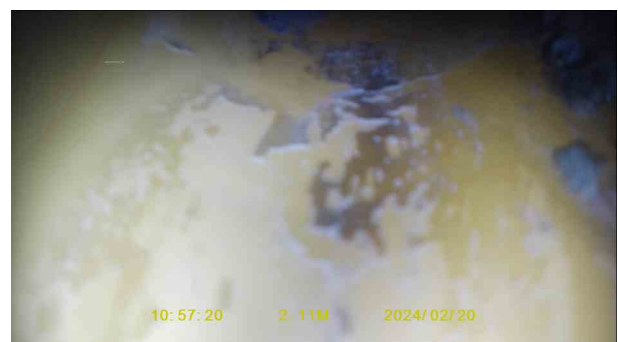
c6a34fc5-3739-4efc-8d4c-76213357c26a.jpg, 00:00:45, 2.11 m
Finish node, manhole, reference: Branch C, Rest bend

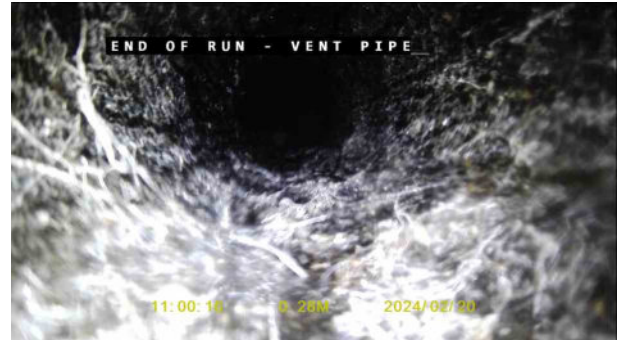
e4e9475f-69f9-45d8-8f38-04630cbdbdc6.jpg, 00:00:19, 0.28
m
Finish node, manhole, reference: Branch D, Vent pipe

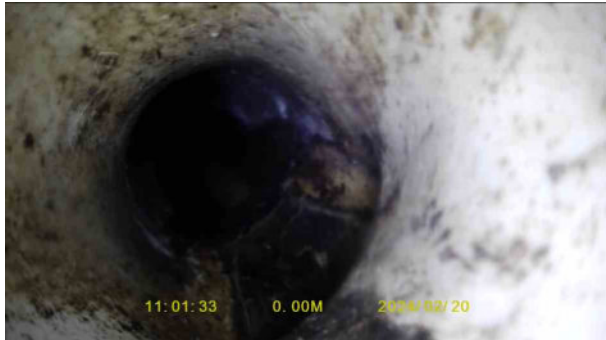
11f4fc9c-ba19-4aad-aca7-5fdd34d41401.jpg, 00:00:08, 0.09 m
Junction at 6 o'clock, 100mm dia, Backdrop

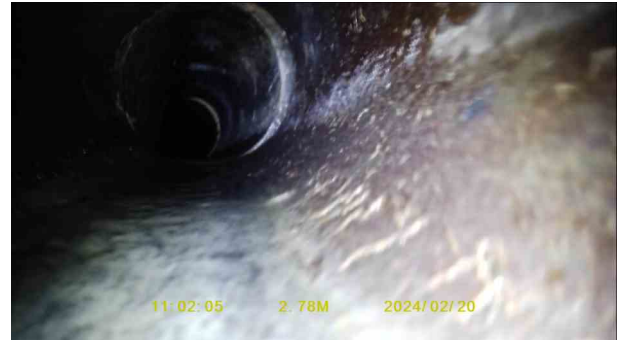
f655621c-2490-4b57-b90c-2478f909dfd8.jpg, 00:00:39, 2.78 m
Joint displaced, medium

Recommendations: Recommend HPWJ/LSR

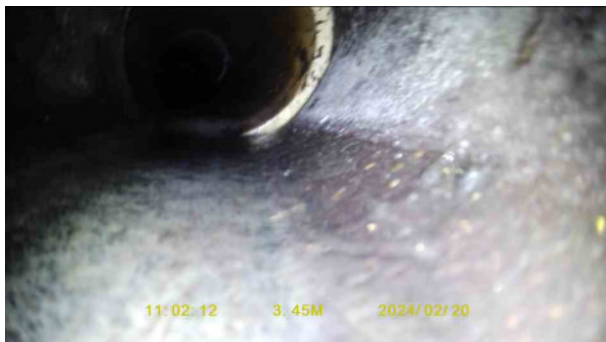
81136733-b89d-435f-a60c-a6bc873af195.jpg, 00:00:46, 3.45 m
Joint displaced, medium

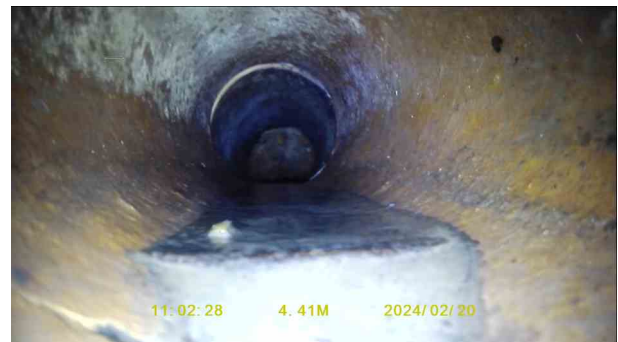
46a8db89-2395-4346-b1ab-494535b5cd78.jpg, 00:01:02, 4.41 m
Attached deposits, encrustation from 5 o'clock to 7 o'clock,

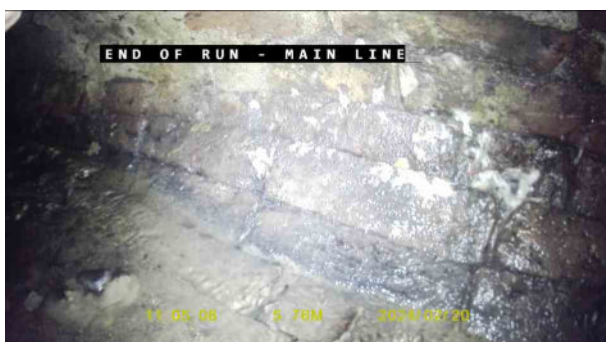
e878b872-6e34-410d-afb7-adb481f5e729.jpg, 00:01:32, 5.76 m
Finish node, manhole, reference: Main line

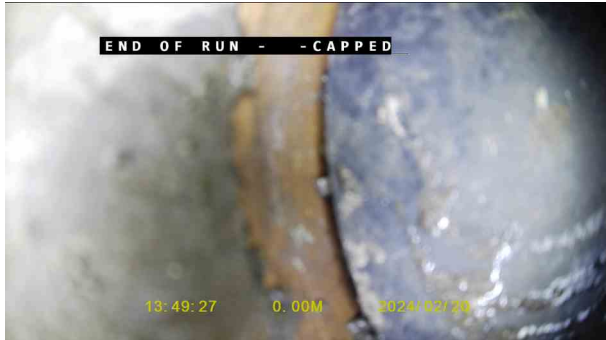
fc91452-5e55-4616-9fb5-a1479d9cbaa1.jpg, 00:00:39, 0.01
m
Finish node, manhole, reference: Capped

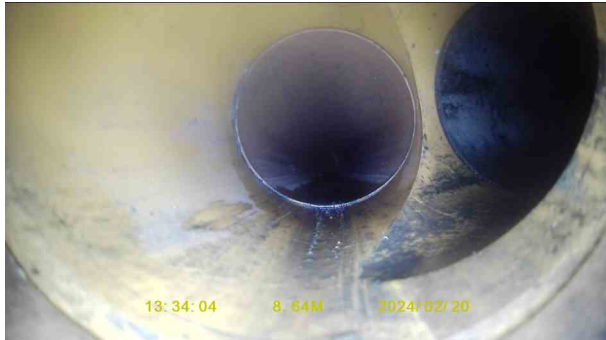
1cff4279-29bc-41d9-a284-c0b1df4fa83c.jpg, 00:01:28, 8.64 m
Junction at 3 o'clock, 100mm dia
