Project Name: Highgate Cemetery

Project Date: 06/03/2024

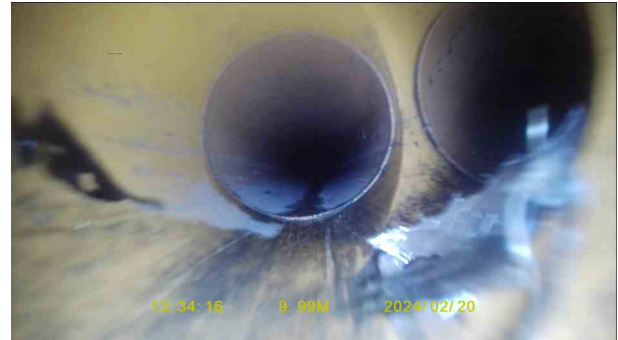
f28f0d2e-5a81-457a-95b7-6385d09598fa.jpg, 00:01:41, 9.99 m
Junction at 3 o'clock, 100mm dia

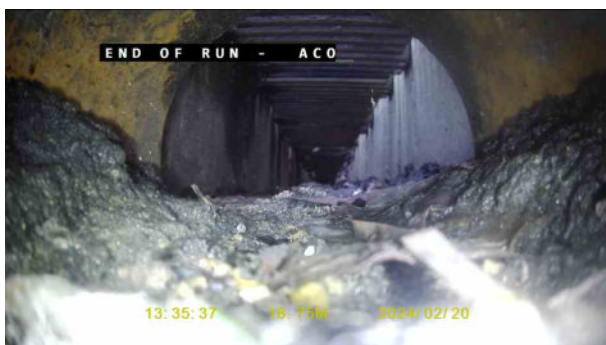
863abe23-34c2-4e95-8c46-44d1baf7e004.jpg, 00:02:46, 18.75 m
Settled deposits, fine, 45% cross-sectional area loss, Aco

Town or Village:	Highgate	Inspection Direction:	Upstream	Upstream Node:	BRANCH B
Road:	Swains Lane	Inspected Length:	18.75 m	Upstream Pipe Depth:	
Location:		Total Length:	18.75 m	Downstream Node:	MH11
Surface Type:		Joint Length:		Downstream Pipe Depth:	0.570 m
Use:	Surface water	Pipe Shape:	Circular		
Type of Pipe:		Dia/Height:	100 mm		
Flow Control:		Material:	Polyvinyl chloride		
Year Constructed:	Not Specified	Lining Type:	No Lining		
Inspection Purpose:		Lining Material:	No Lining		
Comments:					
Recommendations: Recommend HPWJ

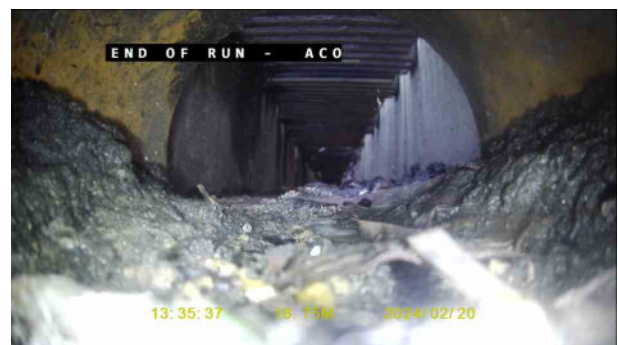
22bee4a0-d2d3-4263-8716-67b4931eaa3c.jpg, 00:02:46, 18.75 m
Finish node, manhole, reference: Branch B, Aco
