## Completed section inspection

Town or Village:	Highgate	Inspection Direction:	Downstream	Upstream Node:	MH11
Road:	Swains Lane	Inspected Length:	3.07 m	Upstream Pipe Depth:	0.570 m
Location:		Total Length:	3.07 m	Downstream Node:	MH13
Surface Type:		Joint Length:		Downstream Pipe Depth:	
Use:	Surface water	Pipe Shape:	Circular		
Type of Pipe:		Dia/Height:	100 mm		
Flow Control:		Material:	Polyvinyl chloride		
Year Constructed:	Not Specified	Lining Type:	No Lining		
Inspection Purpose:		Lining Material:	No Lining		
Comments:					
Recommendations: Recommend HPWJ

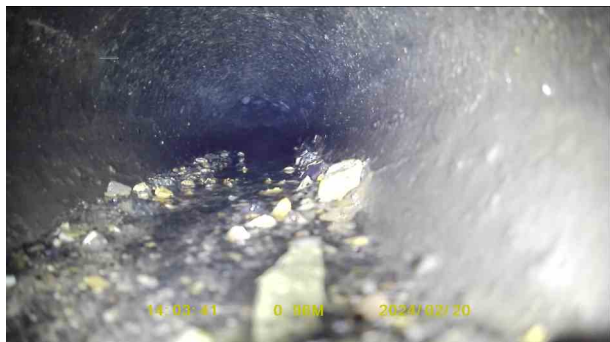
3669f89d-96e6-42b7-ada0-360456e60483.jpg, 00:00:22, 0.36  
m  
Settled deposits, fine, 25% cross-sectional area loss, start

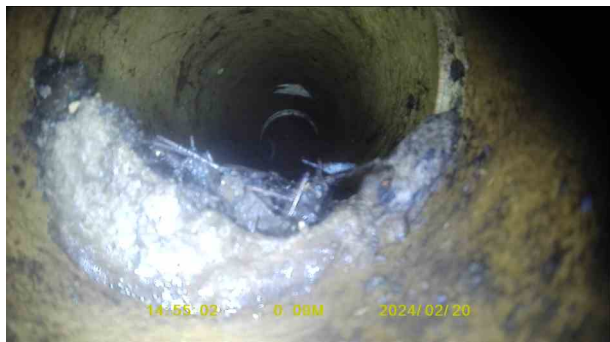
54fe3fcb-6687-4a68-904e-116084061c3e.jpg, 00:00:12, 0.09  
m  
Joint displaced, medium

Town or Village:	Highgate	Inspection Direction:	Upstream	Upstream Node:	BRANCH A
Road:	Swains Lane	Inspected Length:	1.34 m	Upstream Pipe Depth:	
Location:		Total Length:	1.34 m	Downstream Node:	MH14
Surface Type:		Joint Length:		Downstream Pipe Depth:	0.680 m
Use:	Surface water	Pipe Shape:	Circular		
Type of Pipe:		Dia/Height:	100 mm		
Flow Control:		Material:	Vitrified clay		
Year Constructed:	Not Specified	Lining Type:	No Lining		
Inspection Purpose:		Lining Material:	No Lining		
Comments:					
Recommendations:	Recommend Picote/2XLSR's

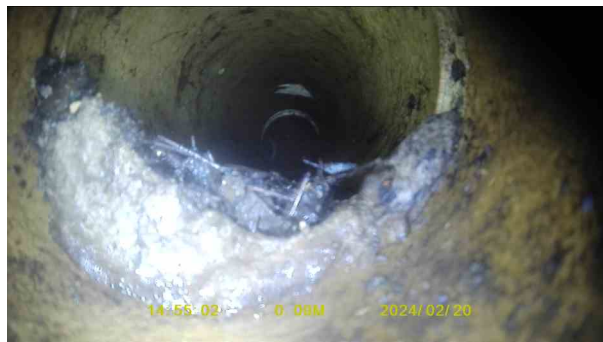
86856354-1afa-42c1-84d1-0830337bb99e.jpg, 00:00:12, 0.09  
m  
Attached deposits, encrustation at joint from 4 o'clock to 9

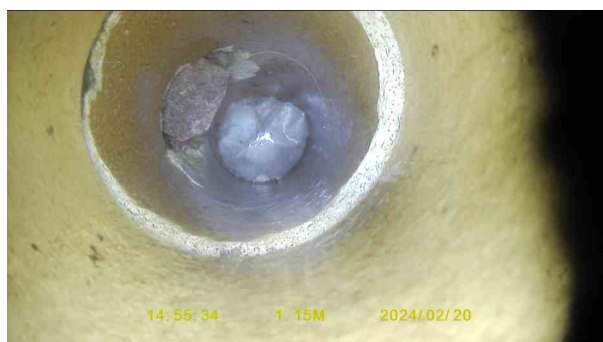
1.15	BJ	Broken pipe at joint from 1 o'clock to 9 o'clock	00:00:44		4
		1.24	OBI	Other obstacles, protruding through wall from 9 o'clock to 11 o'clock, 20% cross-sectional area loss	00:00:45		5

e56fef0e-9556-4087-b72a-802cf6ebdea5.jpg, 00:00:44, 1.15  
m  
Broken pipe at joint from 1 o'clock to 9 o'clock

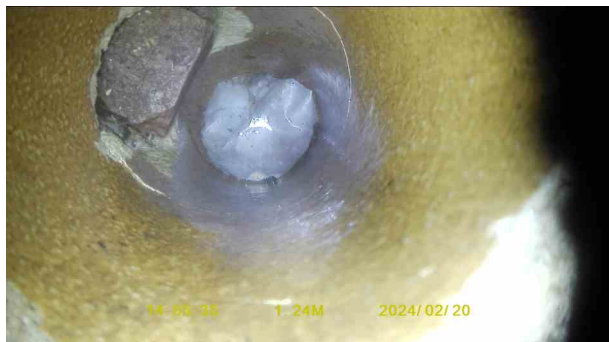
e20c5a1b-250b-45b3-8d80-c9757825fedf.jpg, 00:00:45, 1.24 m  
Other obstacles, protruding through wall from 9 o'clock to 11

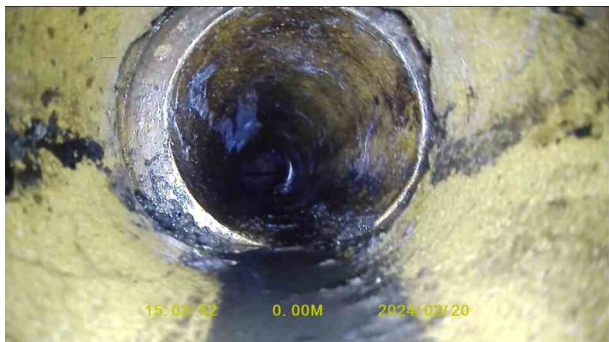
a1961974-abd4-454e-83a3-83ffb079b3ef.jpg, 00:00:12, 0.09  
m  
Joint displaced, large

Town or Village:	Highgate	Inspection Direction:	Downstream	Upstream Node:	MH14
Road:	Swains Lane	Inspected Length:	0.76 m	Upstream Pipe Depth:	0.680 m
Location:		Total Length:	0.76 m	Downstream Node:	MH13
Surface Type:		Joint Length:		Downstream Pipe Depth:	
Use:	Combined	Pipe Shape:	Circular		
Type of Pipe:		Dia/Height:	100 mm		
Flow Control:		Material:	Vitrified clay		
Year Constructed:	Not Specified	Lining Type:	No Lining		
Inspection Purpose:		Lining Material:	No Lining		
Comments:					
Recommendations: Recommend LSR

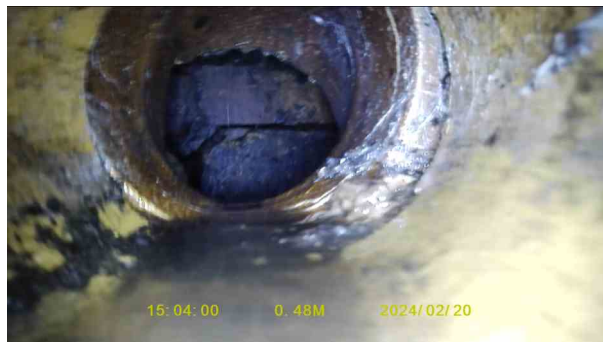
e629018d-3448-4f52-b7a0-6eb6e9a4e77e.jpg, 00:00:20, 0.48  
m  
Joint displaced, large

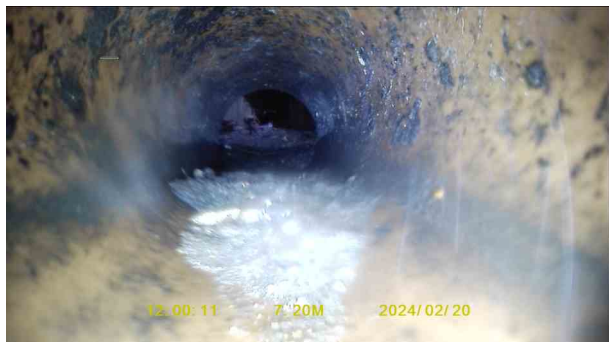
bc17b186-e1f3-43d7-ba4f-f5fee1ec2c81.jpg, 00:01:22, 7.20 m  
Settled deposits, fine, 20% cross-sectional area loss

Recommendations: Investigate possible bellies

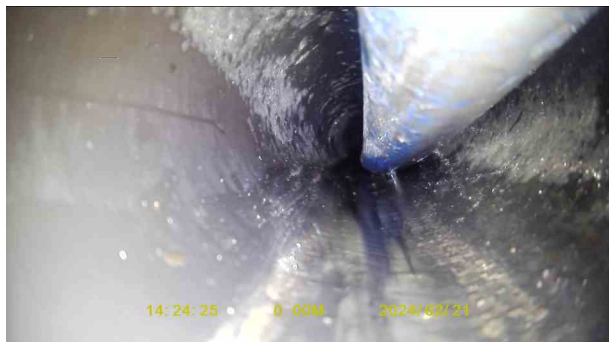
d1176d88-3e27-44d5-8a73-edf3eb462b9c.jpg, 00:00:15, 0.01  
m  
General remark, Hose in pipe

Town or Village:	Highgate	Inspection Direction:	Upstream	Upstream Node:	MH17
Road:	Swains Lane	Inspected Length:		Upstream Pipe Depth:	
Location:		Total Length:	3.16 m	Downstream Node:	MH16
Surface Type:		Joint Length:		Downstream Pipe Depth:	1.060 m
Use:	Surface water	Pipe Shape:	Circular		
Type of Pipe:		Dia/Height:	100 mm		
Flow Control:		Material:	Polyvinyl chloride		
Year Constructed:	Not Specified	Lining Type:	No Lining		
Inspection Purpose:		Lining Material:	No Lining		
Comments:					
Recommendations:	Recommend HPWJ/Further investigation required

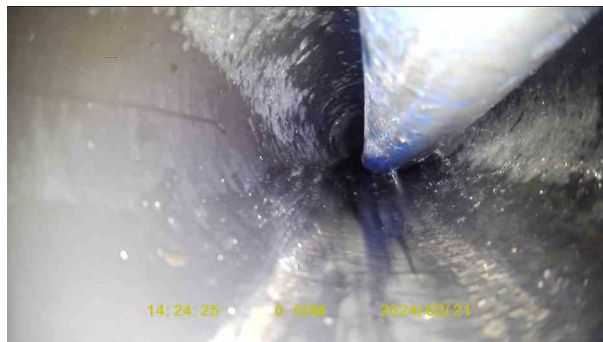
61b9777f-1c7e-484a-86c6-67b1151ca9d6.jpg, 00:00:15, 0.01  
m  
Other obstacles from 1 o'clock to 3 o'clock, 25%

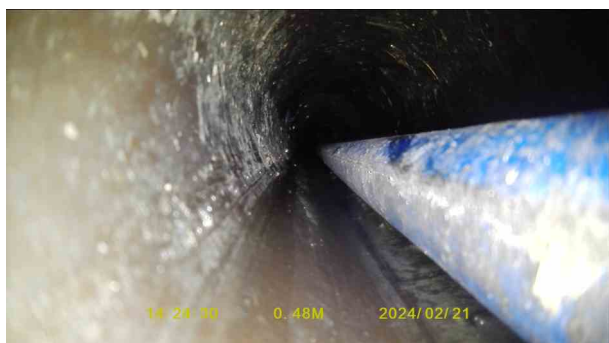
2b74d412-e0a8-464c-9e31-c12150a91c4c.jpg, 00:00:19, 0.48  
m  
Other obstacles from 4 o'clock to 6 o'clock, 25%

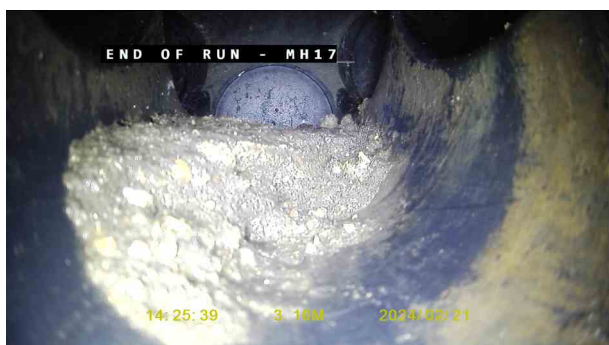
4e2be326-f855-49ca-b772-5fb7d57c2b38.jpg, 00:01:09, 3.16  
m  
Settled deposits, fine, 30% cross-sectional area loss, In

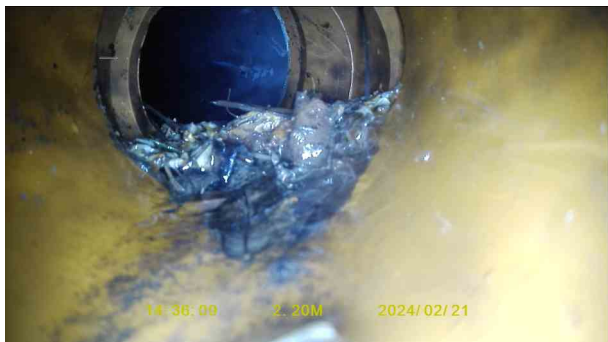
427972de-5d68-4789-ad3f-4aa0ecc2116b.jpg, 00:00:34, 2.20  
m  
Settled deposits, fine, 20% cross-sectional area loss

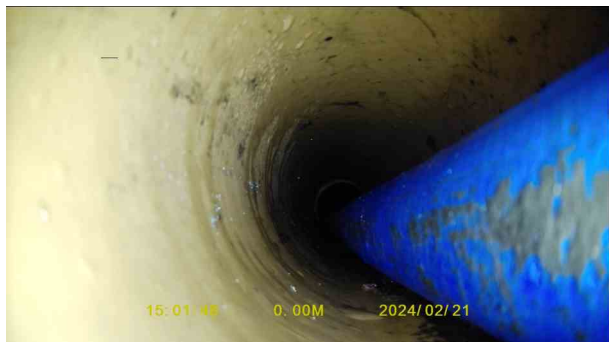
6eec8299-352a-41db-8875-d1e1097aca18.jpg, 00:00:09, 0.01  
m  
Other obstacles from 3 o'clock to 5 o'clock, 25%

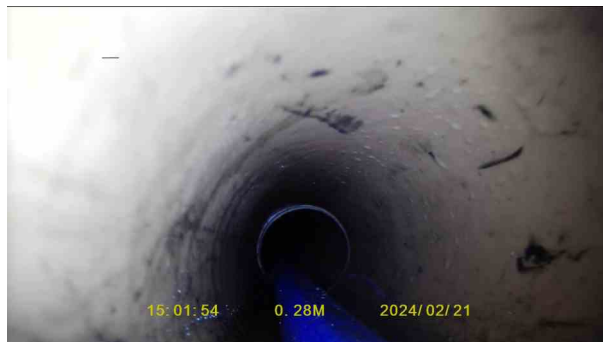
cf5a5643-07b3-4b04-872f-a1eb41d5d638.jpg, 00:00:15, 0.28  
m  
Other obstacles from 5 o'clock to 7 o'clock, 25%

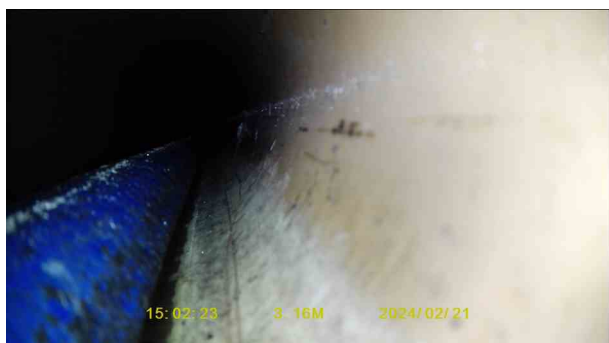
652aefee-05cd-425f-ba92-9fda5dc48866.jpg, 00:00:44, 3.16  
m  
Other obstacles from 6 o'clock to 8 o'clock, 25%

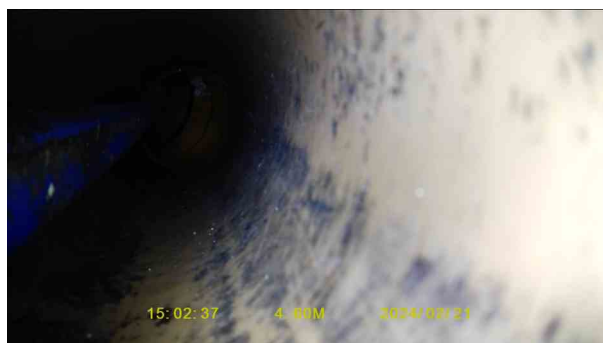
5cd0ca3e-c510-414e-ae2b-2ca209c616e0.jpg, 00:00:58, 4.60  
m  
Other obstacles from 6 o'clock to 8 o'clock, 25%

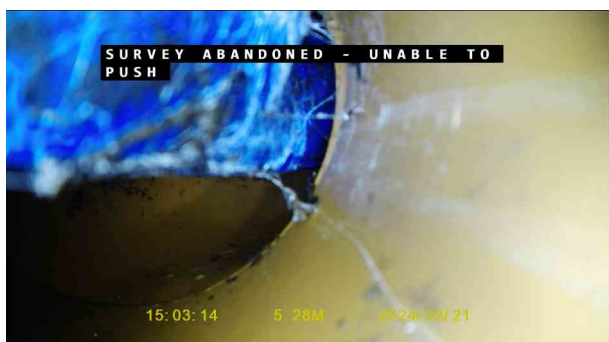
13e196f7-a1fd-4559-91dd-398bd99d5d88.jpg, 00:01:14, 5.28  
m  
Survey abandoned, Camera unable to pass obstruction/Hose

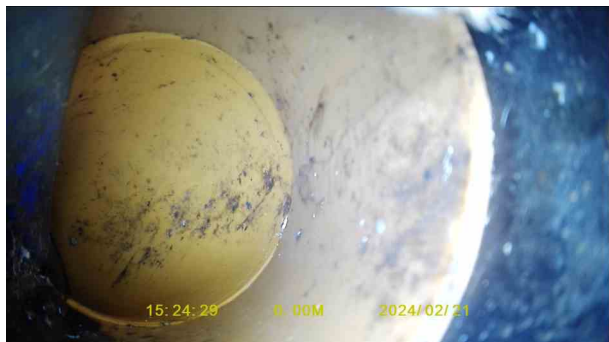
e627b005-8a7f-405c-83c2-5149833629f4.jpg, 00:00:07, 0.01  
m  
Other obstacles at joint from 8 o'clock to 11 o'clock, 20%

**Recommendations:** Further investigation required

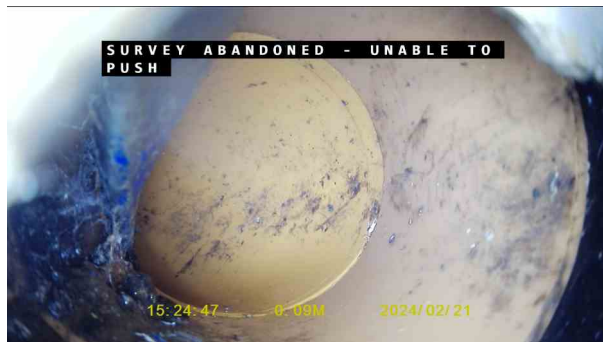
ddf39acd-cb91-4bac-8121-3f3a5a6882cd.jpg, 00:00:19, 0.09  
m  
Survey abandoned, Camera unable to pass obstruction

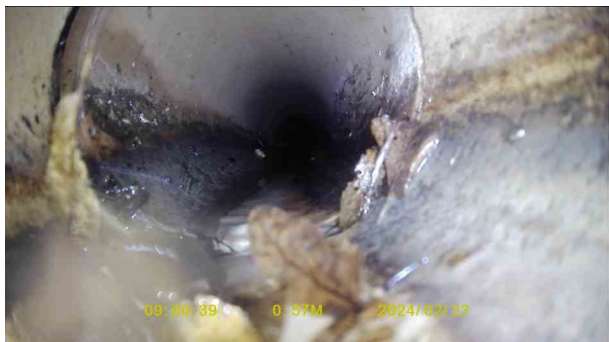
4e79300f-1ec5-462c-bc77-3e3706d264e5.jpg, 00:00:21, 0.57  
m  
Joint displaced, medium

Comments:	
Recommendations:	Recommend LSR

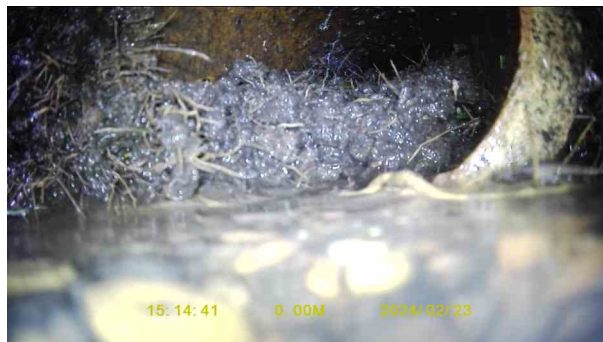
ef91b1b6-ac73-4e48-985f-3cedd3c1e5b7.jpg, 00:00:15, 0.01  
m  
Roots, mass, 55% cross-sectional area loss

Town or Village:	Highgate	Inspection Direction:	Upstream	Upstream Node:	BRANCH A
Road:	Swains Lane	Inspected Length:	0.01 m	Upstream Pipe Depth:	
Location:		Total Length:	0.01 m	Downstream Node:	RWG53
Surface Type:		Joint Length:		Downstream Pipe Depth:	
Use:	Surface water	Pipe Shape:	Circular		
Type of Pipe:		Dia/Height:	100 mm		
Flow Control:		Material:	Vitrified clay		
Year Constructed:	Not Specified	Lining Type:	No Lining		
Inspection Purpose:		Lining Material:	No Lining		
Comments:					
Recommendations: Recommend Root cut/LSR/Further investigation

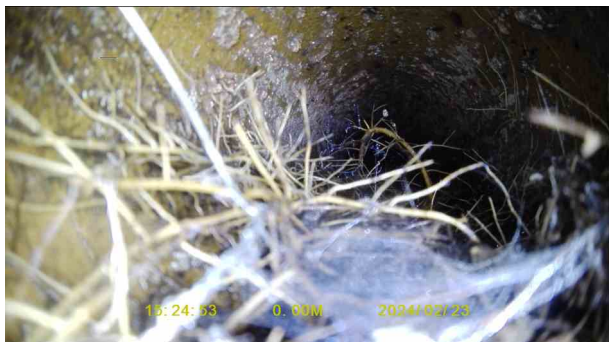
c31913d6-3e81-4ddb-a528-c2514a0cdac8.jpg, 00:00:08, 0.01  
m  
Roots, mass, 40% cross-sectional area loss, start

**Recommendations:** Recommend Root cut/Resurvey

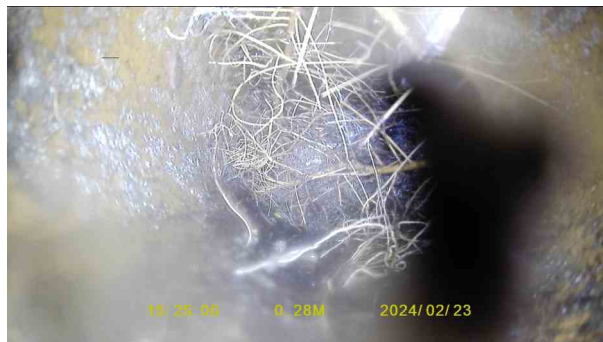
38ea1992-ce32-43af-82a8-5bfceb4d8b7c.jpg, 00:00:19, 0.28  
m  
Roots, mass, 80% cross-sectional area loss, change

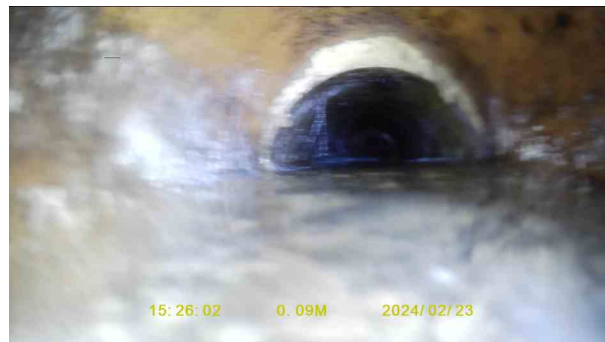
6ee41bfa-2c6b-4ab7-b077-affa711075f3.jpg, 00:00:13, 0.09 m  
Joint displaced, large

Town or Village:	Highgate	Inspection Direction:	Upstream	Upstream Node:	UPSTREAM
Road:	Swains Lane	Inspected Length:	1.63 m	Upstream Pipe Depth:	
Location:		Total Length:	1.63 m	Downstream Node:	RWG54
Surface Type:		Joint Length:		Downstream Pipe Depth:	
Use:	Surface water	Pipe Shape:	Circular		
Type of Pipe:		Dia/Height:	100 mm		
Flow Control:		Material:	Vitrified clay		
Year Constructed:	Not Specified	Lining Type:	No Lining		
Inspection Purpose:		Lining Material:	No Lining		
Comments:					
Recommendations:	Investigate possible bellies/Resurvey

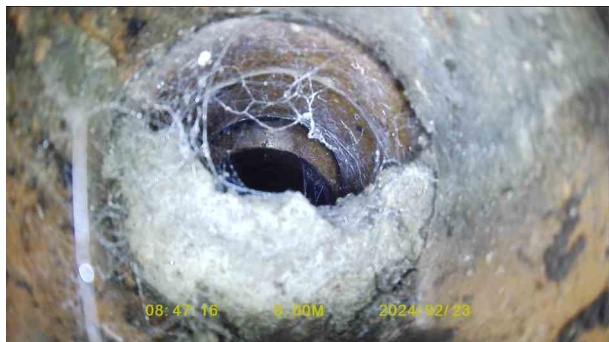
8cc83c31-1c82-4274-93d9-677c2066804e.jpg, 00:00:25, 0.01  
m

Attached deposits, encrustation at joint from 3 o'clock to 10

Comments:	
Recommendations:	Recommend Picote/Resurvey

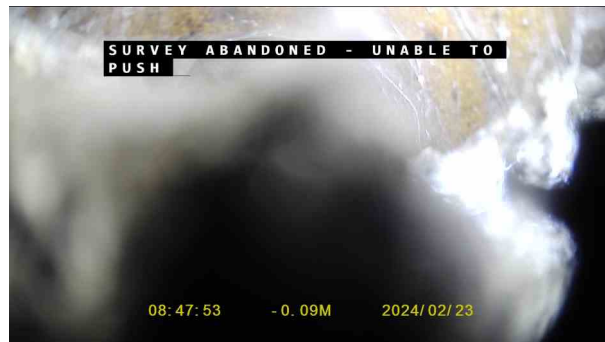
55ab58fb-eb2d-490c-8f4d-aad98e1ce0e4.jpg, 00:00:53, 0.09  
m

Survey abandoned, Camera unable to pass encrustation

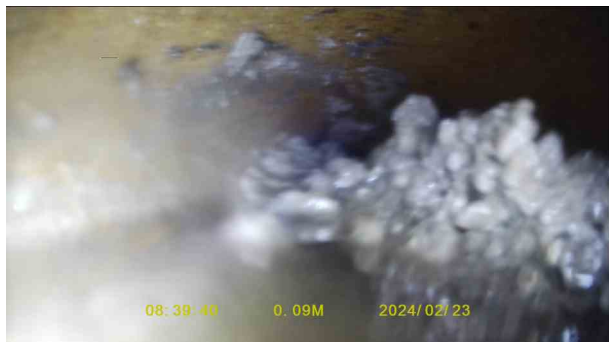
a1b0107d-d7ec-4e34-8021-ecfc20320749.jpg, 00:00:33, 0.09  
m  
Settled deposits, fine, 70% cross-sectional area loss

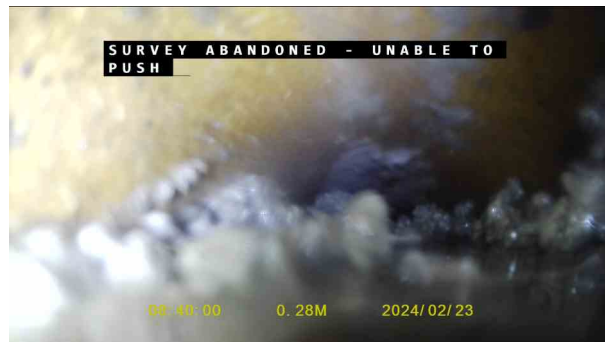
de872583-4a3d-46e0-893b-da2d77759cbe.jpg, 00:00:50, 0.28  
m  
Survey abandoned, Camera unable to pass debris

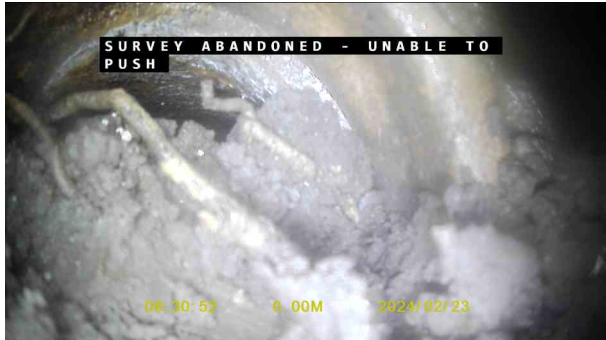
5e992185-dbe2-45d4-85b1-5bdc2159cca4.jpg, 00:00:33, 0.01  
m  
Settled deposits, fine, 85% cross-sectional area loss

**Comments:**  
**Recommendations:** Recommend HPWJ/Resurvey

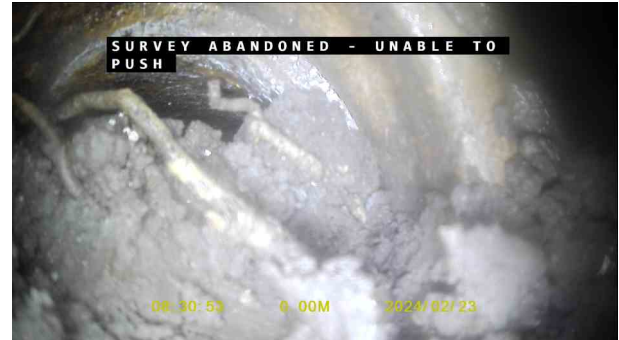
4e1a3962-058e-4481-b28a-02a7cbf8a1ee.jpg, 00:00:32, 0.01  
m  
Survey abandoned, Camera unable to pass debris/Possibly

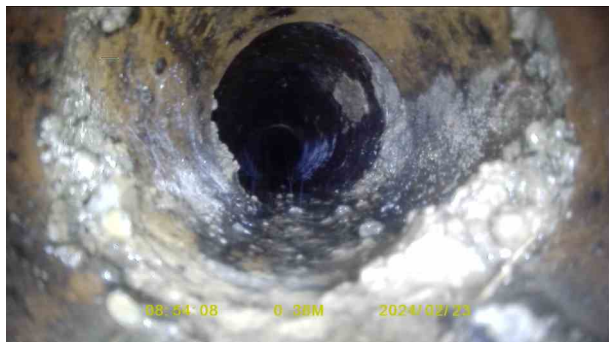
0fcb1316-8cc2-4809-8ee1-7c4c127165c4.jpg, 00:00:23, 0.38 m  
Settled deposits, fine, 15% cross-sectional area loss

Town or Village:	Highgate	Inspection Direction:	Downstream	Upstream Node:	RWG42
Road:	Swains Lane	Inspected Length:	4.22 m	Upstream Pipe Depth:	
Location:		Total Length:	4.22 m	Downstream Node:	DOWNSTREAM
Surface Type:		Joint Length:		Downstream Pipe Depth:	
Use:	Surface water	Pipe Shape:	Circular		
Type of Pipe:		Dia/Height:	100 mm		
Flow Control:		Material:	Vitrified clay		
Year Constructed:	Not Specified	Lining Type:	No Lining		
Inspection Purpose:		Lining Material:	No Lining		
Comments:					
Recommendations:	Recommend HPWJ/2XLSR's/Resurvey

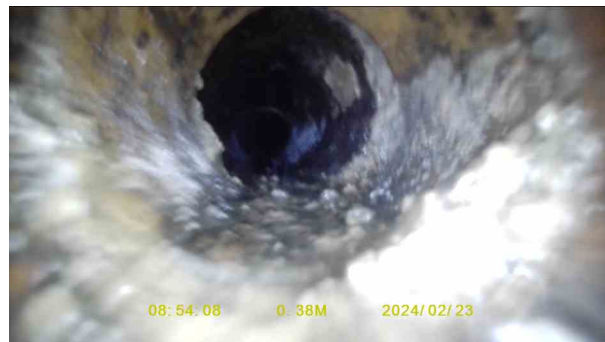
ebf9fdc8-6f5a-468e-87d7-fbdf5e8868cd.jpg, 00:00:24, 0.45 m  
Joint displaced, medium

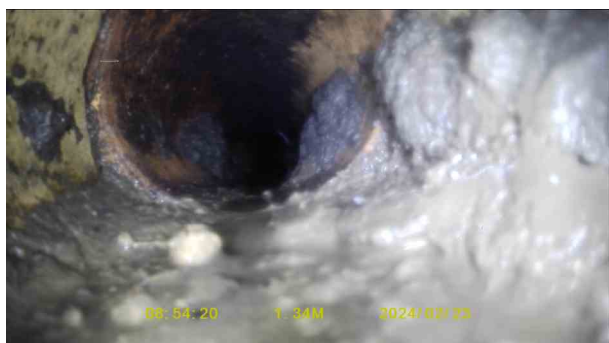
030d482c-0287-4418-866d-885ec74c349b.jpg, 00:00:35, 1.34 m  
Joint displaced, medium

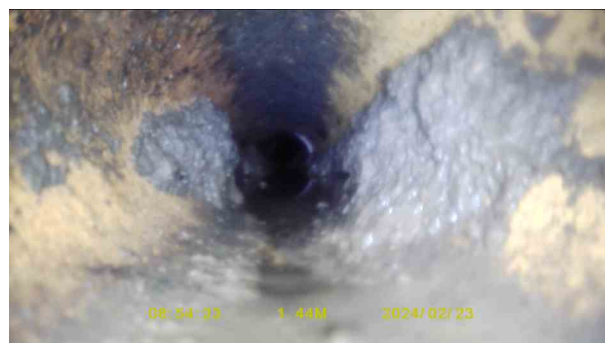
546aff71-f911-49c7-a11a-262728b180b8.jpg, 00:00:38, 1.44 m  
Attached deposits, encrustation from 2 o'clock to 10 o'clock,

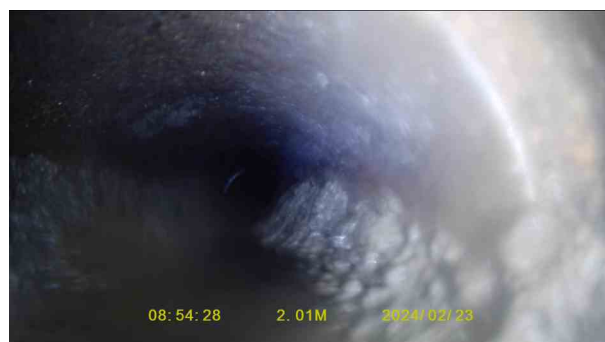
bc94ba6c-7dc1-47db-8010-2a48c268674e.jpg, 00:00:44, 2.01 m  
Attached deposits, encrustation from 2 o'clock to 10 o'clock,

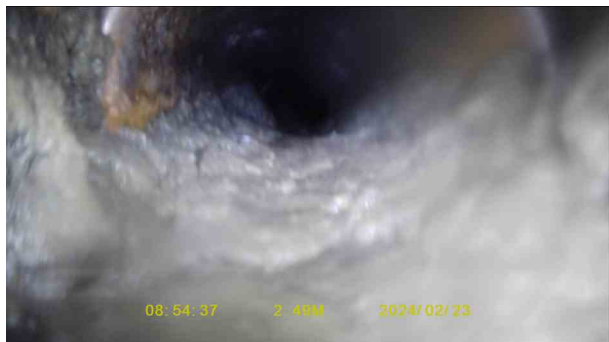
fc254624-ec25-427a-b5d0-166951710ad9.jpg, 00:00:52, 2.49  
m  
Attached deposits, encrustation from 2 o'clock to 10 o'clock,

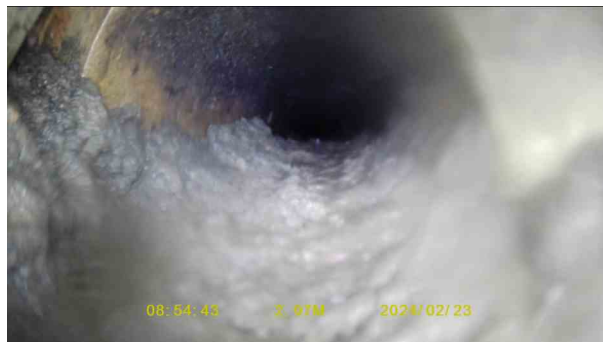
5bde52ec-05ae-43d4-9be4-8f5e391d23ae.jpg, 00:00:58, 2.97  
m  
Joint displaced, large

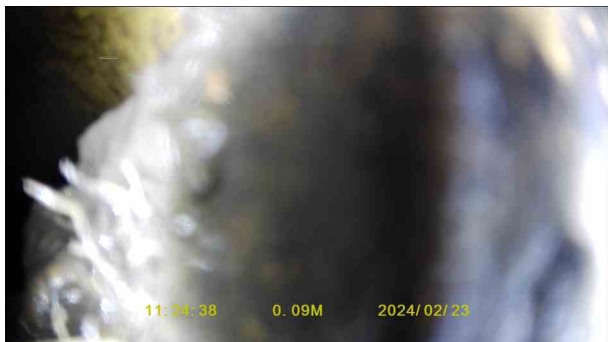
83037877-9036-41bc-b3b6-ba671c318e4d.jpg, 00:00:13, 0.09  
m  
Roots, mass, 50% cross-sectional area loss, start

Town or Village:	Highgate	Inspection Direction:	Downstream	Upstream Node:	RWG49
Road:	Swains Lane	Inspected Length:	1.63 m	Upstream Pipe Depth:	
Location:		Total Length:	1.63 m	Downstream Node:	DOWNSTREAM
Surface Type:		Joint Length:		Downstream Pipe Depth:	
Use:	Surface water	Pipe Shape:	Circular		
Type of Pipe:		Dia/Height:	100 mm		
Flow Control:		Material:	Vitrified clay		
Year Constructed:	Not Specified	Lining Type:	No Lining		
Inspection Purpose:		Lining Material:	No Lining		
Comments:					
Recommendations: Recommend Root cut/Investigate possible bellies/Resurvey

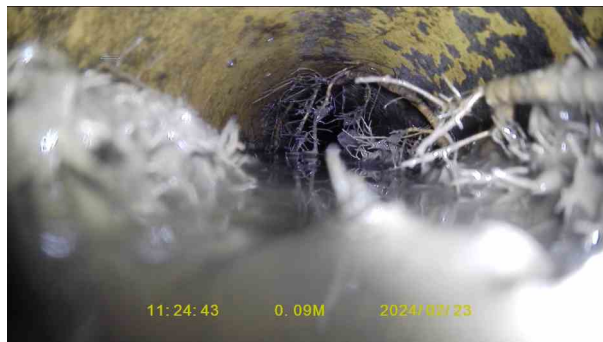
88058ca7-4658-49c0-89f4-0a224abc9857.jpg, 00:00:19, 0.09  
m  
Water level, 40% of the vertical dimension

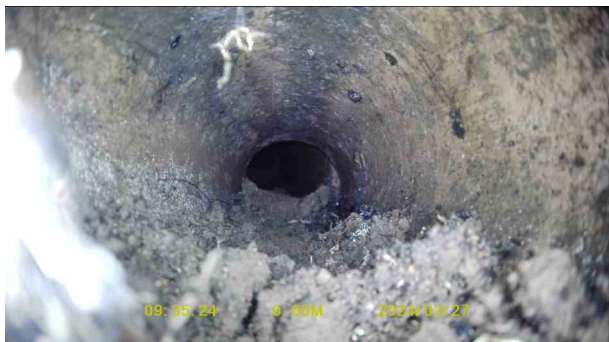
cb26f994-a3e6-44ee-abe5-ce6e57f387f1.jpg, 00:00:10, 0.01  
m  
Settled deposits, fine, 25% cross-sectional area loss, start

Town or Village:	Highgate	Inspection Direction:	Downstream	Upstream Node:	RWG58
Road:	Swains Lane	Inspected Length:	2.01 m	Upstream Pipe Depth:	
Location:		Total Length:	2.01 m	Downstream Node:	DOWNSTREAM
Surface Type:		Joint Length:		Downstream Pipe Depth:	
Use:	Surface water	Pipe Shape:	Circular		
Type of Pipe:		Dia/Height:	100 mm		
Flow Control:		Material:	Vitrified clay		
Year Constructed:	Not Specified	Lining Type:	No Lining		
Inspection Purpose:		Lining Material:	No Lining		
Comments:					
Recommendations: Recommend HPWJ/Relining/Possible excavation/Resurvey

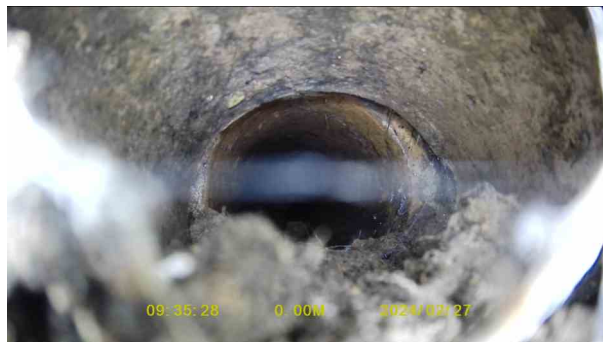
f4f2aa38-92dc-416a-a2d8-a88f5b1b0635.jpg, 00:00:15, 0.09  
m  
Joint displaced, large

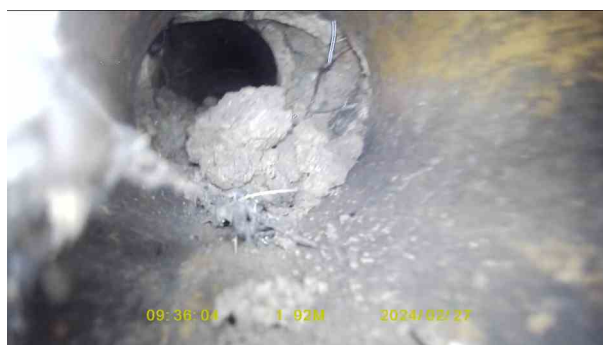
0f05dd2b-d91f-47c4-bc70-f34ff8dd0329.jpg, 00:00:51, 2.01 m  
Joint displaced, large

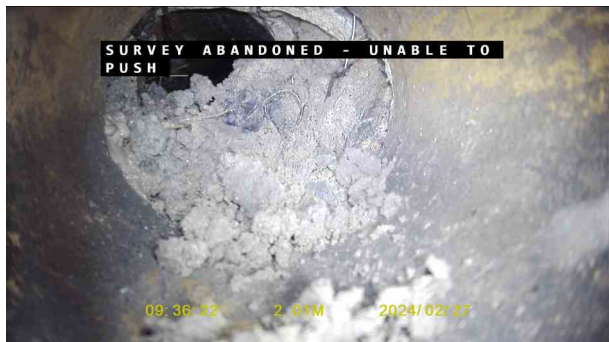
ccd12fb2-d96d-483c-ab35-0a9e8e8272c4.jpg, 00:01:04, 2.01  
m  
Settled deposits, fine, 75% cross-sectional area loss, change

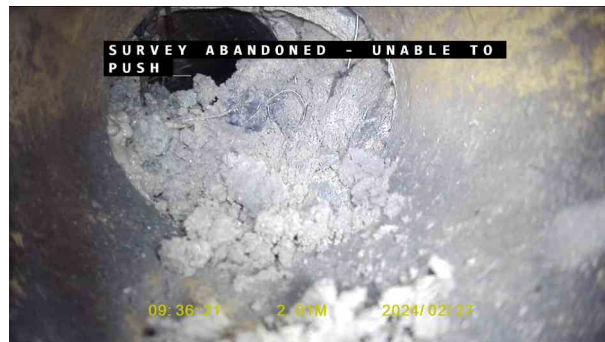
4f1847f5-4869-448b-aa3e-df9f6e82e729.jpg, 00:01:03, 2.01 m  
Survey abandoned, Camera unable to pass JDL

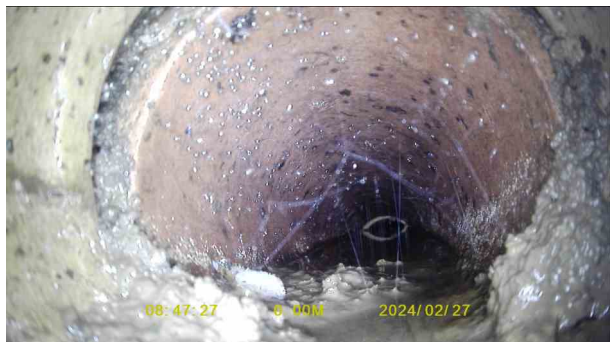
f0e37fa7-f24e-4e91-8c76-1c56c7c197a6.jpg, 00:00:12, 0.01 m  
Joint displaced, large

Town or Village:	Highgate	Inspection Direction:	Upstream	Upstream Node:	BRANCH A
Road:	Swains Lane	Inspected Length:	0.67 m	Upstream Pipe Depth:	
Location:		Total Length:	0.67 m	Downstream Node:	RWG56
Surface Type:		Joint Length:		Downstream Pipe Depth:	
Use:	Surface water	Pipe Shape:	Circular		
Type of Pipe:		Dia/Height:	100 mm		
Flow Control:		Material:	Vitrified clay		
Year Constructed:	Not Specified	Lining Type:	No Lining		
Inspection Purpose:		Lining Material:	No Lining		
Comments:					
Recommendations: Recommend HPWJ/LSR/Investigate possible bellies/Resurvey

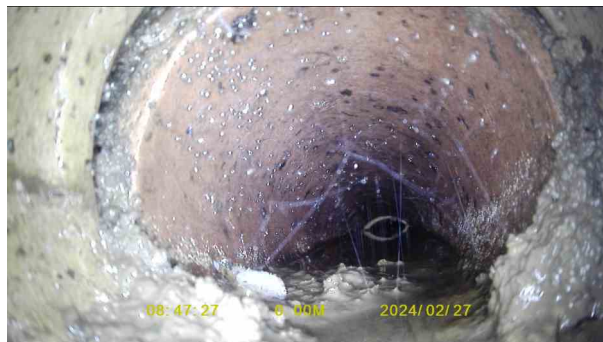
9e581c3b-0d3d-4f9a-bb58-4cf67137c14b.jpg, 00:00:12, 0.01 m  
Settled deposits, fine, 20% cross-sectional area loss, start

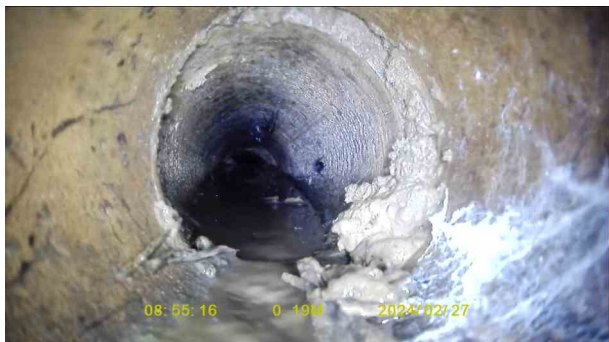
edf2ff39-8159-4d78-86fe-ecea74ac22b2.jpg, 00:00:18, 0.19 m  
Settled deposits, fine at joint, 20% cross-sectional area loss

**Recommendations:** Recommend HPWJ/Root cut/Relining/Investigate possible bellies/Resurvey

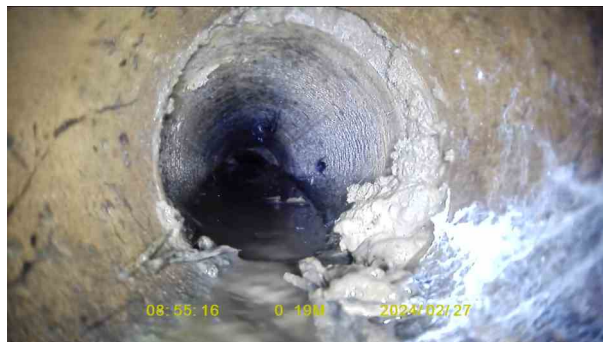
3238a81c-6958-485b-b282-015487cfd794.jpg, 00:00:18, 0.19 m  
Joint displaced, large

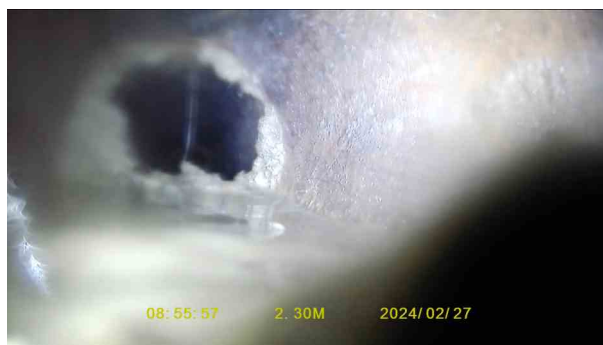
94d3f8ef-6a0a-4c91-97d6-7b3c1c3a0ecc.jpg, 00:00:41, 2.30 m  
Attached deposits, encrustation at joint from 12 o'clock to 12

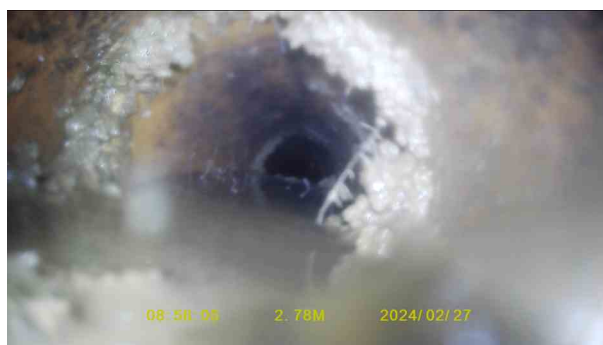
476f513a-e145-4712-aba0-0c70bedffb96.jpg, 00:00:48, 2.78 m  
Roots, fine at joint

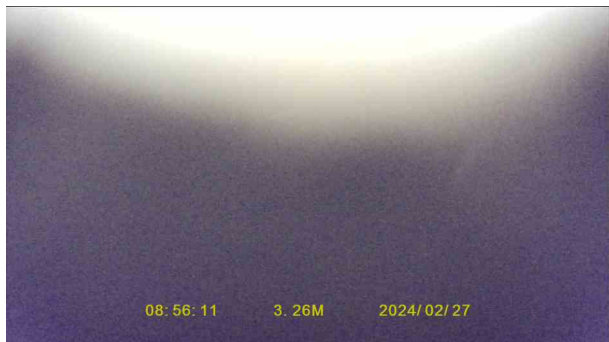
f74f2ac8-981d-456d-a539-eaf09321404c.jpg, 00:00:54, 3.26 m  
Loss of vision, camera under water, start

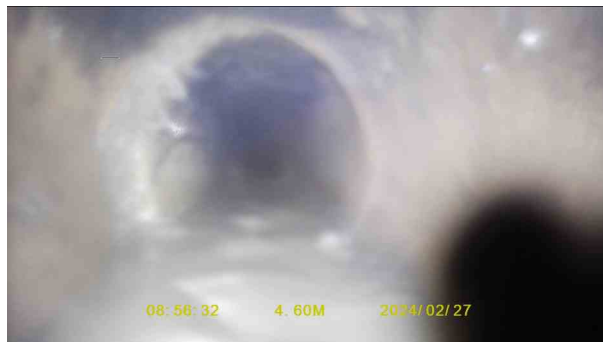
94d5bec5-9cc4-4bfd-a7b9-cdf28f2dc7ed.jpg, 00:01:14, 4.60 m  
Roots, fine at joint

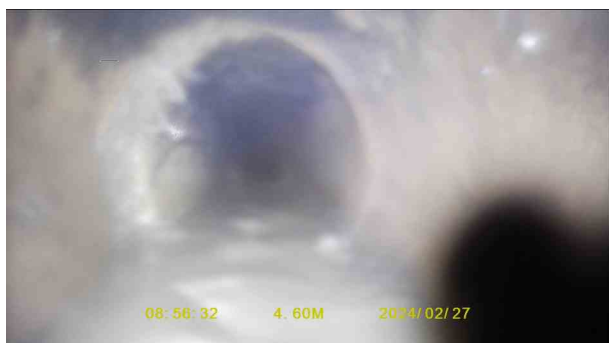
543dc134-2596-4644-b144-d3fd2671e7ea.jpg, 00:01:14, 4.60 m  
Joint displaced, large

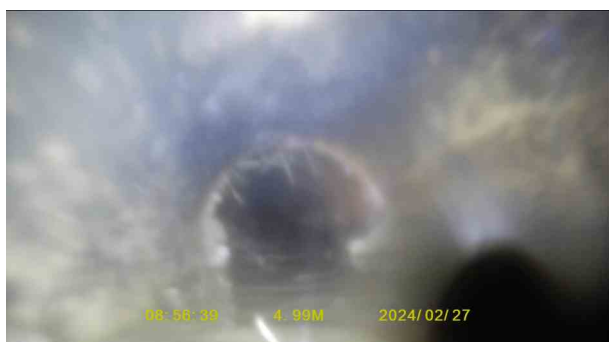
f05e26ae-1973-4ff7-8a06-b59d1cbe2930.jpg, 00:01:21, 4.99 m  
Roots, fine at joint

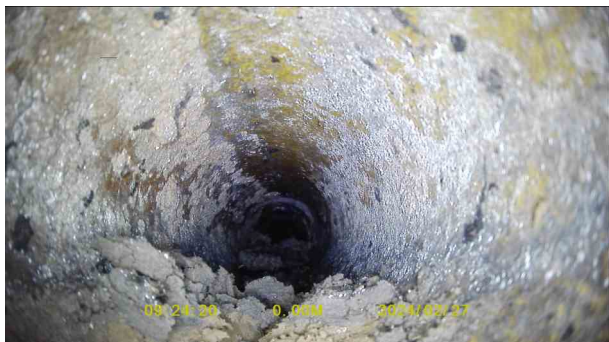
92345a1f-0f0d-44f6-92a0-a963a50cfe03.jpg, 00:00:09, 0.01 m  
Settled deposits, fine, 25% cross-sectional area loss, start

Town or Village:	Highgate	Inspection Direction:	Downstream	Upstream Node:	RWG57
Road:	Swains Lane	Inspected Length:	1.05 m	Upstream Pipe Depth:	
Location:		Total Length:	1.05 m	Downstream Node:	DOWNSTREAM
Surface Type:		Joint Length:		Downstream Pipe Depth:	
Use:	Surface water	Pipe Shape:	Circular		
Type of Pipe:		Dia/Height:	100 mm		
Flow Control:		Material:	Vitrified clay		
Year Constructed:	Not Specified	Lining Type:	No Lining		
Inspection Purpose:		Lining Material:	No Lining		
Comments:					
Recommendations:	Recommend HPWJ/LSR/Resurvey

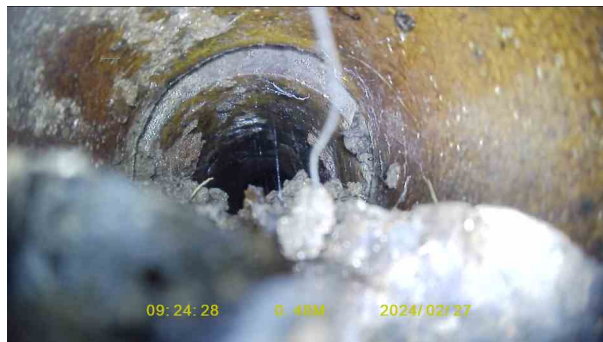
4d362faa-fbf3-4b0d-93b6-bd9cc255c001.jpg, 00:00:17, 0.48 m  
Joint displaced, large

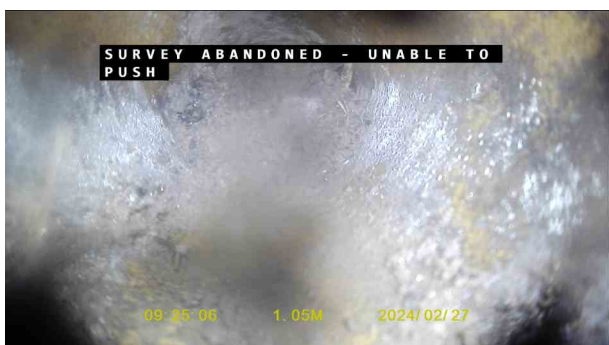
84c7cce2-2a40-4e68-aa6e-d7318382164e.jpg, 00:00:50, 1.05 m  
Survey abandoned, Camera unable to pass debris

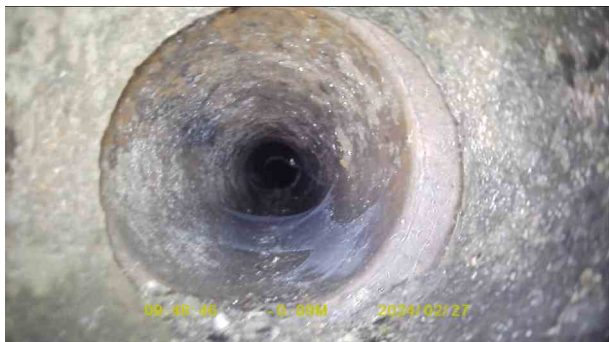
8c62f773-bc83-49bf-bd68-917fa7667e2e.jpg, 00:00:19, 0.09  
m  
Joint displaced, large

Town or Village:	Highgate	Inspection Direction:	Downstream	Upstream Node:	RWG59
Road:	Swains Lane	Inspected Length:	1.82 m	Upstream Pipe Depth:	
Location:		Total Length:	1.82 m	Downstream Node:	DOWNSTREAM
Surface Type:		Joint Length:		Downstream Pipe Depth:	
Use:	Surface water	Pipe Shape:	Circular		
Type of Pipe:		Dia/Height:	100 mm		
Flow Control:		Material:	Vitrified clay		
Year Constructed:	Not Specified	Lining Type:	No Lining		
Inspection Purpose:		Lining Material:	No Lining		
Comments:					
Recommendations:	Recommend root cut/HPWJ/2XLSR's/Investigate possible bellies/Resurvey

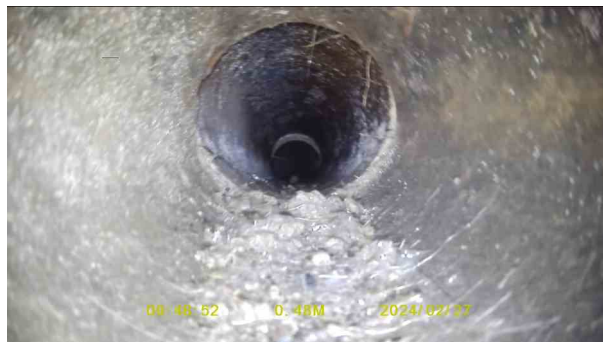
6428489e-c5d8-452f-aa2d-1e93e38ba1ff.jpg, 00:00:25, 0.48  
m  
Roots, fine at joint

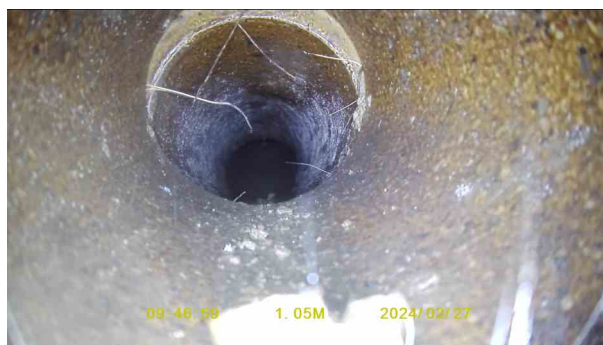
dde8d0b9-63c0-4fd6-a86c-80250d7e6d3d.jpg, 00:00:32, 1.15  
m  
Joint displaced, large

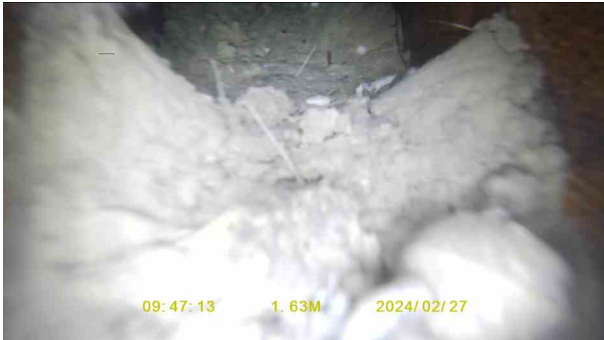
5b71ba6d-9ab2-4946-b49b-98612d70ad92.jpg, 00:00:46, 1.53  
m  
Settled deposits, fine, 40% cross-sectional area loss

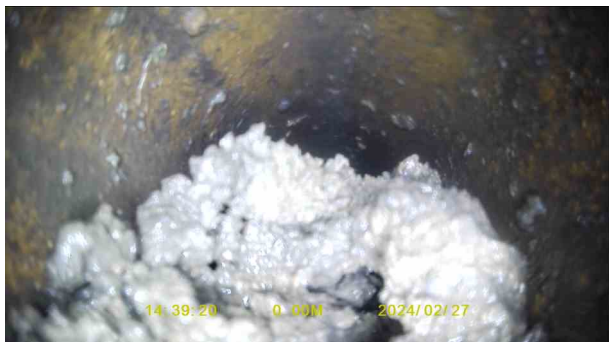
24f01336-08e8-4b56-bea3-61ae8406c6f1.jpg, 00:00:12, 0.01  
m  
Settled deposits, fine, 75% cross-sectional area loss

**Recommendations:** Recommend HPWJ/Resurvey

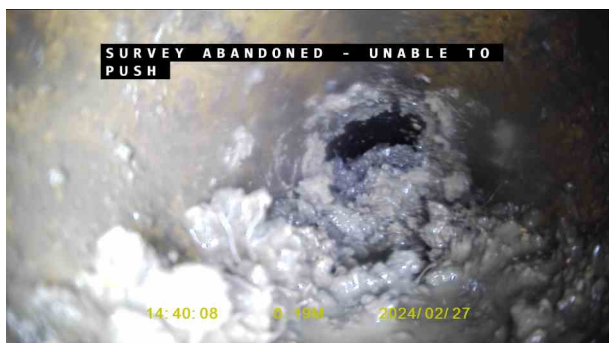
39ad9e52-f44f-45b2-a9b8-f6e2a4fa684d.jpg, 00:00:37, 0.19 m  
Survey abandoned, Camera unable to pass debris

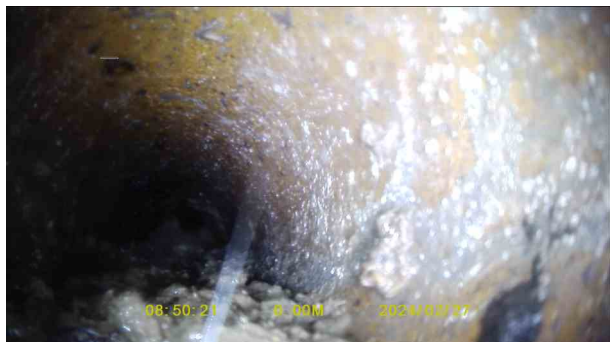
30e5672e-07dd-453b-9b6f-79ff09f2d35b.jpg, 00:00:10, 0.01 m  
Settled deposits, fine, 25% cross-sectional area loss, start

Recommendations: Recommend HPWJ/Resurvey

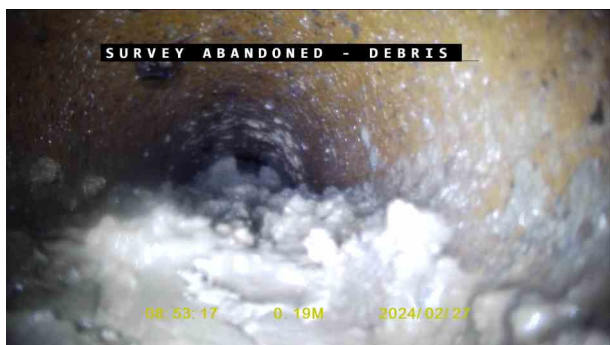
1f51dcea-61a5-4b26-9188-32764b45a606.jpg, 00:00:37, 0.19 m  
Survey abandoned, Camera unable to pass debris

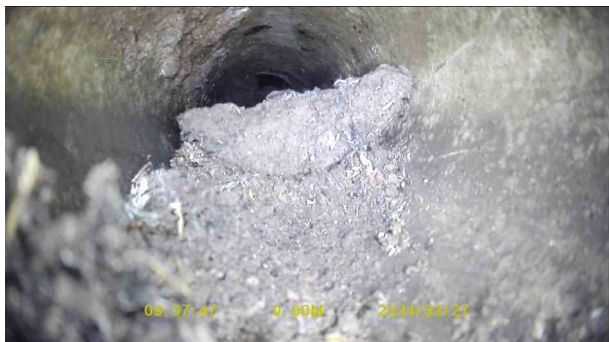
cbedb70e-1abb-451e-8590-e41d940529c4.jpg, 00:00:17, 0.01  
m  
Settled deposits, fine, 60% cross-sectional area loss

**Recommendations:** Recommend HPWJ/Resurvey

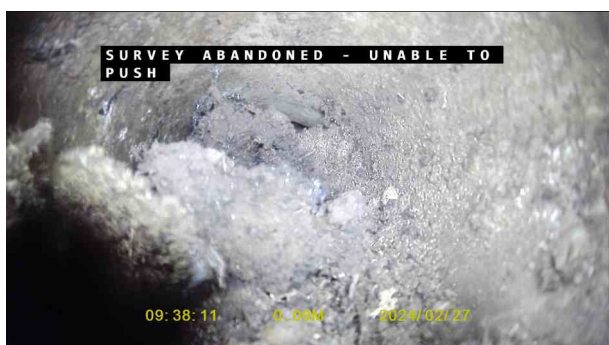
8a9a1b1c-7982-42b2-9fa4-973232a10f63.jpg, 00:00:37, 0.09  
m  
Survey abandoned, Camera unable to pass debris

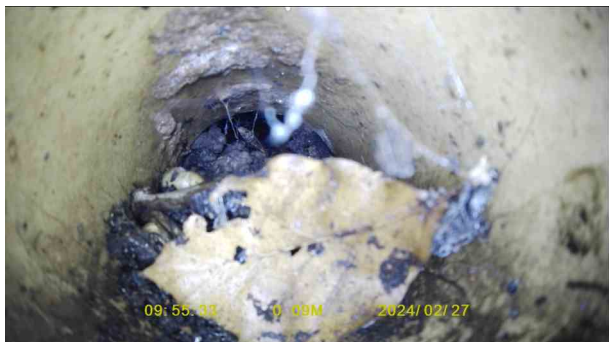
038250da-519e-4f8b-abdf-91c0b59accfb.jpg, 00:00:18, 0.09 m  
Settled deposits, fine, 80% cross-sectional area loss

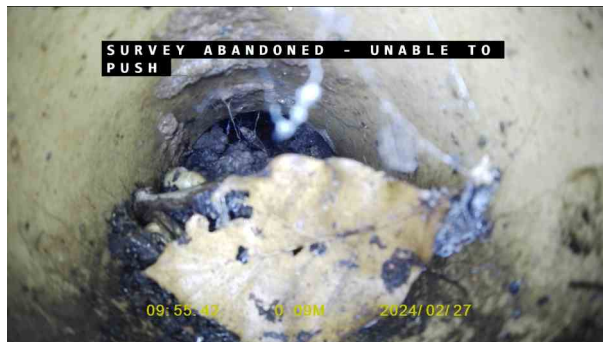
c41e8986-3fa4-49c2-81e9-a6df2293c256.jpg, 00:00:23, 0.09 m  
Survey abandoned, Camera unable to pass debris/Possibly

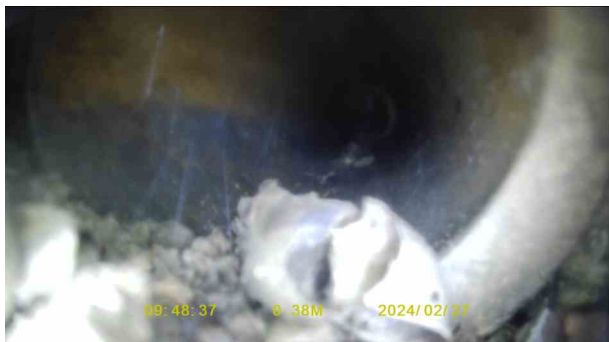
d3045543-19c3-4219-abd9-ac87c87991d2.jpg, 00:00:17, 0.38 m  
Joint displaced, large

Town or Village:	Highgate	Inspection Direction:	Upstream	Upstream Node:	UPSTREAM
Road:	Swains Lane	Inspected Length:	2.01 m	Upstream Pipe Depth:	
Location:		Total Length:	2.01 m	Downstream Node:	RWG59
Surface Type:		Joint Length:		Downstream Pipe Depth:	
Use:	Surface water	Pipe Shape:	Circular		
Type of Pipe:		Dia/Height:	100 mm		
Flow Control:		Material:	Vitrified clay		
Year Constructed:	Not Specified	Lining Type:	No Lining		
Inspection Purpose:		Lining Material:	No Lining		
Comments:					
Recommendations:	Recommend Root cut/Relining/Possible excavation/Resurvey

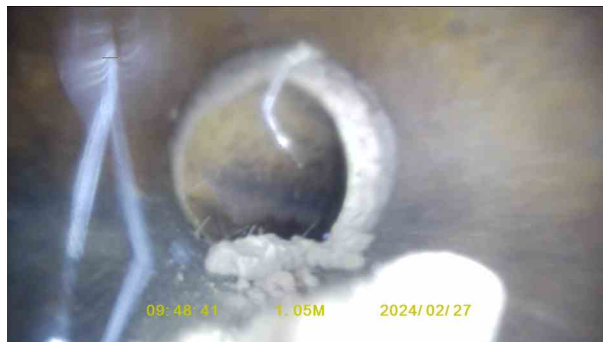
c7163da9-020a-44f5-8fdf-cd71268ab28b.jpg, 00:00:22, 1.05 m  
Joint displaced, large

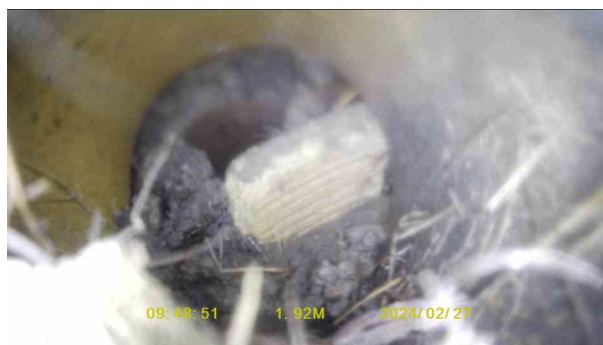
a2ef8350-c24e-4a74-906e-d14d4f6ba4c4.jpg, 00:00:32, 1.92 m  
Open joint, large

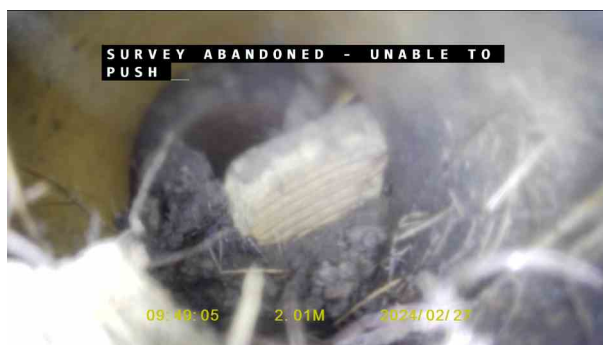
128e637e-cd87-4a72-8c57-c29339dc3771.jpg, 00:00:37, 2.01 m  
Other obstacles, protruding through wall at joint from 2 o'clock

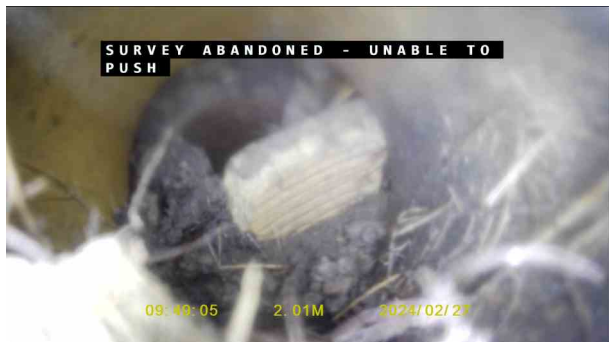
Survey abandoned, Camera unable to pass OJL/Obstruction

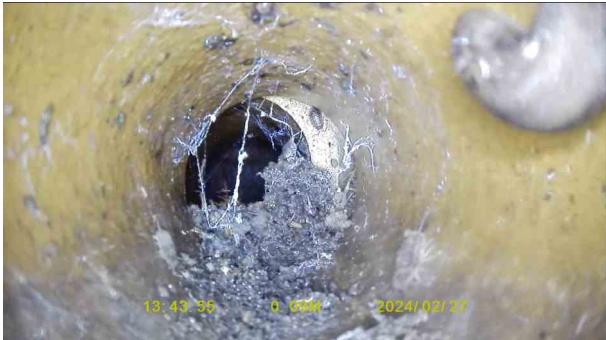
cfa26202-8514-4663-b057-0c61602bc071.jpg, 00:00:19, 0.09  
m  
Settled deposits, fine, 20% cross-sectional area loss

Town or Village:	Highgate	Inspection Direction:	Downstream	Upstream Node:	RWG73
Road:	Swains Lane	Inspected Length:	0.09 m	Upstream Pipe Depth:	
Location:		Total Length:	0.09 m	Downstream Node:	DOWNSTREAM
Surface Type:		Joint Length:		Downstream Pipe Depth:	
Use:	Surface water	Pipe Shape:	Circular		
Type of Pipe:		Dia/Height:	80 mm		
Flow Control:		Material:	Vitrified clay		
Year Constructed:	Not Specified	Lining Type:	No Lining		
Inspection Purpose:		Lining Material:	No Lining		
Comments:					
Recommendations:	Recommend HPWJ/LSR/Possible excavation

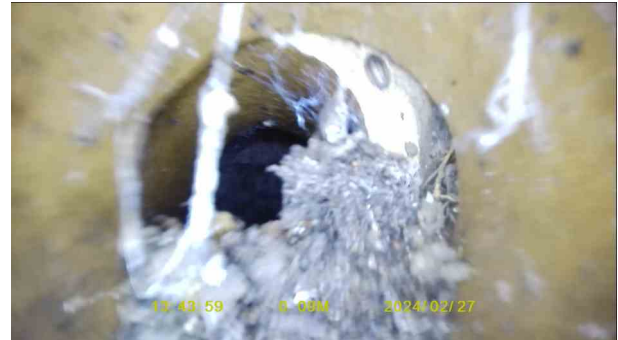
81f01e4d-074d-4ef4-9457-19227b9b81f1.jpg, 00:00:23, 0.09  
m  
Joint displaced, large

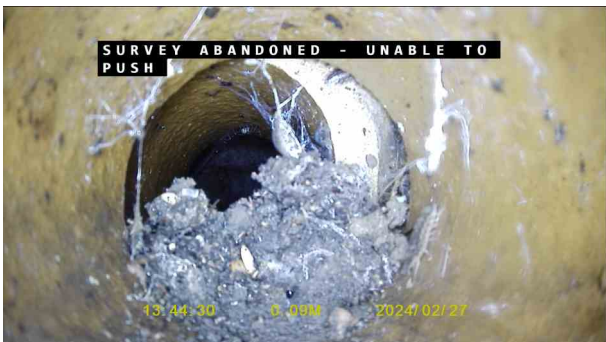
c211d4ed-8ad2-490d-99f5-3b7fd11bd9a1.jpg, 00:00:36, 0.09  
m  
Survey abandoned, Camera unable to pass JDL/Debris

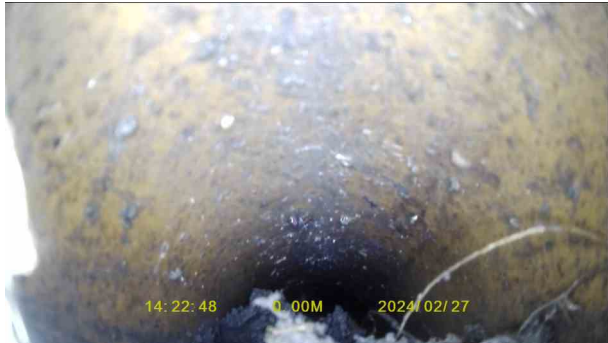
29adea43-d6da-44fe-9536-0bfdcf06eeb1.jpg, 00:00:11, 0.01  
m  
Settled deposits, fine, 40% cross-sectional area loss, start

Comments:  
Recommendations: Recommend HPWJ/Resurvey

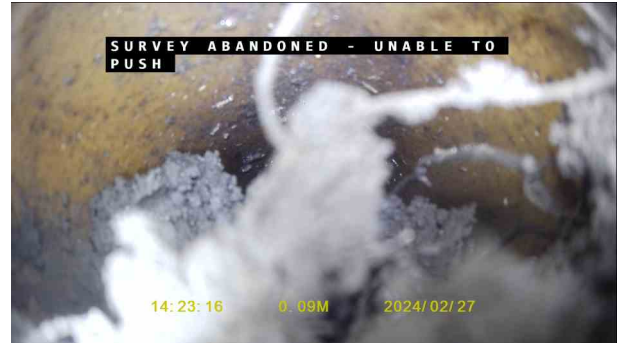
2f514dbb-dea1-4e8c-8afb-a16bb28beaf8.jpg, 00:00:03, 0.19  
m  
Survey abandoned, Camera uable to pass debris

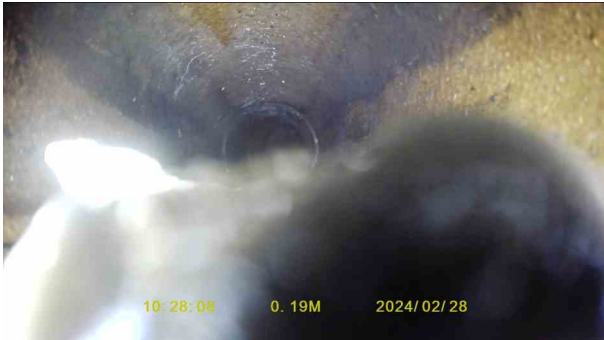
8f1e95cf-5037-488b-ae26-b04371364da1.jpg, 00:00:19, 0.01  
m  
Settled deposits, fine, 25% cross-sectional area loss

**Recommendations:** Recommend HPWJ/Resurvey

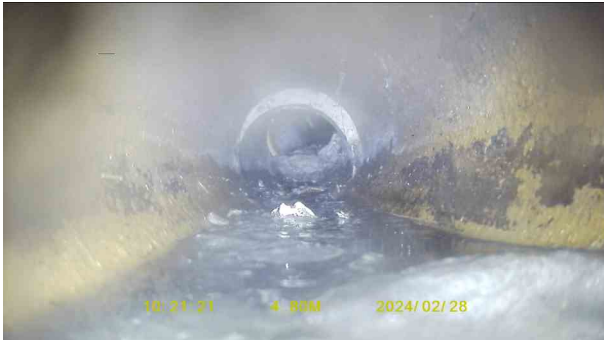
2f091c8d-fe10-47cb-b418-9ad9284ce3d8.jpg, 00:00:12, 0.01  
m  
Settled deposits, fine, 20% cross-sectional area loss

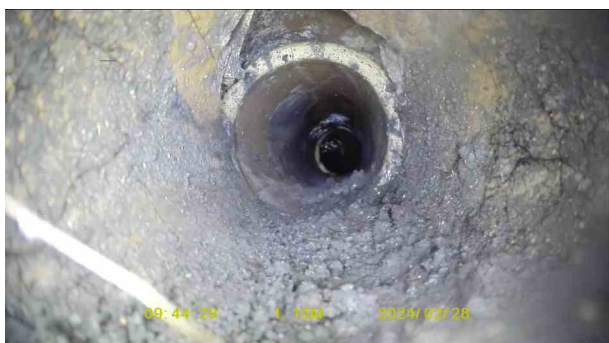
09995635-ead1-4dc6-a789-c8a85ced25e2.jpg, 00:00:23, 1.15  
m  
Hole in drain or sewer from 10 o'clock to 2 o'clock

Town or Village:	Highgate	Inspection Direction:	Upstream	Upstream Node:	BRANCH A
Road:	Swains Lane	Inspected Length:	5.18 m	Upstream Pipe Depth:	
Location:		Total Length:	5.18 m	Downstream Node:	MH20
Surface Type:		Joint Length:		Downstream Pipe Depth:	3.300 m
Use:	Surface water	Pipe Shape:	Circular		
Type of Pipe:		Dia/Height:	100 mm		
Flow Control:		Material:	Vitrified clay		
Year Constructed:	Not Specified	Lining Type:	No Lining		
Inspection Purpose:		Lining Material:	No Lining		
Comments:					
Recommendations:	Recommend HPWJ/Relining/Possible excavation/Resurvey

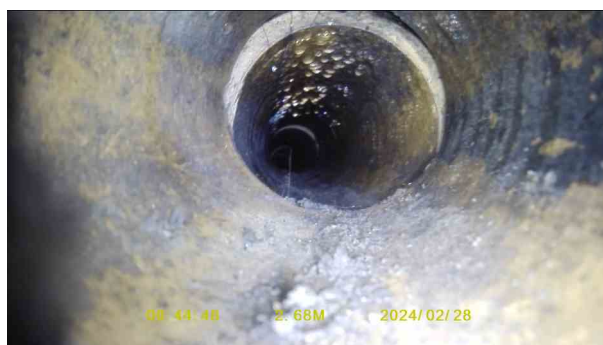
c4737226-e4db-47d8-aabd-d6bc6b44d135.jpg, 00:00:42, 2.68  
m  
Joint displaced, large
