## Completed section inspection

Town or Village:	Highgate	Inspection Direction:	Downstream	Upstream Node:	MH11
Road:	Swains Lane	Inspected Length:	3.07 m	Upstream Pipe Depth:	0.570 m
Location:		Total Length:	3.07 m	Downstream Node:	MH13
Surface Type:		Joint Length:		Downstream Pipe Depth:	
Use:	Surface water	Pipe Shape:	Circular		
Type of Pipe:		Dia/Height:	100 mm		
Flow Control:		Material:	Polyvinyl chloride		
Year Constructed:	Not Specified	Lining Type:	No Lining		
Inspection Purpose:		Lining Material:	No Lining		
Comments:					
Recommendations: Recommend HPWJ

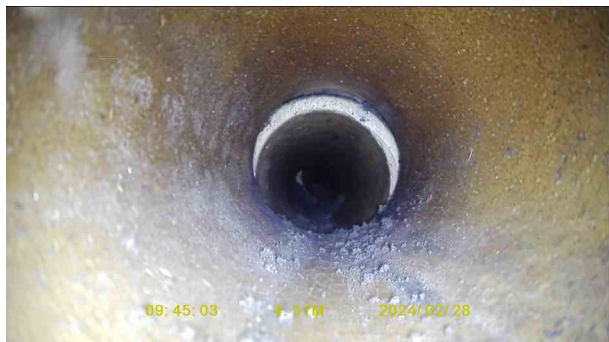
c20c070b-aacd-424d-af35-588278e04c77.jpg, 00:00:57, 4.51 m  
Joint displaced, large

Town or Village:	Highgate	Inspection Direction:	Upstream	Upstream Node:	BRANCH A
Road:	Swains Lane	Inspected Length:	5.18 m	Upstream Pipe Depth:	
Location:		Total Length:	5.18 m	Downstream Node:	MH20
Surface Type:		Joint Length:		Downstream Pipe Depth:	3.300 m
Use:	Surface water	Pipe Shape:	Circular		
Type of Pipe:		Dia/Height:	100 mm		
Flow Control:		Material:	Vitrified clay		
Year Constructed:	Not Specified	Lining Type:	No Lining		
Inspection Purpose:		Lining Material:	No Lining		
Comments:					
Recommendations:	Recommend HPWJ/Relining/Possible excavation/Resurvey

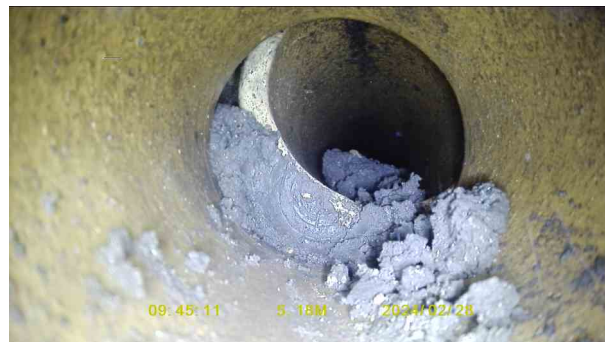
0b86901a-c5d3-4acb-8172-bbdfff70f9fe.jpg, 00:01:05, 5.18 m  
Open joint, large

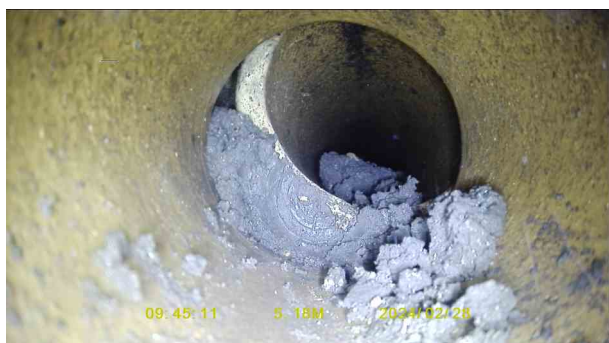
1bdab721-5f99-49eb-8ed6-be60724c47cc.jpg, 00:01:05, 5.18 m  
Joint displaced, large

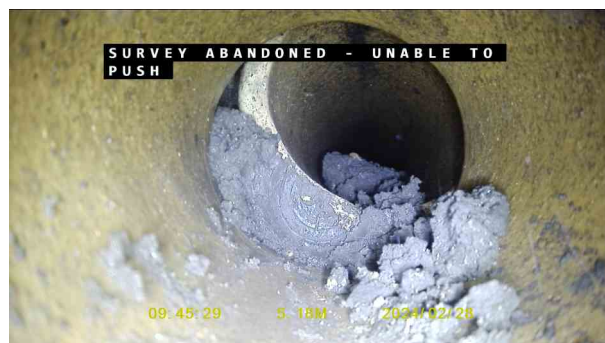
4b256e0b-1001-45ce-892c-500a0a41122e.jpg, 00:01:08, 5.18 m  
Survey abandoned, Camera unable to pass JDL

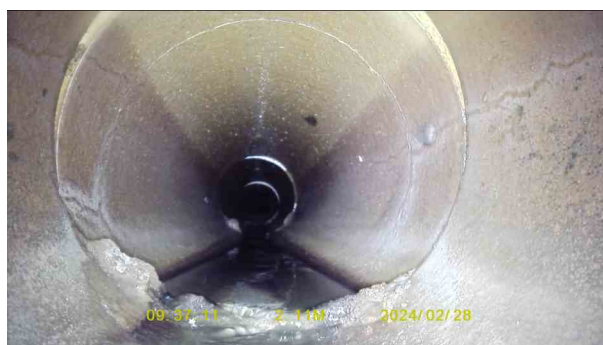
0.19	RFJ	Roots, fine at joint	00:00:15		2
		2.11	CCJ	Crack, circumferential at joint from 8 o'clock to 3 o'clock	00:00:33		2 / 2
		2.11	DEEJ	Attached deposits, encrustation at joint from 5 o'clock to 7 o'clock, 15% cross-sectional area loss	00:00:33		3

fb6a5d86-324c-4a40-b619-137fa61fdd51.jpg, 00:00:33, 2.11 m  
Attached deposits, encrustation at joint from 5 o'clock to 7 o'clock

Comments:	
Recommendations:	Recommend Root cut/Relining/Investigate possible bellies/Resurvey

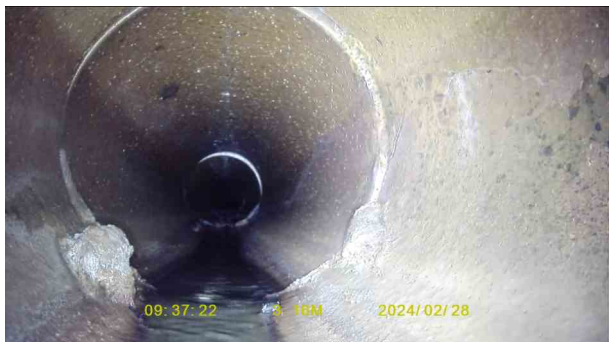
3.16	DEEJ	Attached deposits, encrustation at joint from 7 o'clock to 8 o'clock, 15% cross-sectional area loss	00:00:44		3
		3.63	CLJ	Crack, longitudinal at joint at 3 o'clock	00:00:56		2 / 2

f4ffd01f-f25a-4200-a2ab-bb432de9a09f.jpg, 00:00:44, 3.16 m  
Attached deposits, encrustation at joint from 7 o'clock to 8 o'clock, 15% cross-sectional area loss

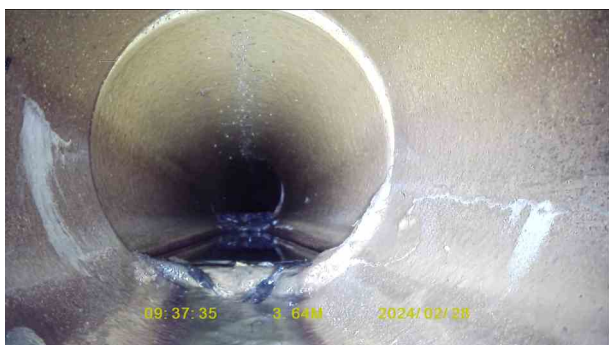
aa3d0a73-6d35-404b-b941-38d745a7c16a.jpg, 00:00:56, 3.64 m  
Attached deposits, encrustation at joint from 4 o'clock to 7

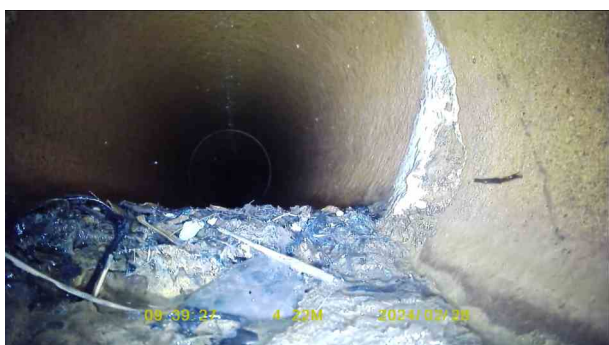
439848db-f8dc-43ef-937d-ba36c4278371.jpg, 00:01:46, 4.22 m  
Attached deposits, encrustation at joint from 4 o'clock to 8

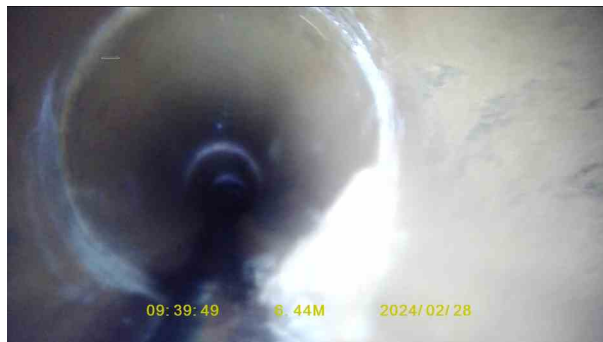
4.80	CCJ	Crack, circumferential at joint from 4 o'clock to 8 o'clock	00:01:57		2 / 2
		6.44	DEEJ	Attached deposits, encrustation at joint from 4 o'clock to 6 o'clock, 15% cross-sectional area loss	00:02:08		3

23bb68e0-1434-4e0c-94b2-39e2347e44b9.jpg, 00:02:08, 6.44  
m  
Attached deposits, encrustation at joint from 4 o'clock to 6

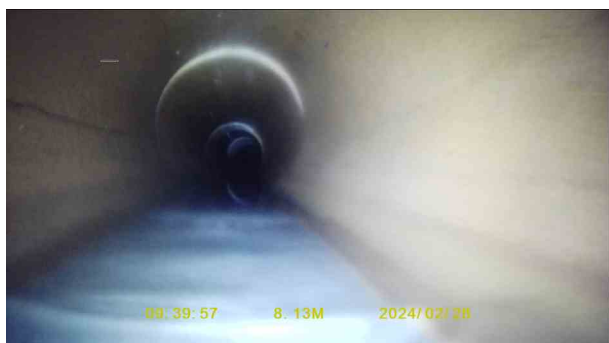
772c8bb4-0770-416f-ab1f-b12b07e31e7f.jpg, 00:02:16, 8.13  
m  
Water level, 20% of the vertical dimension

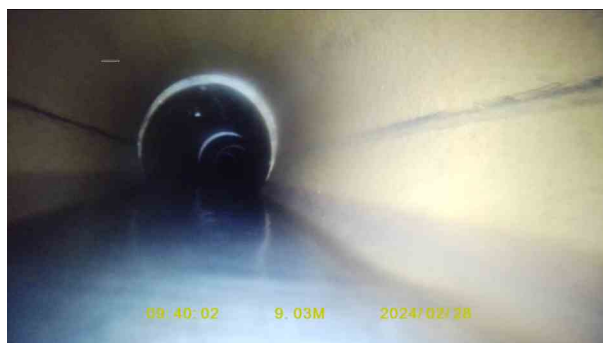
bf1ace71-eab4-4379-88e5-22d3930213c0.jpg, 00:02:21, 9.03  
m  
Water level, 30% of the vertical dimension

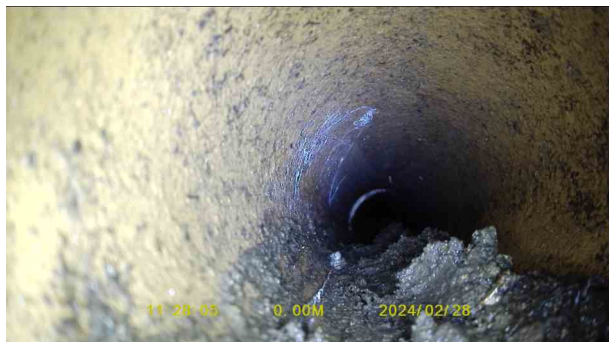
3db440e9-94a5-444e-aeac-e60b9c2334fc.jpg, 00:00:08, 0.01  
m  
Settled deposits, fine, 20% cross-sectional area loss, start

Town or Village:	Highgate	Inspection Direction:	Upstream	Upstream Node:	BRANCH A
Road:	Swains Lane	Inspected Length:	1.23 m	Upstream Pipe Depth:	
Location:		Total Length:	1.23 m	Downstream Node:	MH21
Surface Type:		Joint Length:		Downstream Pipe Depth:	0.500 m
Use:	Surface water	Pipe Shape:	Circular		
Type of Pipe:		Dia/Height:	100 mm		
Flow Control:		Material:	Vitrified clay		
Year Constructed:	Not Specified	Lining Type:	No Lining		
Inspection Purpose:		Lining Material:	No Lining		
Comments:					
Recommendations: Recommend HPWJ/Resurvey

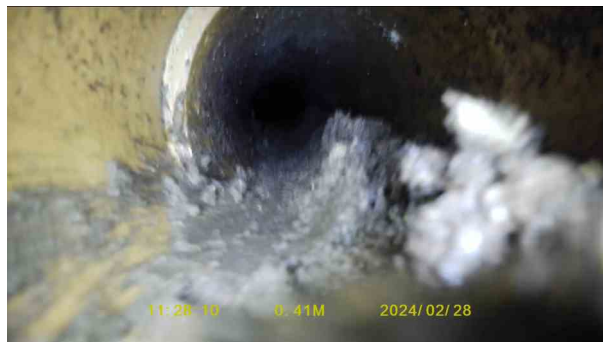
77367d56-7a45-45eb-ad78-ac012a2018e5.jpg, 00:00:13, 0.41  
m  
Joint displaced, medium

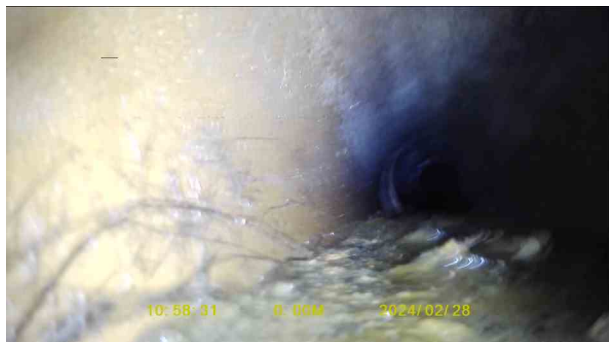
132c5efe-8fb1-4b9e-a824-f4bad41f3c98.jpg, 00:00:13, 0.01 m  
Settled deposits, fine, 25% cross-sectional area loss, start

Town or Village:	Highgate	Inspection Direction:	Downstream	Upstream Node:	MH21
Road:	Swains Lane	Inspected Length:	5.56 m	Upstream Pipe Depth:	0.500 m
Location:		Total Length:	5.56 m	Downstream Node:	DOWNSTREAM
Surface Type:		Joint Length:		Downstream Pipe Depth:	
Use:	Surface water	Pipe Shape:	Circular		
Type of Pipe:		Dia/Height:	150 mm		
Flow Control:		Material:	Vitrified clay		
Year Constructed:	Not Specified	Lining Type:	No Lining		
Inspection Purpose:		Lining Material:	No Lining		
Comments:					
Recommendations: Recommend HPWJ/Relining/Resurvey

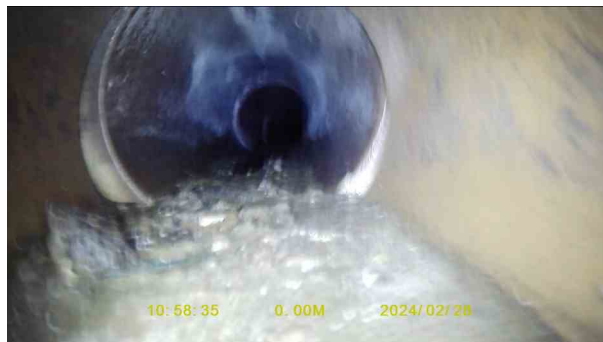
59989cb7-882d-4cad-8231-0d4c84c6b221.jpg, 00:00:13, 0.09 m  
Joint displaced, medium

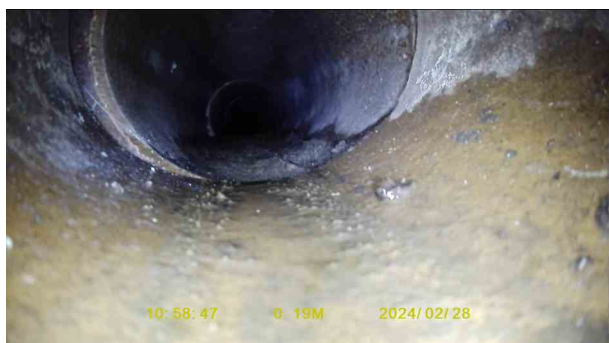
7dc46182-e677-44b7-b370-61bb35cd409f.jpg, 00:00:25, 0.19 m  
Joint displaced, medium

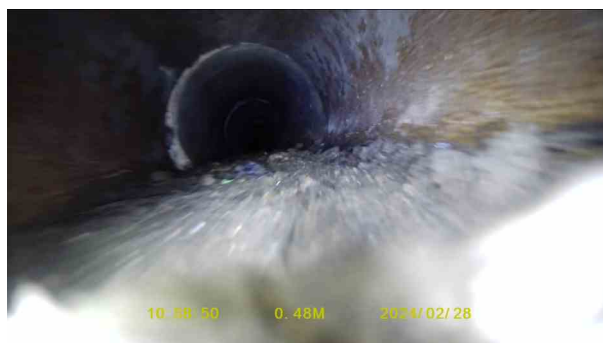
e9bc0550-c807-4021-97ad-5c5421ae3788.jpg, 00:00:28, 0.48 m  
Settled deposits, fine, 25% cross-sectional area loss, start

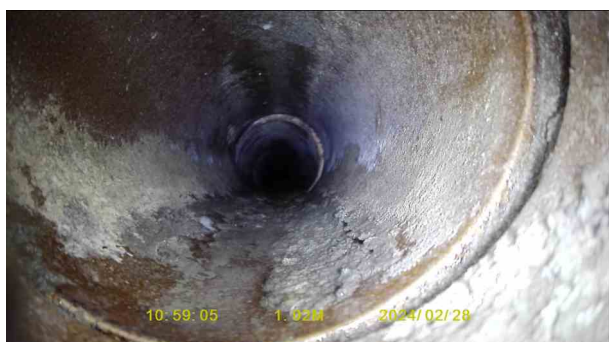
74221590-b06f-4585-a0a0-9d5b4a09d375.jpg, 00:00:43, 1.92 m  
Joint displaced, medium

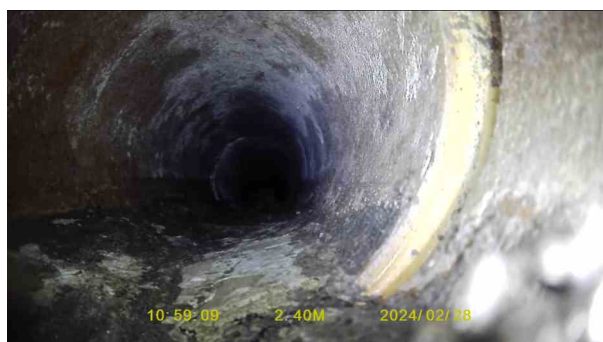
e160bc27-03a4-4946-b649-9492332ef6a9.jpg, 00:00:47, 2.40 m  
Joint displaced, large

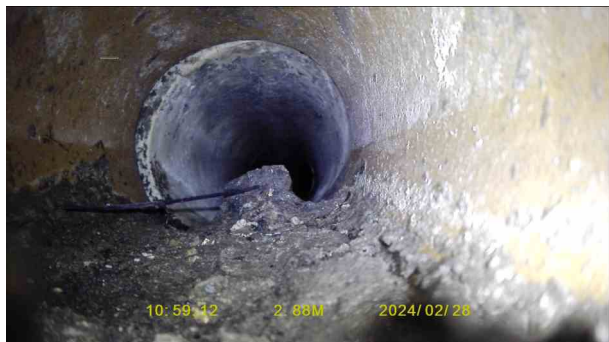
0b1fa437-c79c-4ffa-b5a3-a789f1c390e5.jpg, 00:00:51, 2.88 m  
Joint displaced, medium

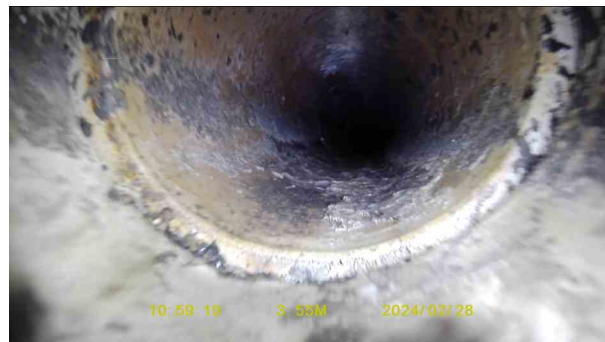
ef59b3cd-38a9-45ec-a904-49bcb886006c.jpg, 00:00:57, 3.55 m  
Joint displaced, medium

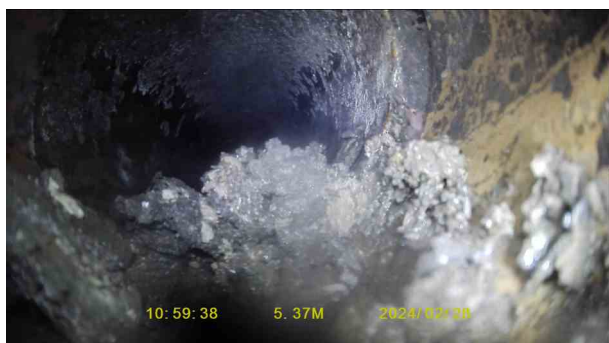
9f08fd98-dd8b-4de9-b0cf-8636eb958aed.jpg, 00:01:16, 5.37 m  
Joint displaced, medium

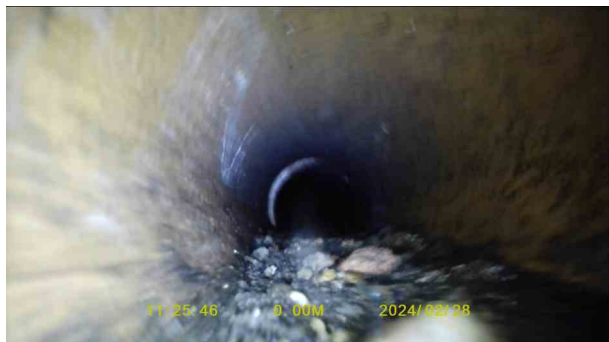
bcbbea21-a523-4d4e-80ec-5267102d0d3b.jpg, 00:00:09, 0.01  
m  
Settled deposits, fine, 20% cross-sectional area loss, start

Town or Village:	Highgate	Inspection Direction:	Upstream	Upstream Node:	UPSTREAM
Road:	Swains Lane	Inspected Length:	8.99 m	Upstream Pipe Depth:	
Location:		Total Length:	8.99 m	Downstream Node:	MH21
Surface Type:		Joint Length:		Downstream Pipe Depth:	0.500 m
Use:	Surface water	Pipe Shape:	Circular		
Type of Pipe:		Dia/Height:	100 mm		
Flow Control:		Material:	Vitrified clay		
Year Constructed:	Not Specified	Lining Type:	No Lining		
Inspection Purpose:		Lining Material:	No Lining		
Comments:					
Recommendations:	Recommend HPWJ/LSR/Resurvey

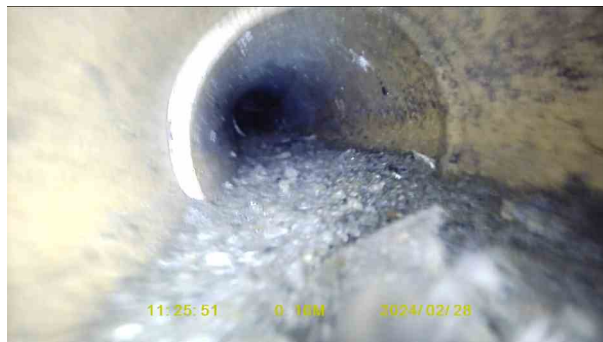
a5bb8a15-44ea-4299-932a-bd0cf48bb56d.jpg, 00:00:15, 0.16  
m  
Joint displaced, medium

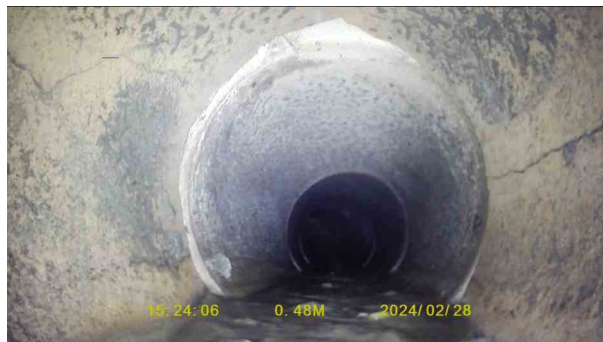
97553212-8f60-4b8f-9d8c-d75e09502bee.jpg, 00:00:16, 0.48 m  
Settled deposits, fine, 20% cross-sectional area loss, start

**Comments:**  
**Recommendations:** Recommend LSR/HPWJ/Investigate possible bellies/Resurvey with crawler unit

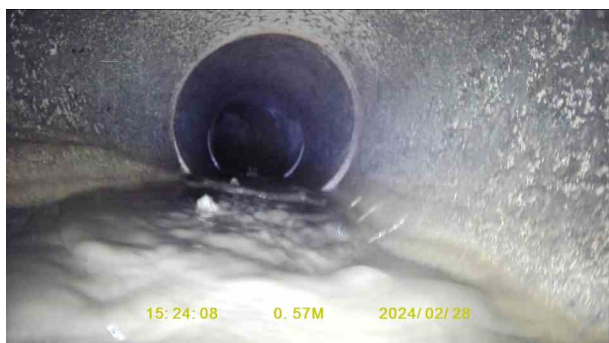
0ddb4aba-a1ce-4d32-bc0a-b2261925cef3.jpg, 00:00:18, 0.57 m  
Water level, 20% of the vertical dimension

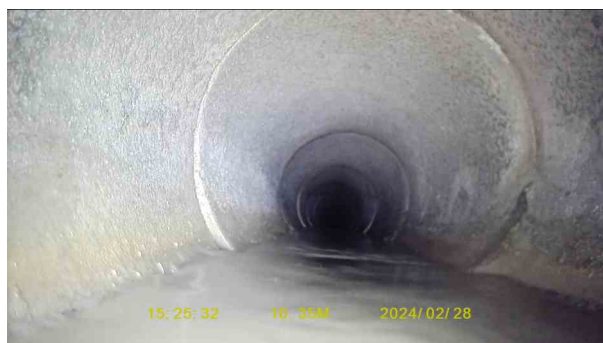
f8c42220-fb22-455e-a4fb-0b886136aeeb.jpg, 00:01:42, 10.35 m  
Water level, 20% of the vertical dimension

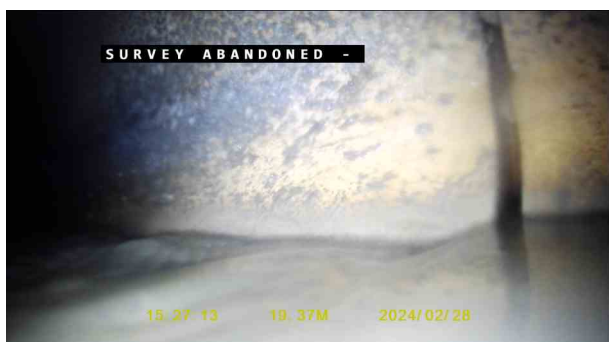
aa4ac5ef-aa4b-42b4-970f-9f78c96b2de4.jpg, 00:03:19, 19.37 m  
Survey abandoned, Camera unable to push further due to pipe

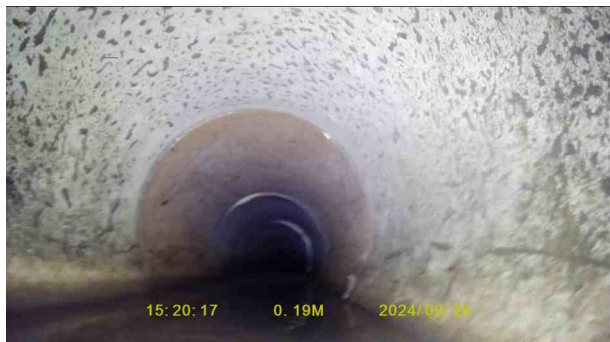
5f63d655-58e9-4f14-acae-1c6df74d127f.jpg, 00:00:08, 0.19 m  
Water level, 20% of the vertical dimension

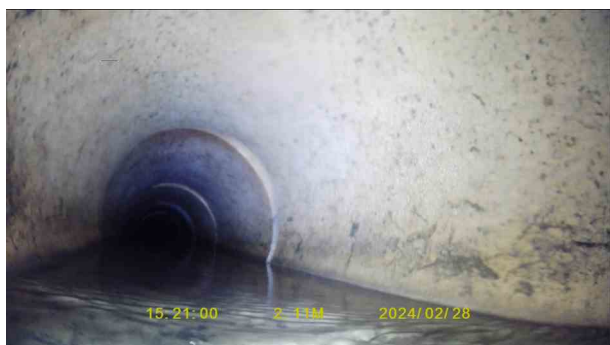
6ab524fc-49ec-4ec2-b2e6-076abcf96f41.jpg, 00:00:51, 2.11 m  
Attached deposits, encrustation from 5 o'clock to 7 o'clock,  
20% cross-sectional area loss, start

**Comments:**  
**Recommendations:** Recommend HPWJ/LSR/Investigate possible bellies/Resurvey with crawler unit

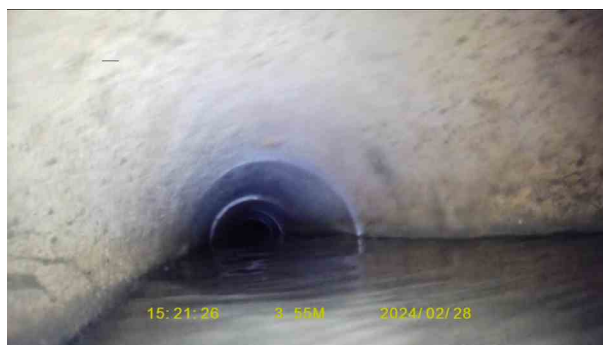
7016f20e-0a01-442c-bf39-0fb44cff4202.jpg, 00:01:17, 3.55 m  
Water level, 50% of the vertical dimension

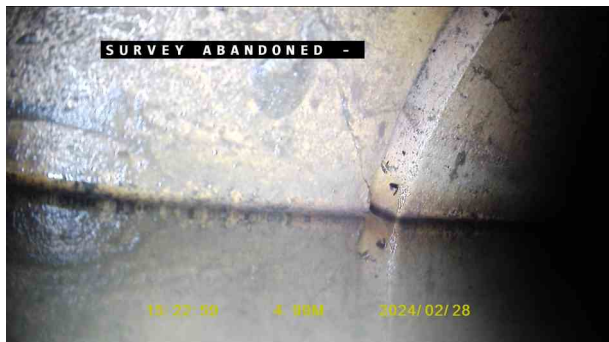
e556d635-d279-413f-9fcd-78f9d69848af.jpg, 00:02:00, 4.99 m  
Survey abandoned, Camera unable to push further due to size  
of pipe

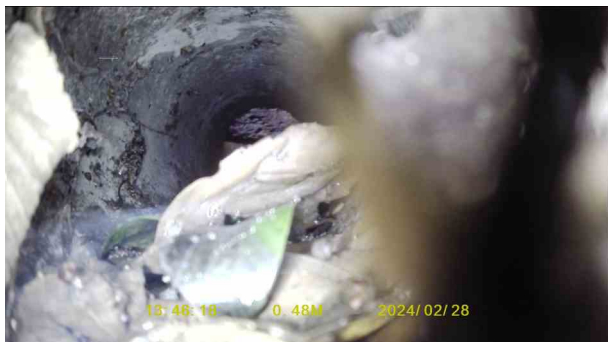
e6148df6-479e-471a-969a-ecfed70f1506.jpg, 00:00:19, 0.48 m  
Settled deposits, fine, 30% cross-sectional area loss, start

Comments:	
Recommendations:	Recommend HPWJ

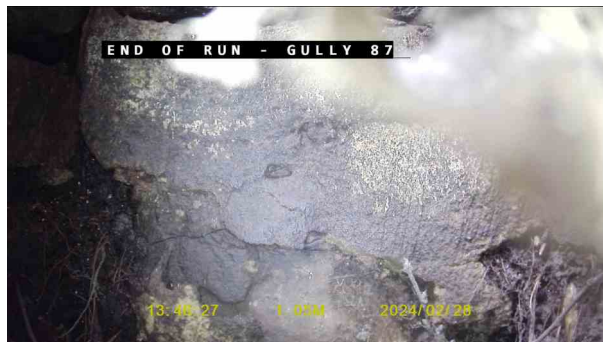
4b26d012-440d-49f9-9acf-45206912f23f.jpg, 00:00:28, 1.05 m  
Finish node, gully, reference: Branch A, Gully 87

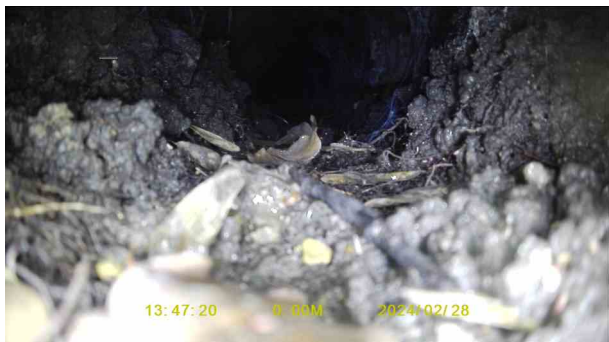
30f79e78-da89-42c6-84c5-4574d547f018.jpg, 00:00:08, 0.01 m  
Settled deposits, fine, 25% cross-sectional area loss, start

Comments:	
Recommendations:	Recommend HPWJ/Further investigation required

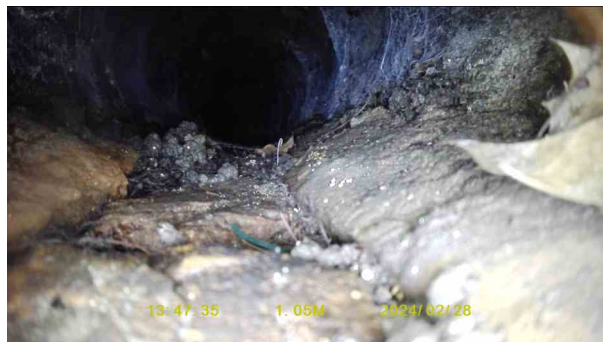
bd31d3c1-edec-4323-81ff-9816ca29f87c.jpg, 00:00:22, 1.05 m  
Displaced bricks, single brick false from 5 o'clock to 7 o'clock, start

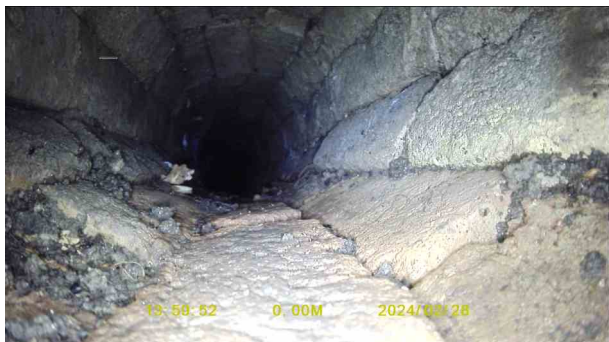
9daad588-bbf3-4842-9033-69c1b1e0e1ac.jpg, 00:00:09, 0.01  
m  
Displaced bricks, single brick false from 5 o'clock to 8 o'clock,

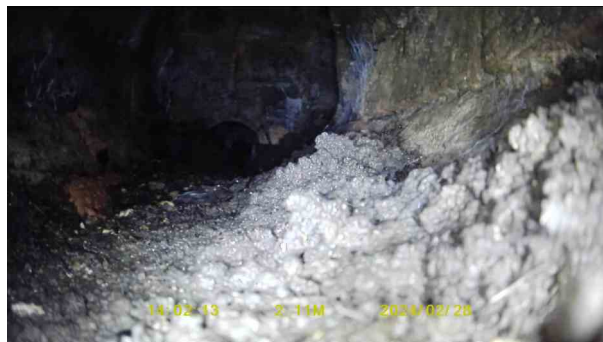
4e7e90c9-6055-4082-9f23-ab097ef6750d.jpg, 00:01:07, 2.11  
m  
Settled deposits, fine, 15% cross-sectional area loss

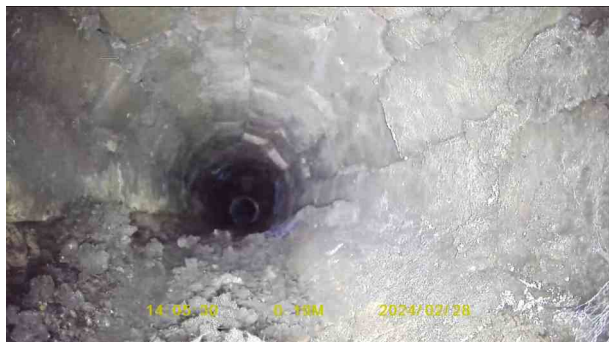
50f3a794-5c57-475e-ba55-f575440f4af4.jpg, 00:00:24, 0.19 m  
Displaced bricks, single brick false from 7 o'clock to 8 o'clock

Comments:	
Recommendations:	Recommend HPWJ

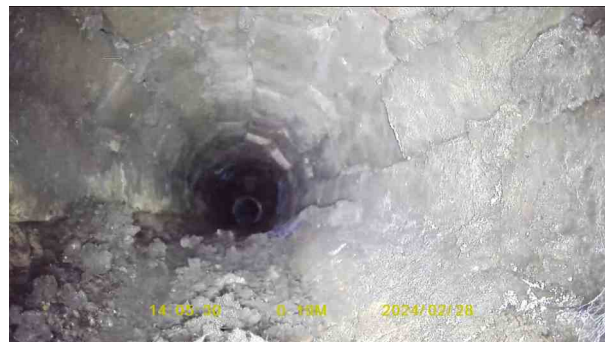
62f9f226-191d-46b7-b105-37053ebf86d5.jpg, 00:00:24, 0.19 m  
Settled deposits, fine, 15% cross-sectional area loss, start

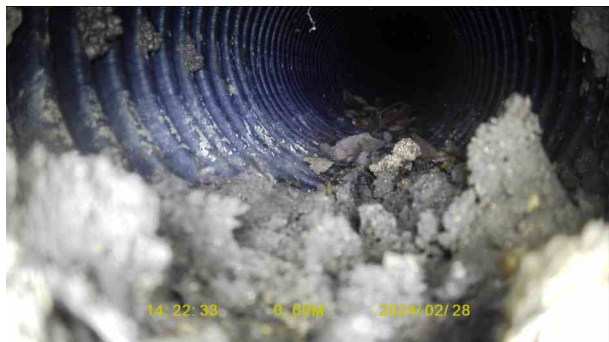
e2e8edde-2345-4477-b8a3-180d35a8a02e.jpg, 00:00:08, 0.01 m  
Settled deposits, fine, 15% cross-sectional area loss, start

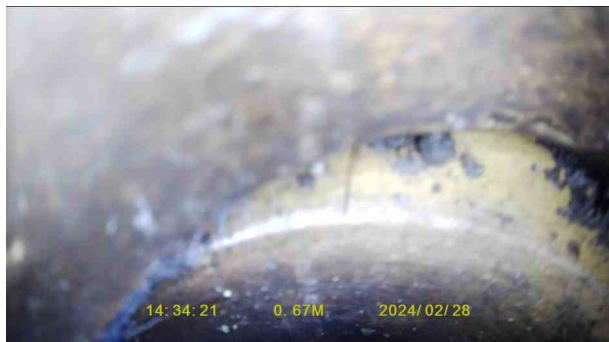
0e816eaf-fb99-41fb-bdc6-a8c9d913ec43.jpg, 00:00:25, 0.67 m  
Joint displaced, large, Just before blind junction

Town or Village:	Highgate	Inspection Direction:	Downstream	Upstream Node:	RWG92
Road:	Swains Lane	Inspected Length:	0.76 m	Upstream Pipe Depth:	
Location:		Total Length:	0.76 m	Downstream Node:	DOWNSTREAM
Surface Type:		Joint Length:		Downstream Pipe Depth:	
Use:	Surface water	Pipe Shape:	Circular		
Type of Pipe:		Dia/Height:	100 mm		
Flow Control:		Material:	Vitrified clay		
Year Constructed:	Not Specified	Lining Type:	No Lining		
Inspection Purpose:		Lining Material:	No Lining		
Comments:					
Recommendations:	Recommend LSR/Possible excavation

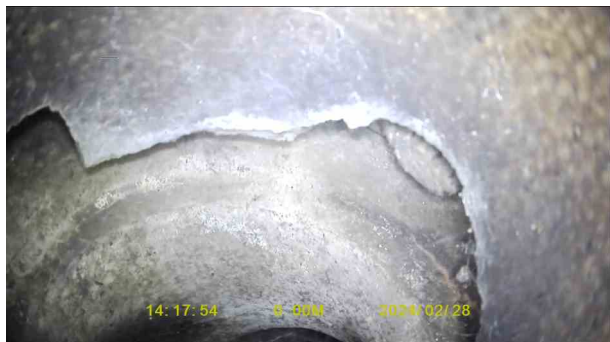
8f4116a7-56b5-4a17-b527-4a1083713b61.jpg, 00:00:07, 0.09 m  
Joint displaced, large

Town or Village:	Highgate	Inspection Direction:	Downstream	Upstream Node:	RWG89
Road:	Swains Lane	Inspected Length:	0.19 m	Upstream Pipe Depth:	
Location:		Total Length:	0.19 m	Downstream Node:	DOWNSTREAM
Surface Type:		Joint Length:		Downstream Pipe Depth:	
Use:	Surface water	Pipe Shape:	Circular		
Type of Pipe:		Dia/Height:	100 mm		
Flow Control:		Material:	Vitrified clay		
Year Constructed:	Not Specified	Lining Type:	No Lining		
Inspection Purpose:		Lining Material:	No Lining		
Comments:					
Recommendations:	Recommend excavation

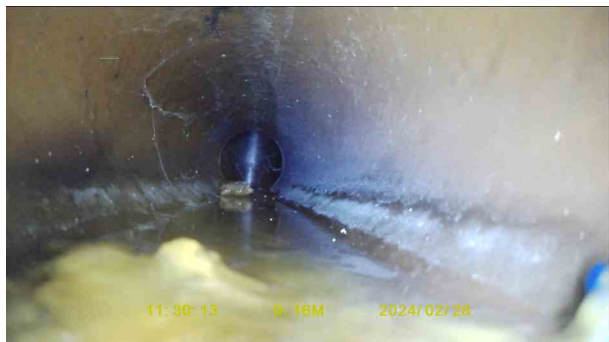
7f1e18e7-65cc-4e0b-8342-9da276334a4a.jpg, 00:00:13, 0.01  
m  
Settled deposits, fine, 15% cross-sectional area loss
