Project Name: Highgate Cemetery

Project Date: 06/03/2024

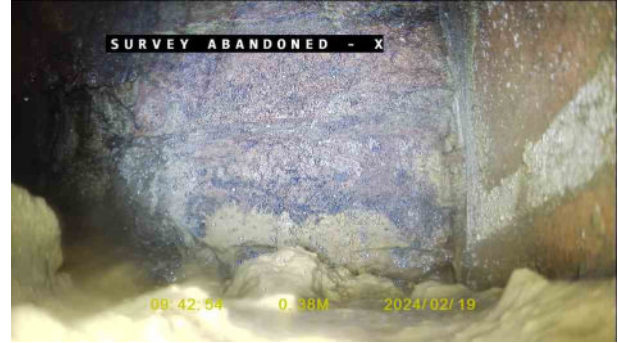
3c00efde-69b7-42c1-98b3-cf335e25a556.jpg, 00:00:26, 0.38
m
Survey abandoned, Further investigation required

Recommendations: Recommend HPWJ/Further investigation required

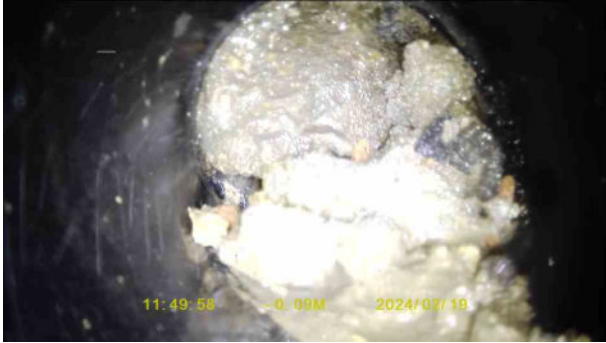
63c30535-253e-4492-9378-4942cecf6de7.jpg, 00:00:10, 0.09
m
Settled deposits, coarse, 90% cross-sectional area loss

Comments:
Recommendations: Recommend HPWJ/Root cut/Relining/Investigate possible bellies

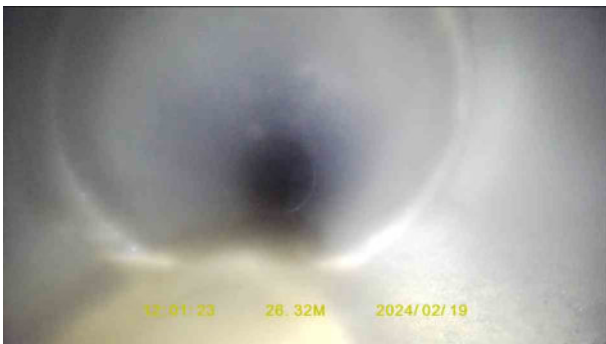
510d2746-6122-4fdc-ac3b-1094141f82cf.jpg, 00:03:03, 26.32
m
Joint displaced, large

Comments:
Recommendations: Recommend HPWJ/Root cut/Relining

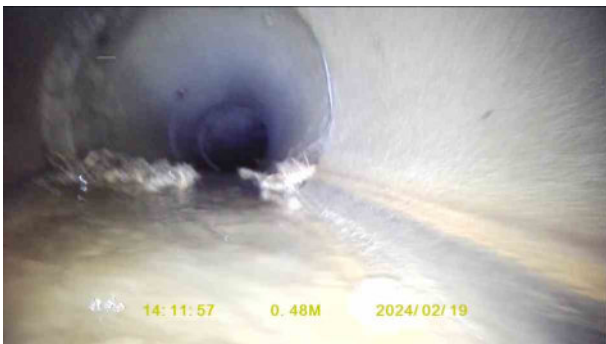
2e89adef-f018-4708-8a79-ba4d7296c35f.jpg, 00:00:12, 0.48 m
Roots, mass at joint, 20% cross-sectional area loss, start

Comments:
Recommendations: Recommend HPWJ/Relining/Resurvery

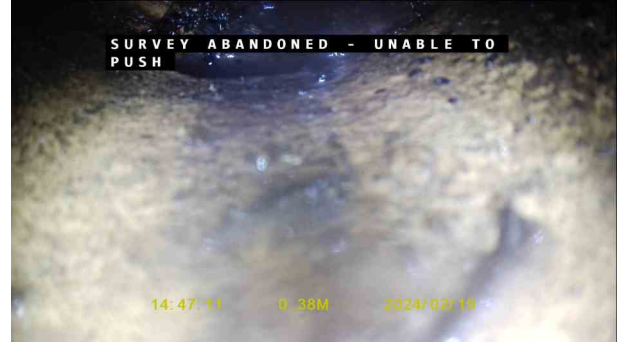
dc8cd36c-e0e8-45ce-b8dd-c6d740336fe6.jpg, 00:00:29, 0.38
m
Survey abandoned, Camera unable to pass JDL

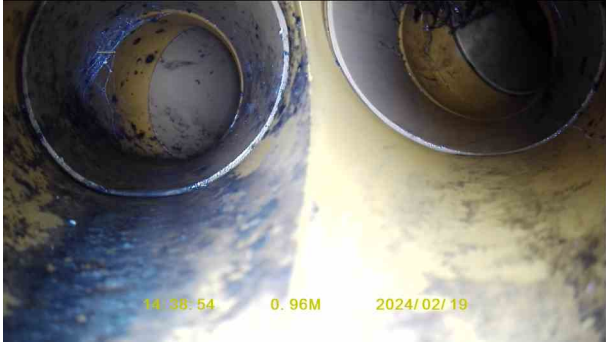
41f72c97-9439-41e7-b088-fc9b7d6f4cbe.jpg, 00:00:17, 0.96 m
Junction at 3 o'clock, 100mm dia

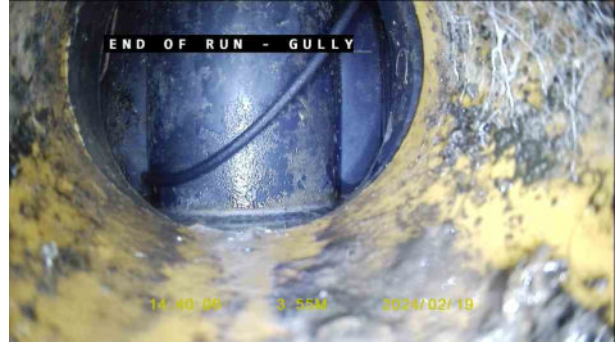
3cb6016e-00e2-42e6-84af-f0a38952b4d5.jpg, 00:01:19, 3.55 m
Finish node, gully, reference: Upstream

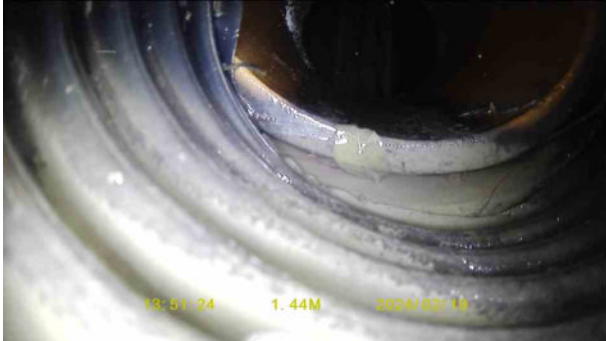
77433b44-5b3a-43c0-89b1-d2bb0d35f7f7.jpg, 00:00:17, 1.44
m
Joint displaced, large

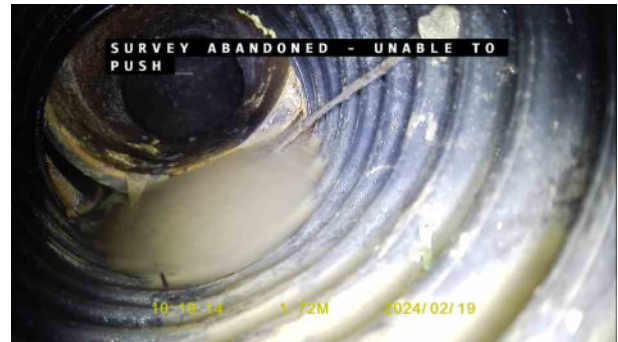
644f0a5a-3b8e-45d1-9ddd-94a4859114db.jpg, 00:00:58, 1.72 m
Survey abandoned, Camera unable to pass OJL/JDL

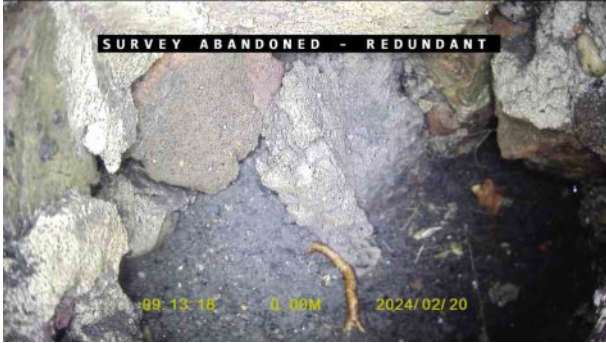
35029dbd-931a-4a6e-b368-7022e0edb8a7.jpg, 00:00:33, 0.01
m
Survey abandoned, Redundant

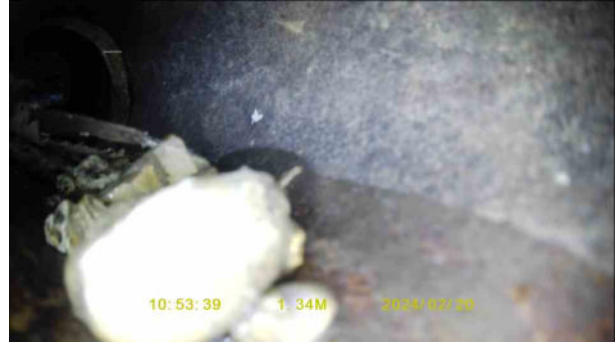
b1ec5c73-cb1b-4989-bafa-742f6e4b7188.jpg, 00:00:39, 1.15 m
 Settled deposits, fine, 20% cross-sectional area loss

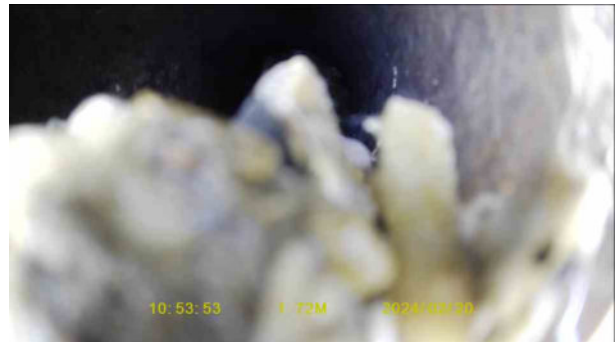
2972d6b0-2d48-4596-bb9a-7648fd527920.jpg, 00:00:47, 1.82 m
 Settled deposits, coarse, 30% cross-sectional area loss, start

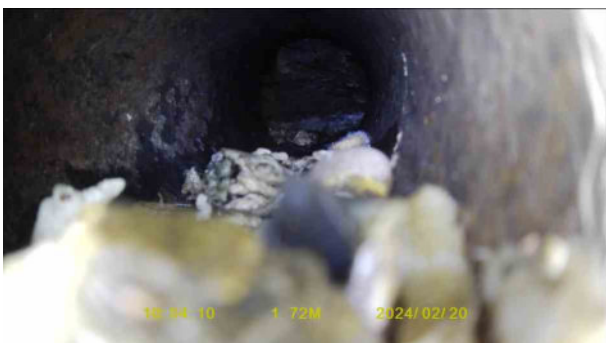
1dff81b8-6366-44e7-99e8-c7580857e882.jpg, 00:01:04, 1.82 m
 Survey abandoned, Camera unable to pass debris

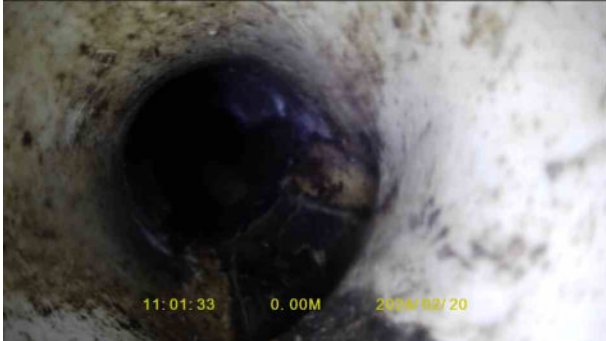
11f4fc9c-ba19-4aad-aca7-5fdd34d41401.jpg, 00:00:08, 0.09 m
 Junction at 6 o'clock, 100mm dia, Backdrop

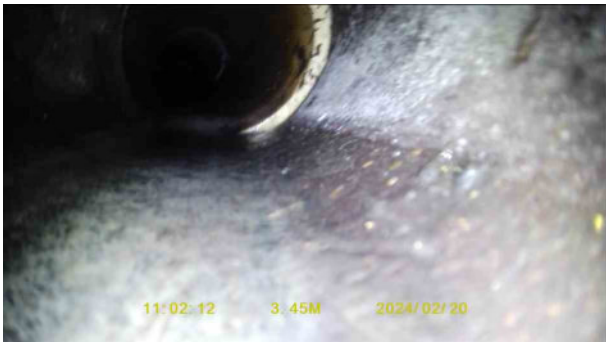
81136733-b89d-435f-a60c-a6bc873af195.jpg, 00:00:46, 3.45 m
 Joint displaced, medium
