**STATEMENT OF HERITAGE SIGNIFICANCE
10 REGENT'S PARK TERRACE, LONDON NW1**

**For
Mr Godeau & Ms Gastaldo
December 2016**

G R Bennett BA MA DipTP IHBC

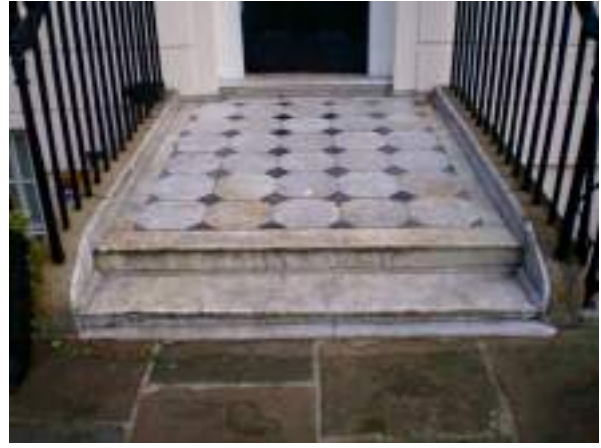
Steps and landing detail. Non-original marble tiles and step cladding. No Significance. Harmful modern alteration.

- On the pavement vaults' wall, rerun the white plastic plume pipe and the condensate pipes internally to reduce their visual impact and paint their outlets to match the wall.
- Remove the marble cladding and tiling from the front entrance steps and landing and reinstate the steps in Portland stone and the landing in York stone using large slabs to the original design.
- Remove the basement build-out of the kitchen area under the front entrance bridge and reinstate the wall in line with the bridge. Replace the front basement entrance door with an appropriately detailed four-panelled door with flush panels with butt and beaded edges externally and flat recessed panels with no mouldings internally.

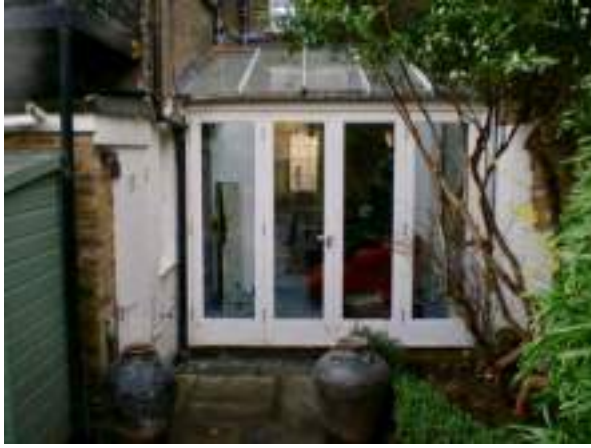
Modern Conservatory. No Significance. No architectural merit. Harmful modern alteration.

- Replace the basement rear conservatory with a more attractive one in a period design with doors that match the design and detailing of the first-floor half-landing French doors.

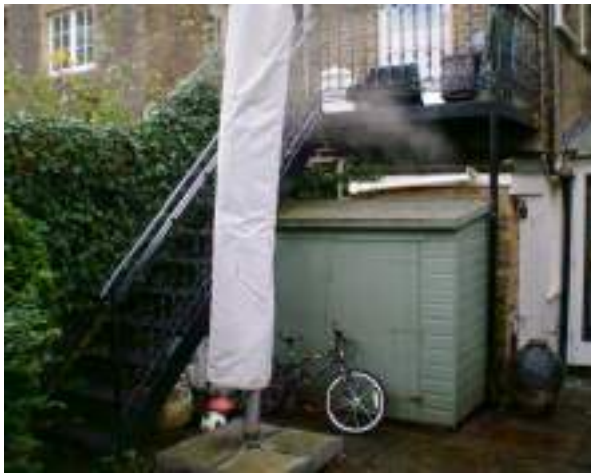
Modern decorative iron stairs and balcony. No Significance.

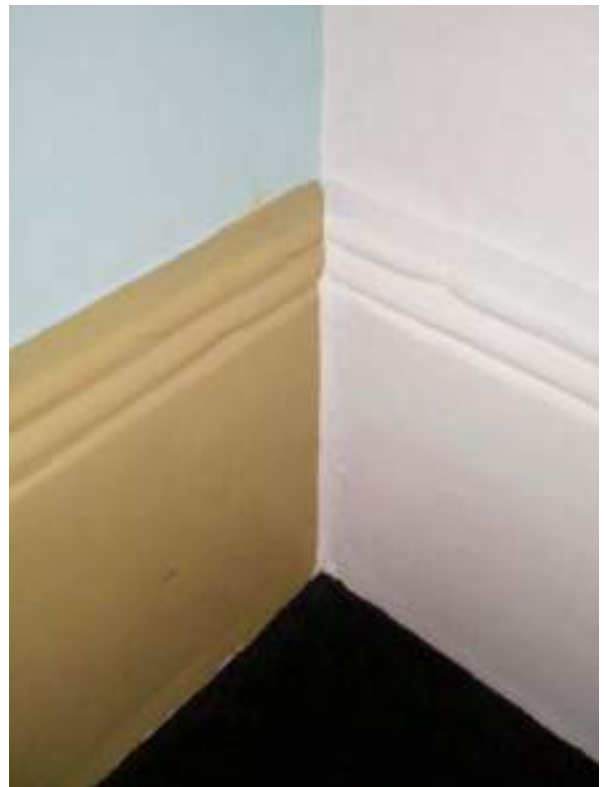
Detail of first floor landing's original skirting boards - High Significance.

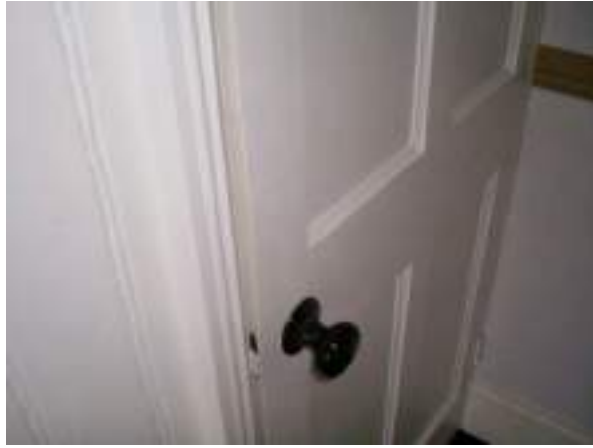
Second floor landing. Airing cupboard - Harmful modern alteration.

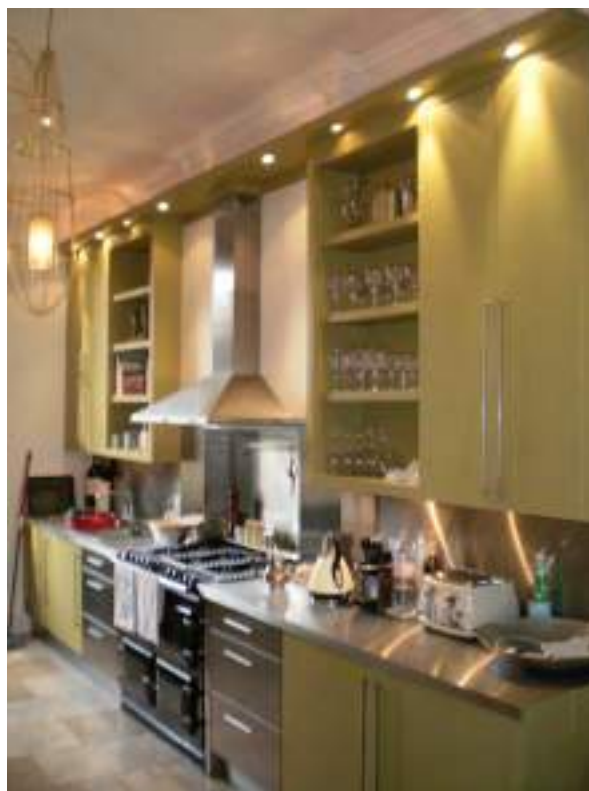
Ground floor front room. Fireplace and face of chimneybreast removed and aga inserted - Harmful modern alteration.

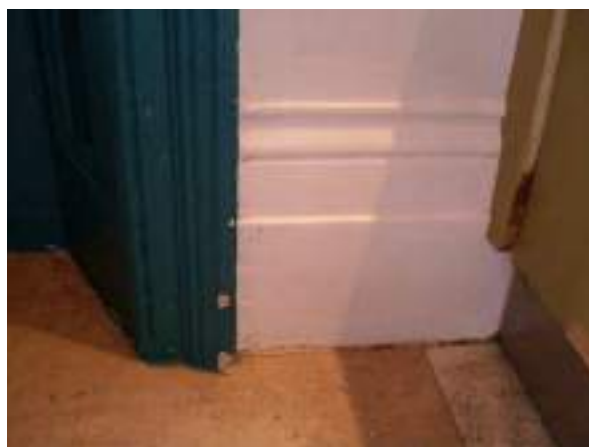
Ground floor front room. Detail of original window architrave and skirting board - High Significance.

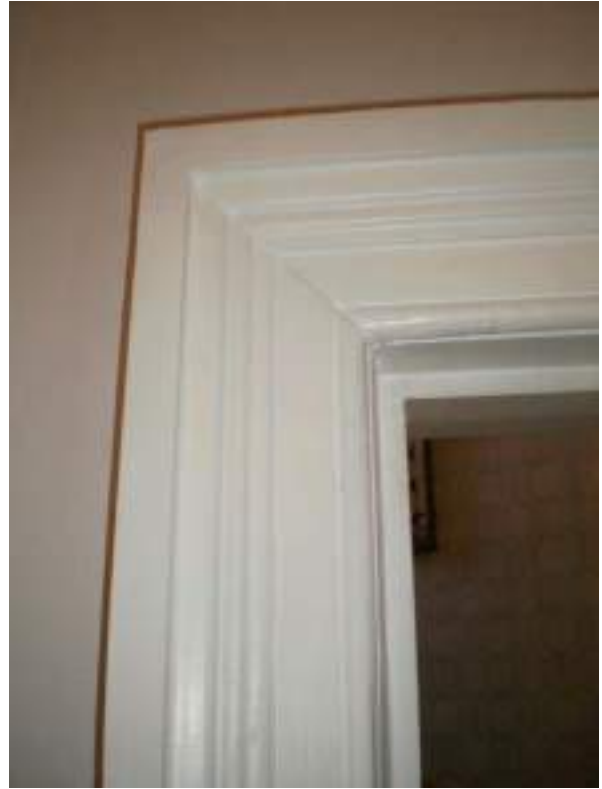
Ground floor rear room. Door architrave a modern restoration - No Significance, but high architectural merit.

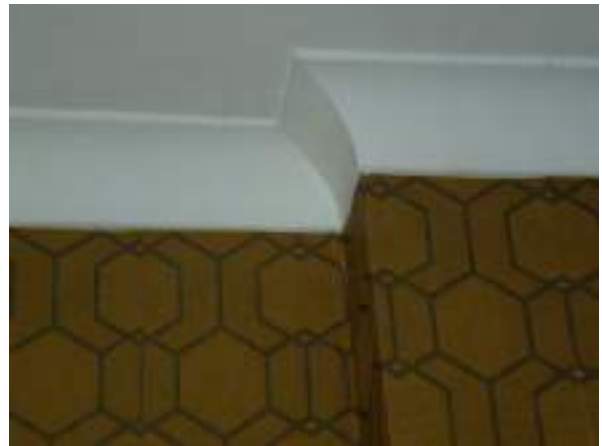
Ground floor rear room. Modern ceiling coving - No Significance. Harmful modern alteration.

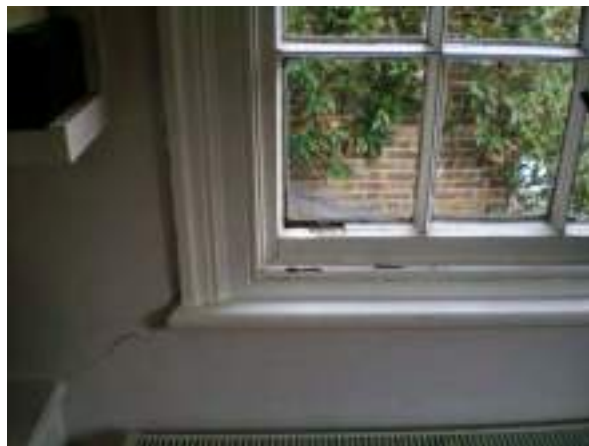
Ground floor rear wing. Window detail. Original architrave - Medium Significance.

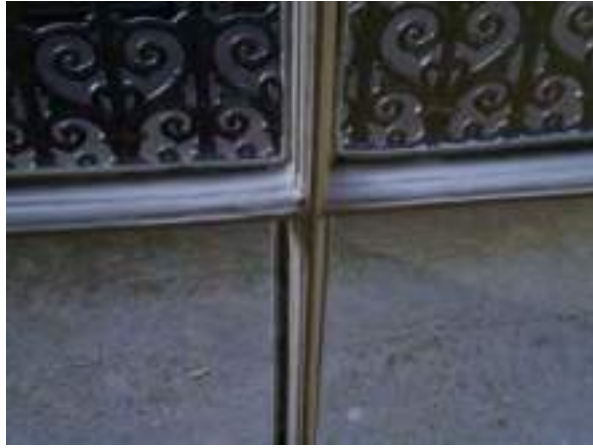
First floor front room. Non-original long ovolo window joinery detail - No Significance.

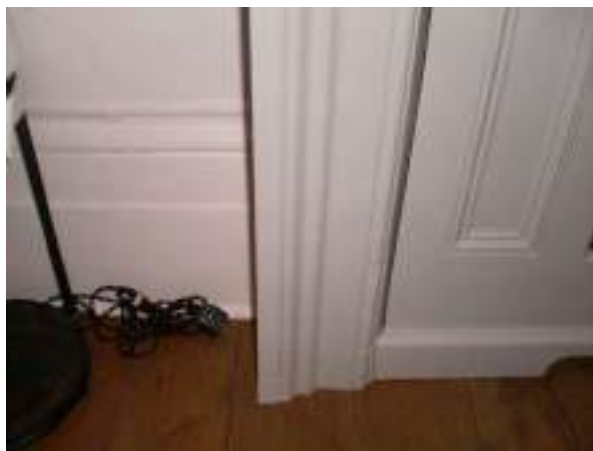
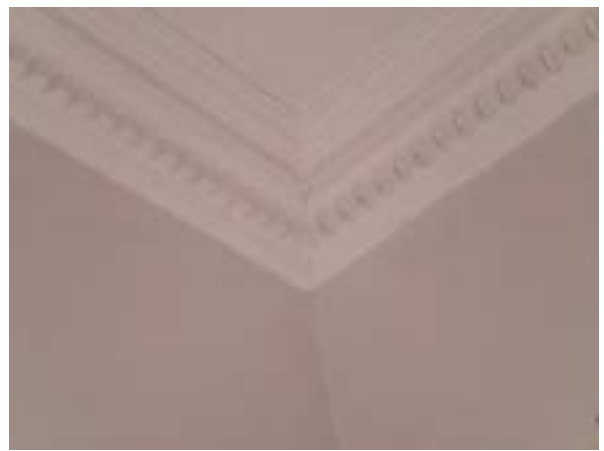
First floor front room. Original skirting board - High Significance. Radiator cabinet - No Significance.

First floor front room. Non-original period ceiling cornice - No Significance. Medium architectural merit. Good quality and worthy of retention.

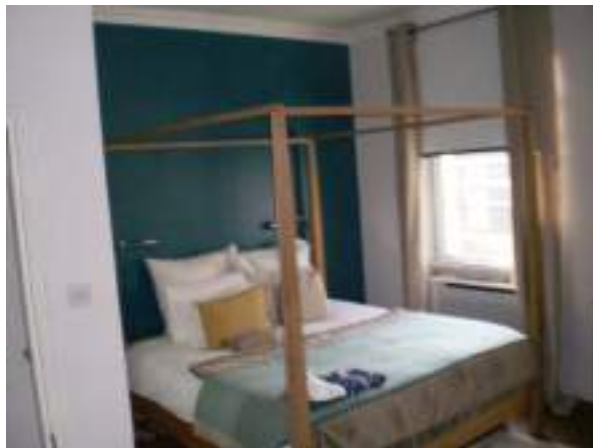
Second floor front room. Room proportions and layout compromised by alterations to partition wall and door and built-in wardrobes. Overall - Medium Significance.

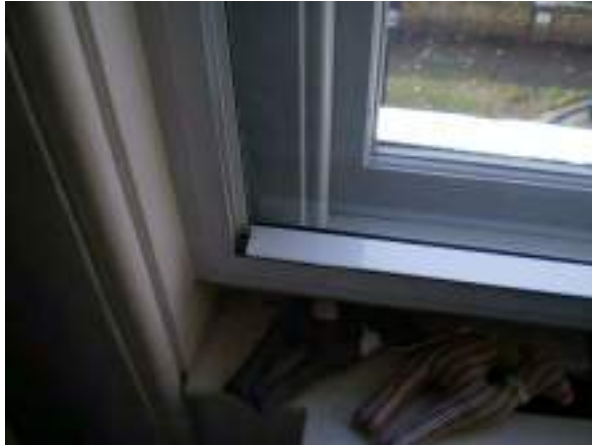
Second floor front room. Window sashes with non-matching ovolo mouldings. Secondary glazing.

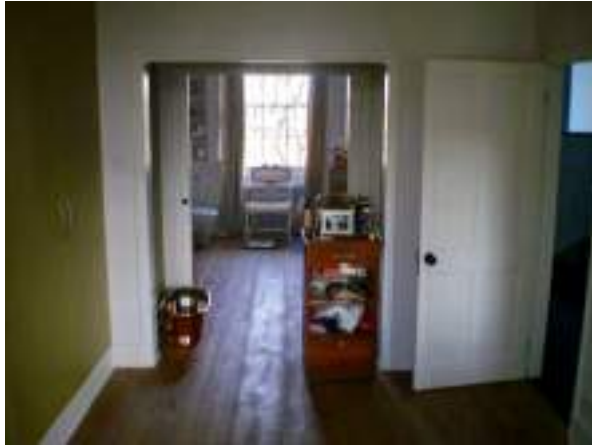
Second floor, view through into rear room. Modern arch. Harmful alteration.

- Reinstate the missing entrance door to the first floor front room to match the originals.
- Install pair of doors in archway between front and rear rooms on the second floor to match the original doors.

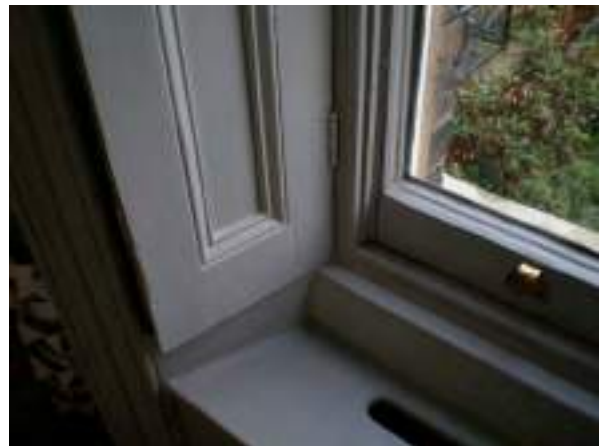
Second floor rear room. Original window shutters and window joinery - High Significance.

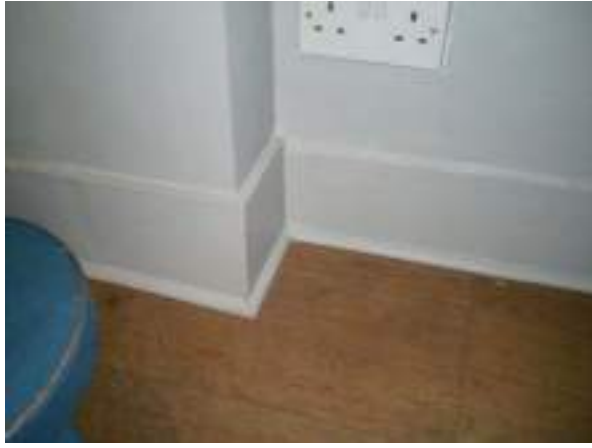
Third floor front north room. Original skirting board in recess - Low Significance. Modern skirting board around chimneybreast not an exact match.

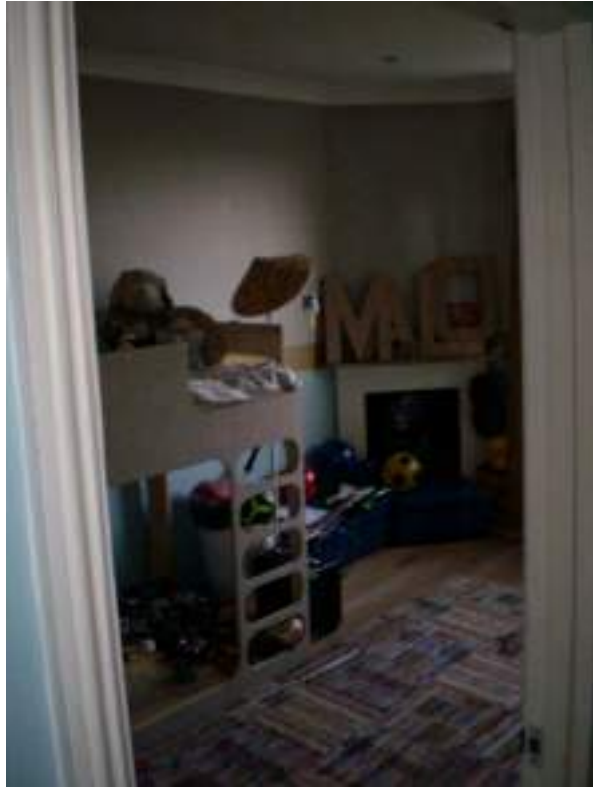
Third floor rear north bedroom. Overall - Low Significance. Modern cornice and spotlights - inappropriate modern alterations.

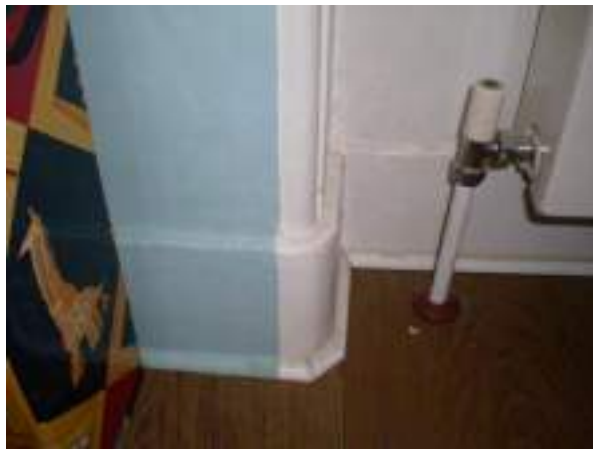
Third floor rear north bedroom. Original skirting boards - Low Significance

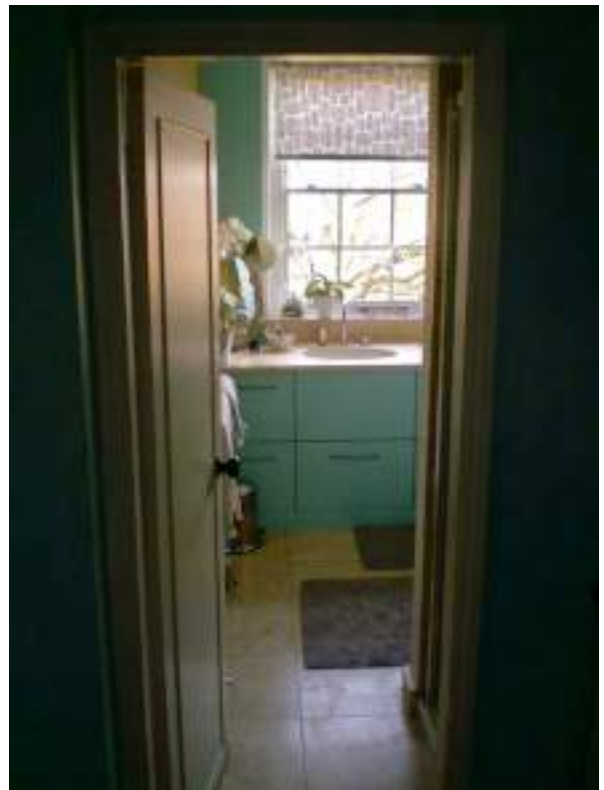
Third floor rear south bathroom. No original features remain. Negligible Significance.
