ACLAND BURGHLEY SCHOOL
CONSERVATION & HERITAGE REPORT

INTRODUCTION

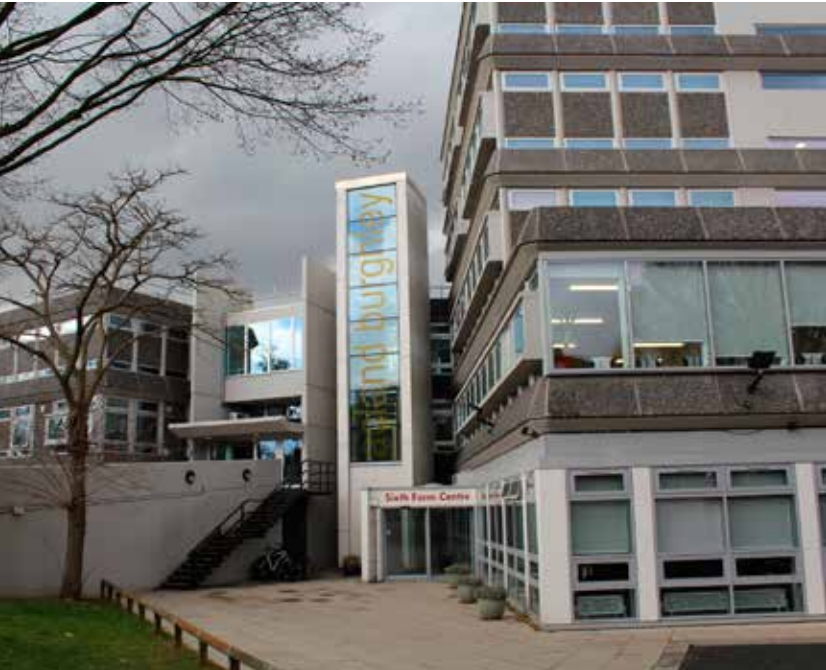
4.2 View from the south side lower level showing distinctive precast concrete cladding panels to the elevation and recent replacement aluminium windows to the main school building.

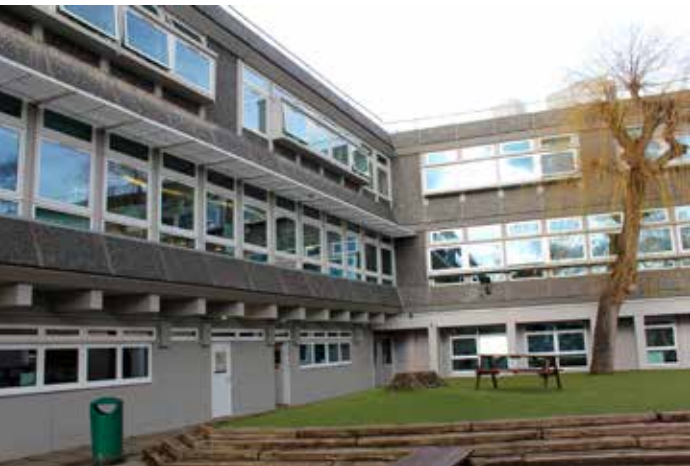
4.5 Existing main school building showing the recent replacement glazing, distinctive double layered windows (right) and iconic pre-cast concrete cladding units. Howell Killick, Partidge and Amis made excellent use of the expressive qualities of pre-cast concrete throughout their oeuvre.

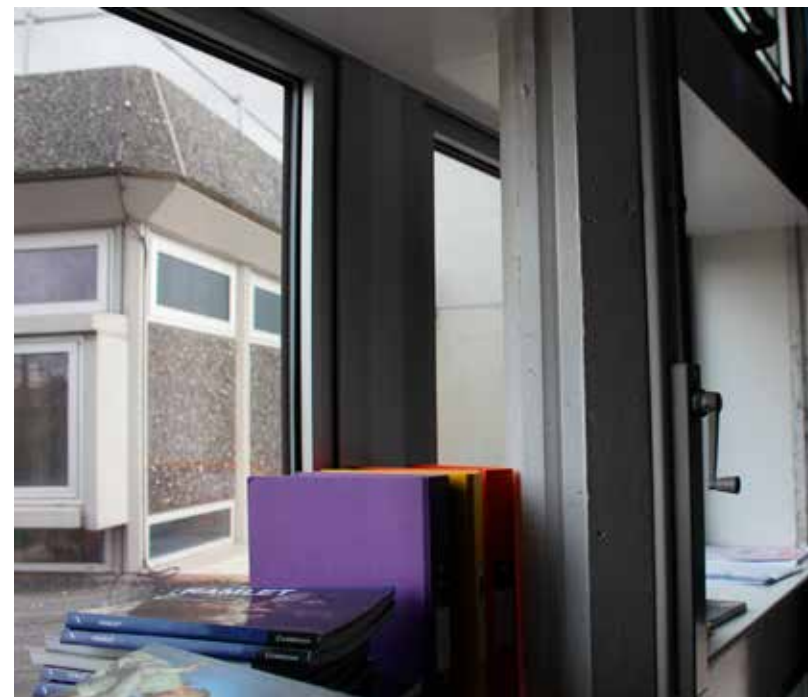
6.5 The distinctive double window design seen from inside a classroom. Although the original windows have been replaced, the original configuration and useful, deep cill remain.

16. Replacement pipework within the classroom services voids, including replacing the panels that the radiators are fixed to below the windows.
17. Replacement of the sub-mains distribution boards and electrical rewires which will require new PVC tubular conduit and PVC dado trunking to classroom areas.

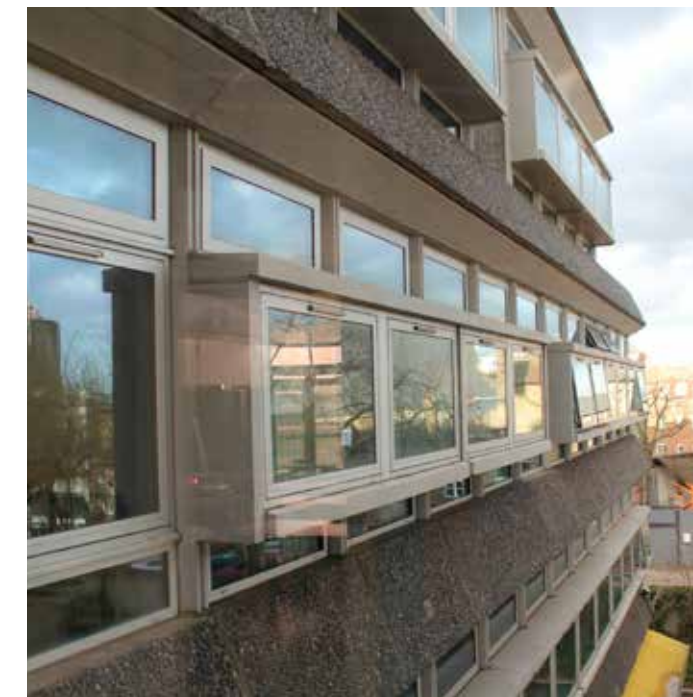
6.6 The double window design seen from the exterior. The original projecting service conduit still remains below the windows at each level. This technical drawing (*above right*) shows how the hot water pipes to serve the radiators were cleverly concealed in this purpose designed feature. *For full technical drawing see appendix 2.*

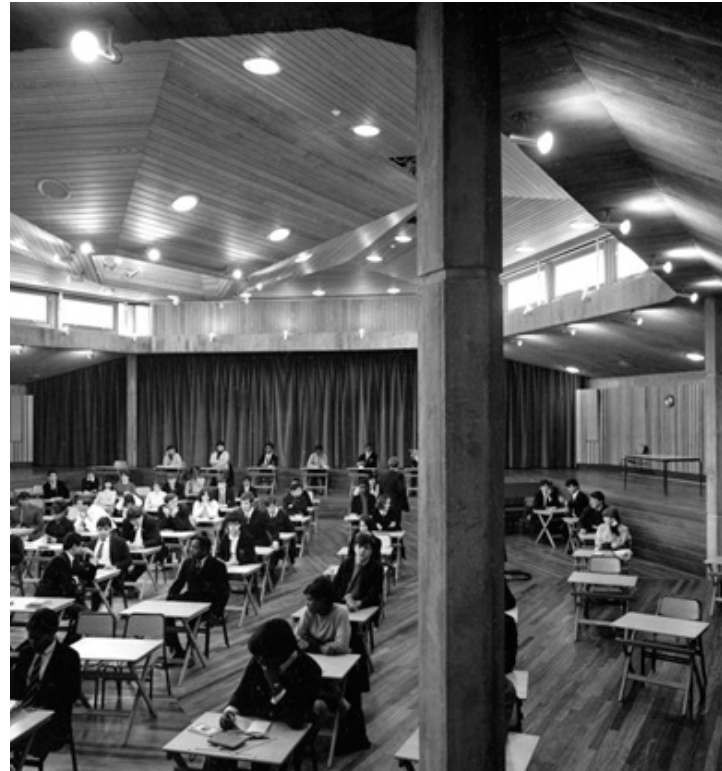
8.2 This photograph shows the main internal volume of the assembly hall. Note the original flush-fitting down lighters integrated into the timber ceiling. These are now sadly lost, leaving behind the empty holes we see today. Also visible are the stainless steel angled lighting to the periphery and the skylight surround.

Whilst not included in the current proposed scope of works, we see huge potential for incremental enhancement of the heritage assets through the removal of insensitive accretions, such as the recent Assembly Hall lighting, and the repair of original features. These could include inset lighting, and the timber battens around the periphery, while deleterious alternations such as the wall view holes could be ameliorated through sensitive design.

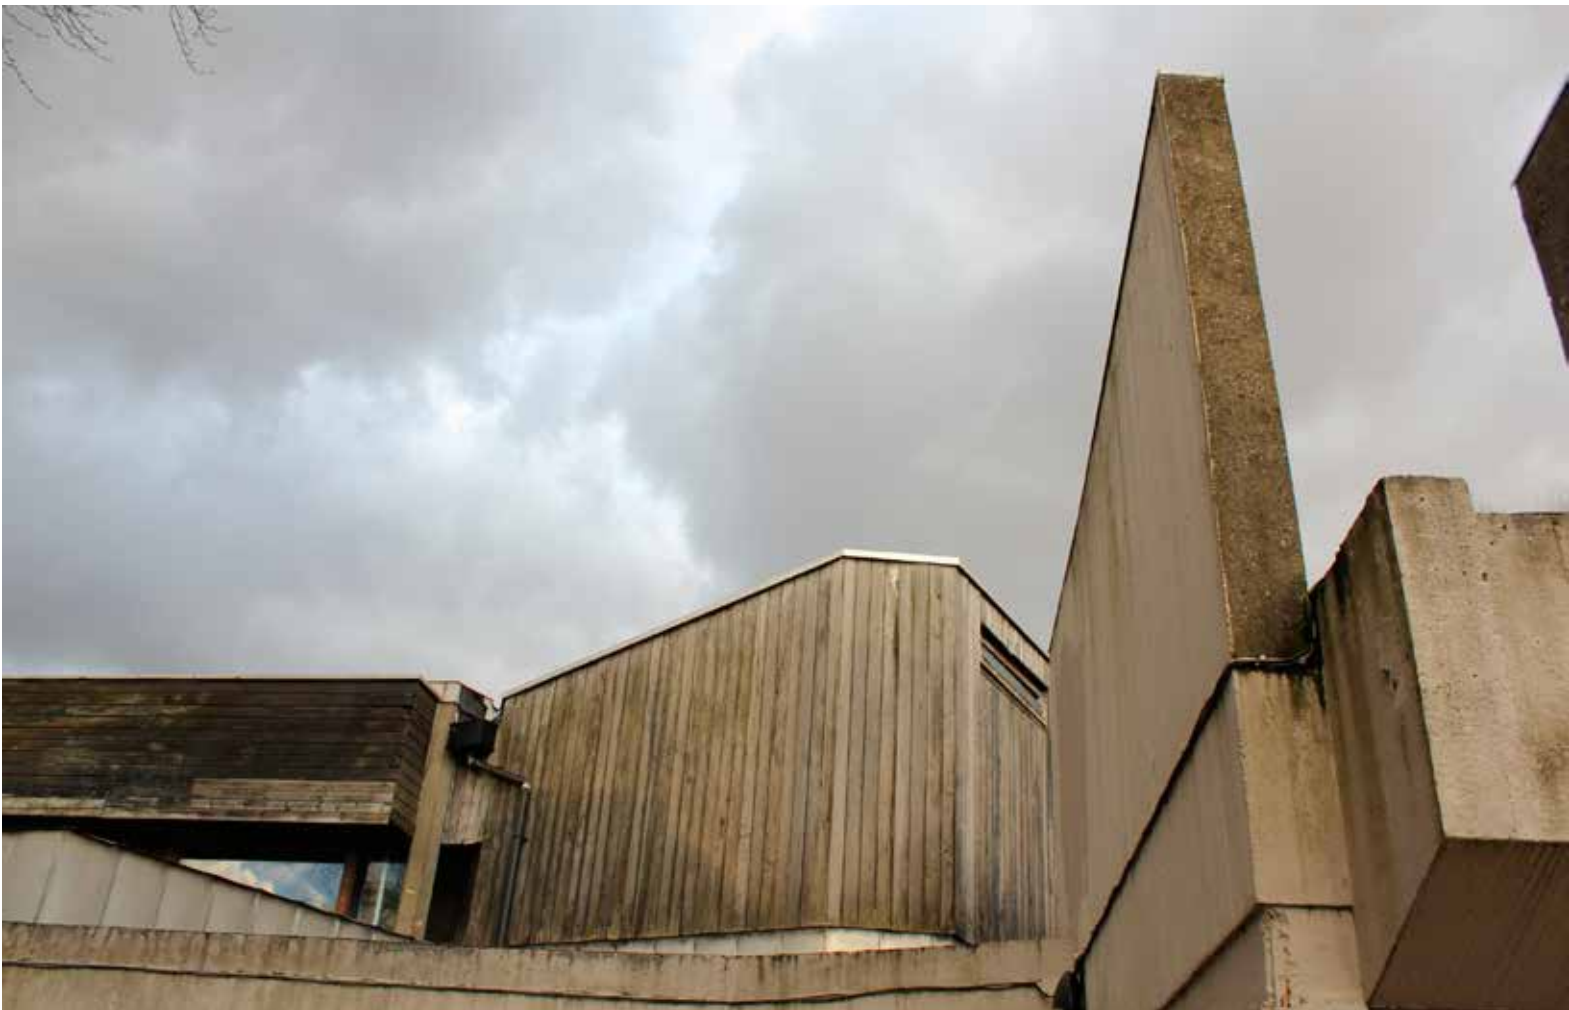
9.1 An external view of the assembly hall upper level. Visible is the simple palette of materials used throughout the building; concrete, timber, glass and aluminium. The distinctive timber-clad form in the centre of this image is the flytower, over the main stage area.

9. The timber cladding at roof level and fly tower of Assembly Hall - partial replacement of decayed timber and re-varnishing. Varnish to complement wooden surrounds of clerestory windows.

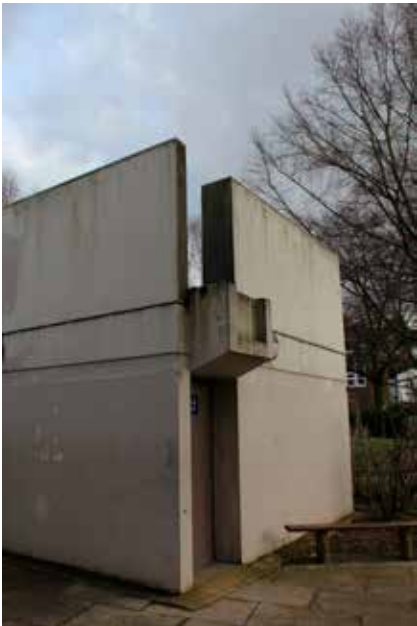
9.4 To the rear of the assembly hall is an entrance to the textiles room, previously the drama studio.

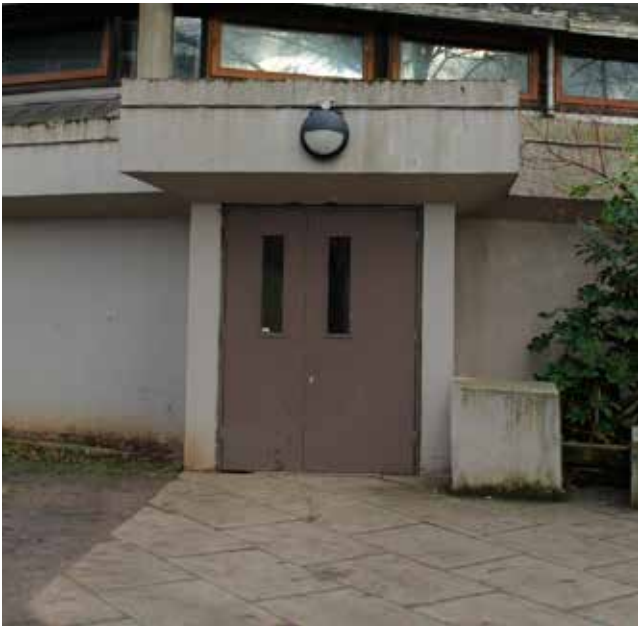
9.6 The original timber doors survive to the assembly hall.

4. Replacement rooflights to circulation corridors in Assembly Hall - replacements to duplicate polycarbonate originals.
5. External Fire Escape Doors to Assembly Hall - Overhaul 4 No. existing painted timber emergency exit double doorsets - reference drawings and pictures of originals, consider reinstating original external handrails (now lost). Research and duplicate the original paint finishes.

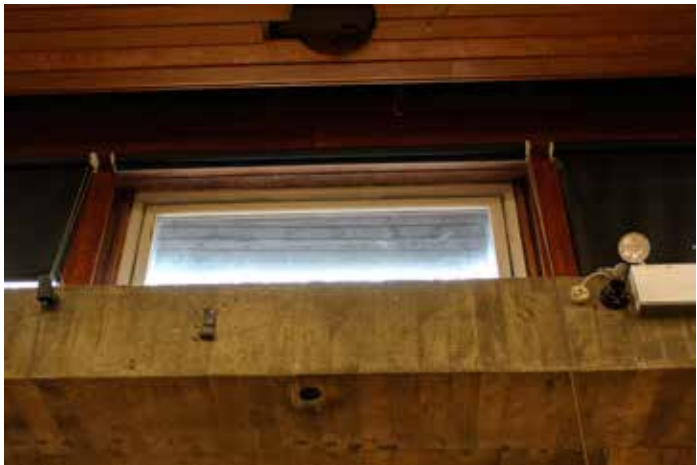
10.3 A close up view of one of the timber clerestory windows.

3. Clerestory Windows to Assembly Hall - refurbish and add new blinds/opening mechanisms - retain the glazing units rather than replace, ensure new mechanisms complement the original building design.

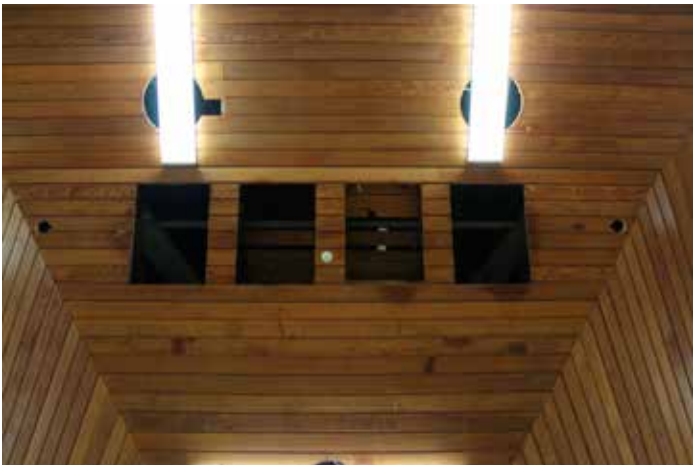
10.4 The original rectangular stage lighting apertures.

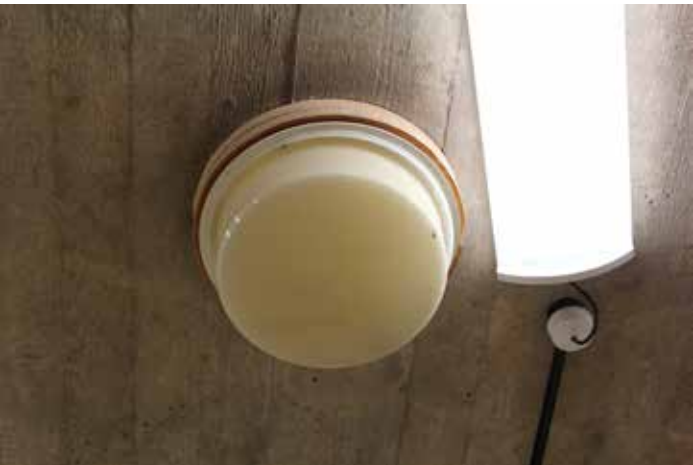
10.5 Round ceiling lamp next to modern strip lighting.

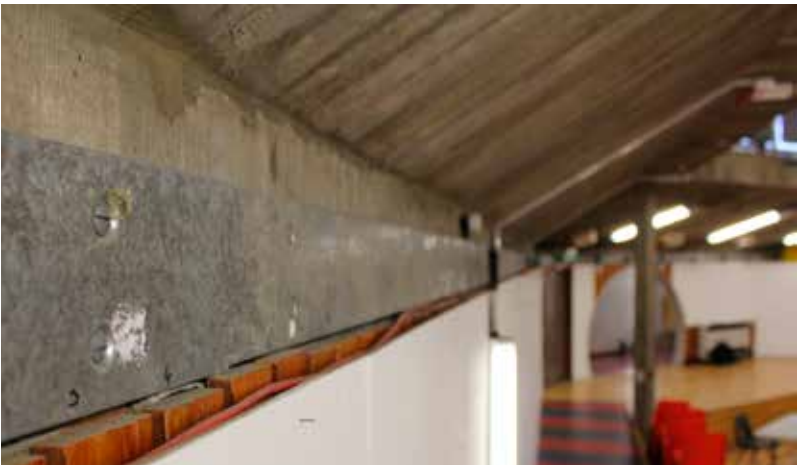
10.6 The original timber cladding to the internal periphery survives behind modern white boarding.

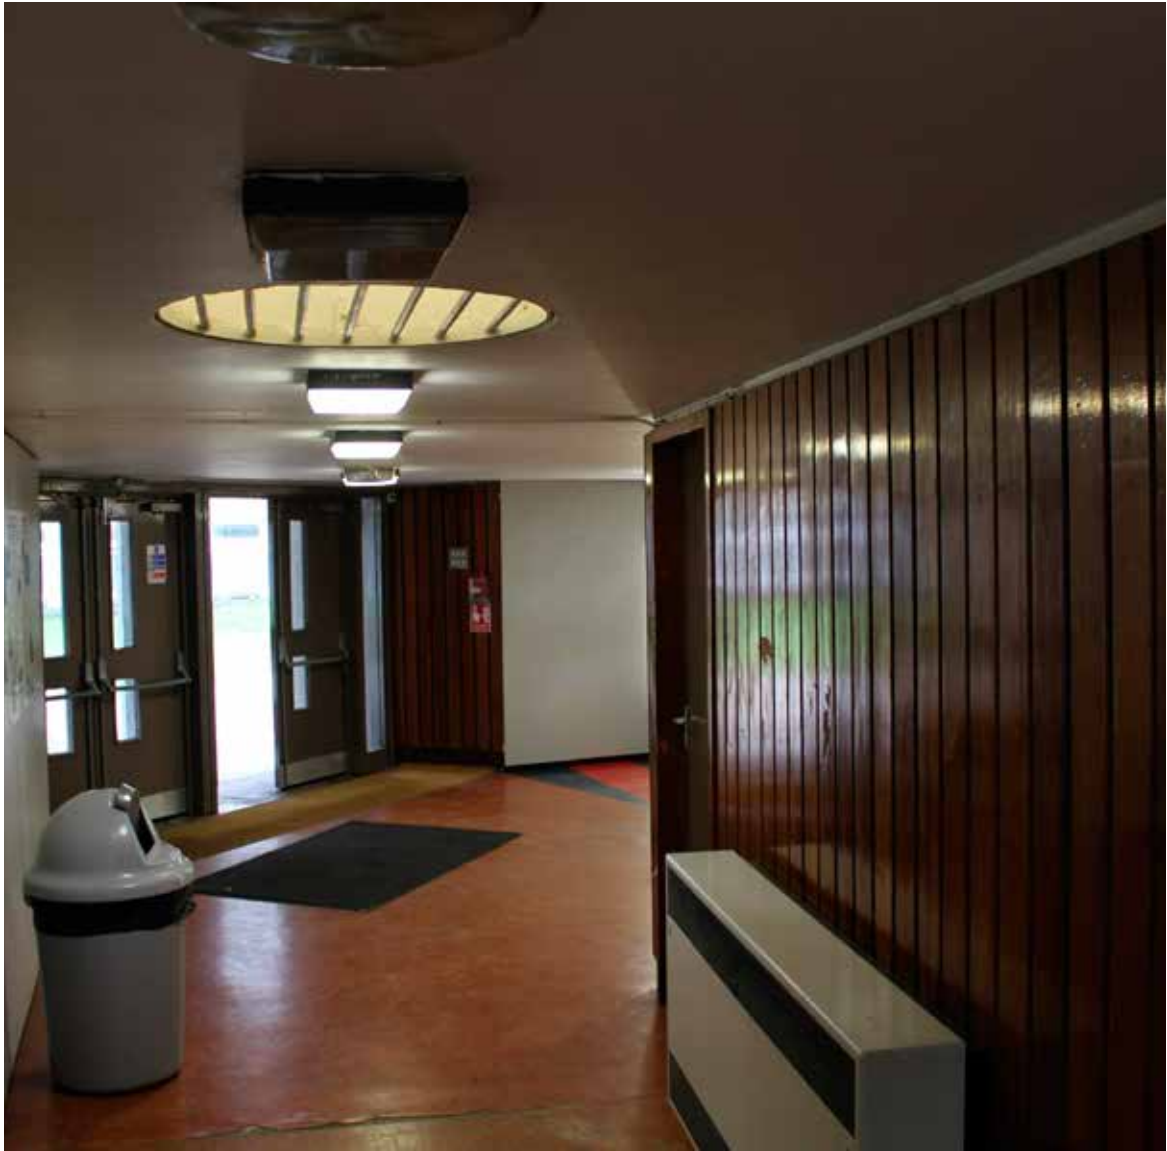
11.2 A view toward the original main entrance doors of the assembly hall. Circular sky-lights to the ceiling and varnished timber cladding to the projection room to the right.

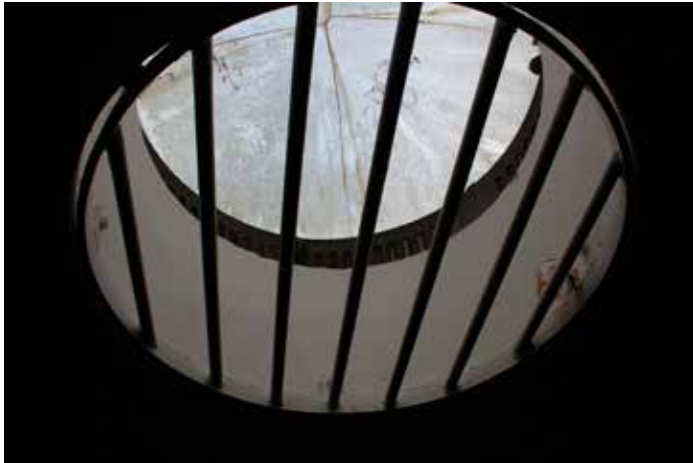
11.3 View of one of a series of domed skylights to the circulation corridor.

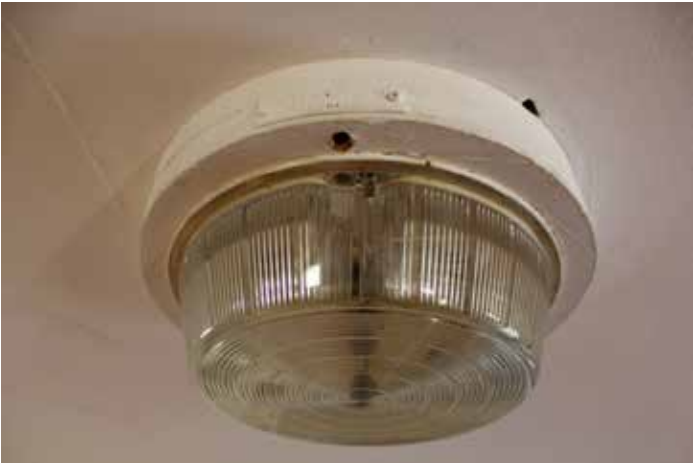
11.4 Existing corridor lighting.

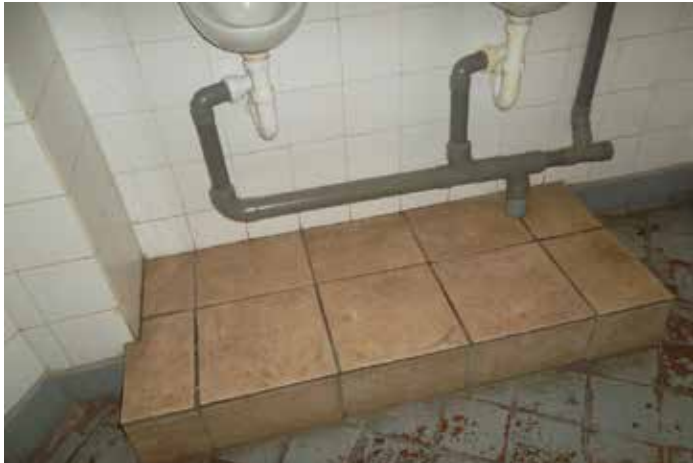
12.3 Modern plastic piping and plinth to the urinals in the boys toilet.

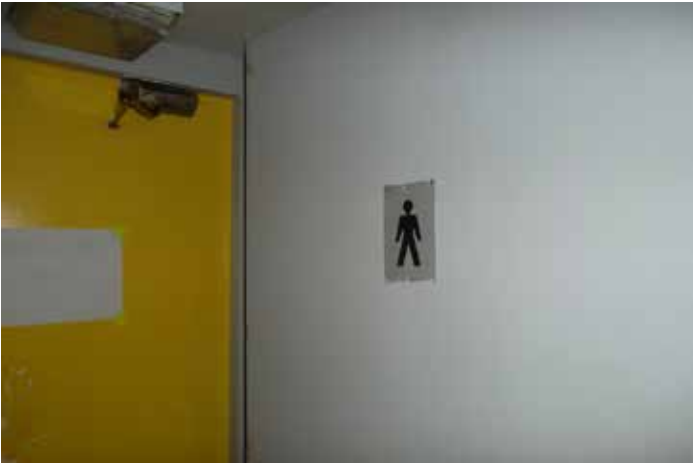
12.4 The original door signage should be retained where possible.

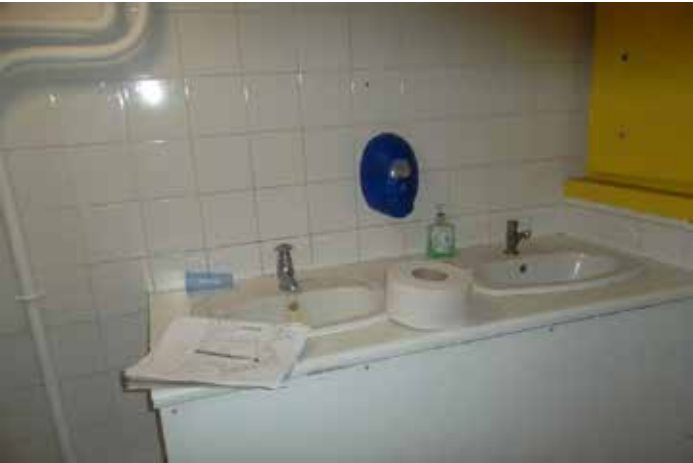
12.5 Modern sink unit with original white glazed tiles behind.

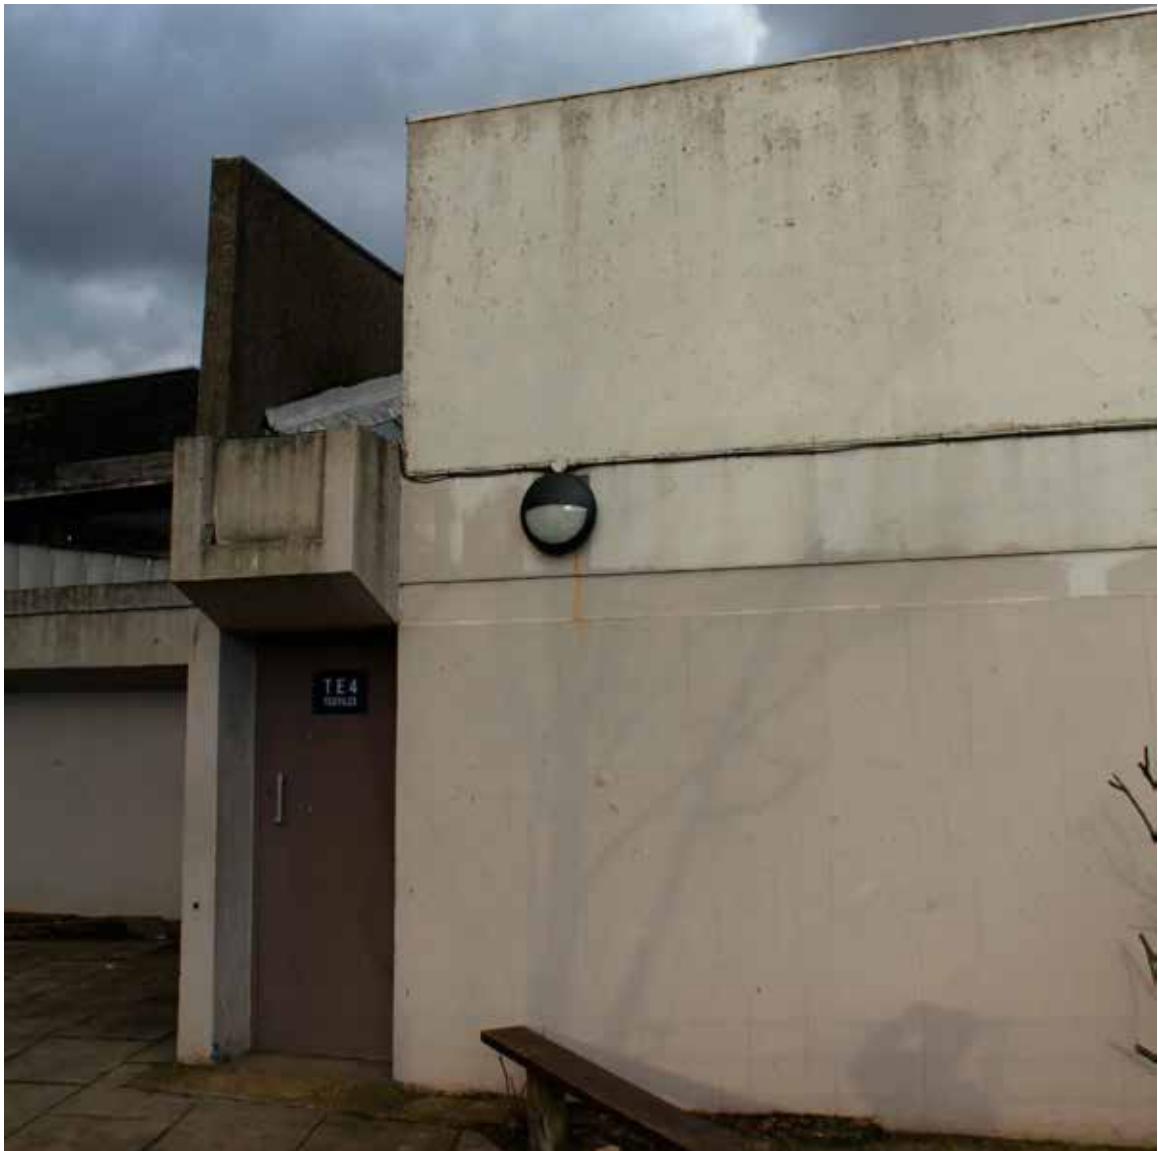
13.1 The entrance door to the former drama studio - later textile room is located toward the rear of the assembly hall complex.

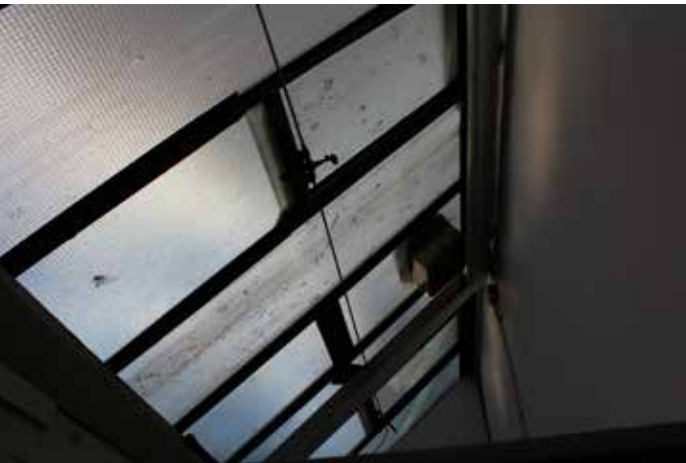
13.4 A view of several existing skylights with the blind retracted.

2. Replacement Patent Glazed Roof and Valley Gutter Linings to Textile Classroom (former drama studio) - new double glazed roof to a design matching the original, with aluminium frames to match the original finish.

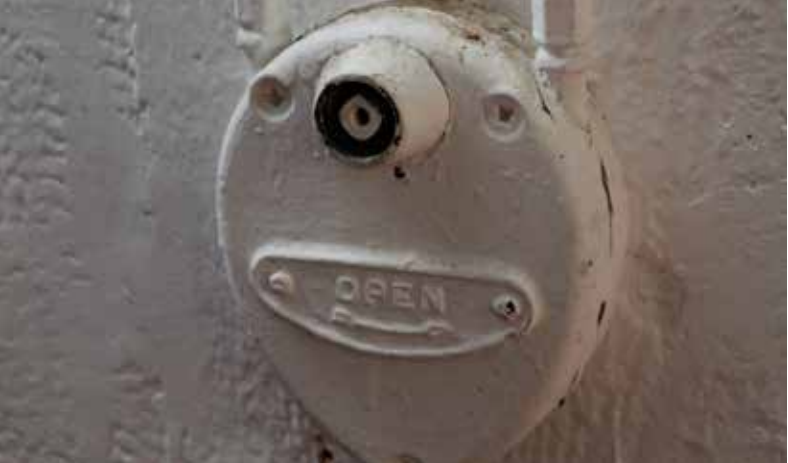
13.6 An original ventilator opener crank to operate the skylights above.

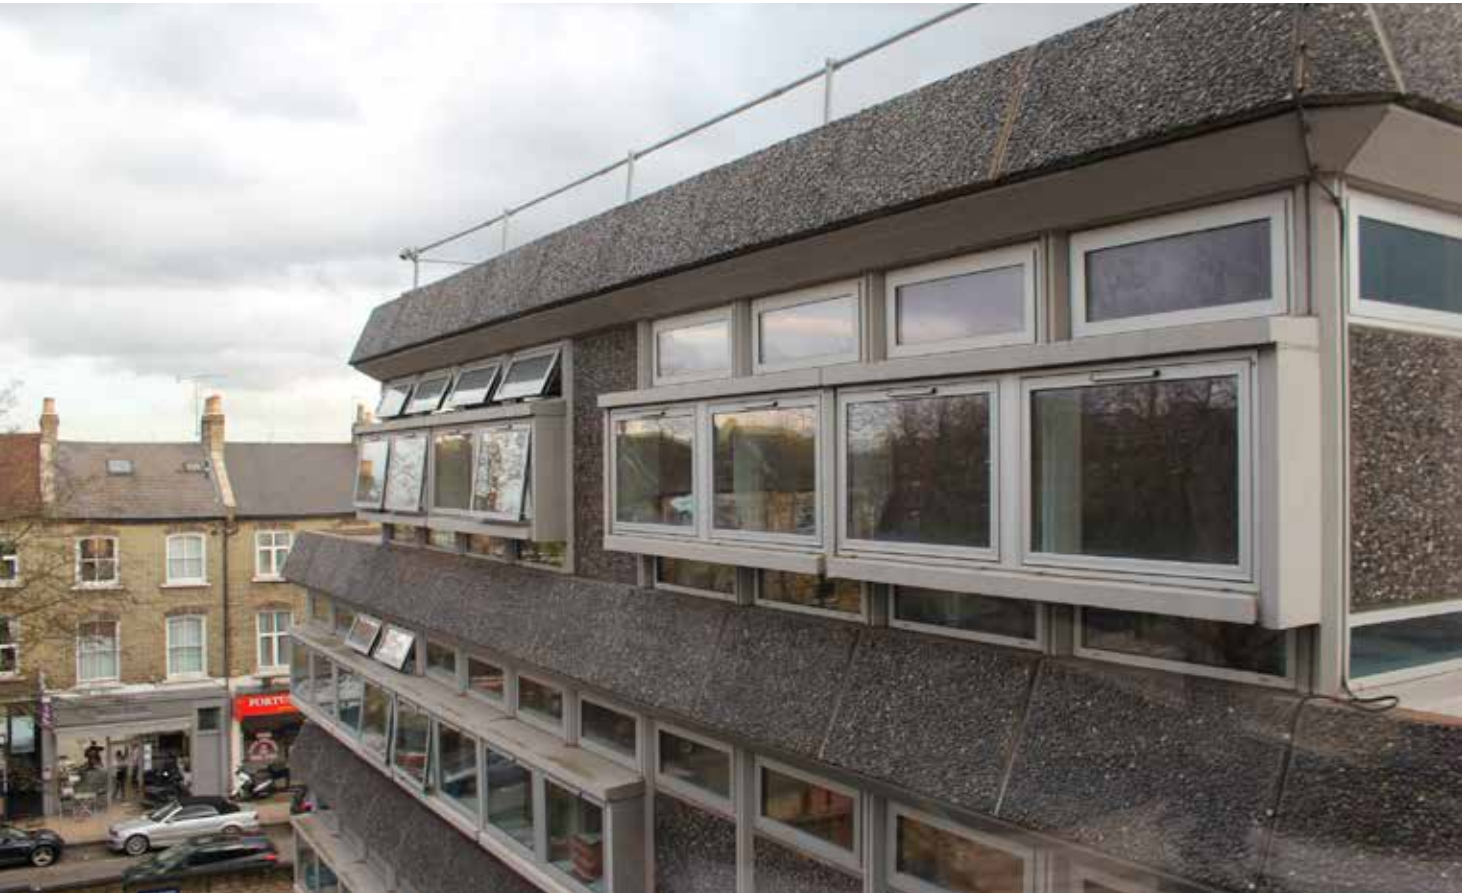
14.1 An external view of a series of classrooms in the main building. The original projecting services conduit, constructed from pre-cast concrete panels, still remains below the windows at each level. The services void cleverly conceals the hot water pipes that serve the classroom radiators, situated directly underneath the windows to the periphery.

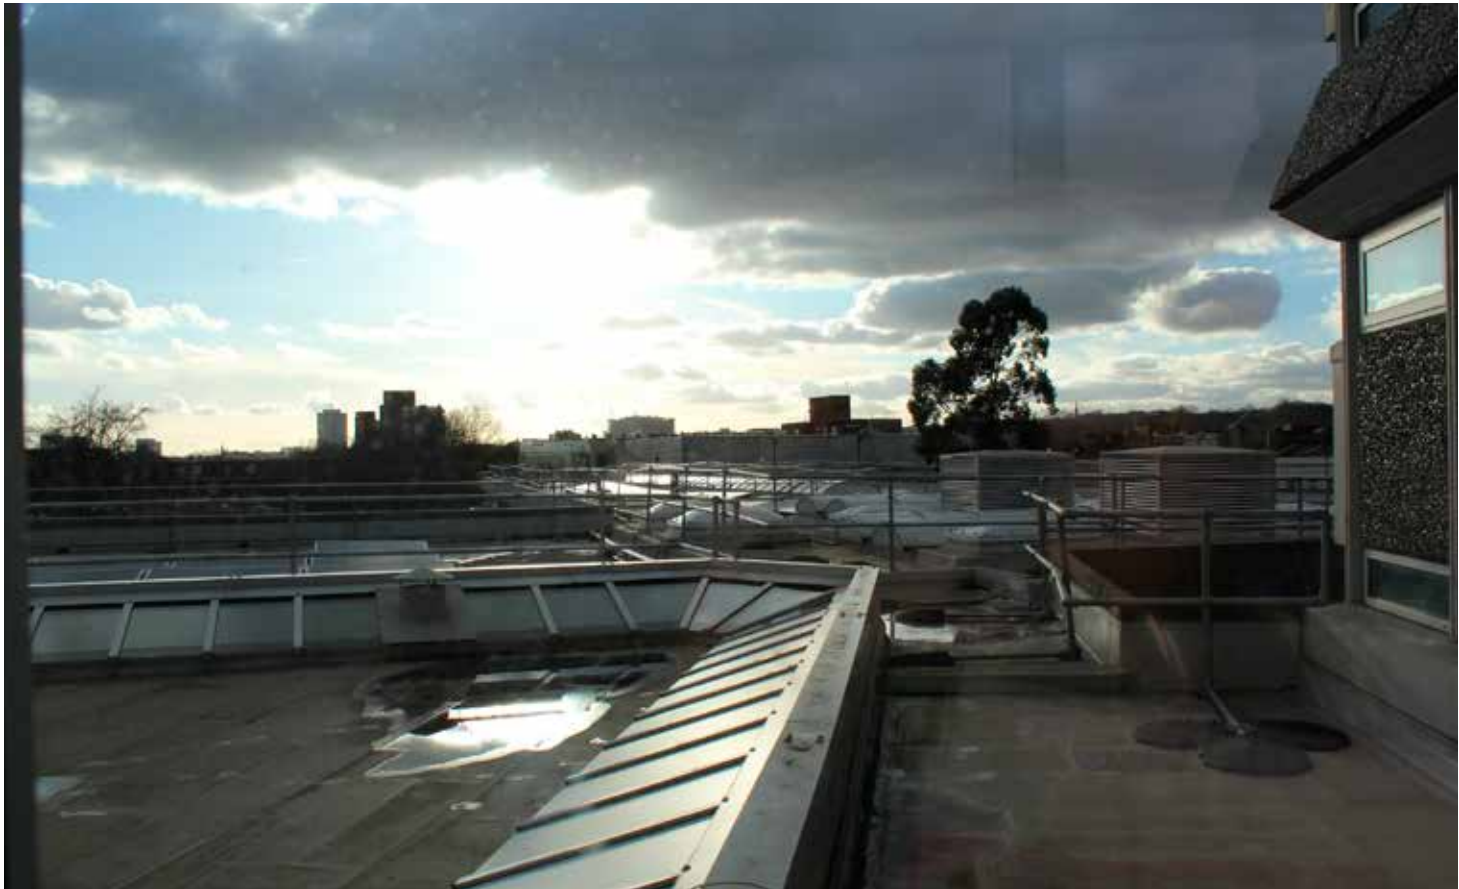
14.2 The flat roof deck above the art room with the continuous skylight to the periphery.

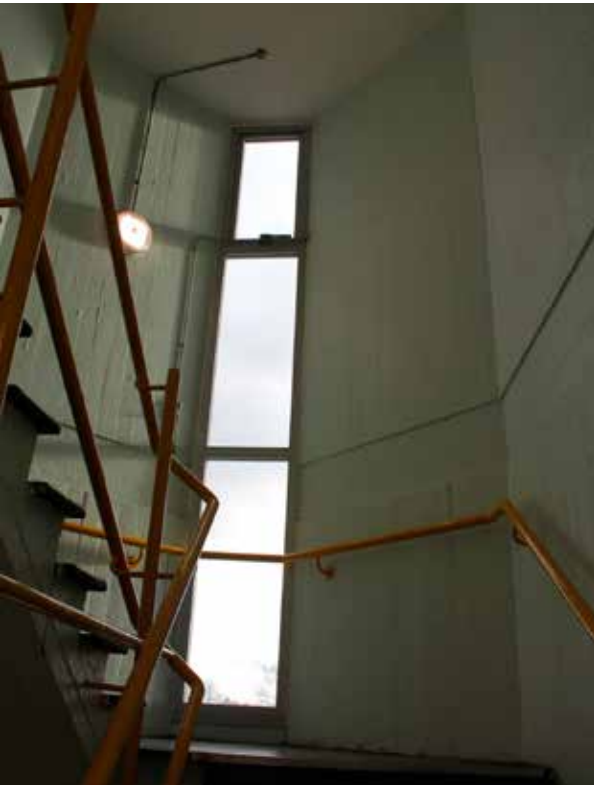
14.3 One of three original stair towers that serve the main teaching blocks.

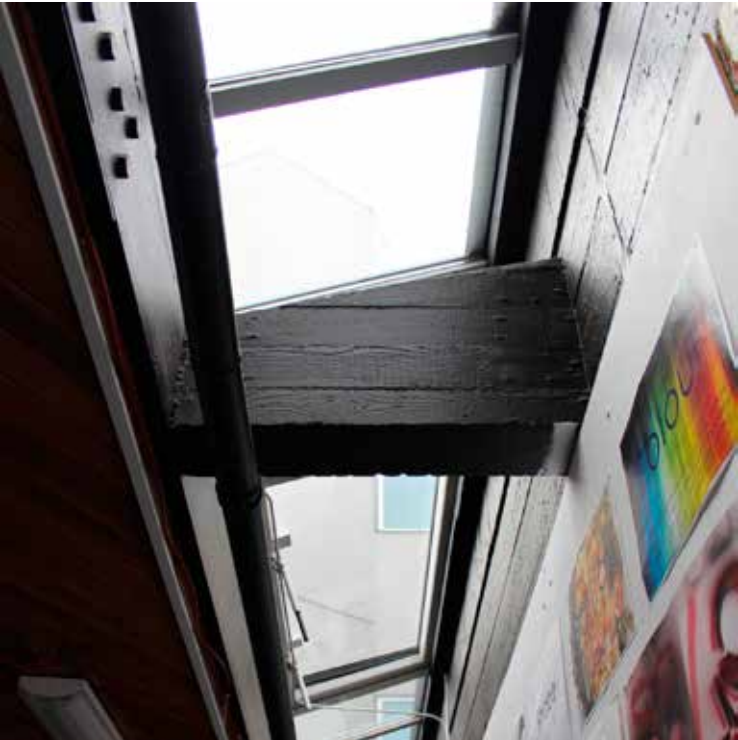
15.1 An internal view of the art room skylight to the periphery of the ceiling.
