**Asbestos Survey Report**  
**Project Ref. No: 133483**  
**Highgate Newtown Community Centre**  
**Demolition survey**

## **Highgate Newtown Community Centre**

**Survey Type:** Demolition survey

**Project Reference Number:** 133483

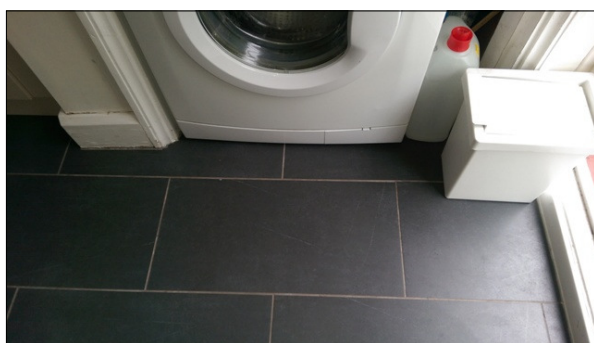
Non asbestos bitumen adhesive to concrete floor. (1m2)

| <b>Action required:</b> | None | | |

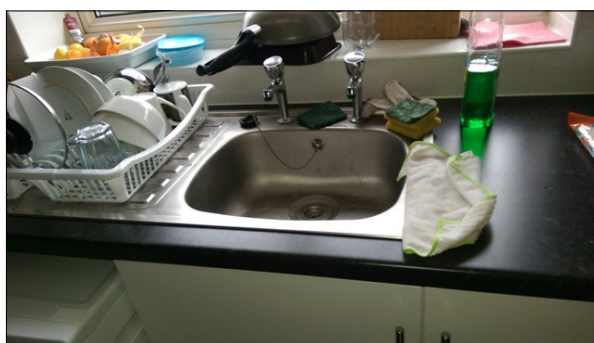
Non asbestos bitumen sink pad. (1no)

| <b>Action required:</b> | None | | |

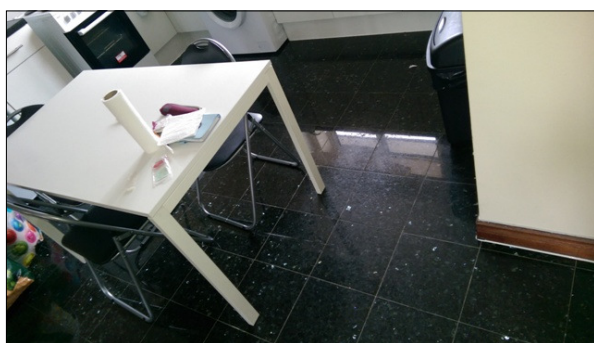
Non asbestos bitumen adhesive to concrete floor. (20m2)

| <b>Action required:</b> | None | | |

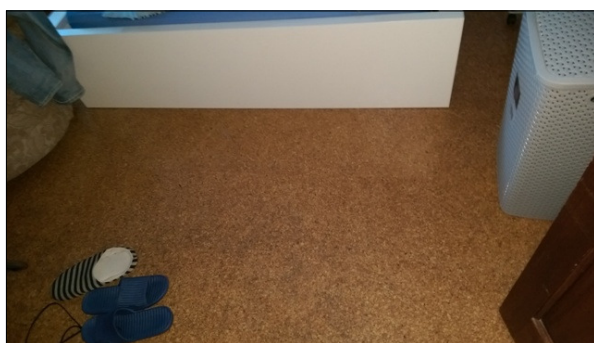
Non asbestos bitumen adhesive to concrete floor. (12m2)

| <b>Action required:</b> | None | | |

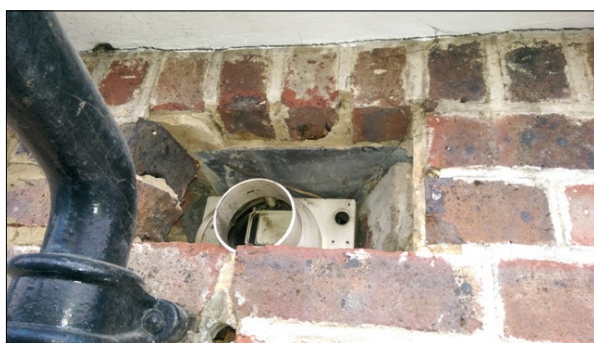
Non asbestos cement slate to wall of air vent.  
(<1m2)

| Action required: | None | | |

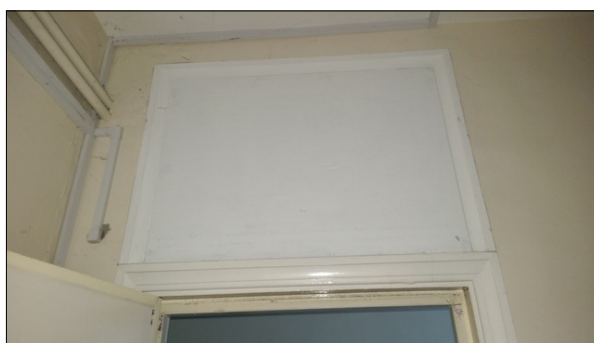
Non asbestos insulating board infill panel above door. (<1m2)

| <b>Action required:</b> | None | | |

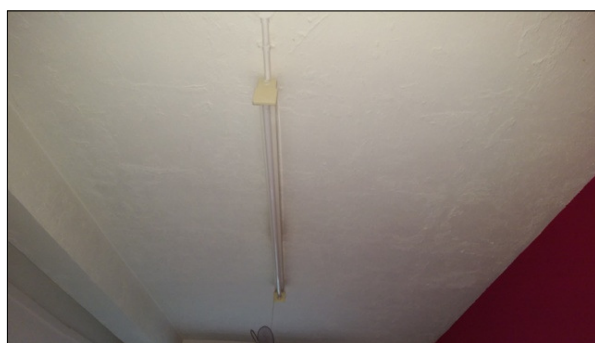
Non asbestos textured coating to ceiling. (12m2)

| <b>Action required:</b> | None | | |

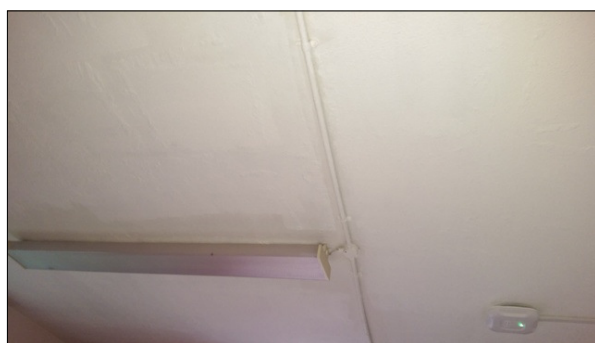
Non asbestos textured coating to ceiling. (15m2)

| <b>Action required:</b> | None | | |

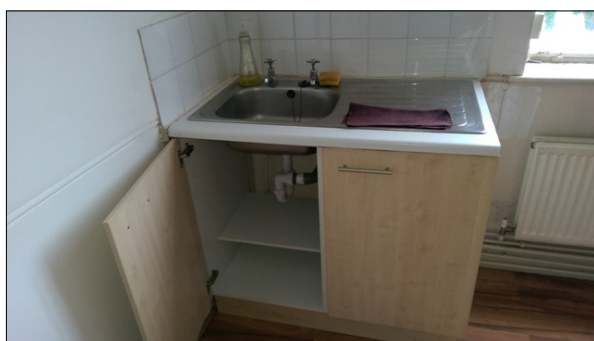
Non asbestos bitumen sink pad. (1m2)

| <b>Action required:</b> | None | | |

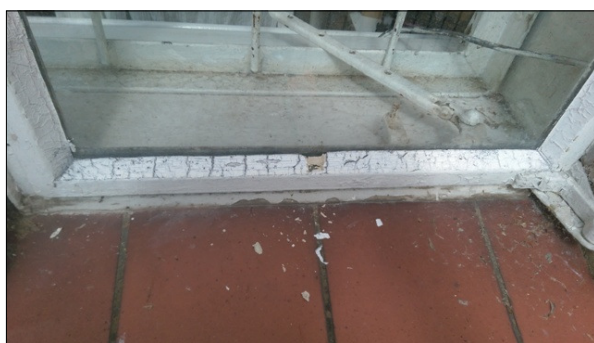
Non asbestos putty to windowsill throughout building. (<10m2)

| <b>Action required:</b> | None | | |

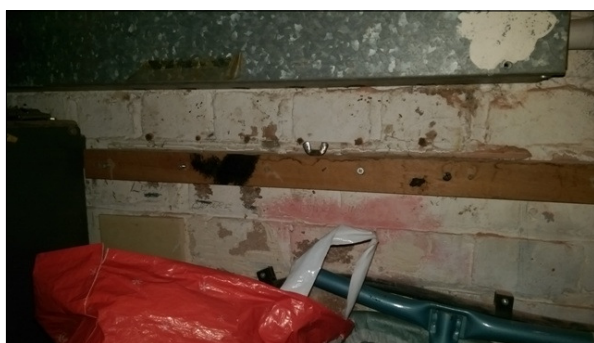
Non asbestos rawl plug to brick wall. (<1m2)

| <b>Action required:</b> | None | | |

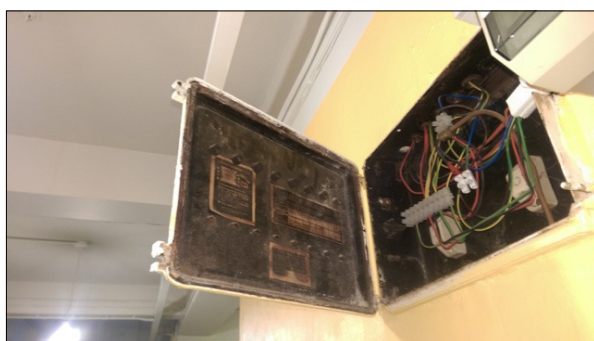
Non asbestos gasket seal within electrics.

| <b>Action required:</b> | Remove | | |

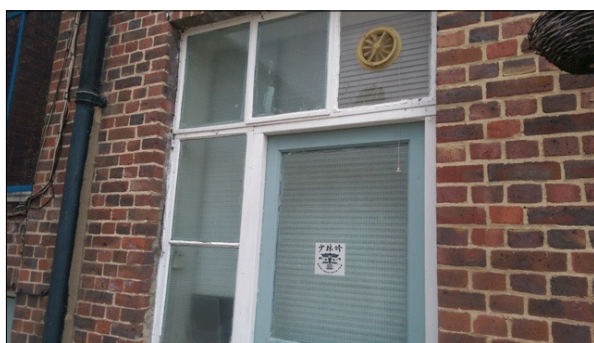
Non asbestos putty seal to windows throughout floor. (<10m2)

| <b>Action required:</b> | None | | |
