## Condition Report

**The Hoo,  
17 Lyndhurst Gardens  
Hampstead  
London**

November 2019

SDA Consulting LLP  
Edward House  
Deva Centre  
Trinity Way  
Salford  
Manchester  
M3 7BE

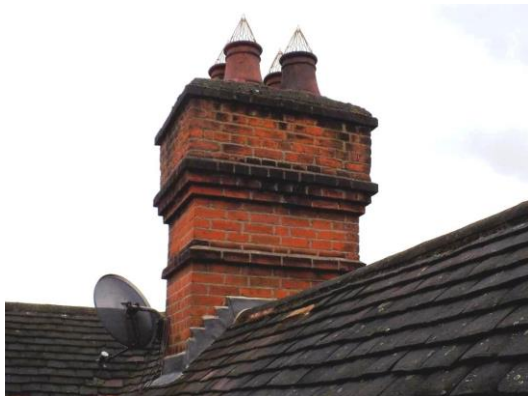
Chimney stack 3

The chimney stacks are all generally plumb and appear to be free from significant cracking as a result of structural movement. There are varying amounts of spalled bricks to many of the chimney stacks, primarily at high level below the cappings and the decorative corbel courses. This is due to water run-off from the cappings and the corbels soaking the bricks and freeze thaw cycles causing spalling of the faces of the bricks. This appears to have been made worse to many of the stacks by later repointing with cement rich mortar that does not allow the wall to breathe and dry out naturally and which holds back moisture and traps it within the bricks, causing the bricks to spall when this freezes.

The spalled bricks will need to be replaced to match existing and the cement mortar pointing should be removed back to the original pointing and then repointing using a lime, rather than cement mortar that will allow the walls to dry out naturally.

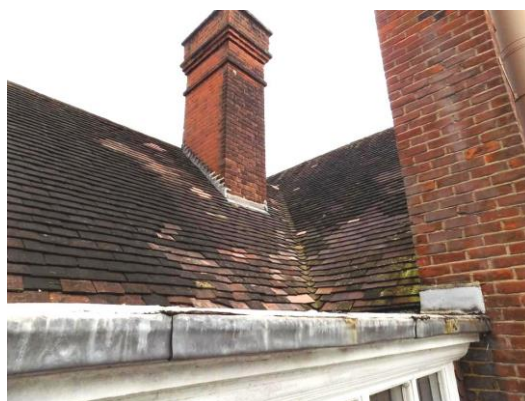
The majority of roofs are true to line and level with no significant deflection or distortion noted to the roof structures and ridge lines. The tiles themselves are generally well fixed although relatively extensive areas have clearly been patch repaired and partially retiled at various times in the past. The areas that have been patched and repaired are concentrated around valley gutters and chimney stacks and are thought to be due to damage caused by access onto the roofs to repair chimneys and other features rather than failure of the tile fixings themselves. This patch repair is most evident to the roofs around the south east terrace and the roofs around the chimneys and either side of valley/box gutters such as roofs 9 and 12-15.

Patched tiles to roofs 16 &amp; 17

A number of isolated tiles are broken, missing or slipped and a general overhaul of the tiled roofs will be required to refix loose and slipped tiles and replace broken and missing tiles. There is one area at the back of the dormer window to roof 6 where a coating has been applied as a poor quality patch repair and this should be retiled.

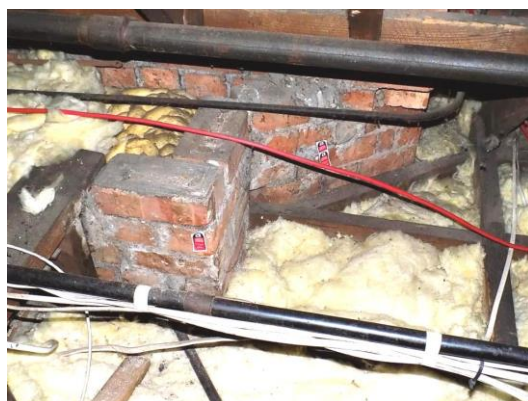
Asbestos stickers to brickwork

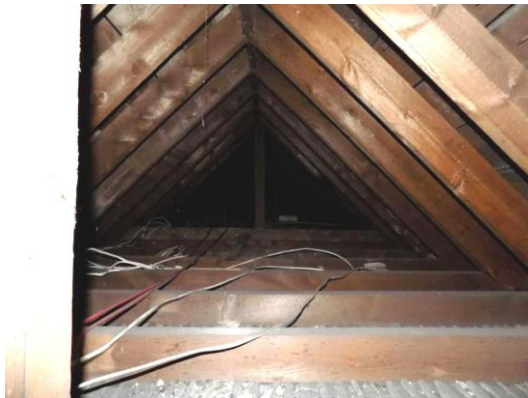
No insulation to roof void 5

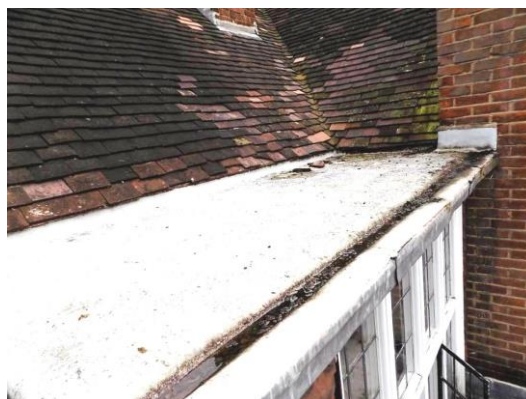
The flat roofs to the more recent extension and the projecting ground floor areas, dormers and bay windows to the original building are generally only in fair condition. All these roofs have been covered with a liquid coating and this appears to have been applied directly to the original roof coverings of asphalt, felt, chippings and lead. There are blisters evident to a number of areas of the flat roof to the extension and plants are growing out of the coating near to the main staircase window. The coating is also split and peeling off to a number of the dormers and bay window roofs.

The liquid coating is a relatively poor quality patch repair for a historic building and appears to have been applied without repairing or preparing the substrate material. It will be very difficult to remove the coatings without damaging the underlying roofing and whilst most areas are free of leaks now, it is expected that re-covering of the roofs on a phased basis will be required. This will involve removing much of the original coverings below the coatings and replacement with new lead and asphalt, in keeping with the historic nature of the house. It will also allow increased insulation to be fitted although this will require careful design and detailing to the roofs and surrounding upstands to accommodate the increased thickness of insulation. This will be most evident to the flat roof over the former reception office to the north side of the house where the original leaded window cill heights are very low.

Coated flat roof to bay window

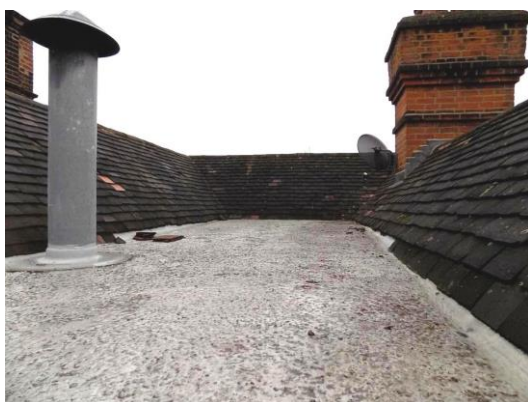
Coated flat roof 9 over lift

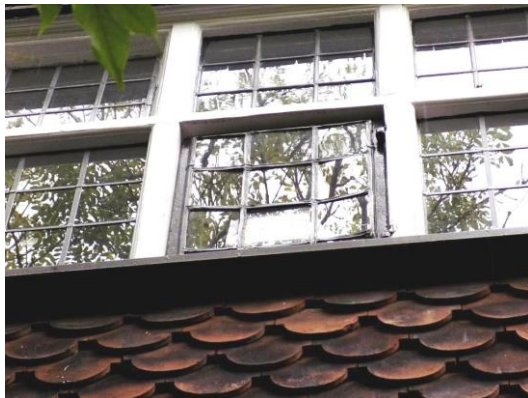
Distorted leaded window

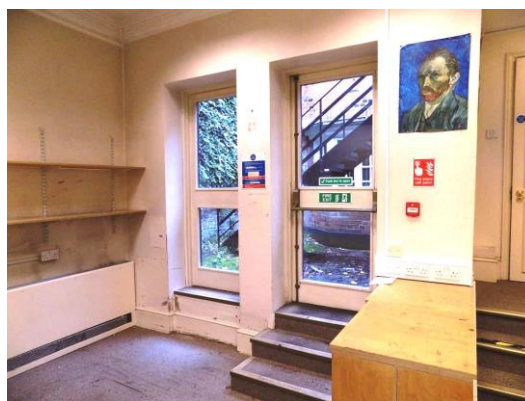
Commercial fire escape ironmongery

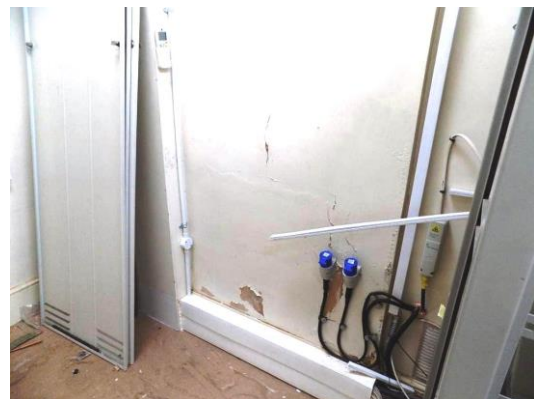
Damp to IT room on north side

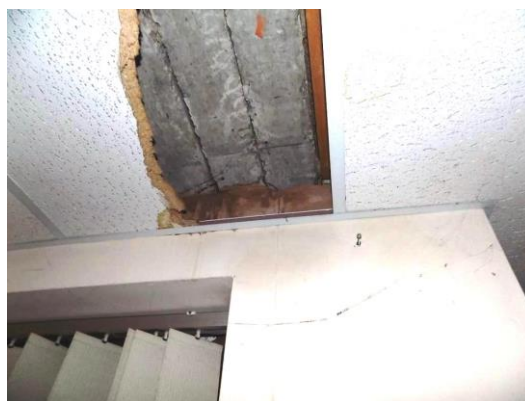
Damp to lower floor of extension

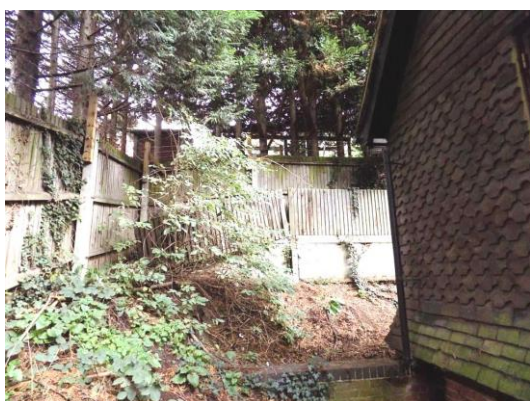
Slipped fence panel to north west corner

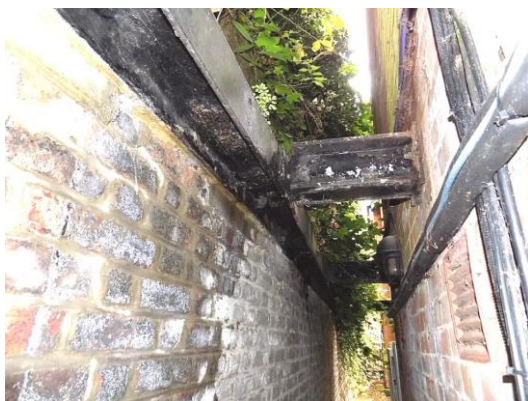
Steel beams and braces to north wall
