## 7.1 APPENDIX: POST-FIRE PHOTOGRAPHIC SURVEY- INITIAL SITE VISIT

## 7.2 APPENDIX: POST-FIRE PHOTOGRAPHIC SURVEY- PRE-DEBRIS REMOVAL

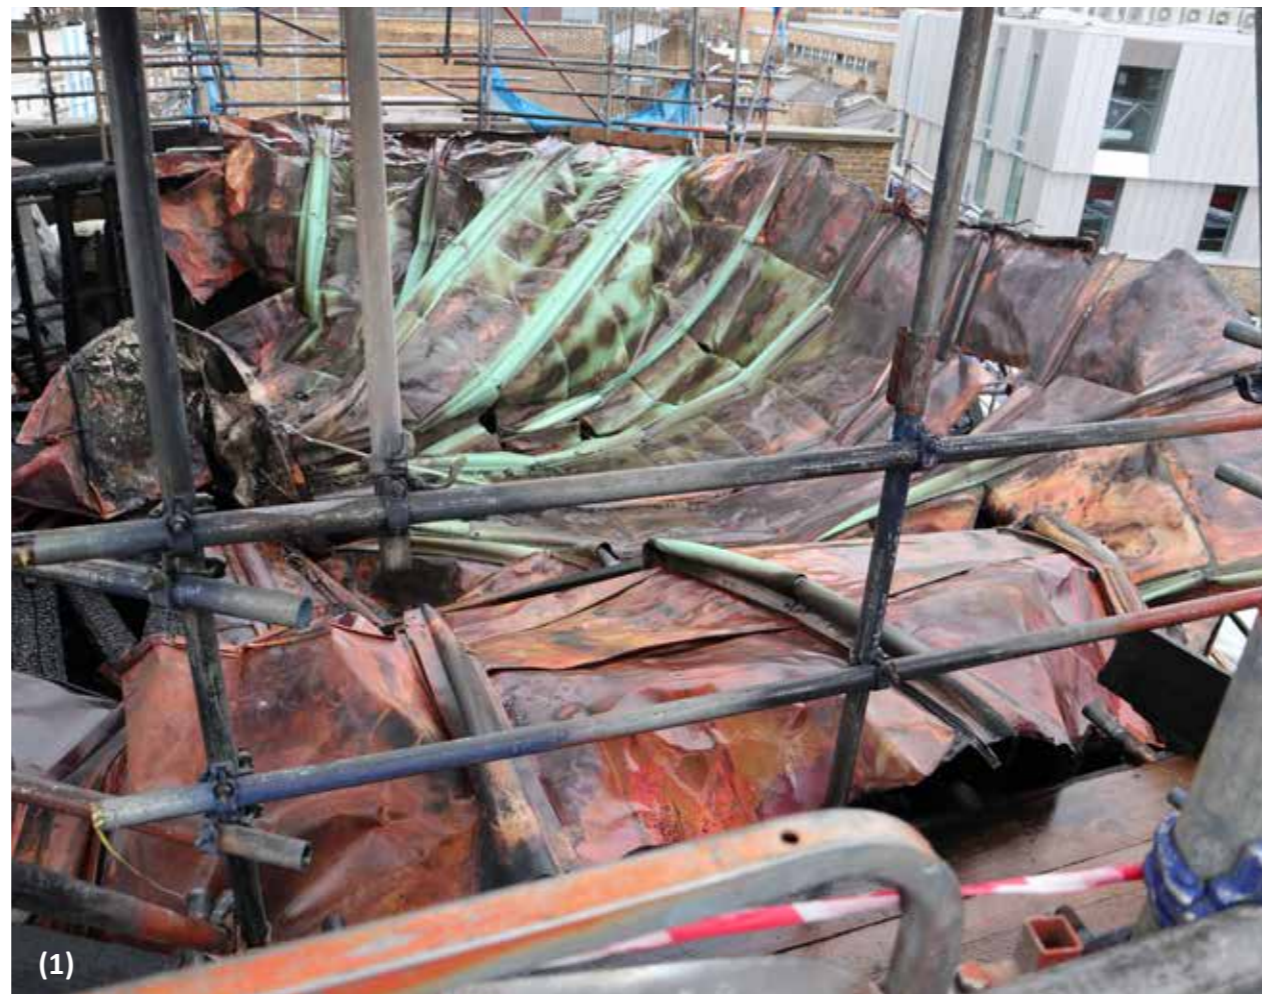
### 1. NE view of collapsed copper roof cladding

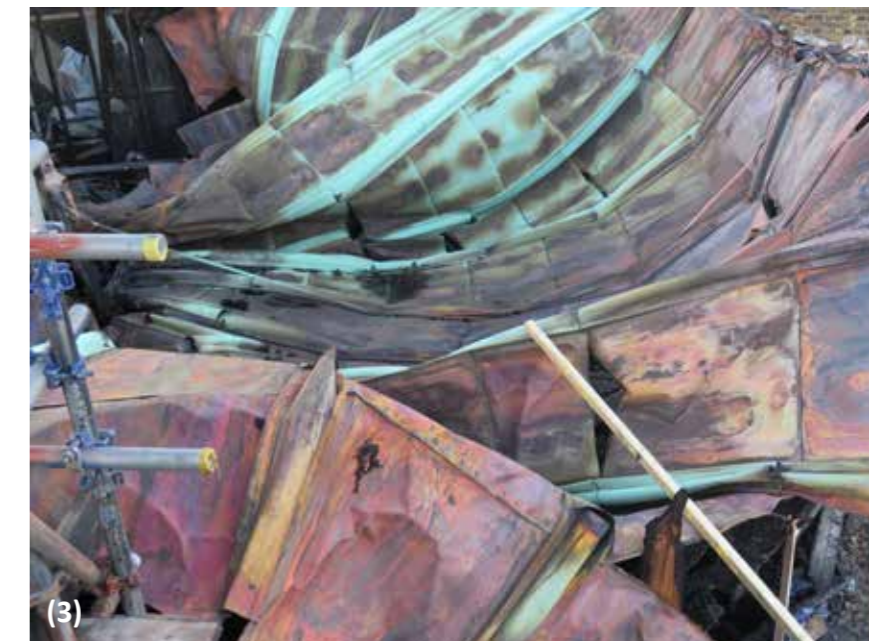
### 3. Closer view of collapsed copper roof cladding

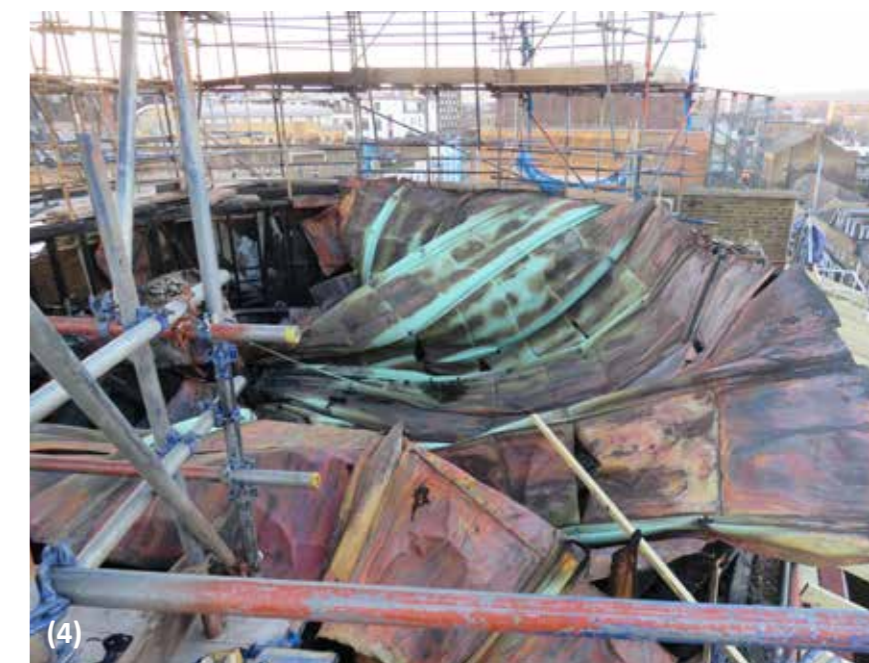
### 4. N view of collapsed copper roof cladding

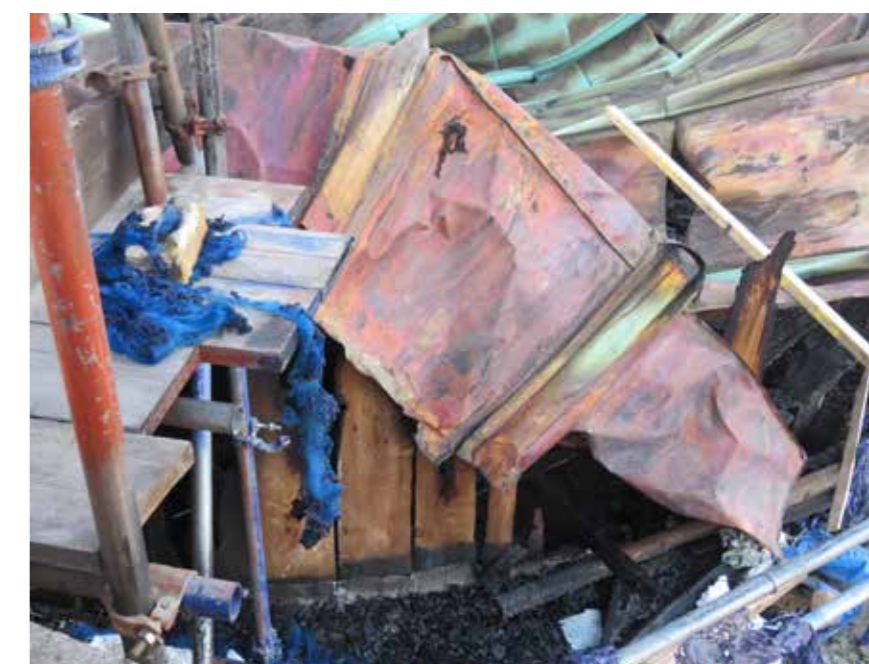
### 5. Collapsed copper over wall boarding and perimeter ring

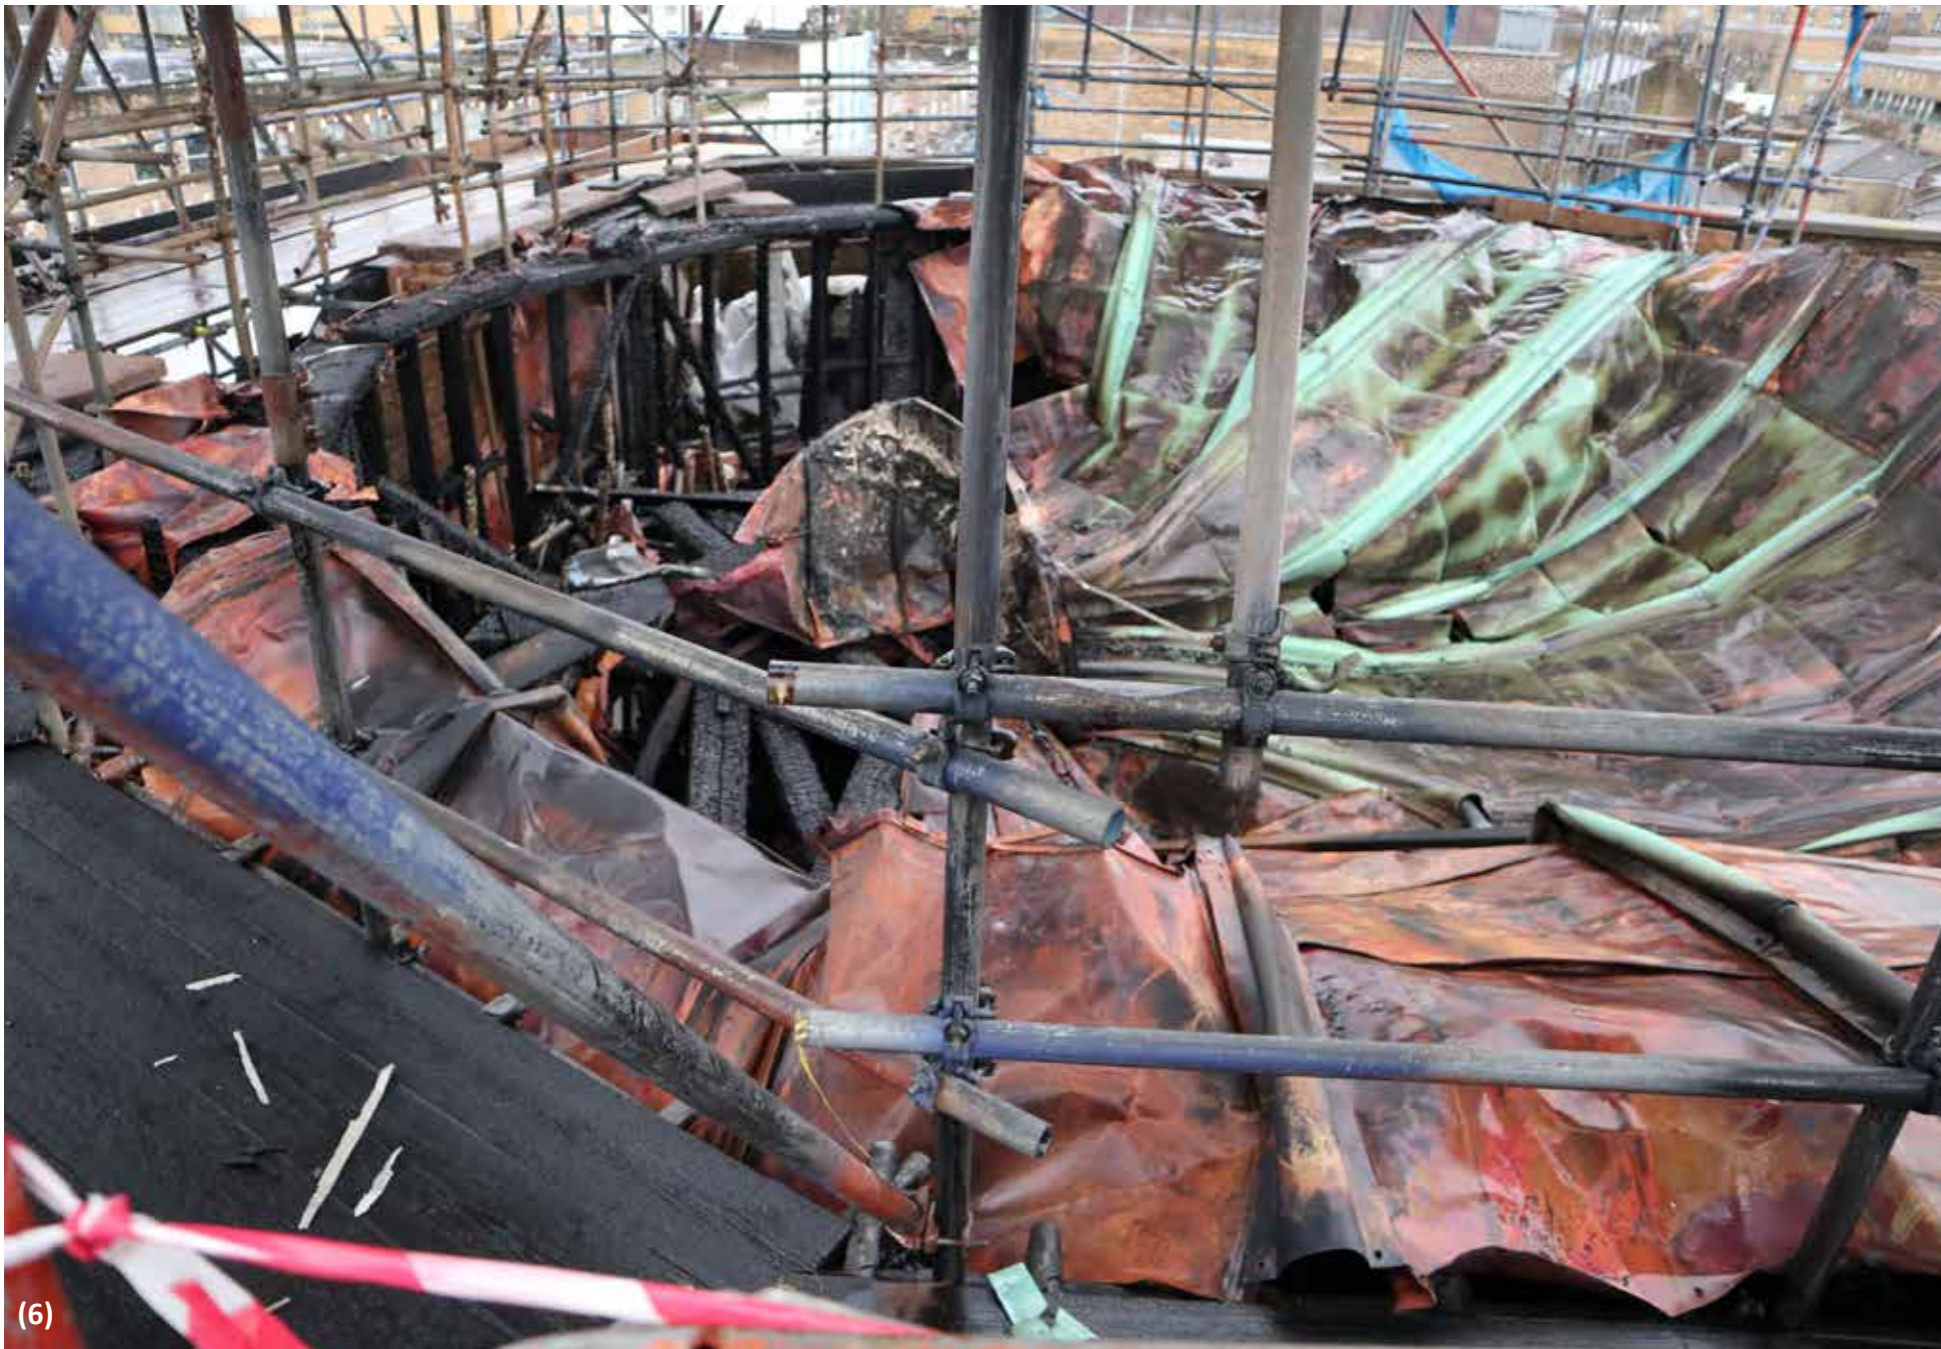
(6)

### 6. Inside view of collapsed copper roof cladding

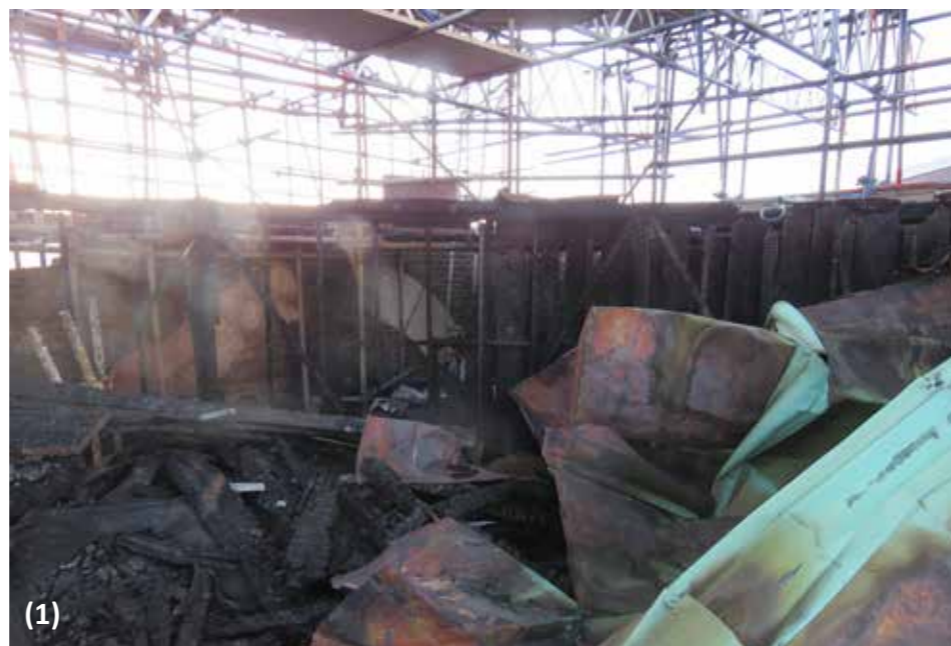
#### 1. Copper roof sheet and debris at centre of dome

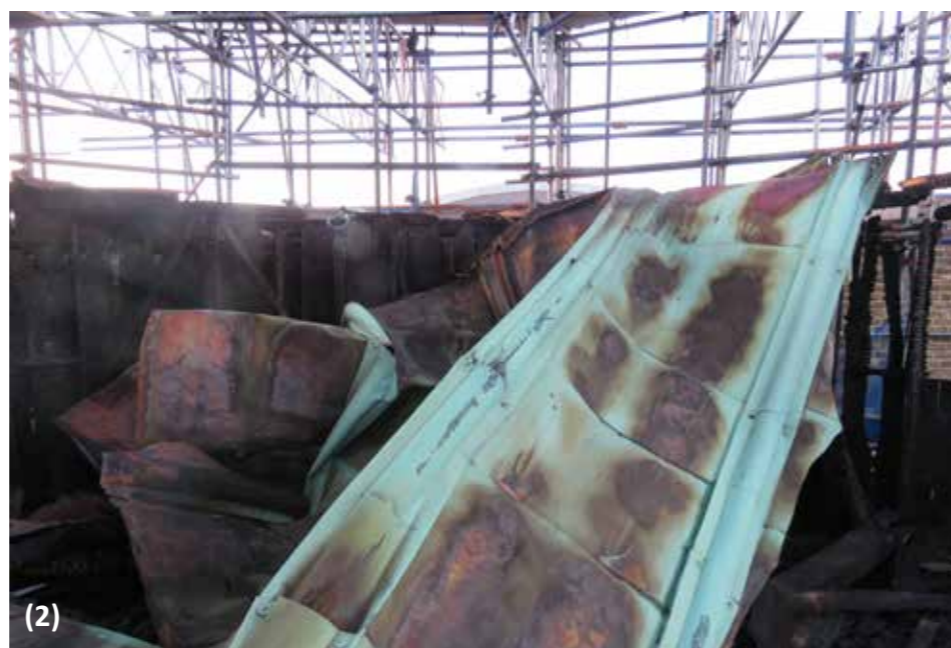
#### 2. Damaged copper roof sheet facing N from centre of dome

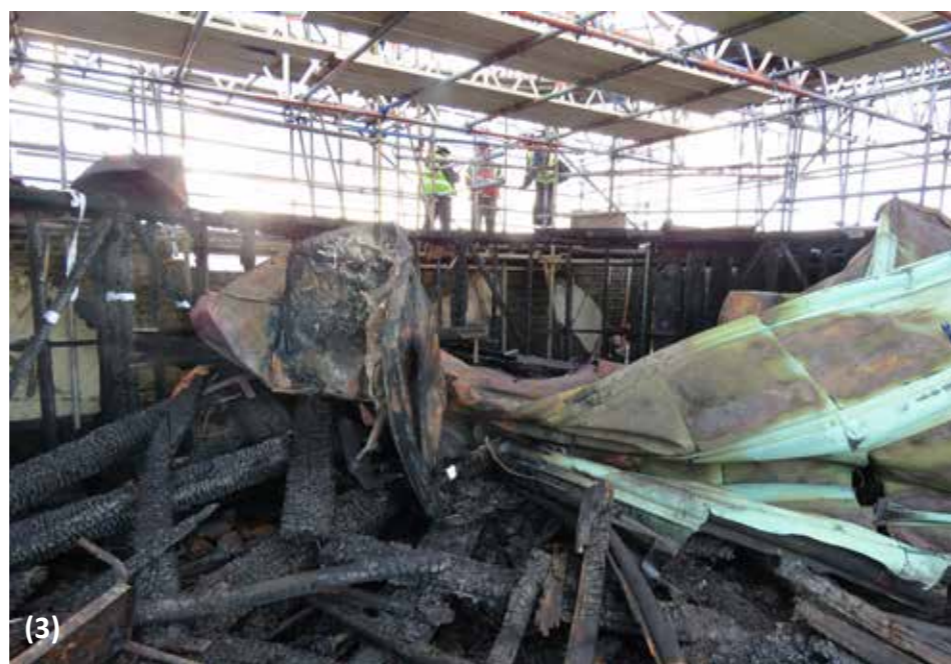
#### 3. Charred timbers and Copper roof sheet at centre of dome

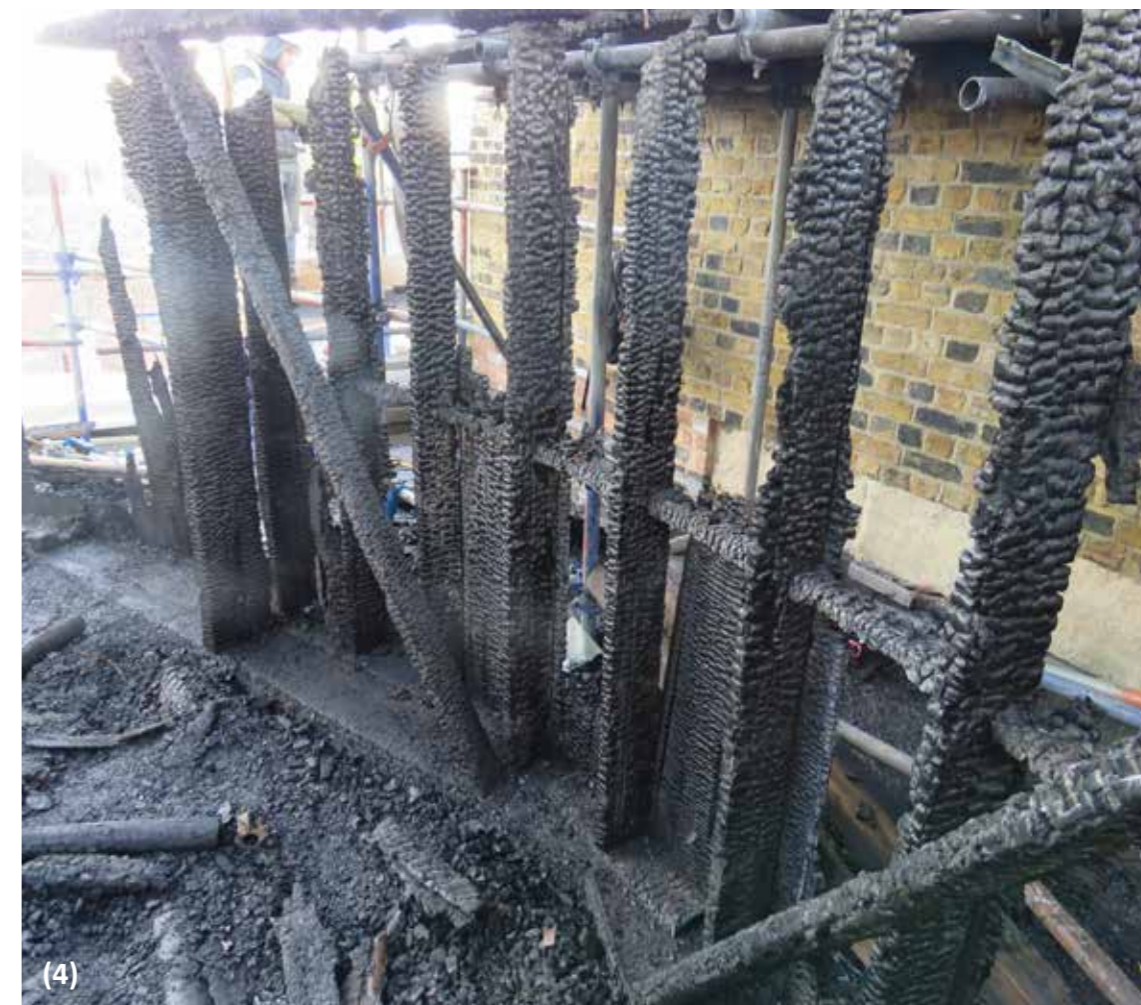
#### 4. Charred timber on perimeter ring of the dome

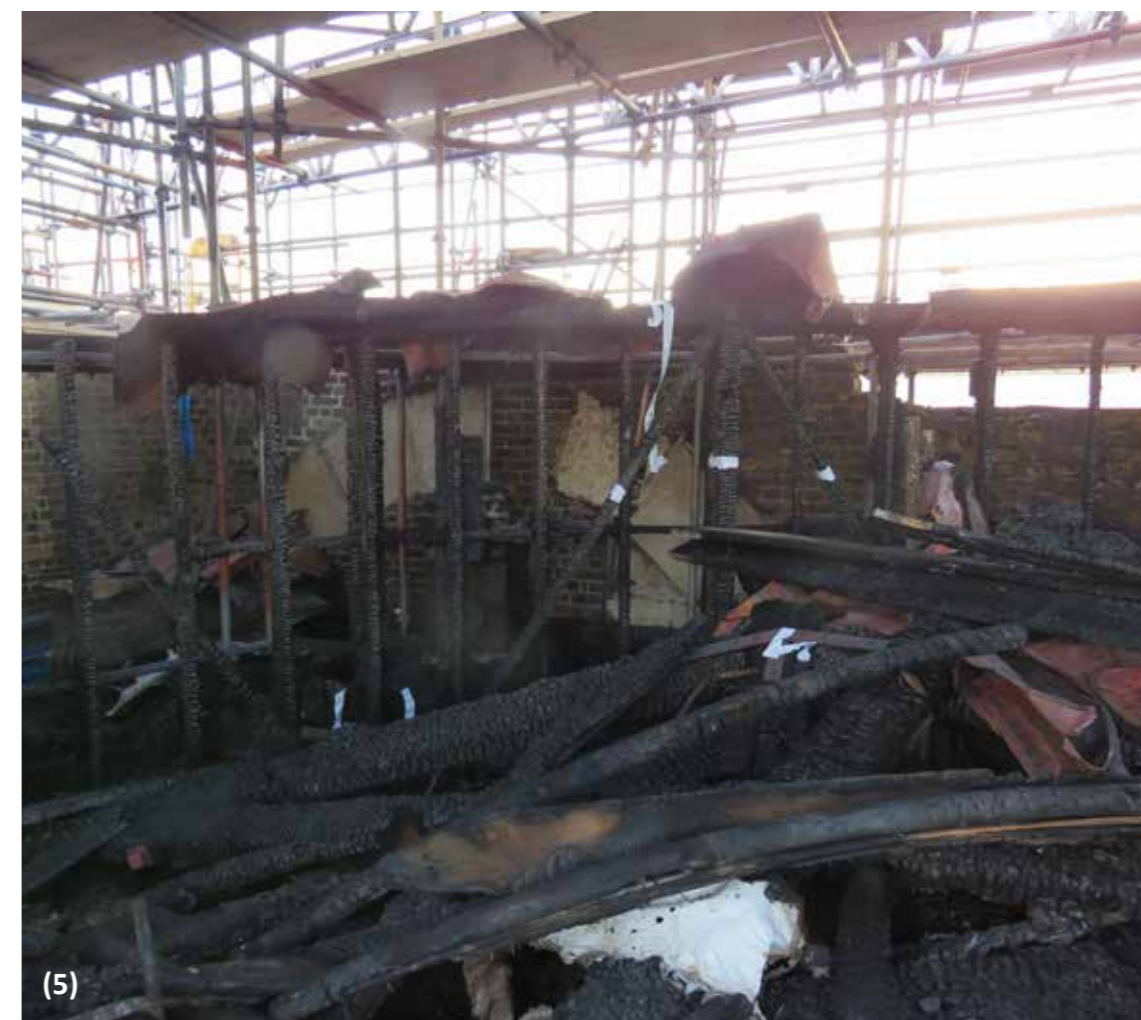
#### 5. Charred timbers facing W at centre of dome

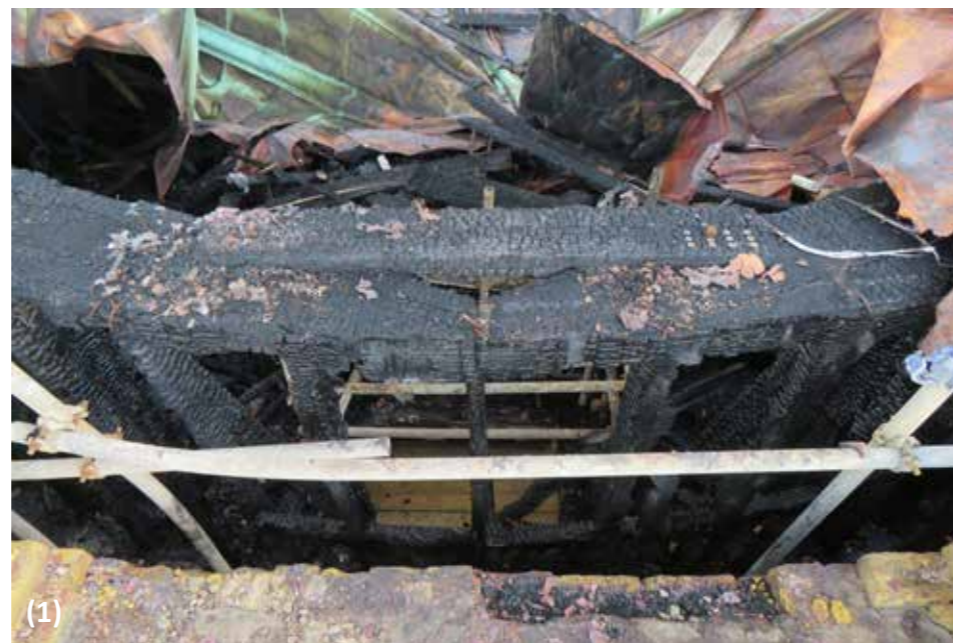
**1. Charred upper wall plate and horizontal rafter wall tie**

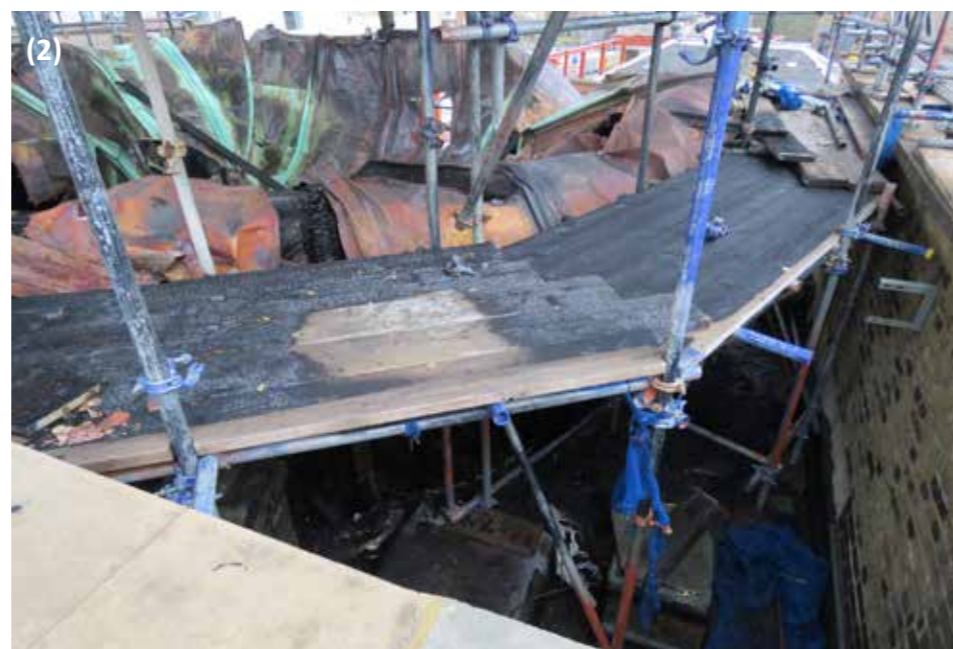
**2. SE corner by brick wall and piers on W side of building**

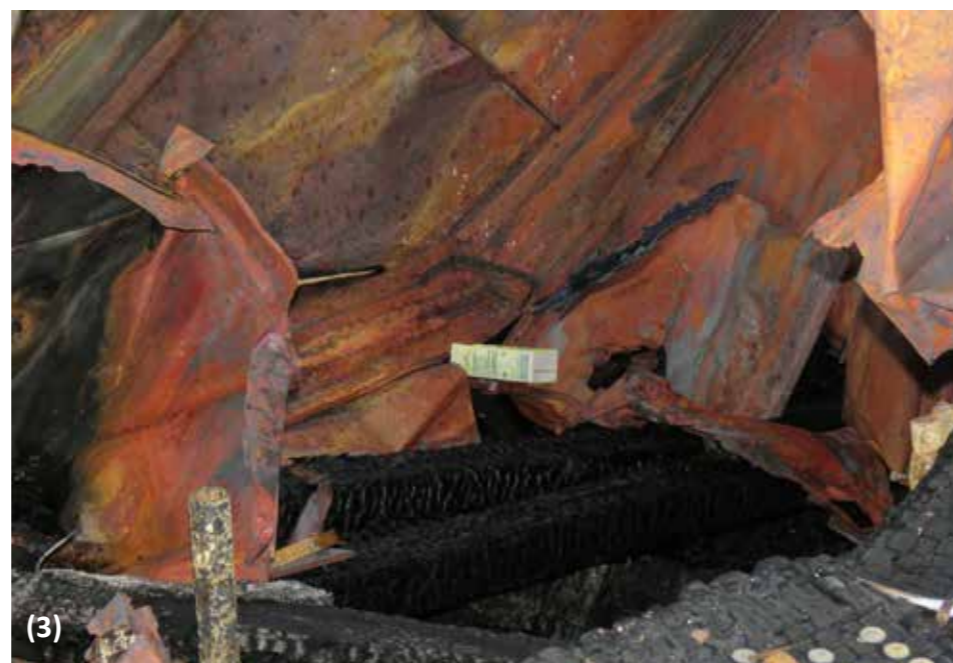
**3. Collapsed and discoloured cooper roof cladding**

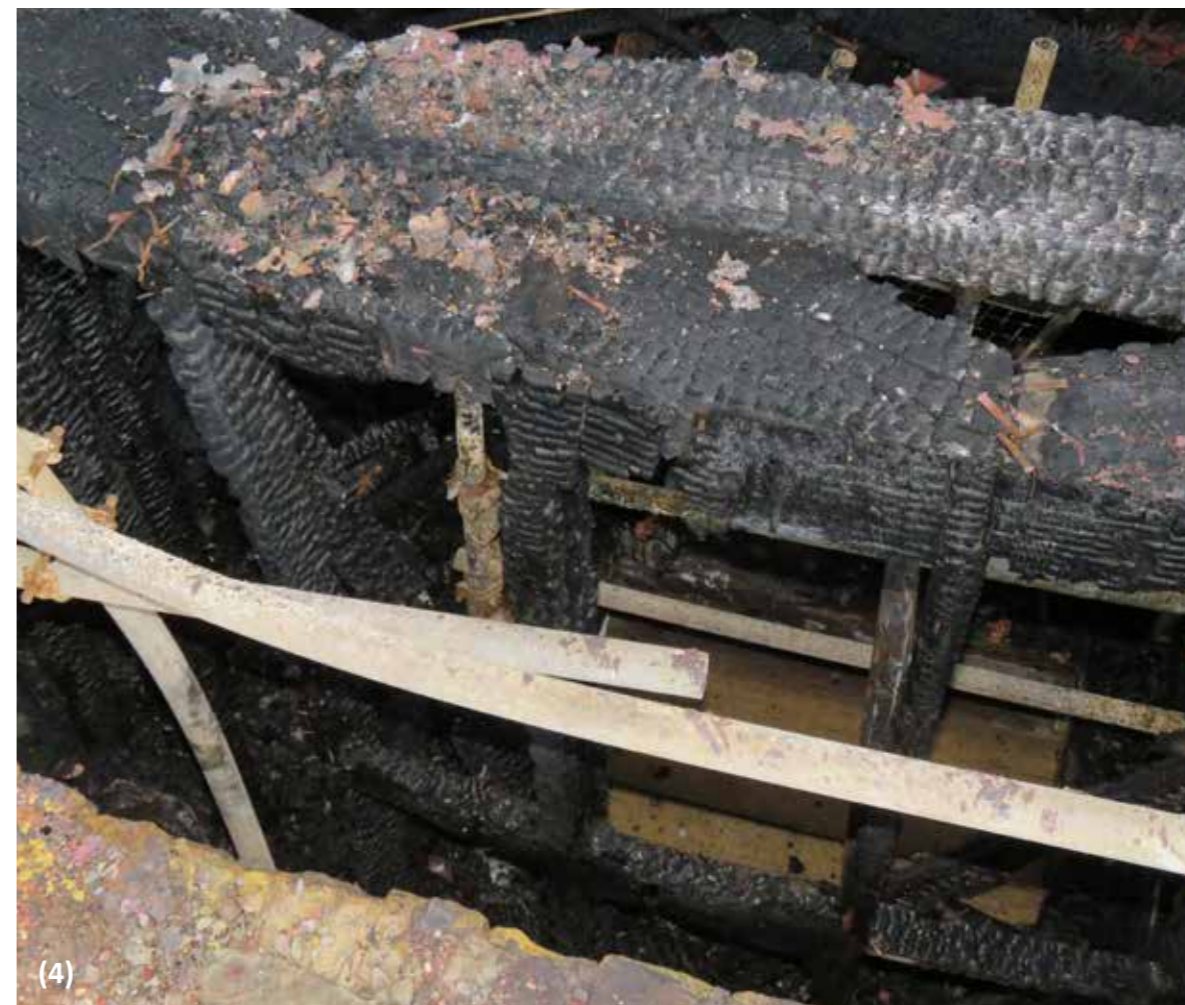
**4. Charred W wall structure**

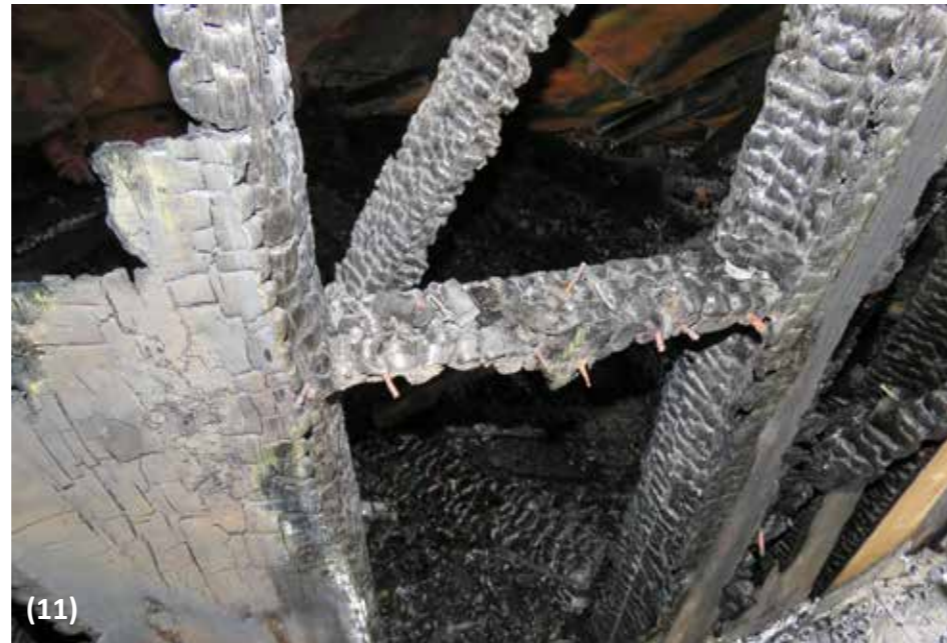
#### 11. Charred wall boarding and wall studs and ties

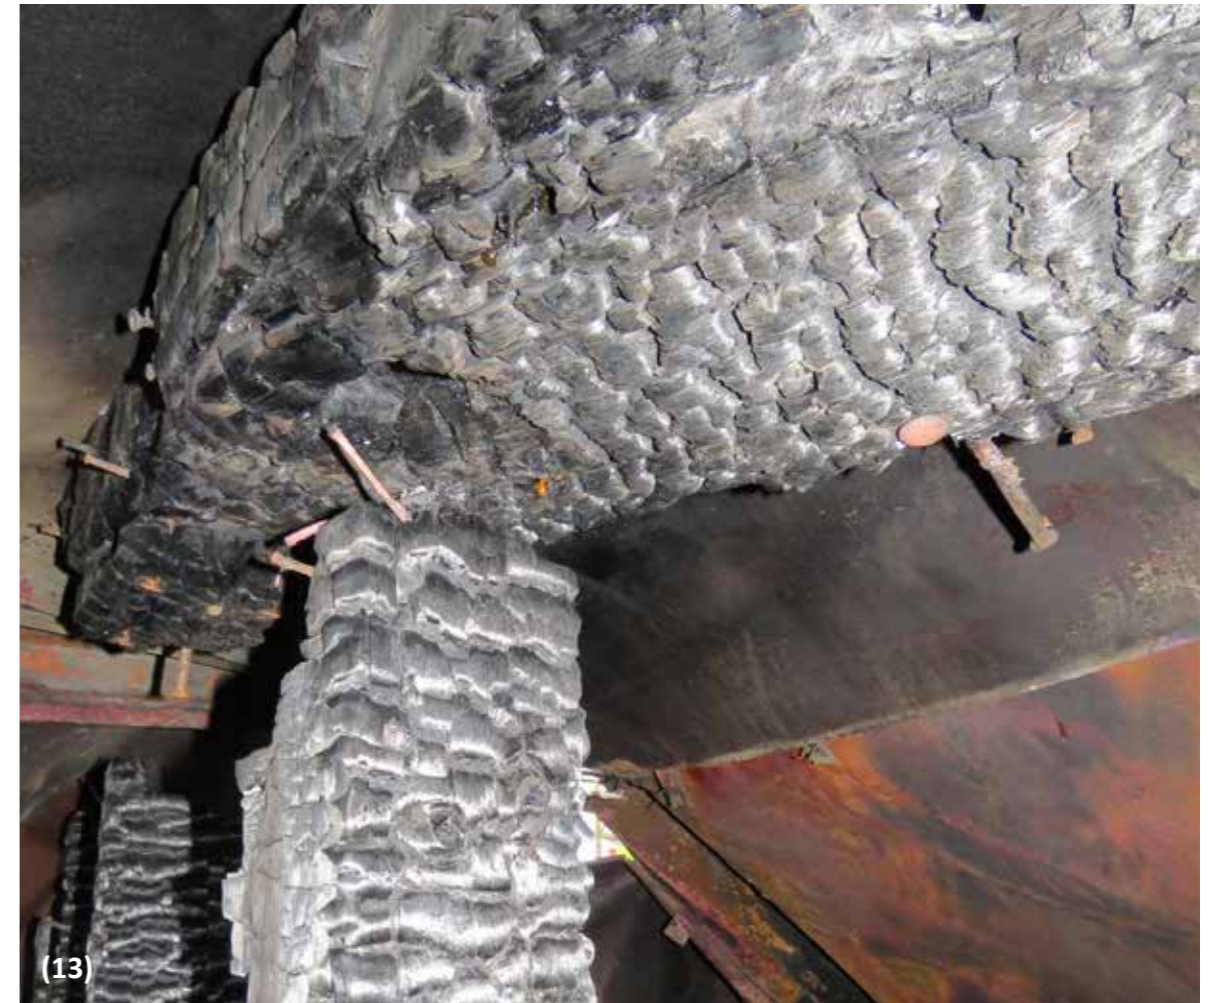
#### 13. Charred outer upper rafter plate with top of wall stud

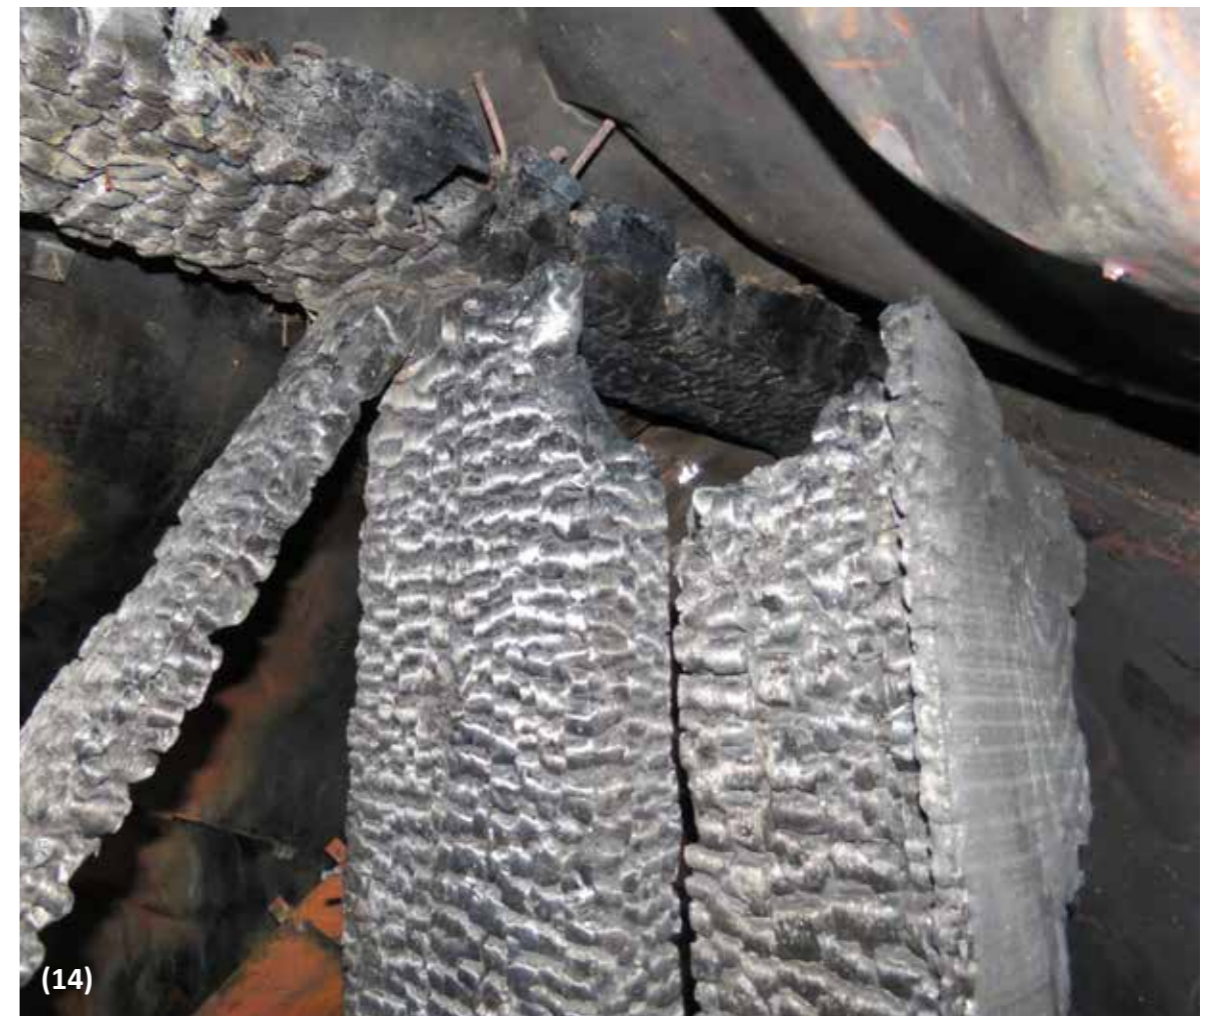
#### 14. Collapsed upper rafter plate above main post junction

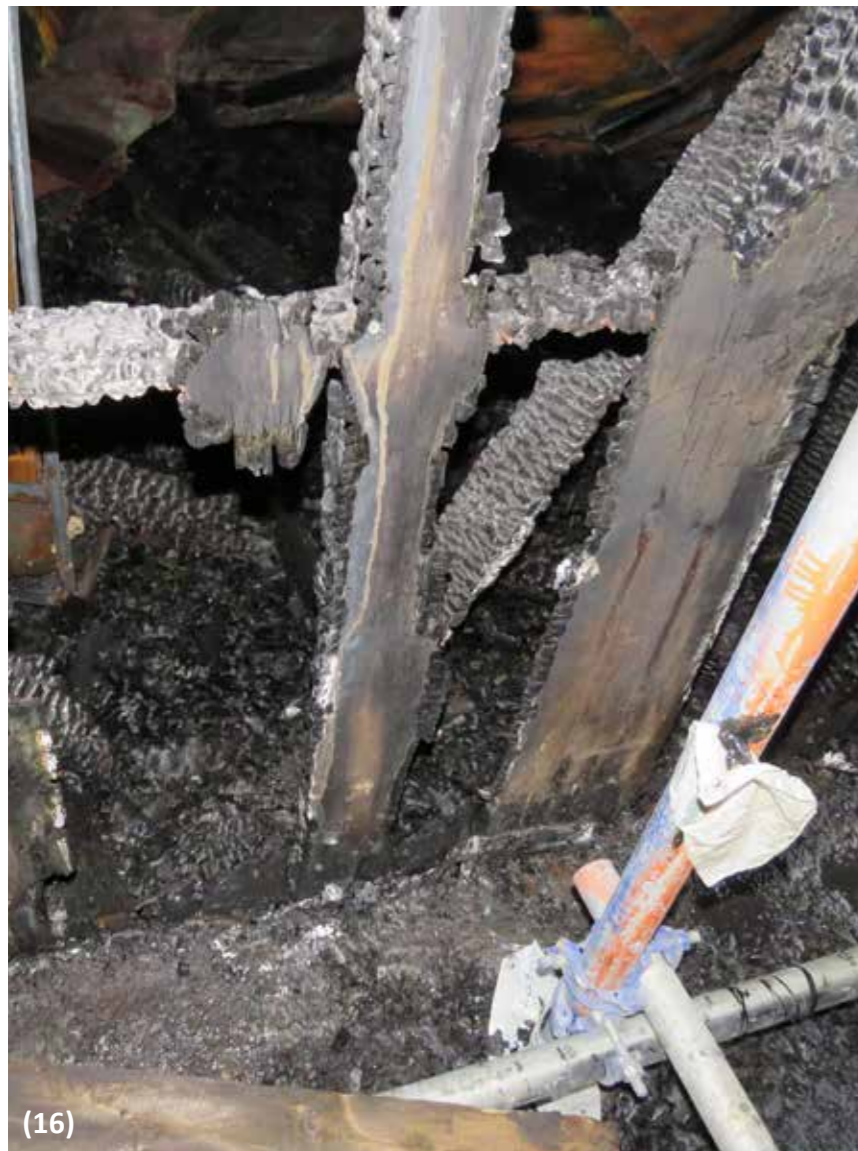
#### 16. Charred wall boarding and wall studs and ties

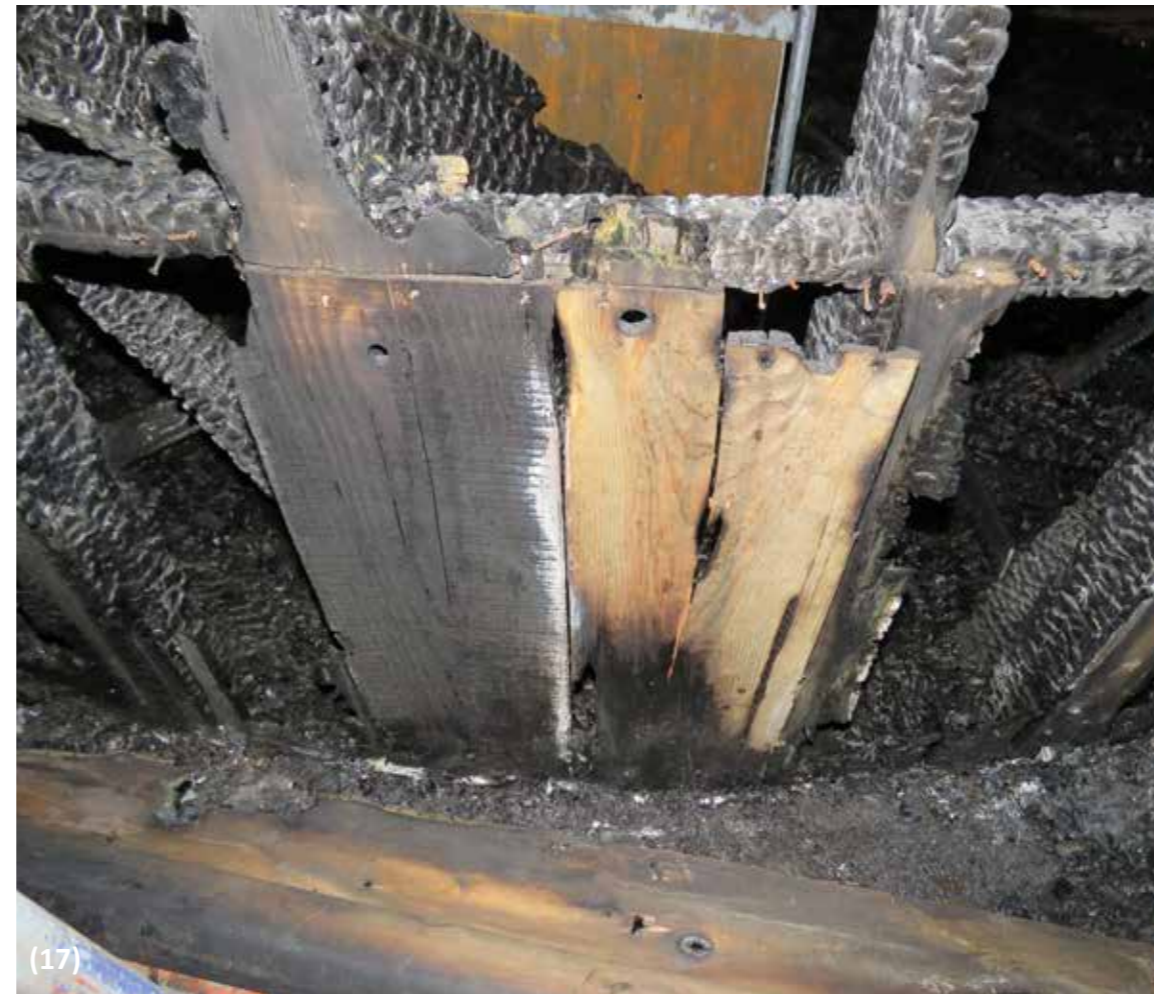
#### 17. Charred wall boarding and wall studs and ties on perimeter ring

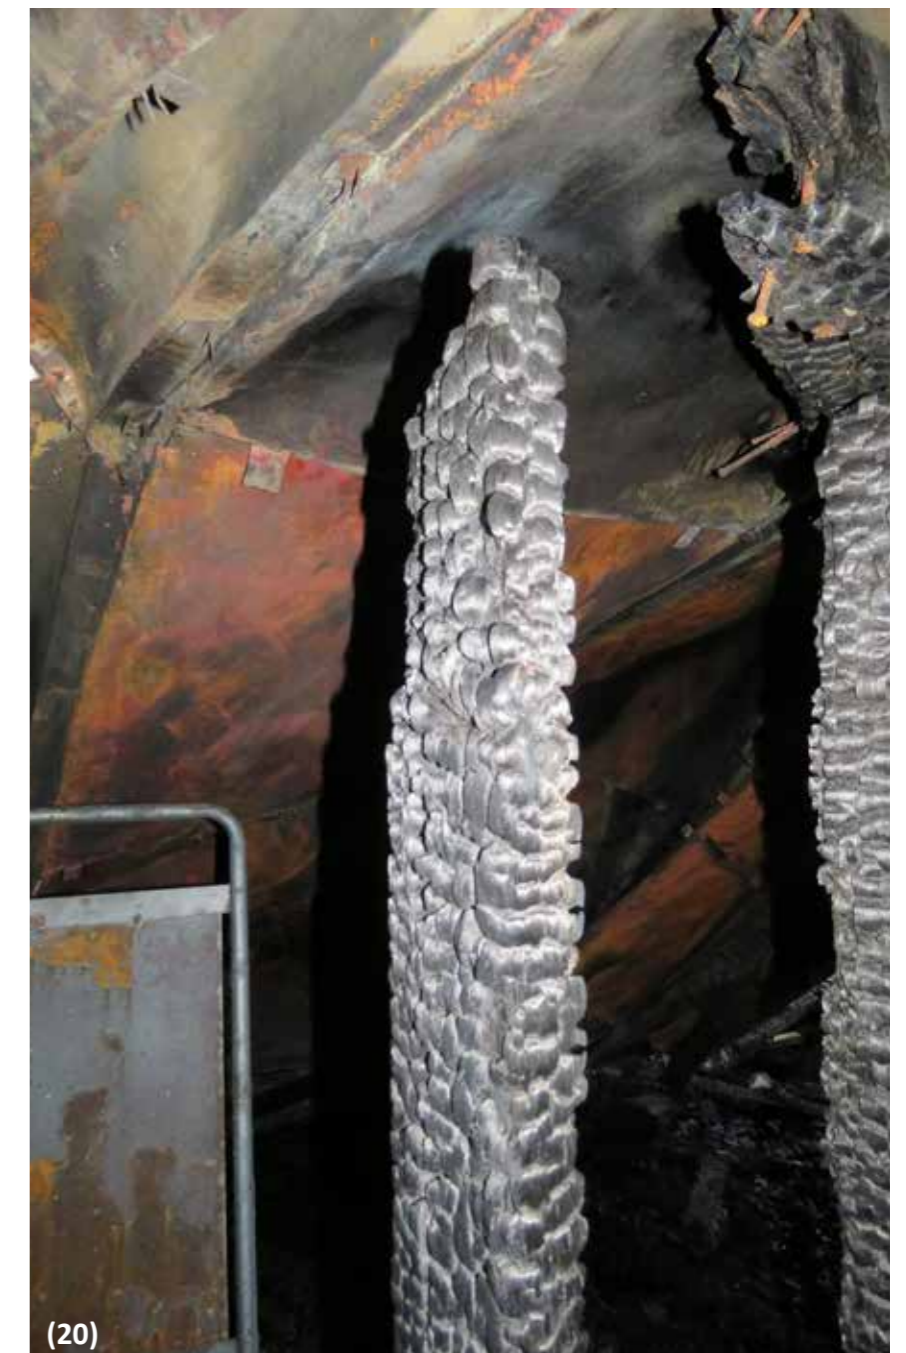
#### 20. Debris underneath collapsed copper roof cladding

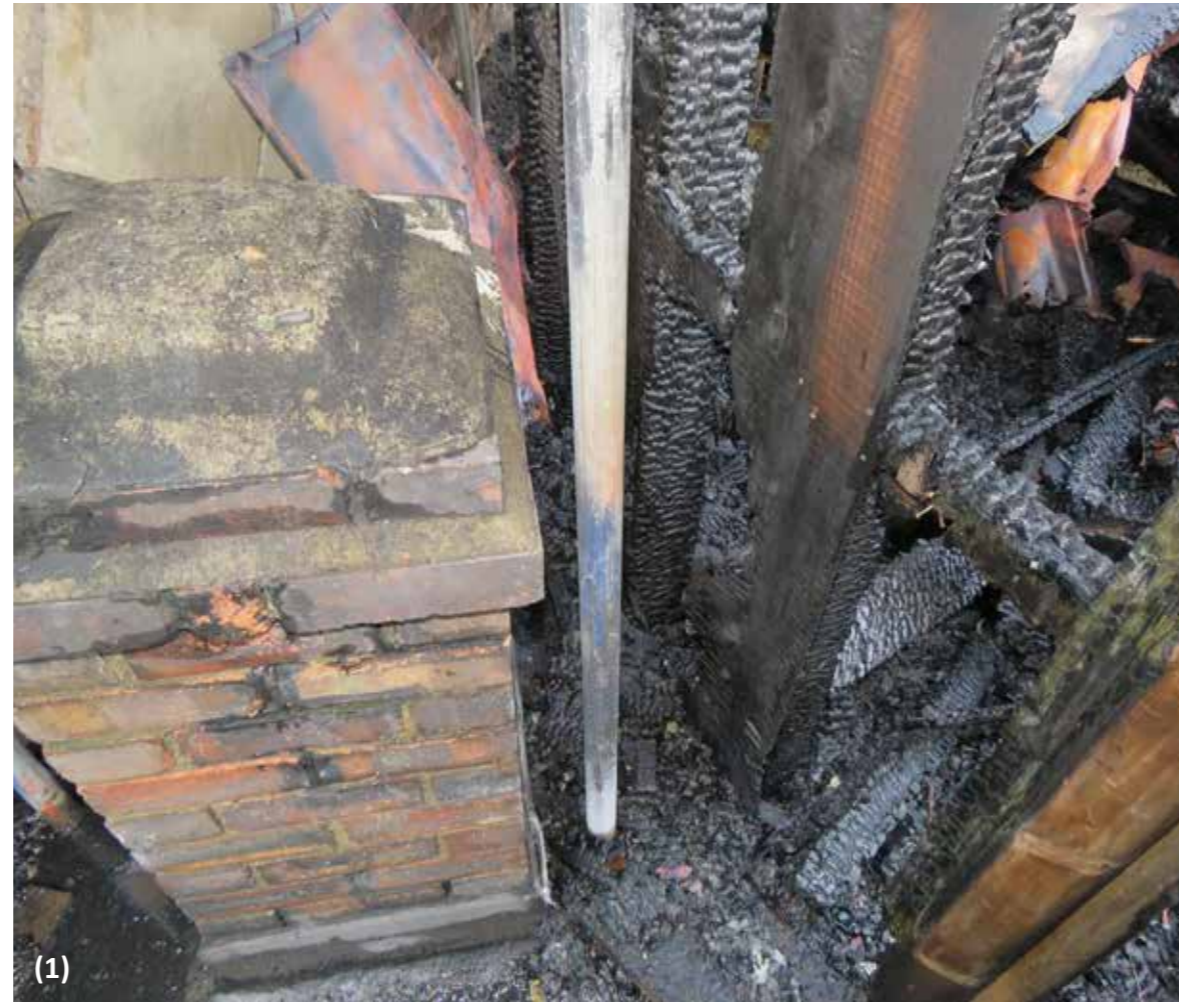
#### 1. Brick pier and charred wall boarding

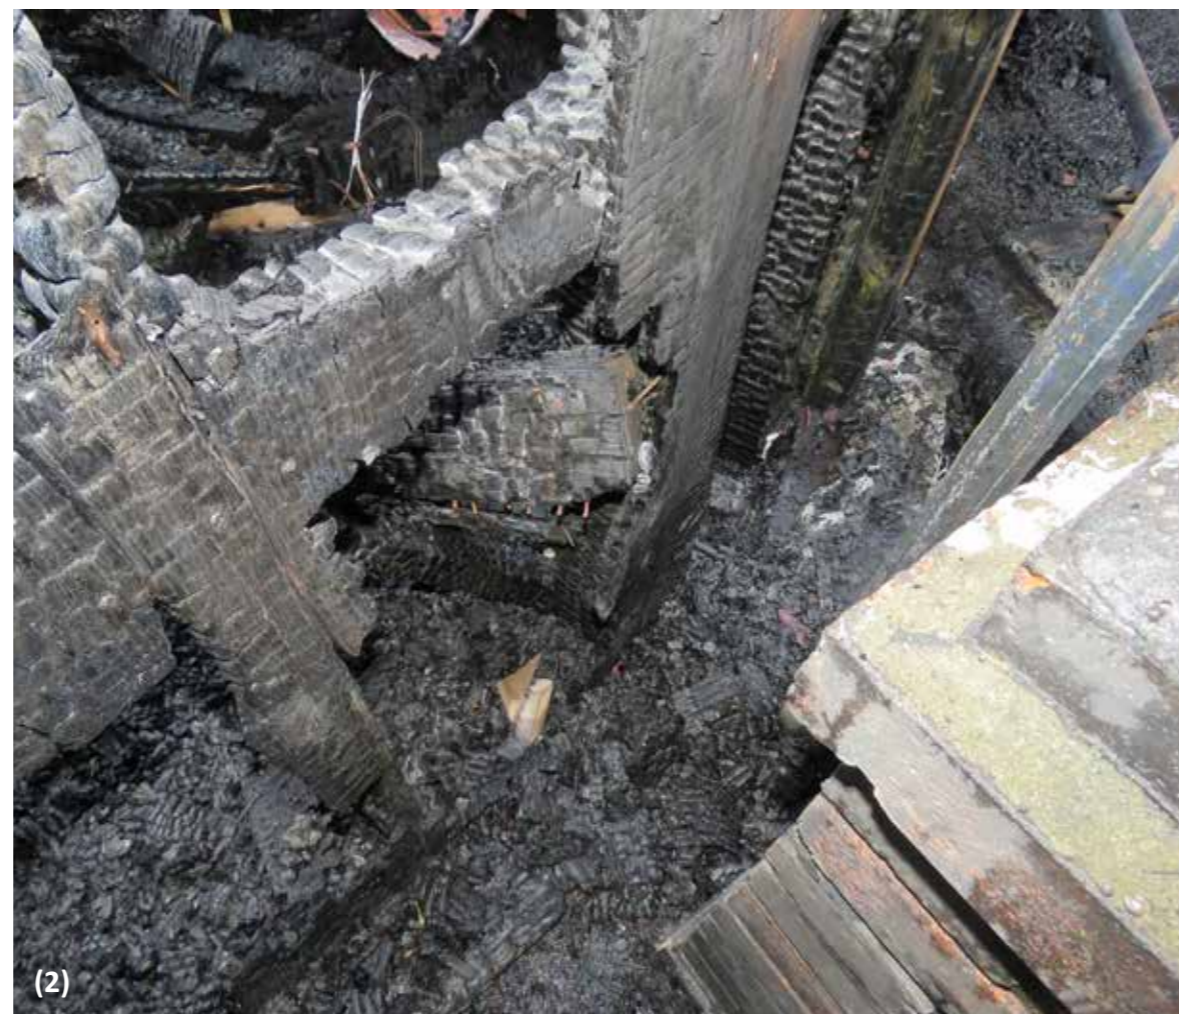
#### 2. View of the perimeter ring by brick pier

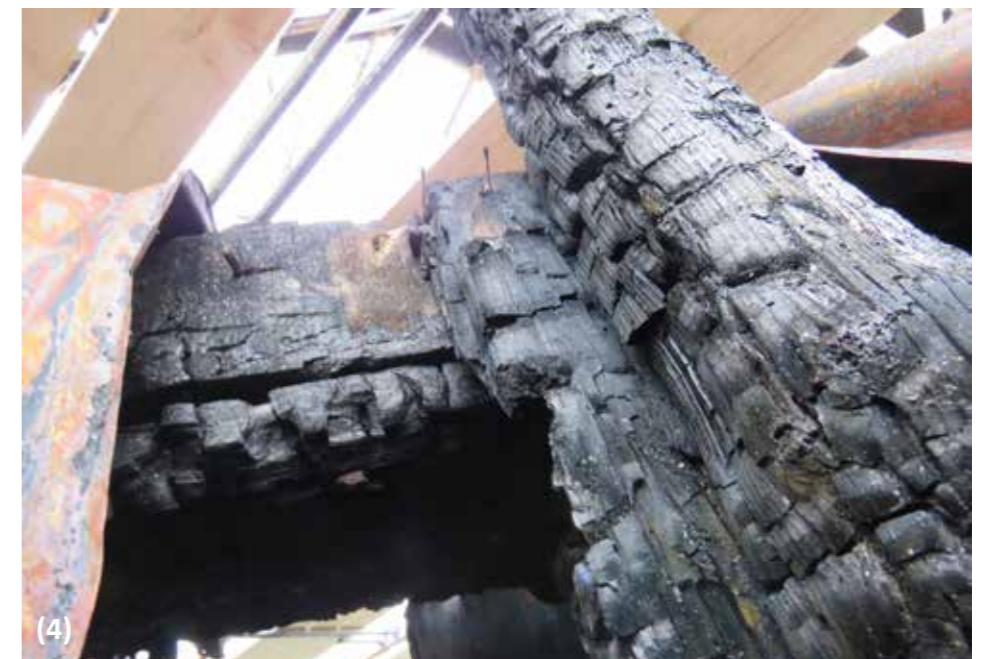
#### 4. Charred timber roof roll
