## 7.1 APPENDIX: POST-FIRE PHOTOGRAPHIC SURVEY- INITIAL SITE VISIT

## 7.2 APPENDIX: POST-FIRE PHOTOGRAPHIC SURVEY- PRE-DEBRIS REMOVAL

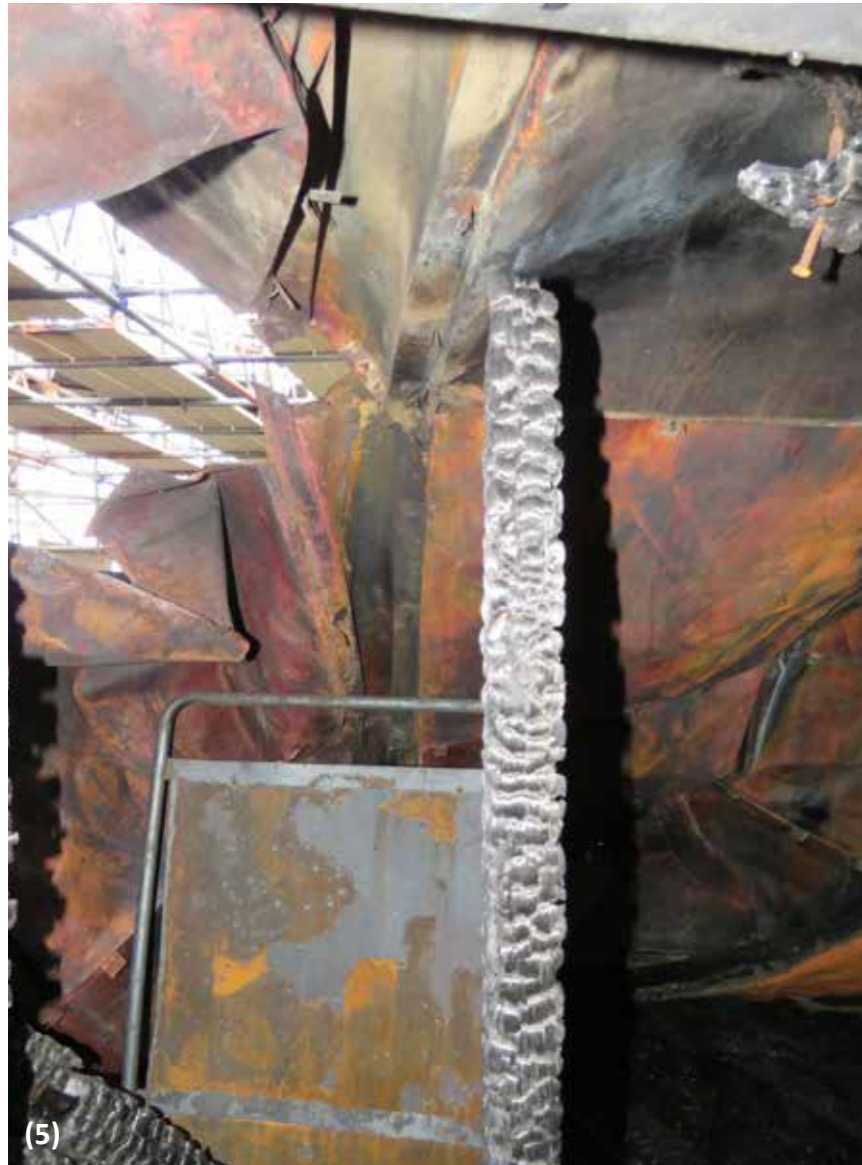
### 5. Underneath collapsed copper roof cladding

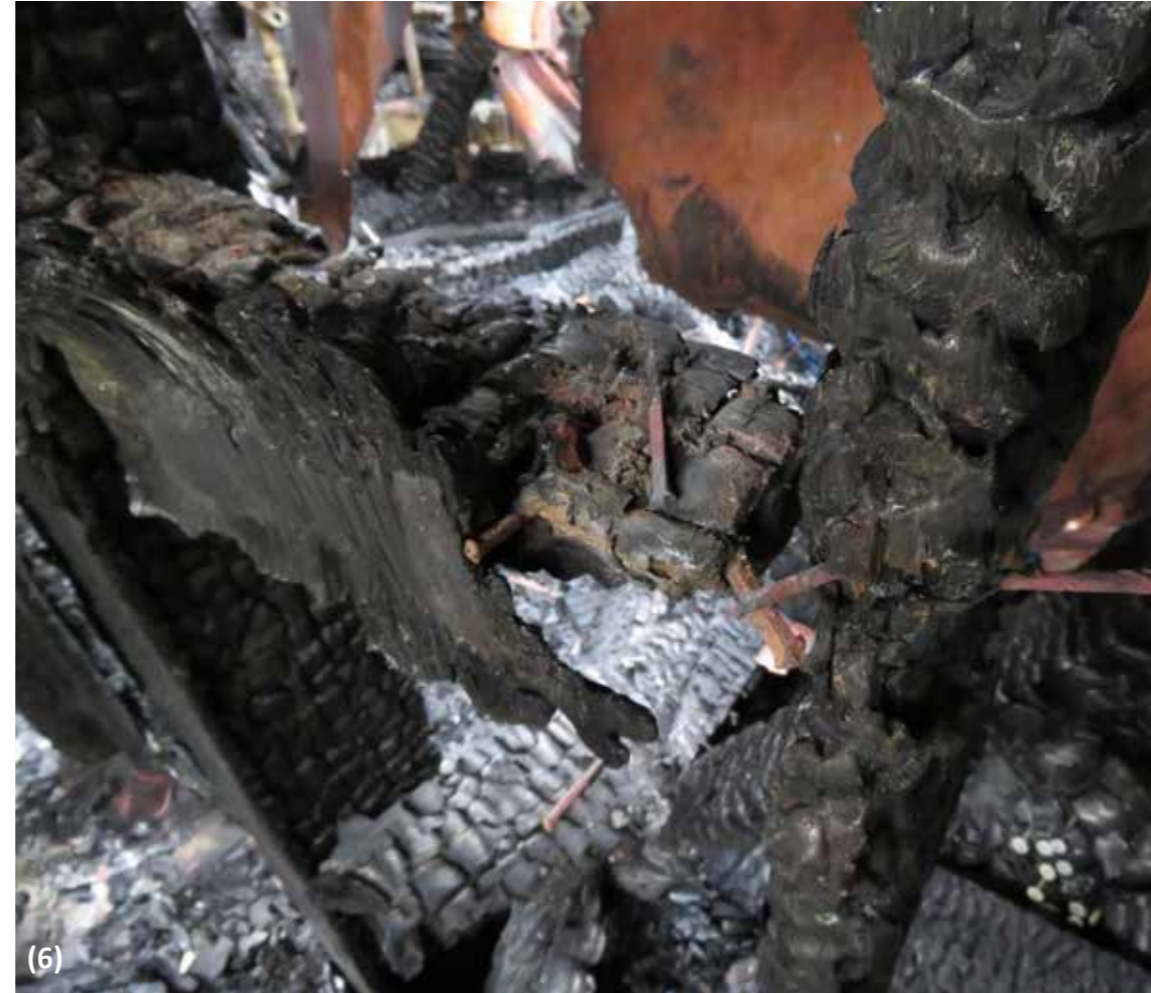
### 6. Detail showing wall stud ties and attachment to wall boarding

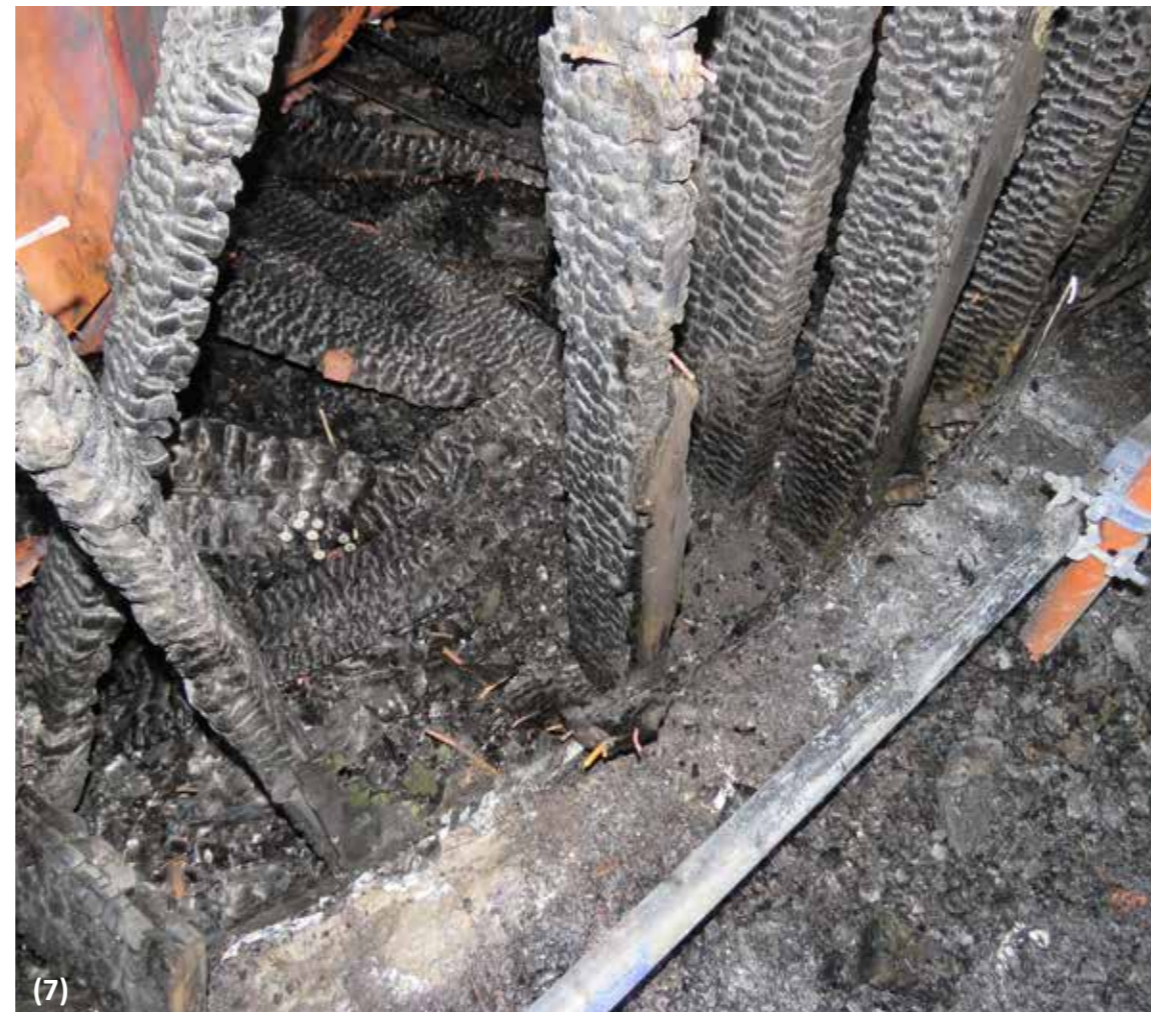
### 7. View of the domes' perimeter ring

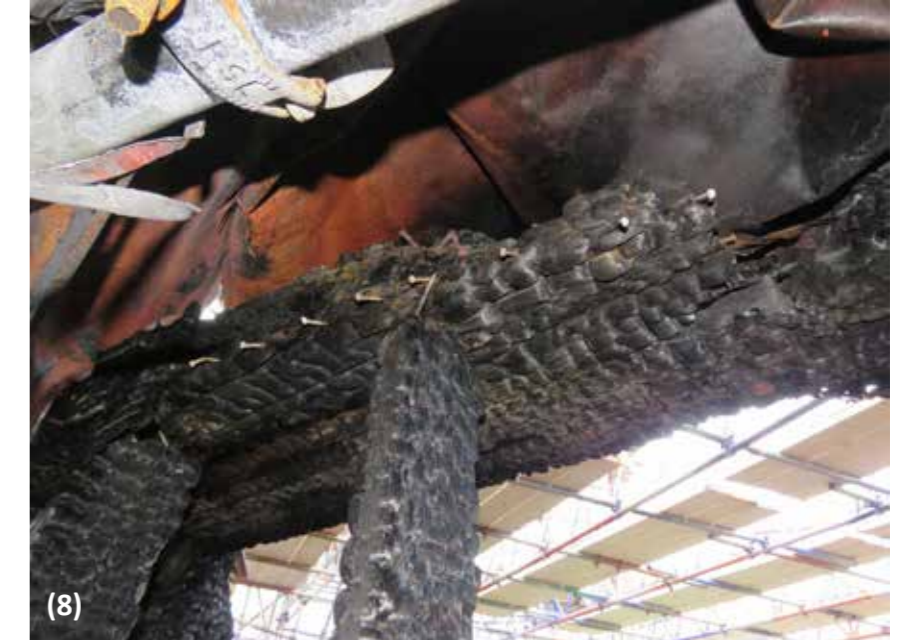
### 8. Charred upper rafter plate and wall studs

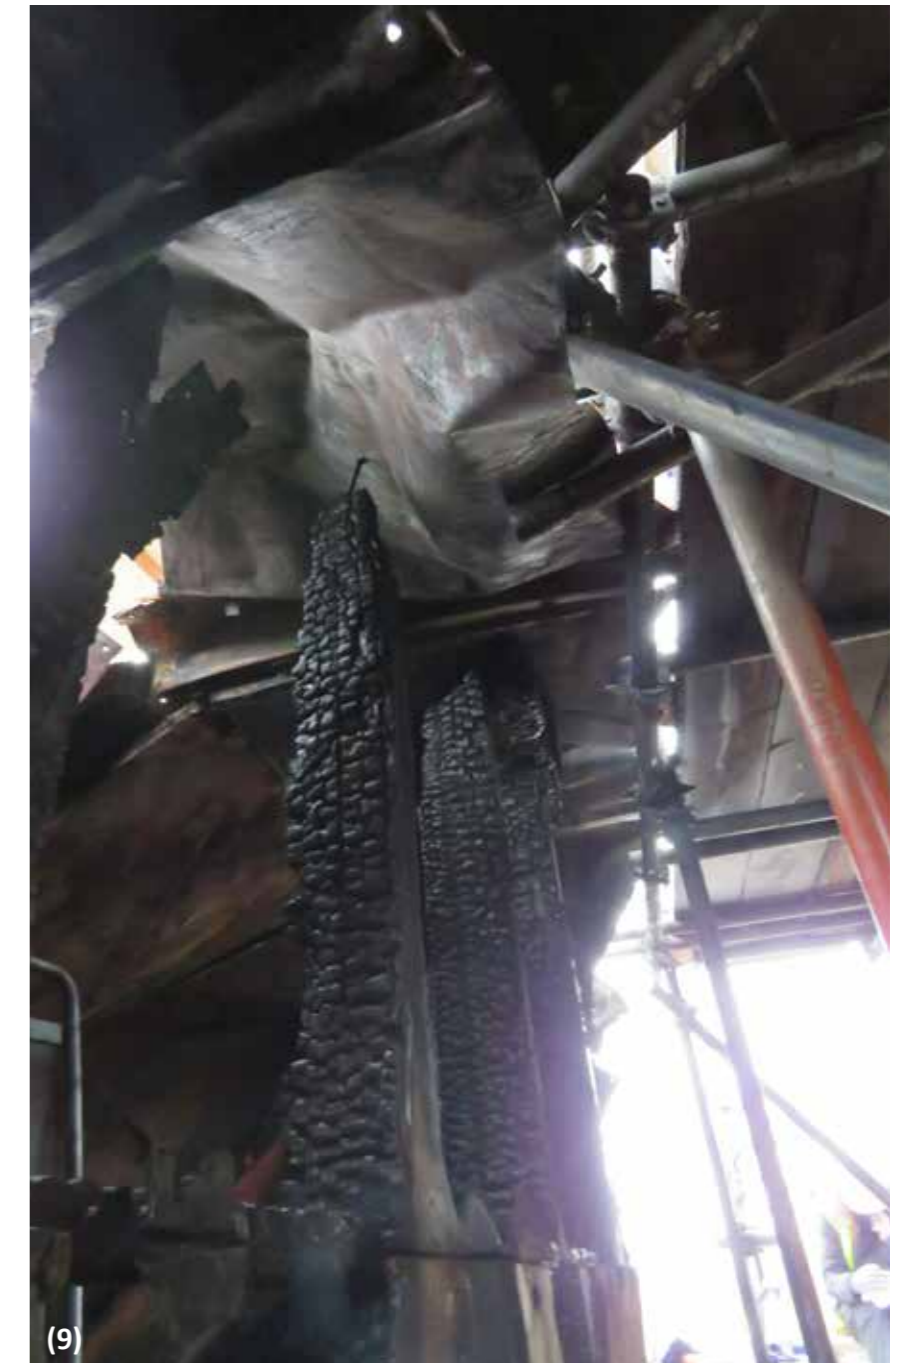
### 9. Loose copper debris overhanging the walls on the perimeter ring

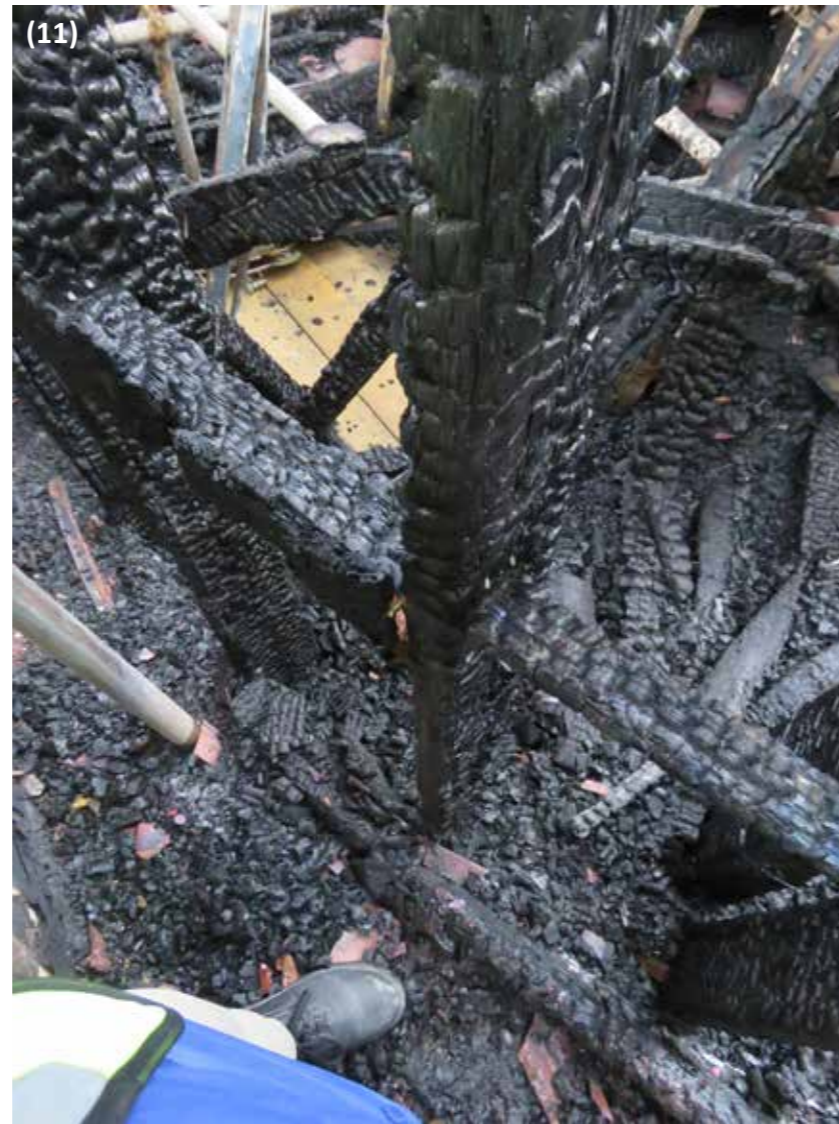
#### 11. Condition of perimeter ring by the hatch door

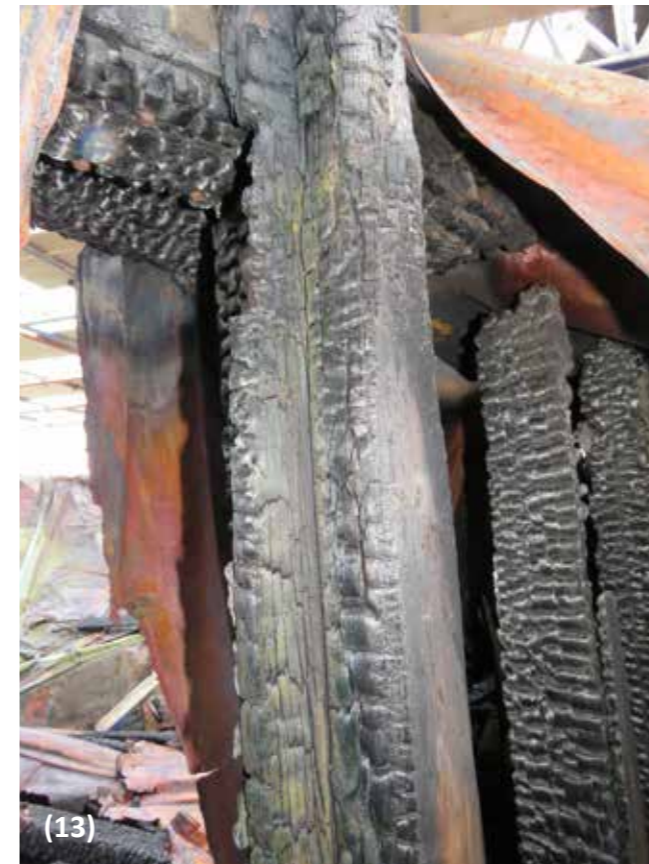
#### 12. Damaged wall structure along the perimeter ring

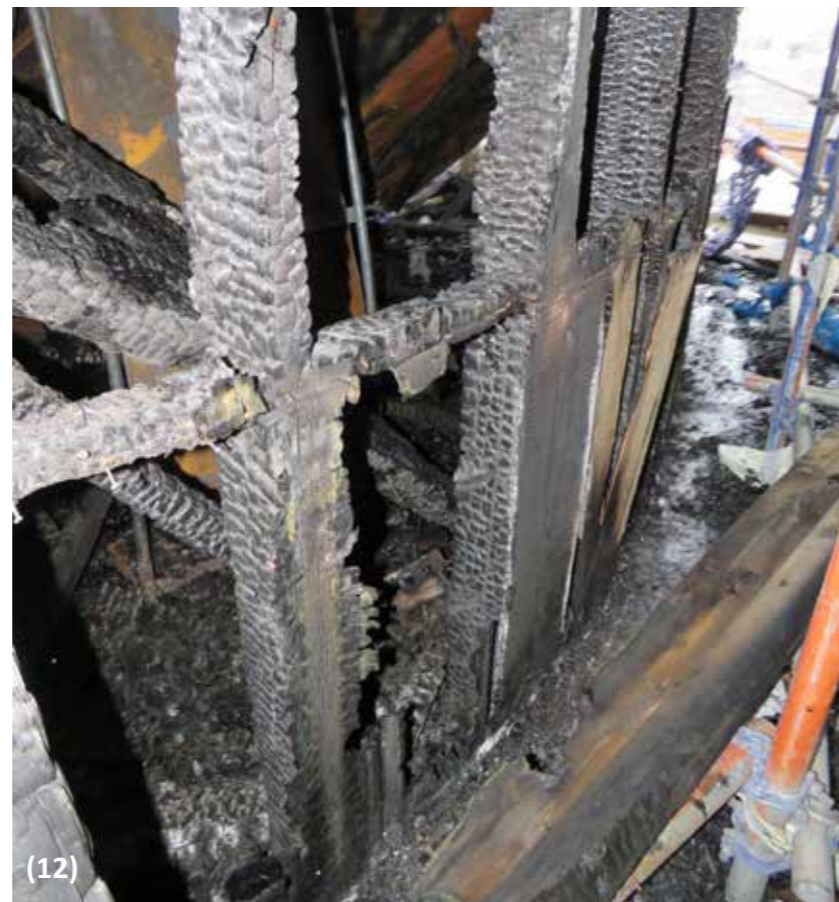
#### 14. Damaged wall structure along the perimeter ring

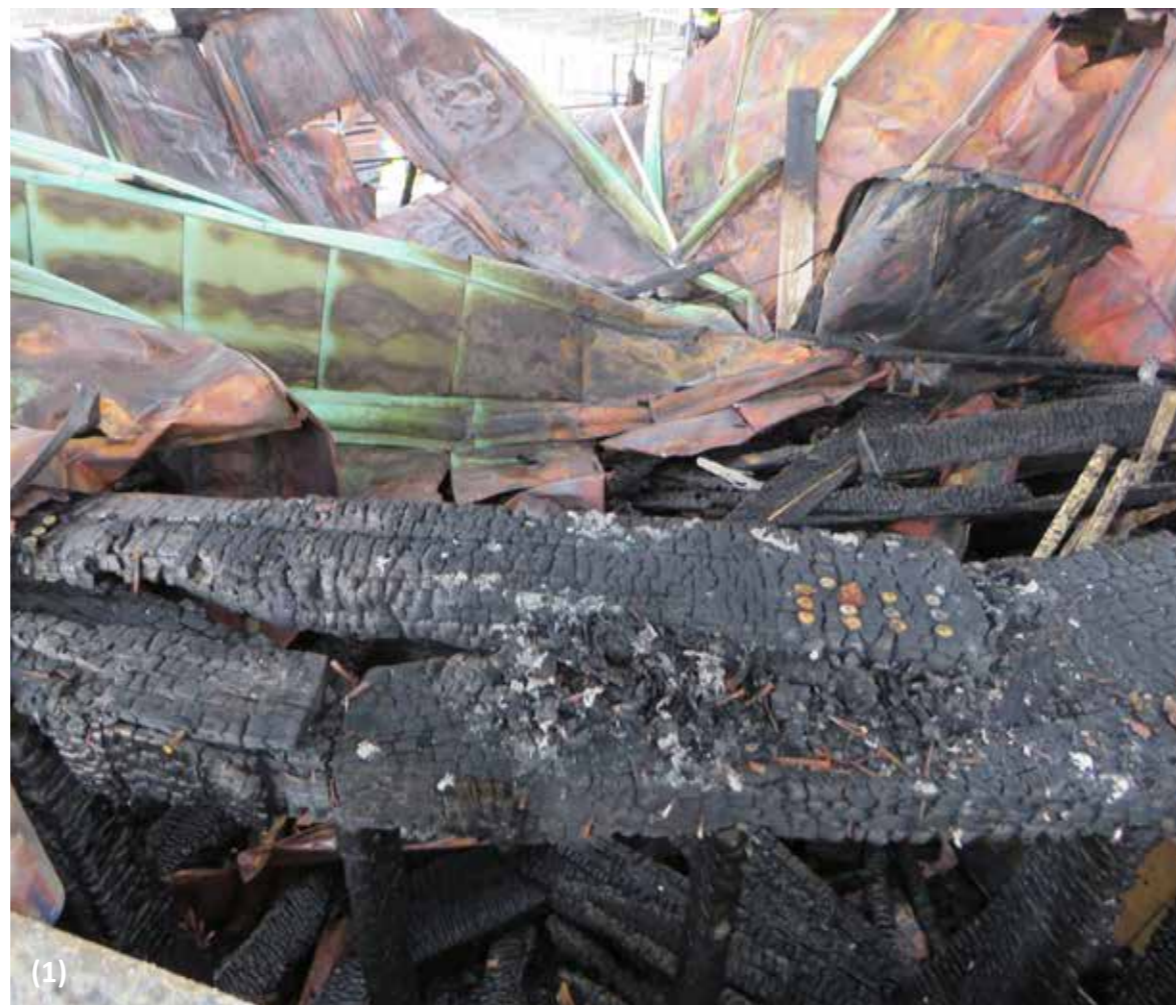
##### 1. Roof debris over partly standing wall structure

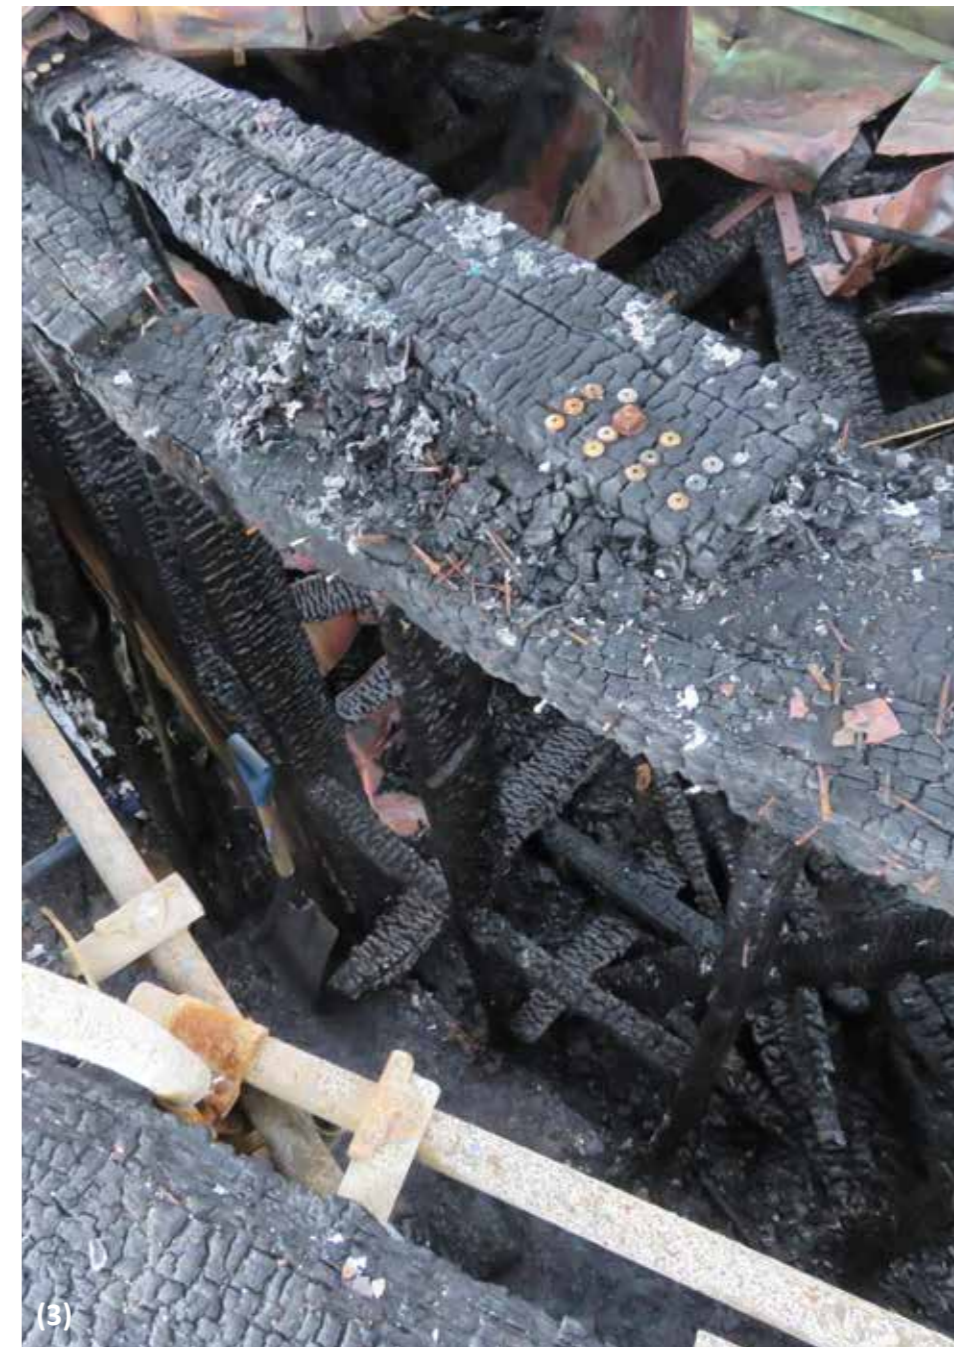
##### 3. Dome Condition Post Fire

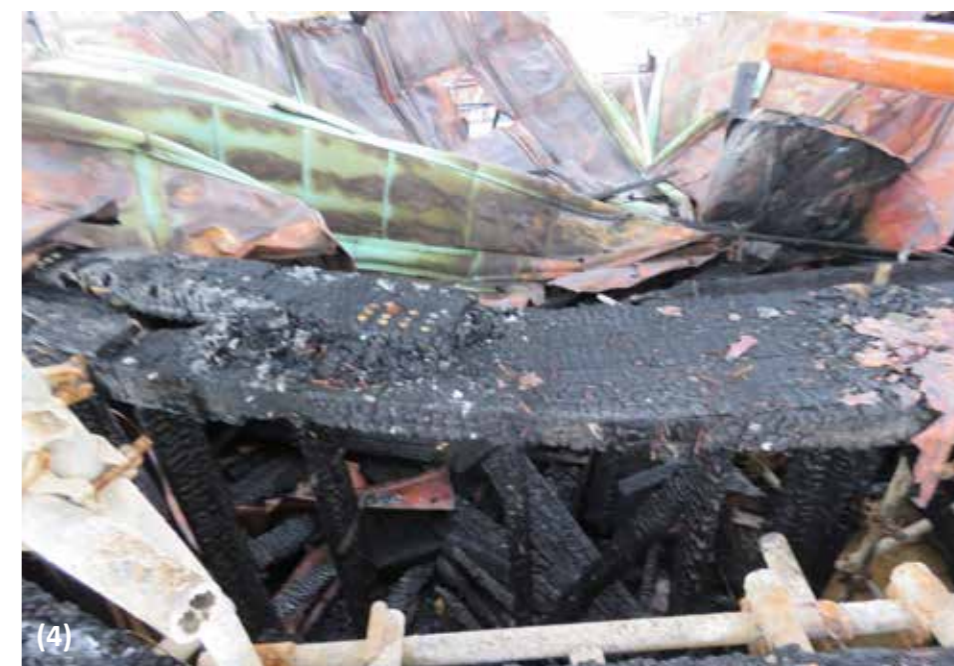
##### 4. Dome Condition Post Fire

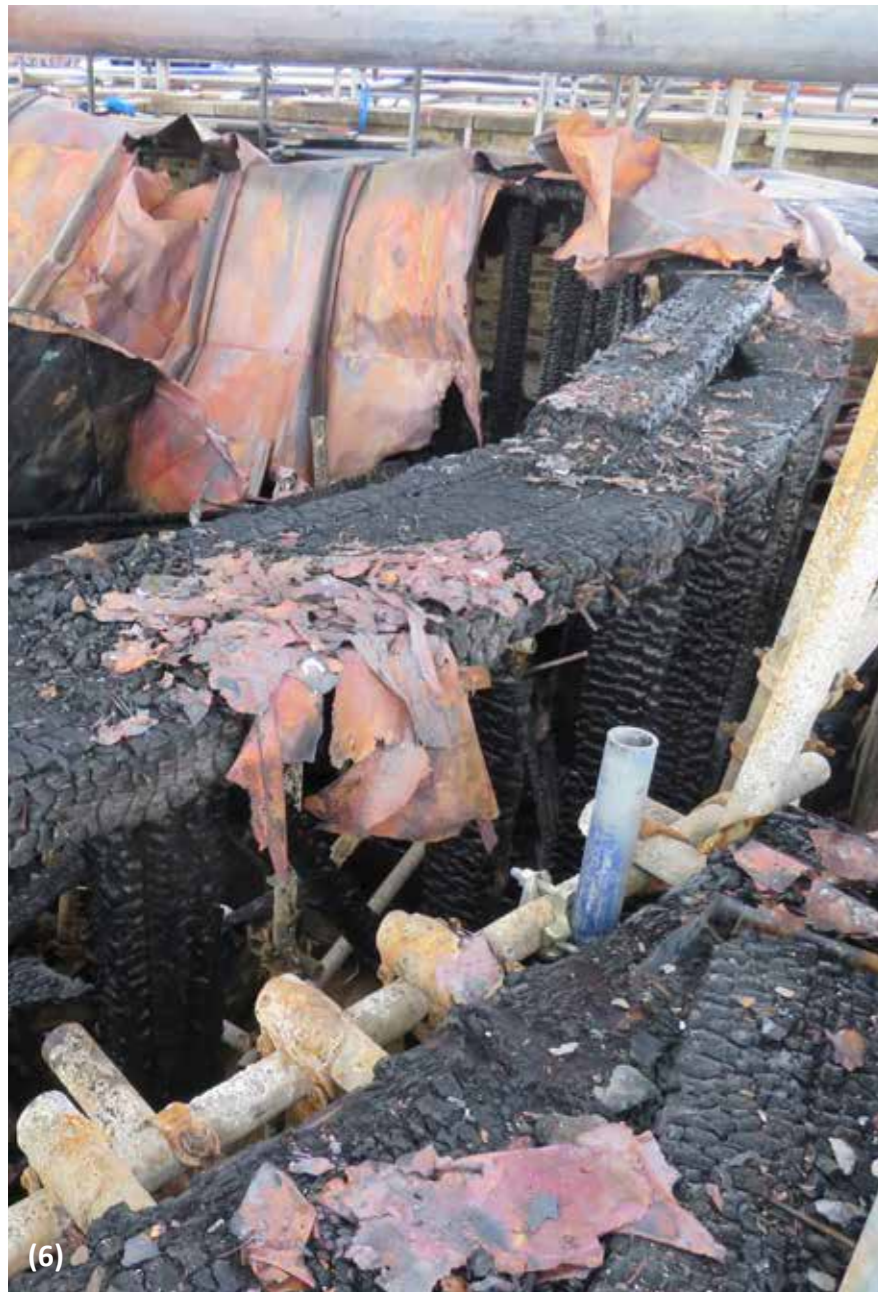
#### 6. Loose discoloured debris scattered over the upper rafter plate

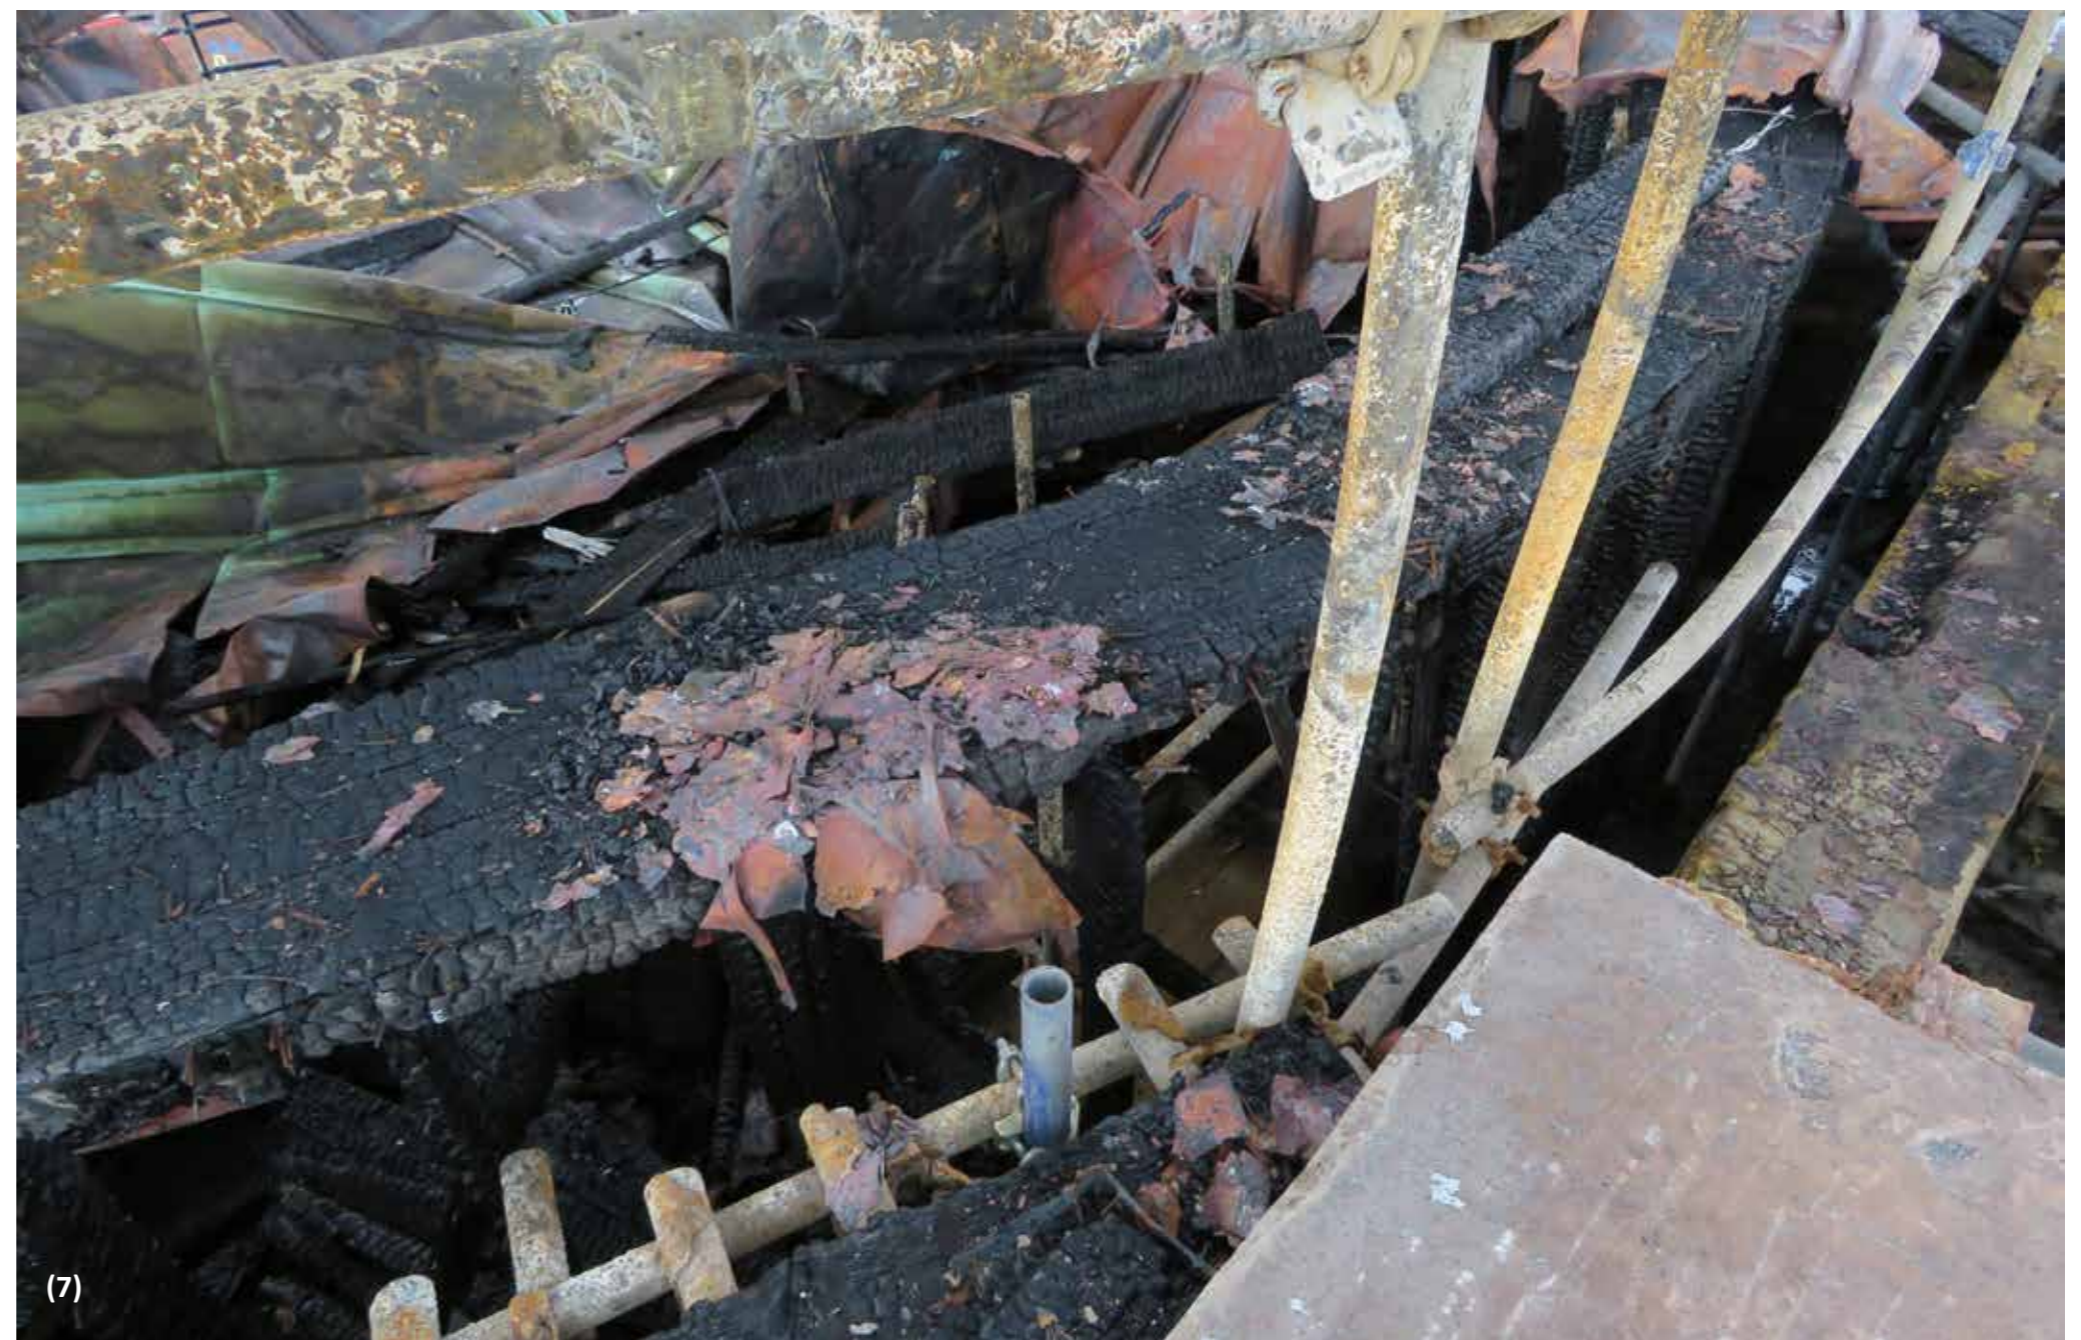
#### 7. Loose discoloured debris scattered over the upper rafter plate

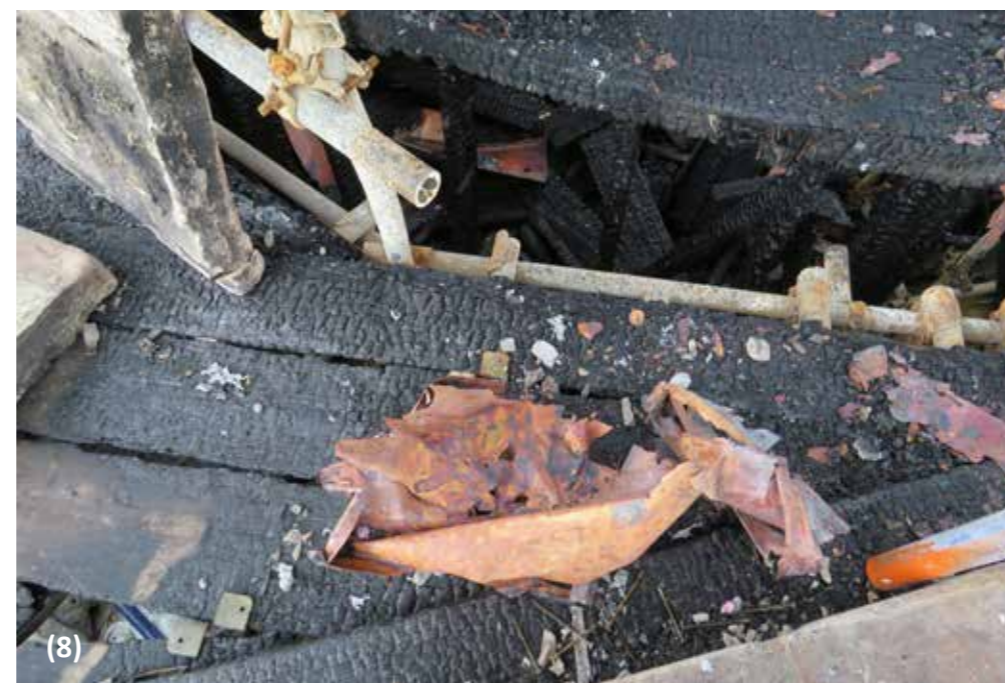
#### 8. Loose discoloured cooper debris scattered over scaffolding

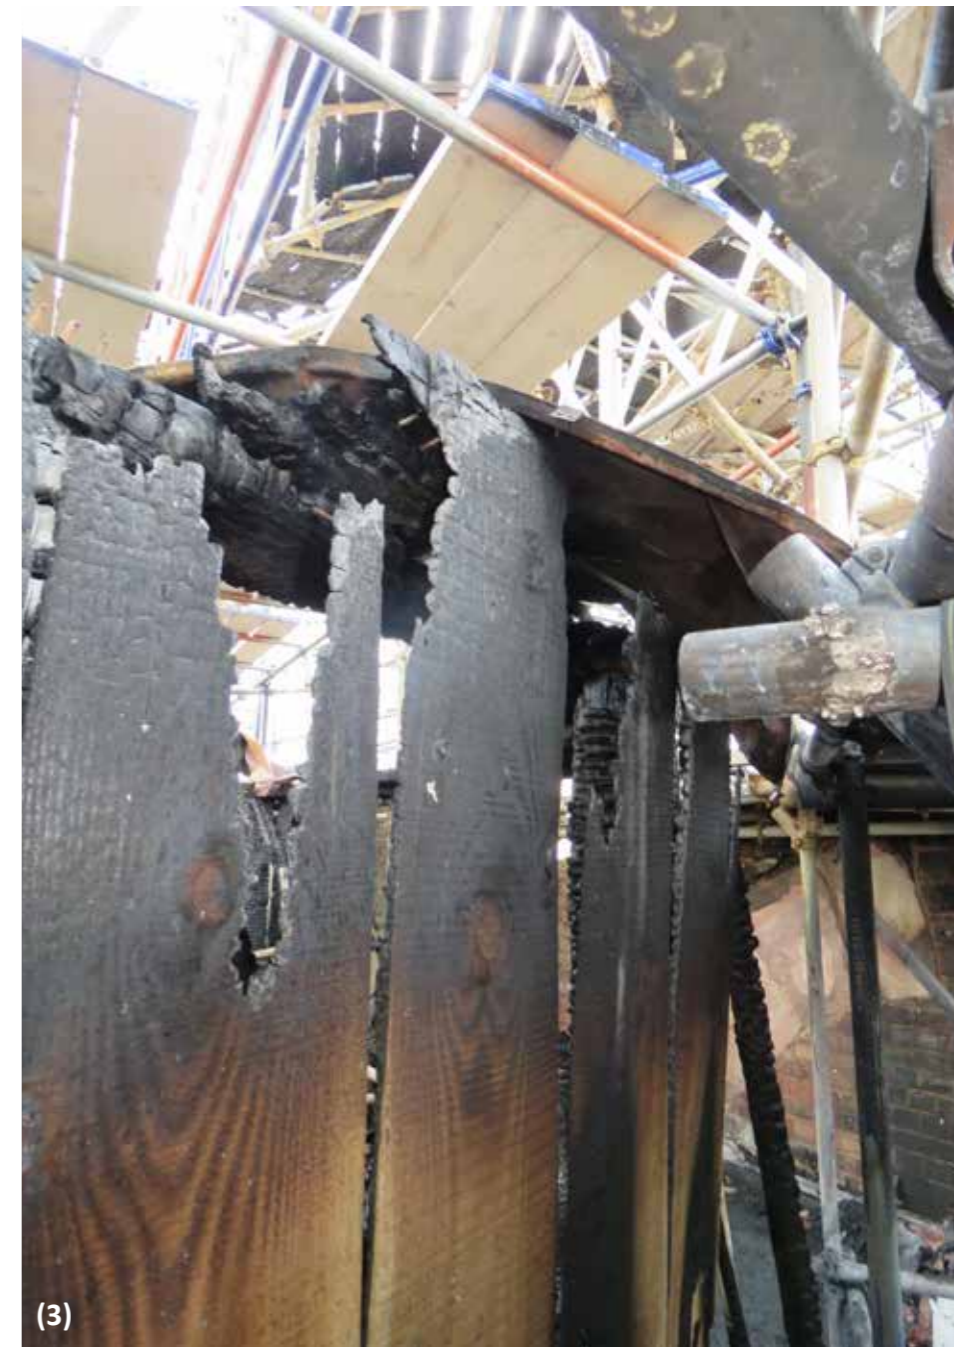
#### 3. Wall boardings with evident fire damaged

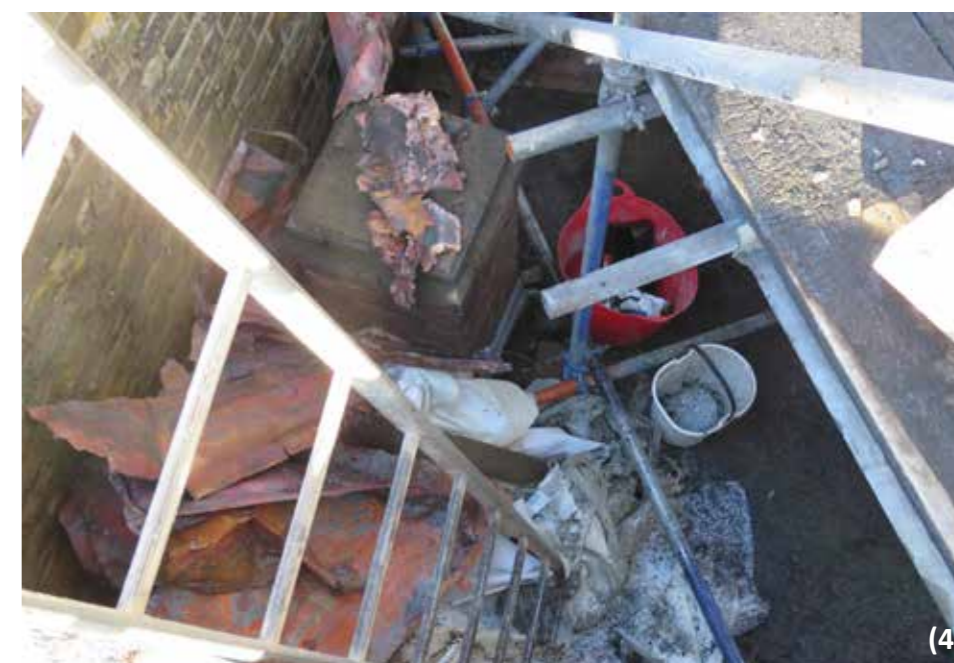
#### 4. Loose copper debris by the NW pier

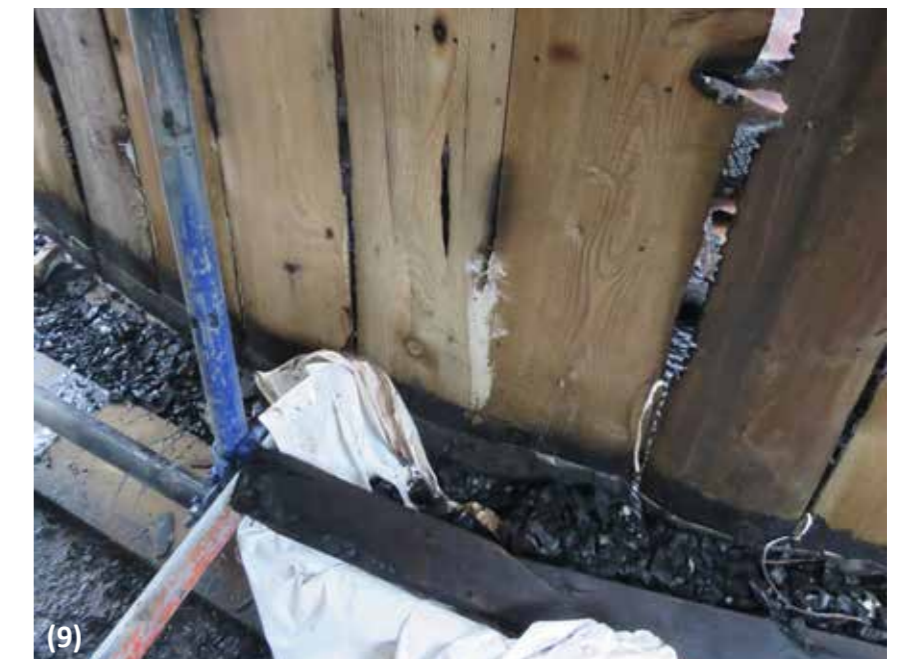
SLHA 13.02.2020 NW Section 5 (38)

### 9. Wall boardings with evident fire damaged

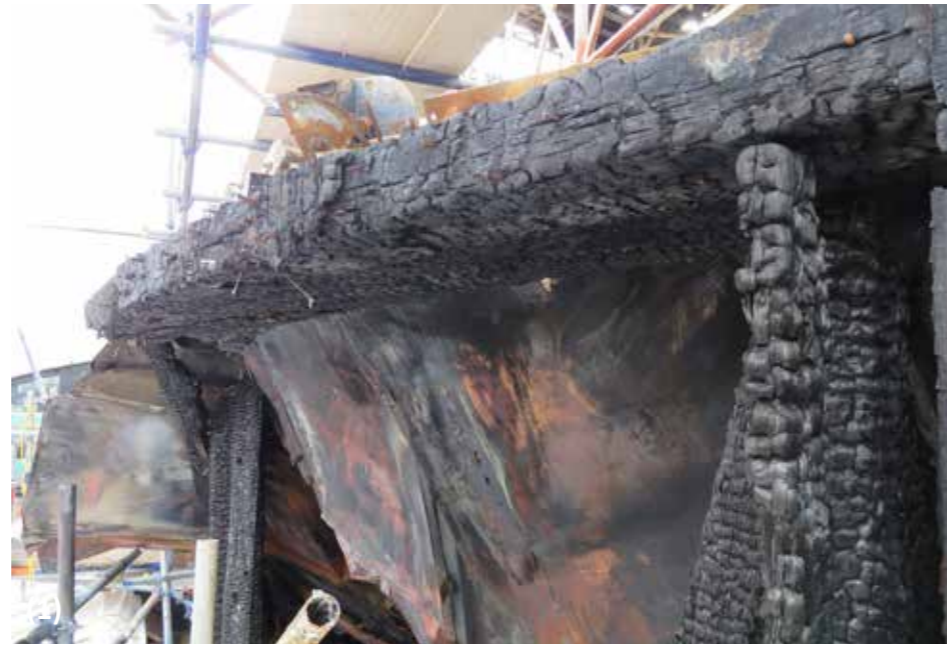
SLHA 13.02.2020 NE Section 6 (32)

#### 1. Charred outer upper rafter plate

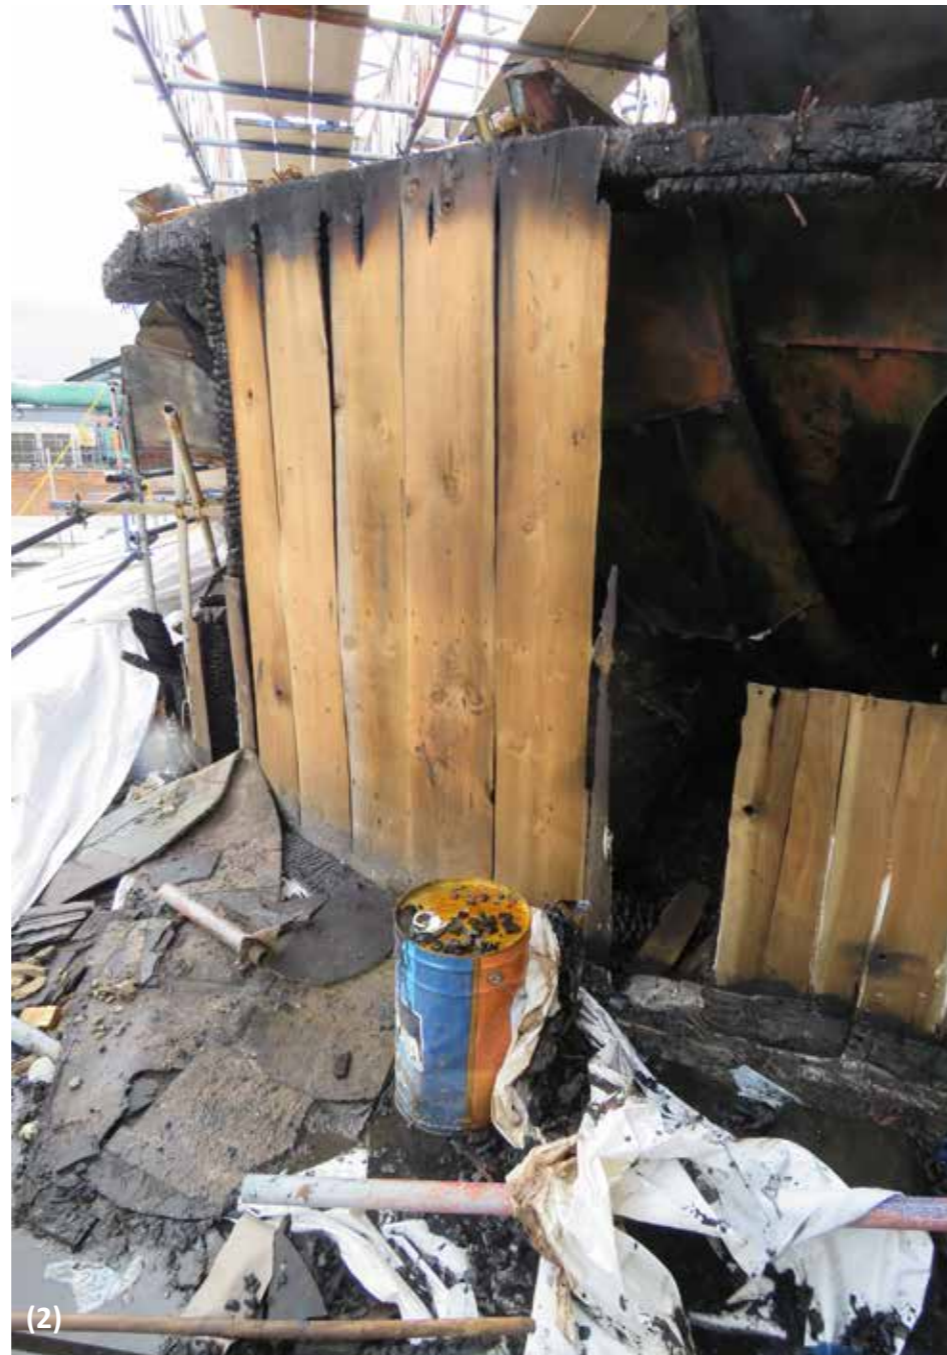
SLHA 13.02.2020 NE Section 6 (36)

#### 2. Wall boarding with minimal damaged compared to rest

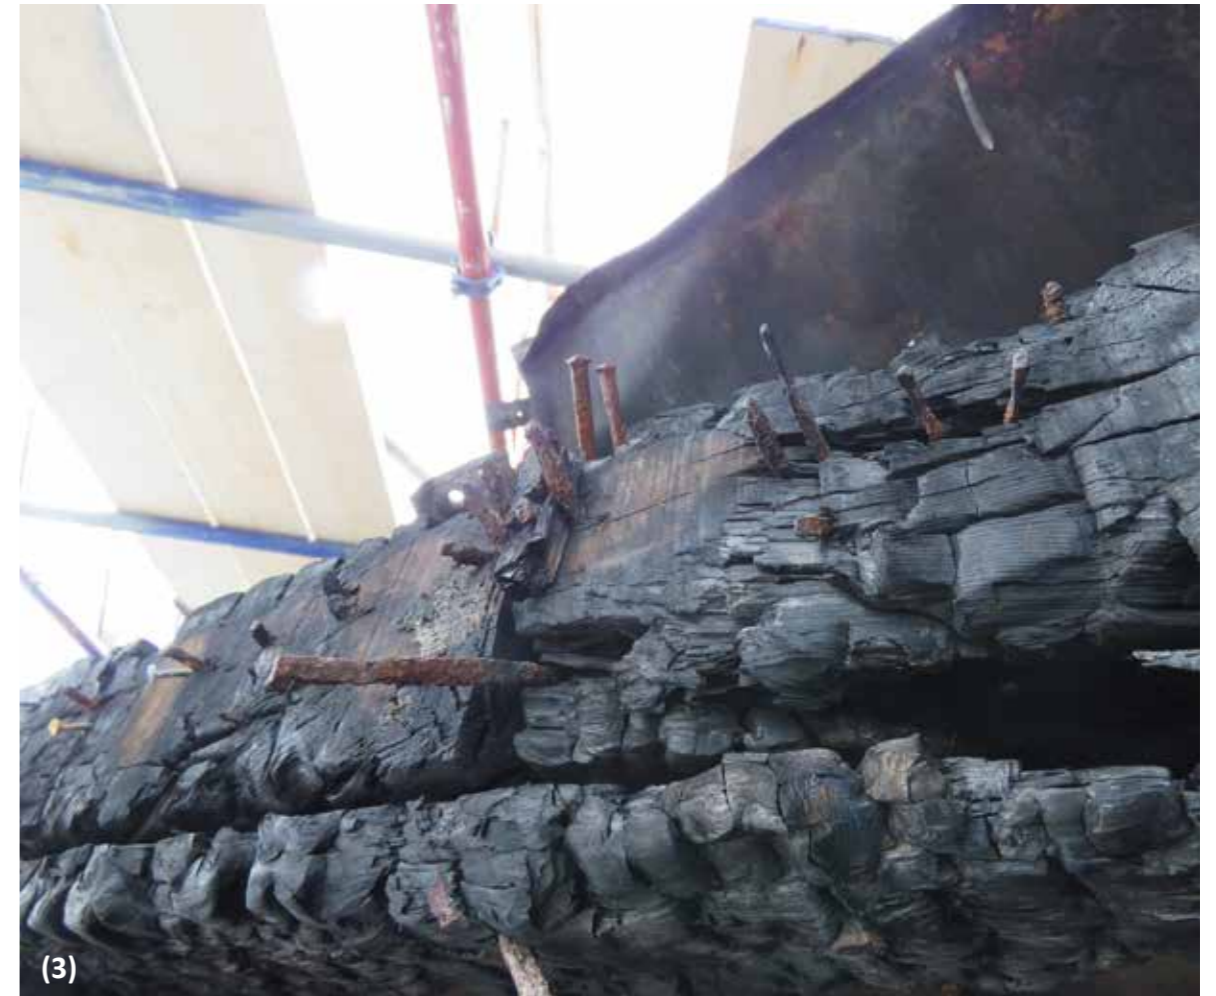
SLHA 13.02.2020 NE Section 6 (22)

#### 3. Historic nails used for construction on the rafter plate

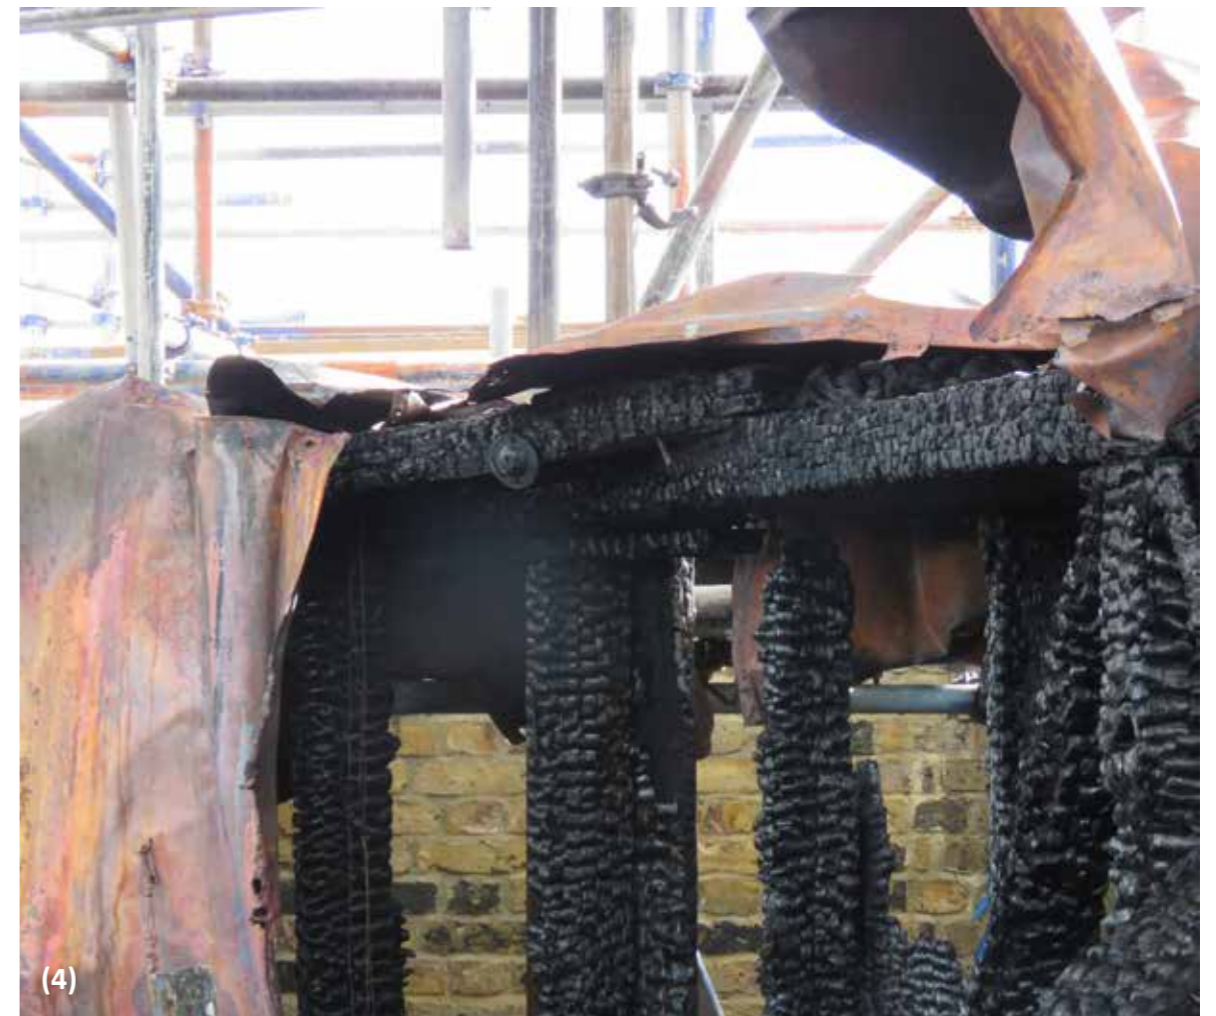
SLHA 13.02.2020 NE Section 6 (50)

#### 4. View of corner junction of horizontal rafter wall tie

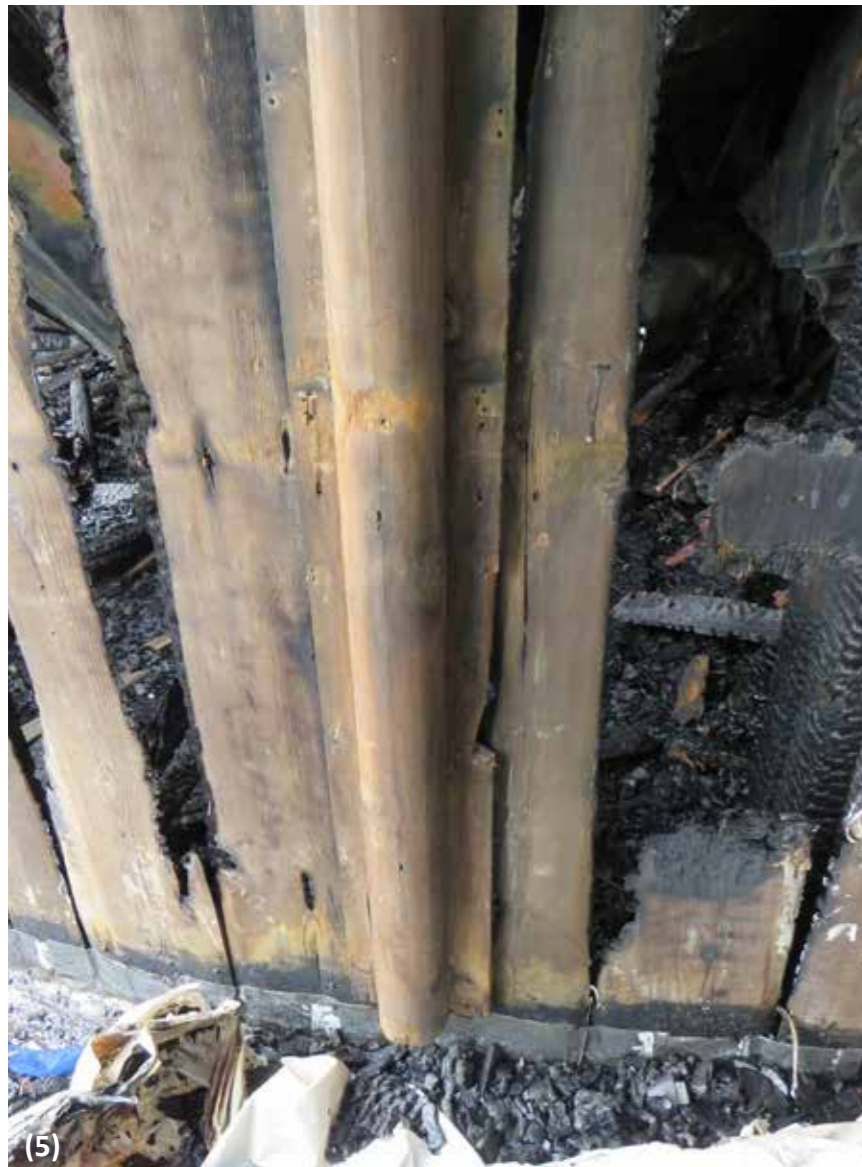
SLHA 13.02.2020 NE Section 6 (6)

### 5. Slightly damaged timber roof roll at base level
