## 7.1 APPENDIX: POST-FIRE PHOTOGRAPHIC SURVEY- INITIAL SITE VISIT

## 7.2 APPENDIX: POST-FIRE PHOTOGRAPHIC SURVEY- PRE-DEBRIS REMOVAL

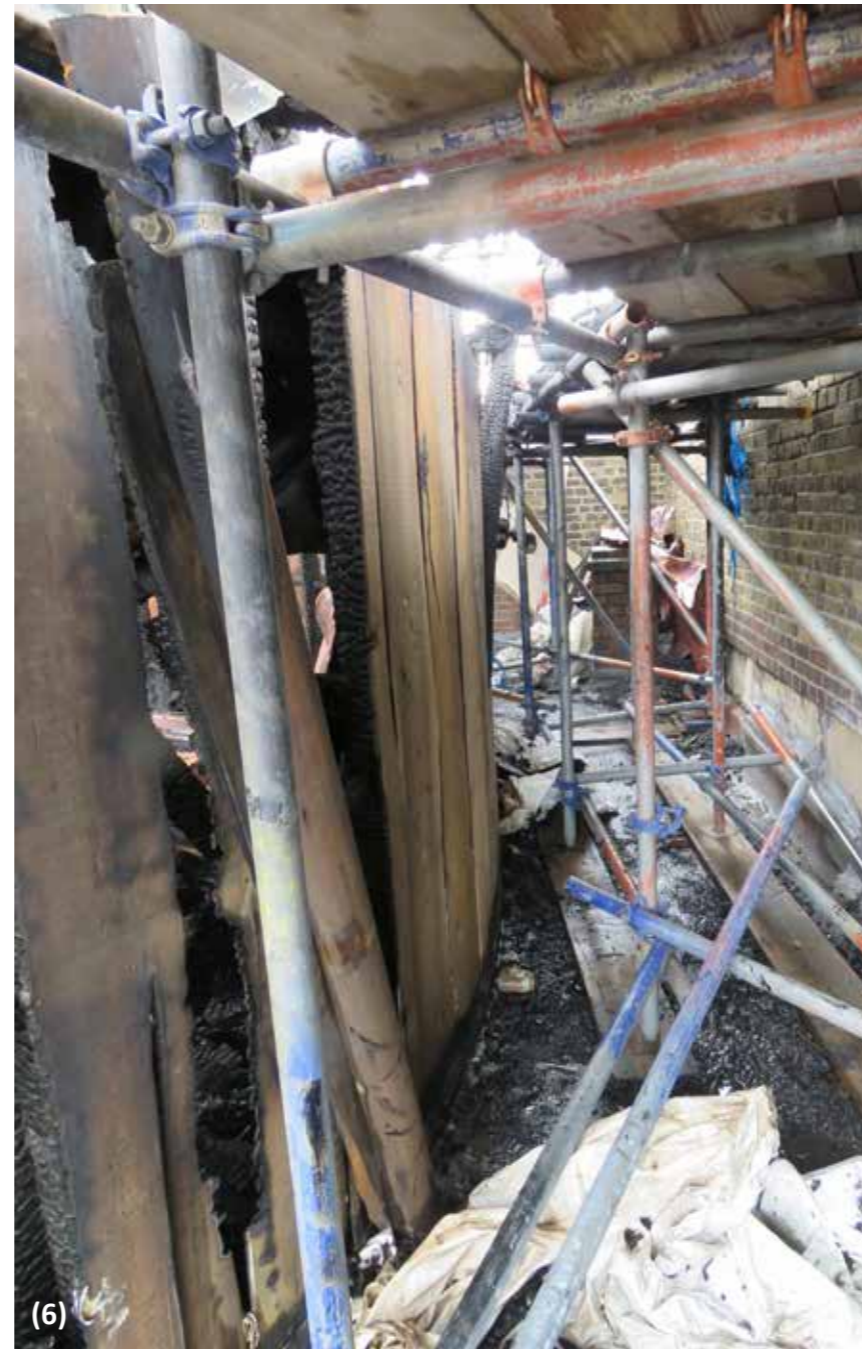
SLHA 13.02.2020 NE Section 6 (4)

### 6. View of wall structure on perimeter ring

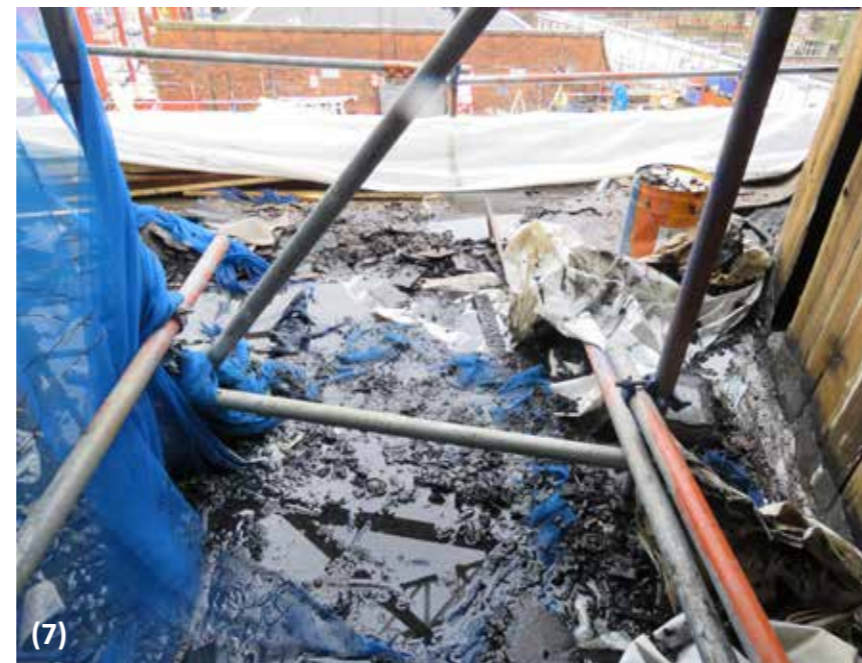
SLHA 13.02.2020 NE Section 6 (1)

### 7. Build up of rainwater on on NE corner

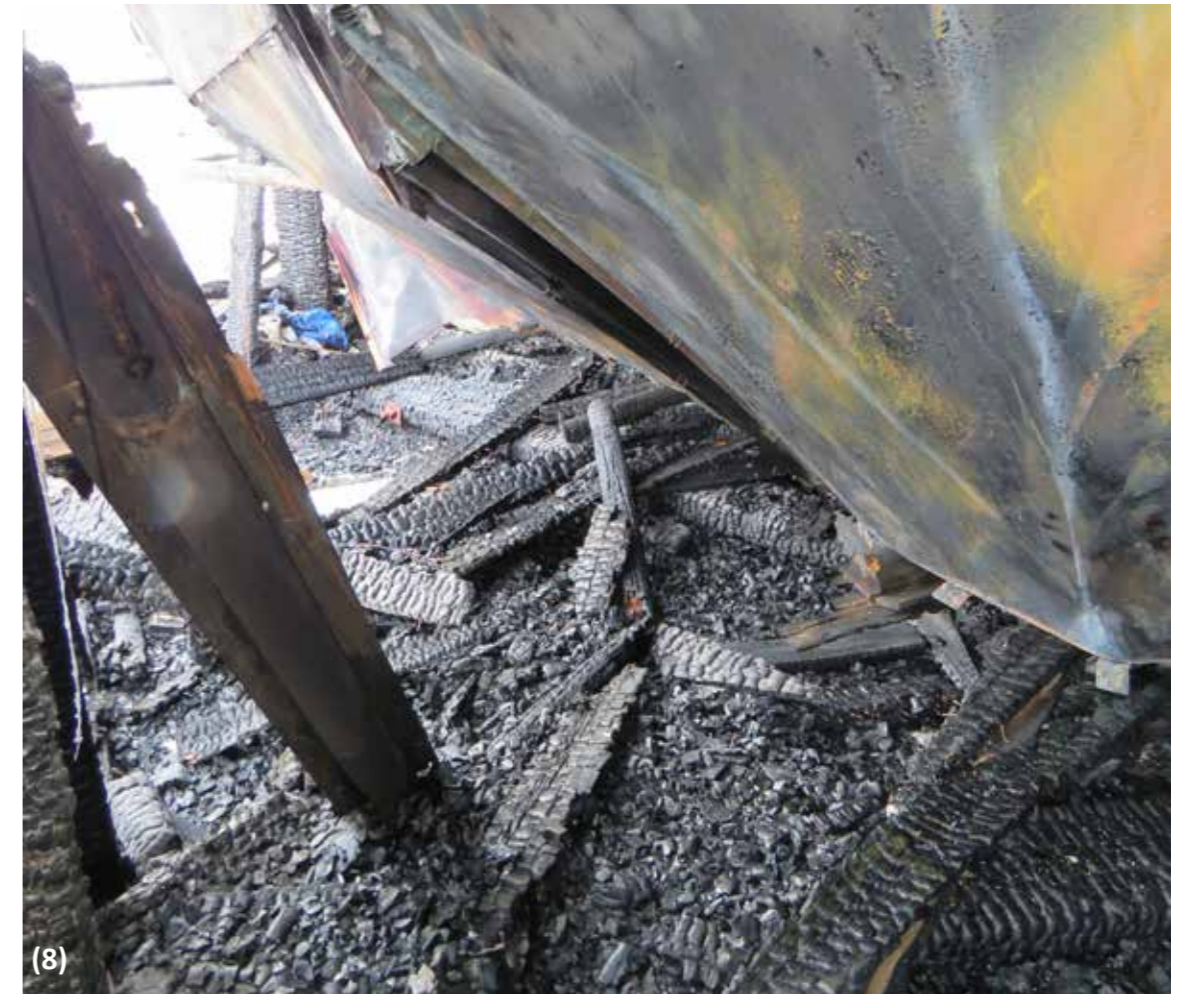
SLHA 13.02.2020 NE Section 6 (39)

### 8. Timber roof roll from roof debris

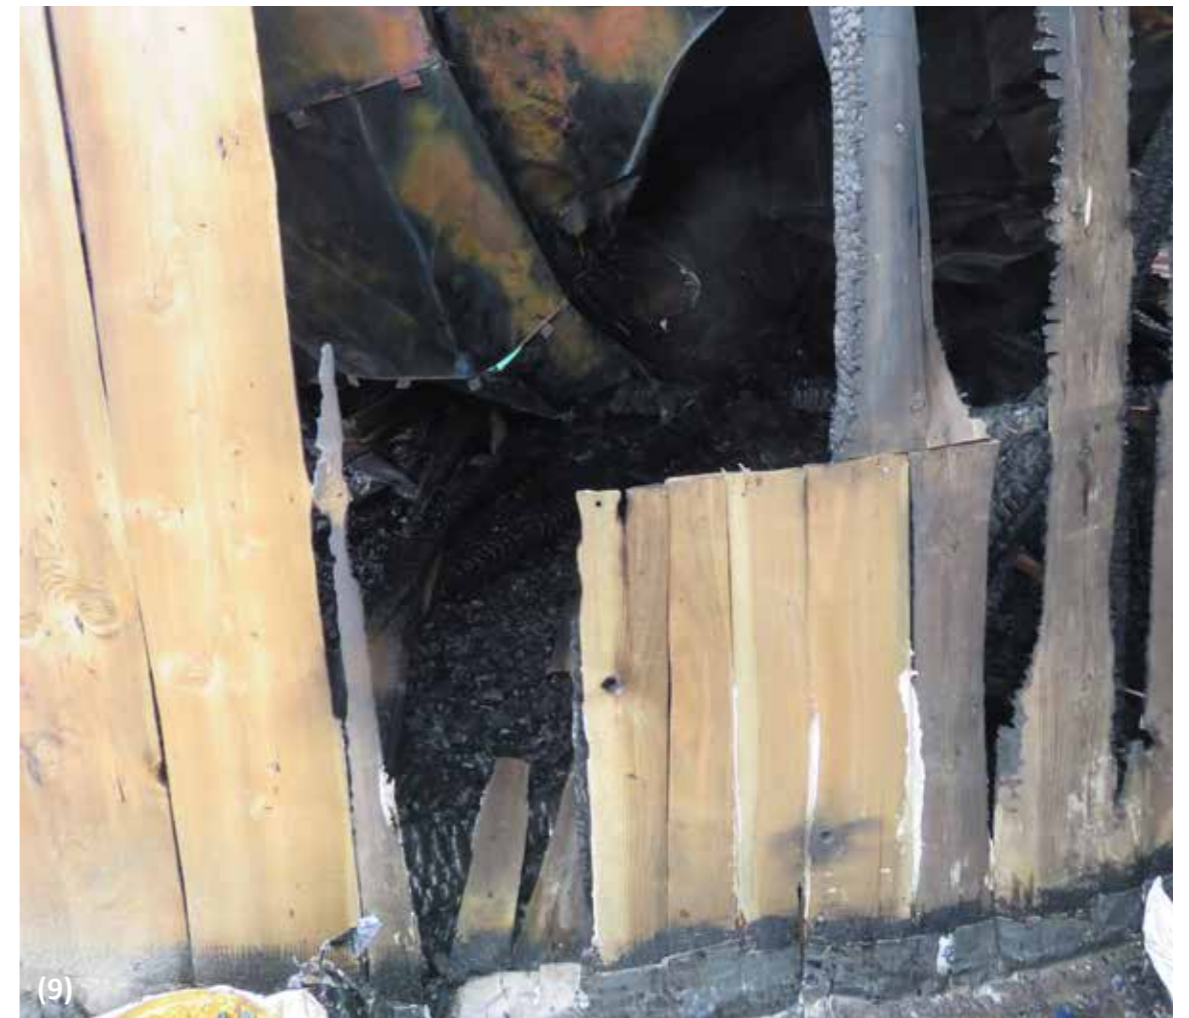
SLHA 13.02.2020 NE Section 6 (12)

### 9. Further damaged wall boarding
