**Window/Door Report**  
**40 Chester Terrace**  
**London**  
**NW1 4ND**

**BA Ref: P20-265**

**June 2020**

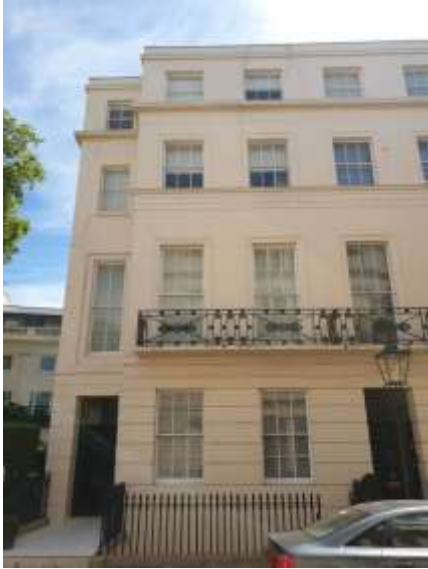
West Elevation (Front)  
General arrangement

- 1.2.1 The Front (West) elevation windows are in generally good condition. Fine lambs tongue mouldings remain. There is some evidence of timber rot to cills and lower frames to upper stories in particular. Original glass replaced with float glass generally.

- 4.1.2 West and North elevation windows require overhaul generally and isolated treatment of timber rot by splicing in new timber or careful use of proprietary epoxy resin repair system.

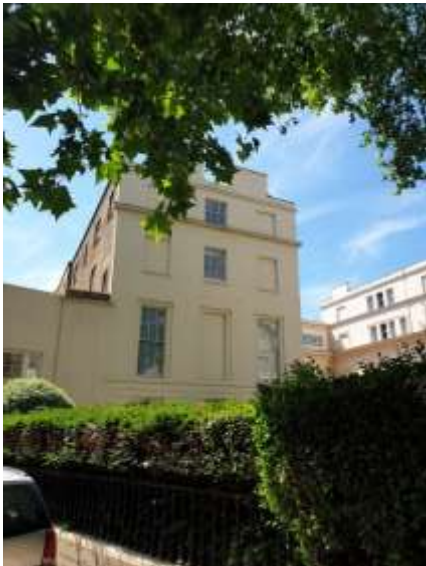
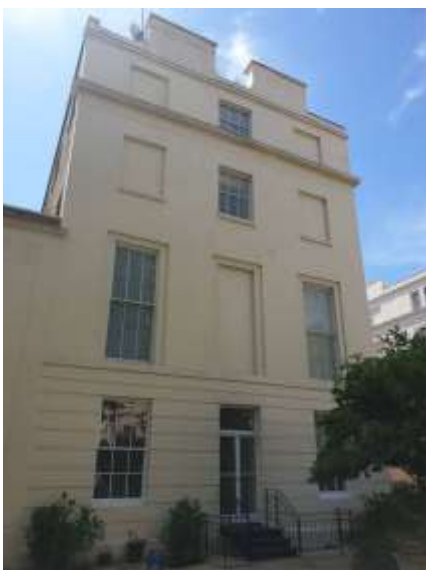
North Elevation (Left)  
General arrangement

- 1.2.2 The Left (North) elevation windows are in generally good condition. Fine lambs tongue mouldings remain. There is some evidence of timber rot to cills and lower frames to upper stories in particular. Original glass replaced with float glass generally.

- 1.3.1 The two pairs of external doors to the Left (North) elevation are likely not original. They are worn and daylight was observed between leaves. Consideration should be given to replacement with more sympathetic design, glazing bars to match elsewhere and appropriate ironmongery.
- 1.3.2 The internal doors surveyed are all modern, replacements with modern hinges and door furniture. They are in in good operational and decorative condition.

- 4.1.3 North elevation doors require major overhaul. Consideration should be given to replacement with more sympathetic design, glazing bars to match elsewhere and appropriate ironmongery.

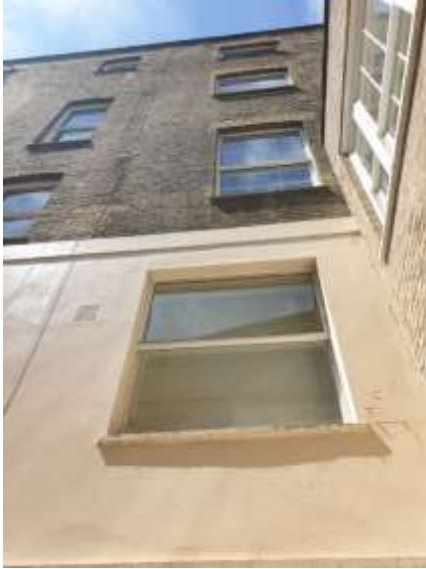
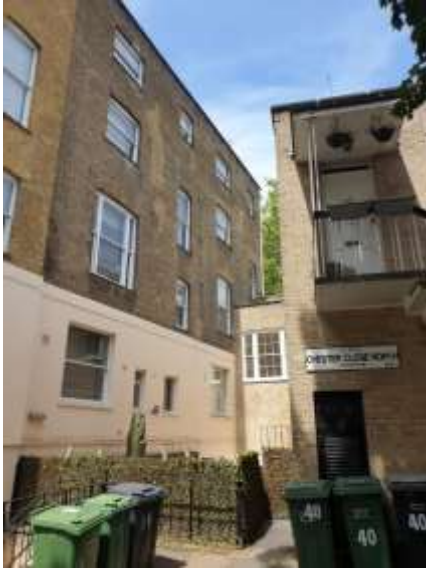
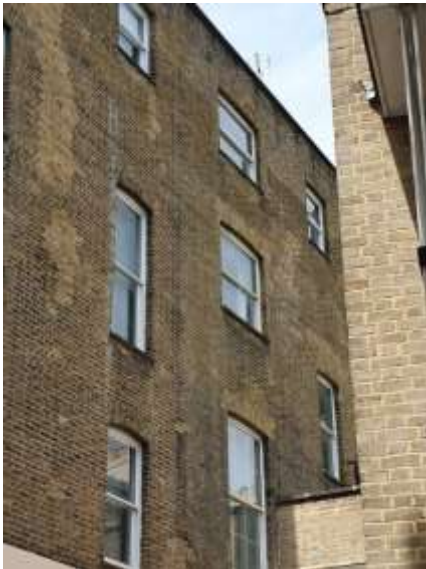
East Elevation (Rear)  
General arrangement

- 1.2.3 The Rear (West) elevation windows are in fair to poor condition. All have been significantly altered with the introduction of double glazed units and brush seals. Generally slimlite double glazed units have been installed to the upper sashes with unsightly aluminium spacer bars used to lower sashes.

- 3.1.5 East (Rear) elevation;  
Painted timber vertical sliding sash windows.  
Glazing; All windows have had replacement double glazed units installed. Generally slimlite type units to the upper sashes and more basic units with aluminium spacer bars to the lower sashes.  
Comments; Window frames generally in good condition. Some worn sashes and timber rot to upper floors. All windows have been previously refurbished with the introduction of rebated draught stripping and all double glazed as noted above. Glazing format is consistent with original with the exception of Window W1.05 which has had unsympathetic mock glazing bars added behind the outer glazing pane. All sash mechanisms appear operable but window restrictors are fitted throughout.  
Ironmongery; All sash locks and finger lifts have been replaced with modern units.

- 4.1.4 East elevation windows require the most attention. Most are in fair to poor condition but require varying levels of remedial work. The double glazing and particularly the fake glazing bars to W1.05 detract from the appearance of the building and consideration should be given to replacement with appropriate materials/design.

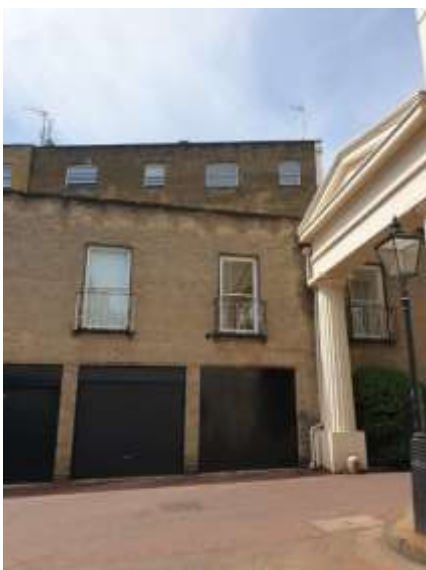
East Elevation (Rear)  
General arrangement  
Garage Block

- 1.2.4 The rear garage conversion has modern replica windows. The frames and glazing bars are a good aesthetic match. They are glazed in single 8mm float glass. All in good condition.

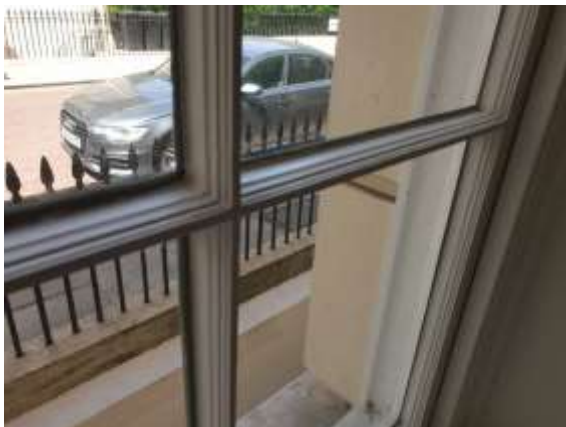
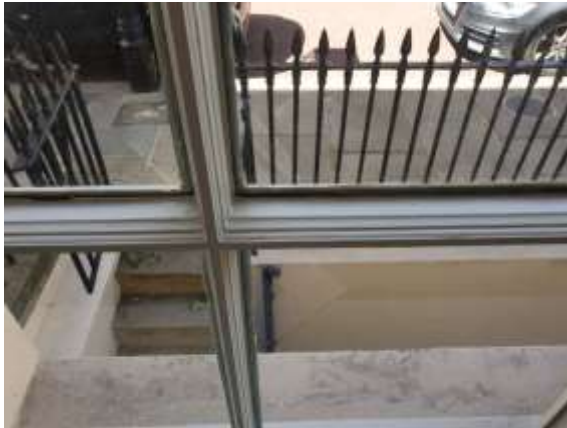
WG.02  
Reception/sitting room  
All windows in good condition  
Evidence of previous refurbishment  
including insertion of brush draught  
proofing and replacement glass.

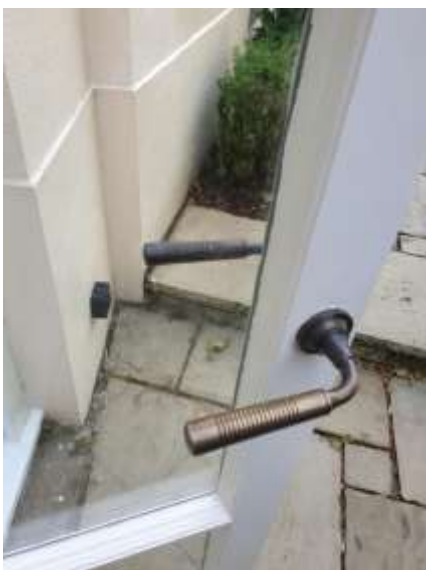
The double doors to the garden (WG.04) are painted timber with slim lambs tongue glazing bars and modern float glass. The door leaves themselves are worn and there are daylight gaps where the two leaves meet.

WG.04  
Dining  
Doors in fair condition but poorly fitting in frame.  
Evidence of previous alteration /replacement and replacement glass.

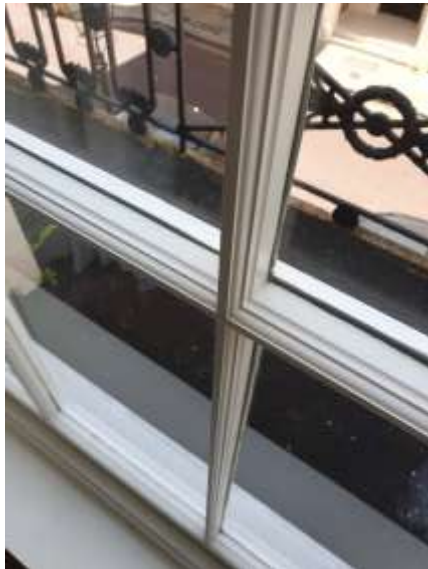
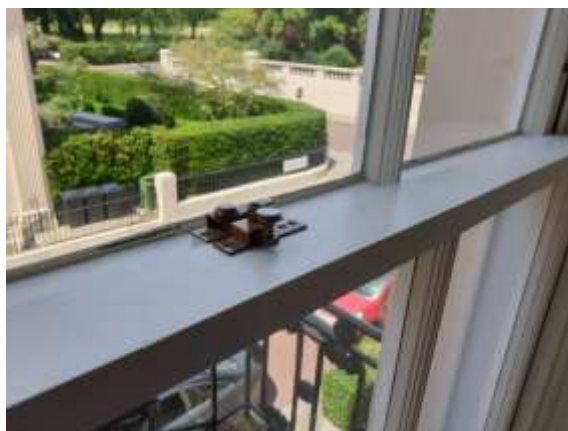
W1.03  
Master Bedroom

W1.02 / W1.03  
Internal view Master Bed  
All windows in good condition  
Evidence of previous refurbishment  
including insertion of brush draught  
proofing and replacement glass.

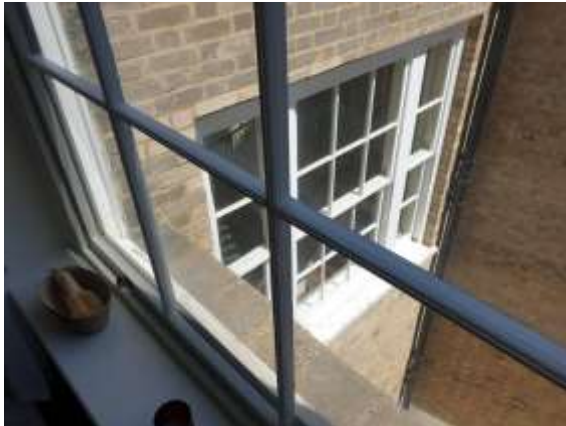
W1.05  
Master En Suite  
Slimlite Double Glazed upper  
Double glazed Alum spacer bottom

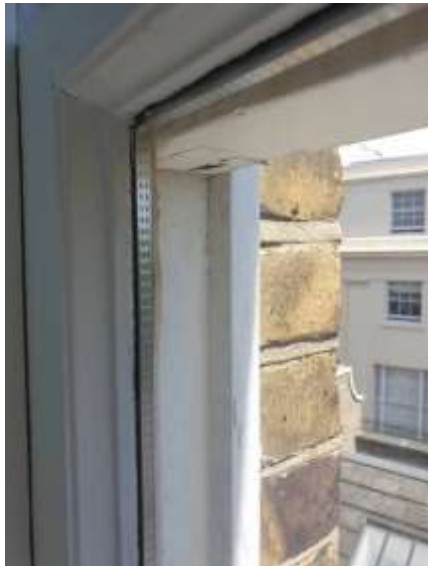
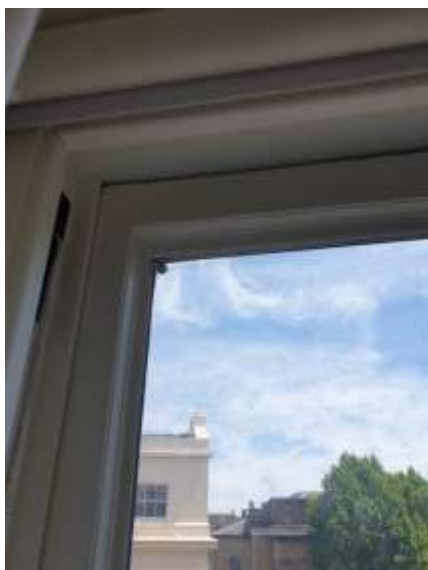
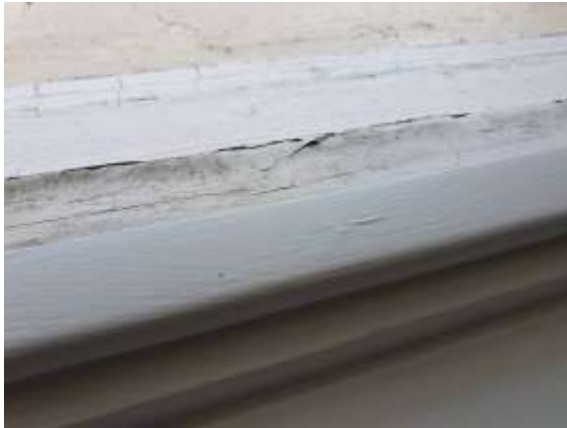
W2.04  
Guest Bedroom 2  
Slimlite Double Glazed upper  
Double glazed Alum spacer bottom

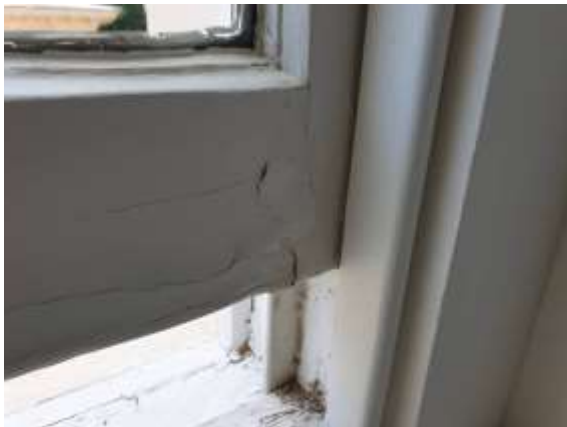
W2.04  
Guest Bedroom 2  
Some rot to cill and lower frames

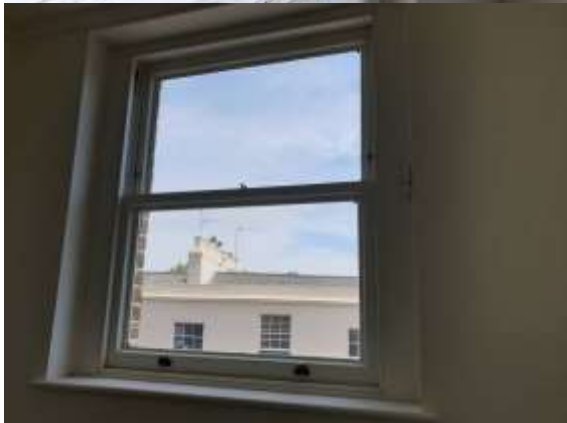
W2.05  
Stairwell Rear  
Slimlite Double Glazed upper  
Double glazed Alum spacer bottom

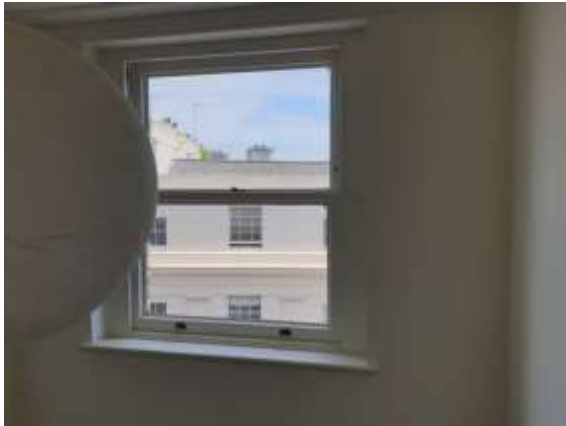
W3.05  
Stairwell Rear  
Slimlite Double Glazed upper  
Double glazed Alum spacer bottom

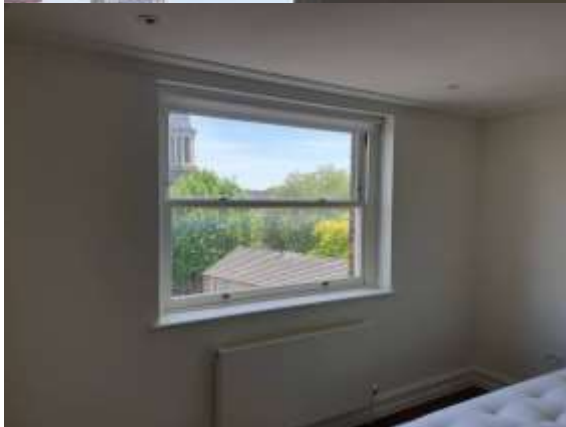
W3.04  
Back Bedroom  
Slimlite Double Glazed upper  
Double glazed Alum spacer bottom

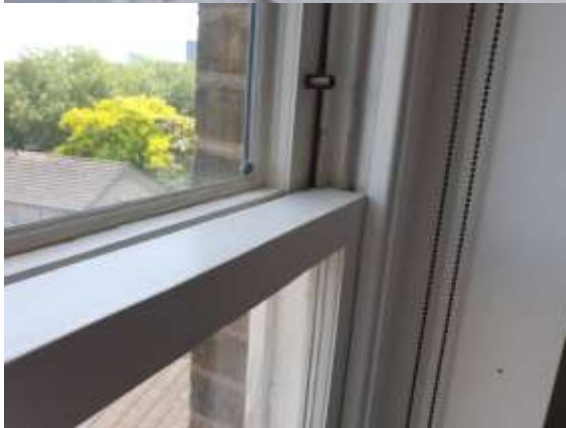
W3.04  
Back Bedroom  
Slimlite Double Glazed upper

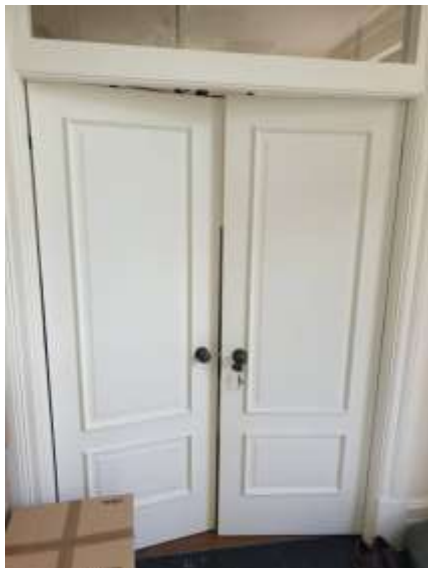
DG.08  
Modern door leaves  
Condition Good

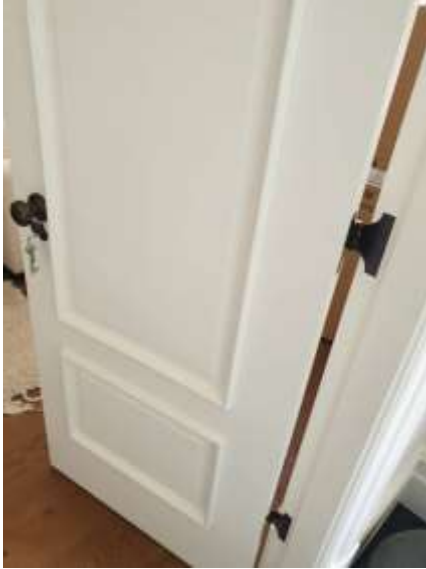
DG.08  
Modern door leaves  
Condition Good

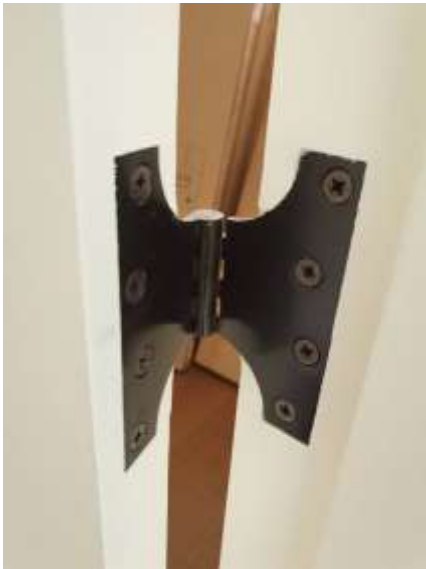
DG.08  
Modern hinges

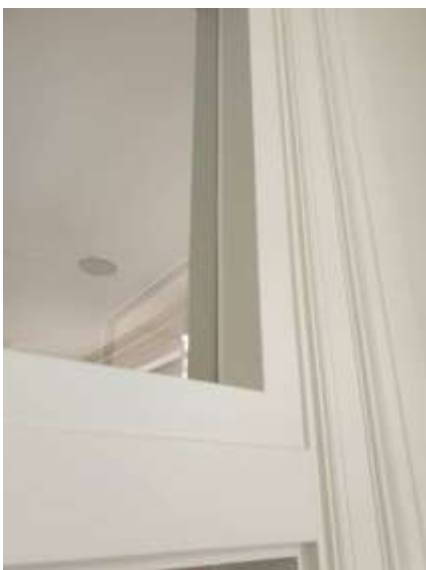
DG.08  
Glazed light over. Modern float glass.

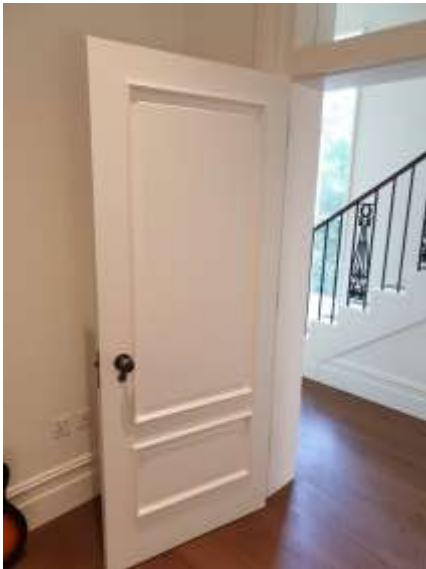
DG.10  
Modern door leaf  
Condition Good

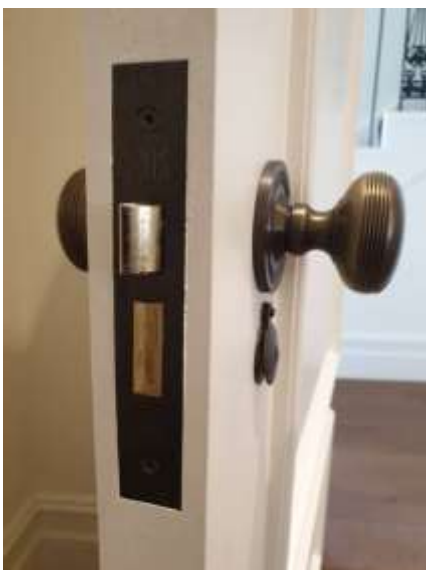
DG.10  
Modern knob and mortice latch

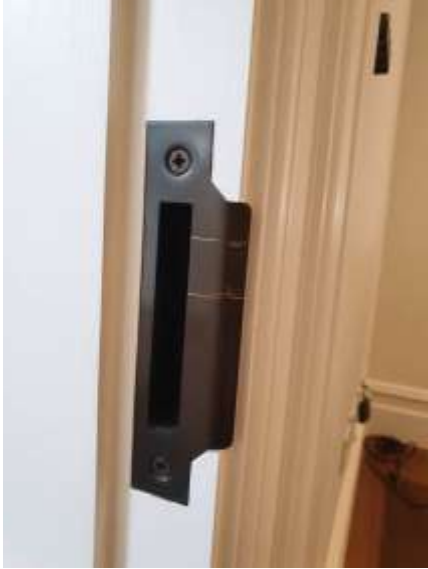
DG.10  
Modern ironmongery

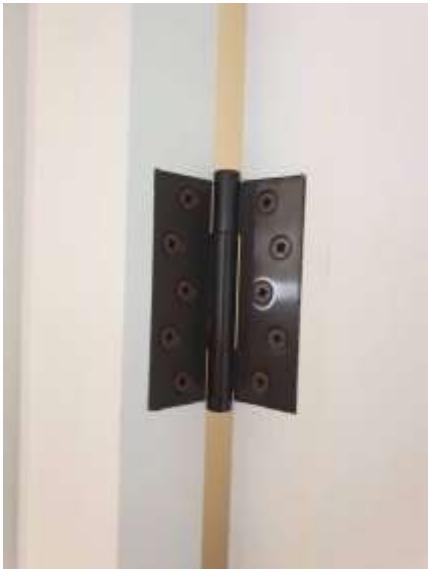
DG.10  
Modern hinges

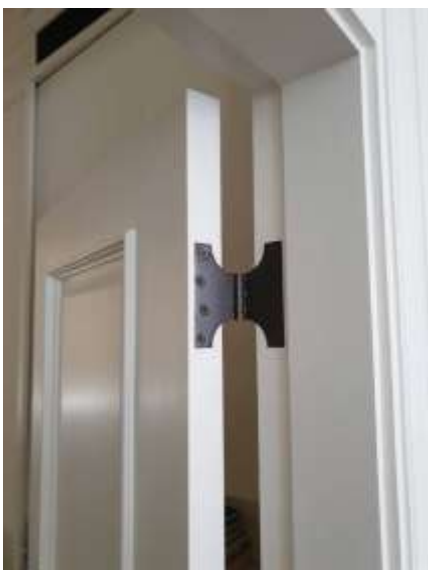
DG.09  
Modern hinges

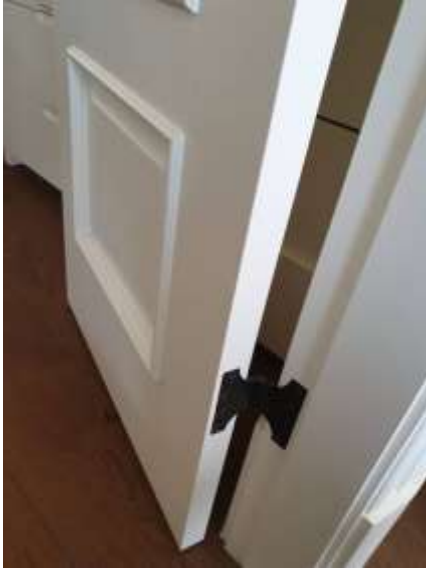
DG.09  
Modern hinges

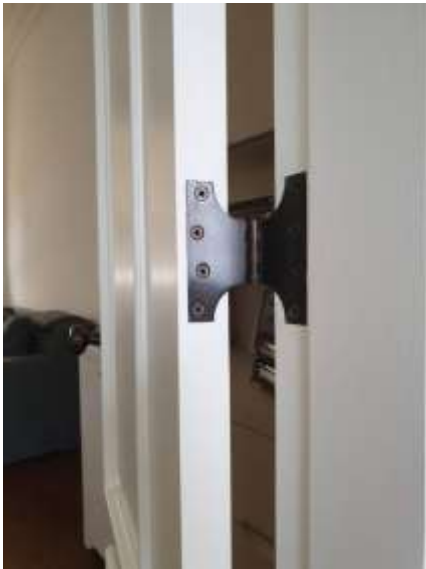
DG.09  
Modern hinges

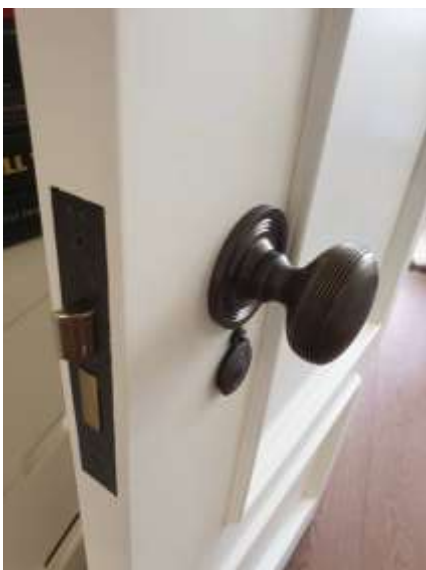
DG.09  
Modern handles/mortice latch

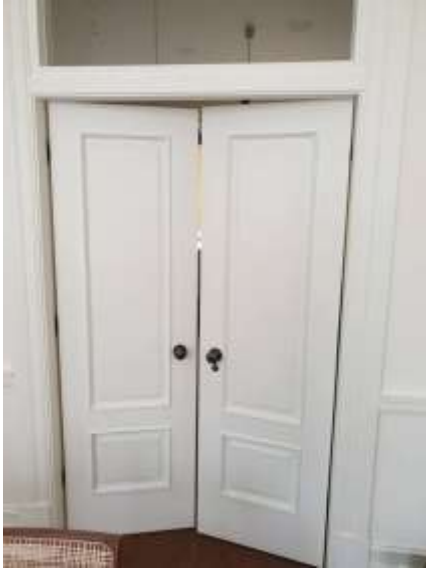
DG.09  
Modern door leaves  
Condition Good

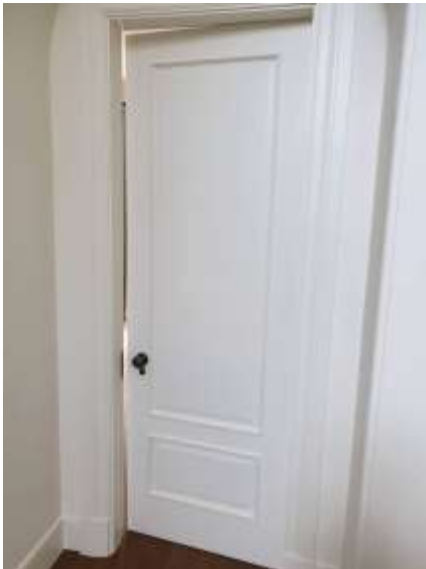
D1.04 (Master Bed)  
Modern door leaf  
Condition Good

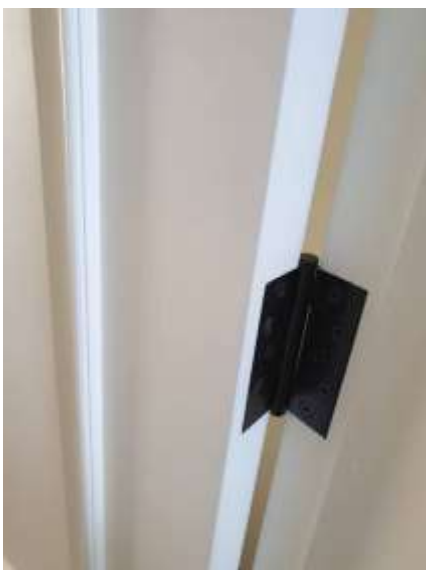
D1.04  
Modern hinges

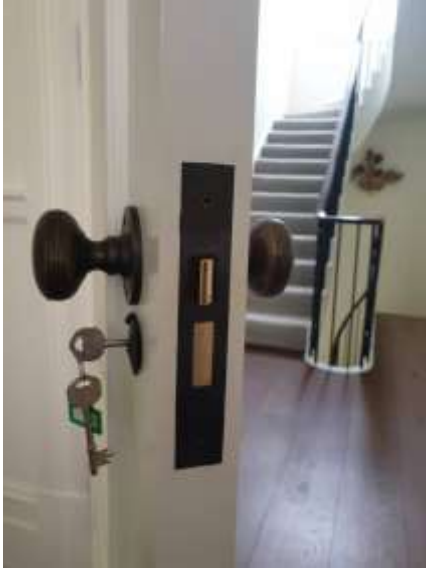
D1.04  
Modern ironmongery

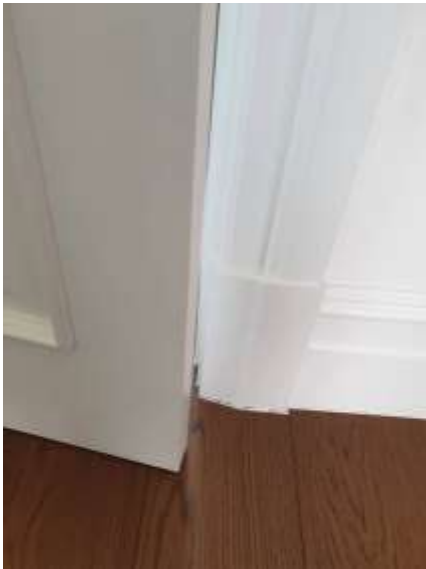
D1.04  
Skirting/architrave interface.  
Evidence of previous  
alteration/refurbishment
