82 Fitzjohn Avenue
Photographic walkthrough

External Photographs

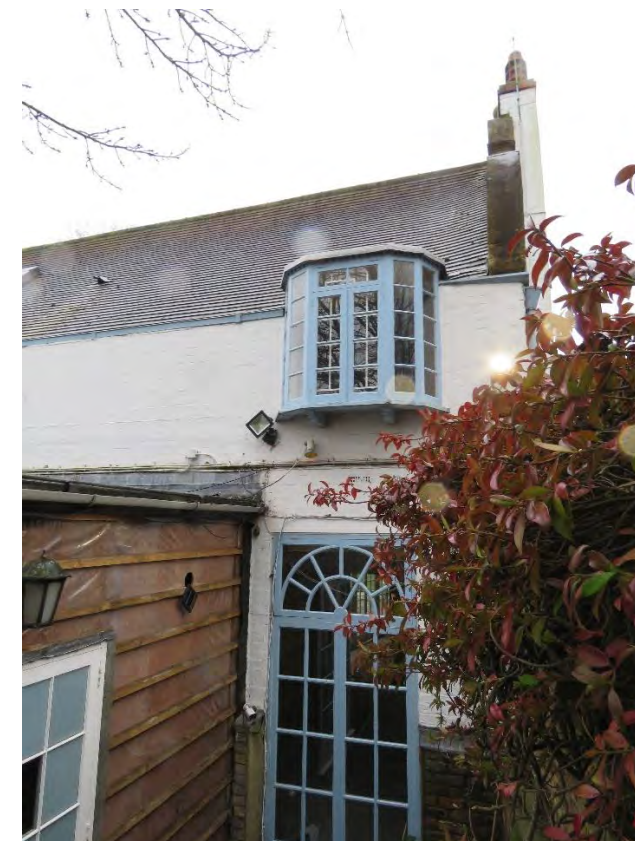
Figure 8: View of the east elevation (north end) showing part of the gable, the bay window at first floor and the large French doors at ground floor.

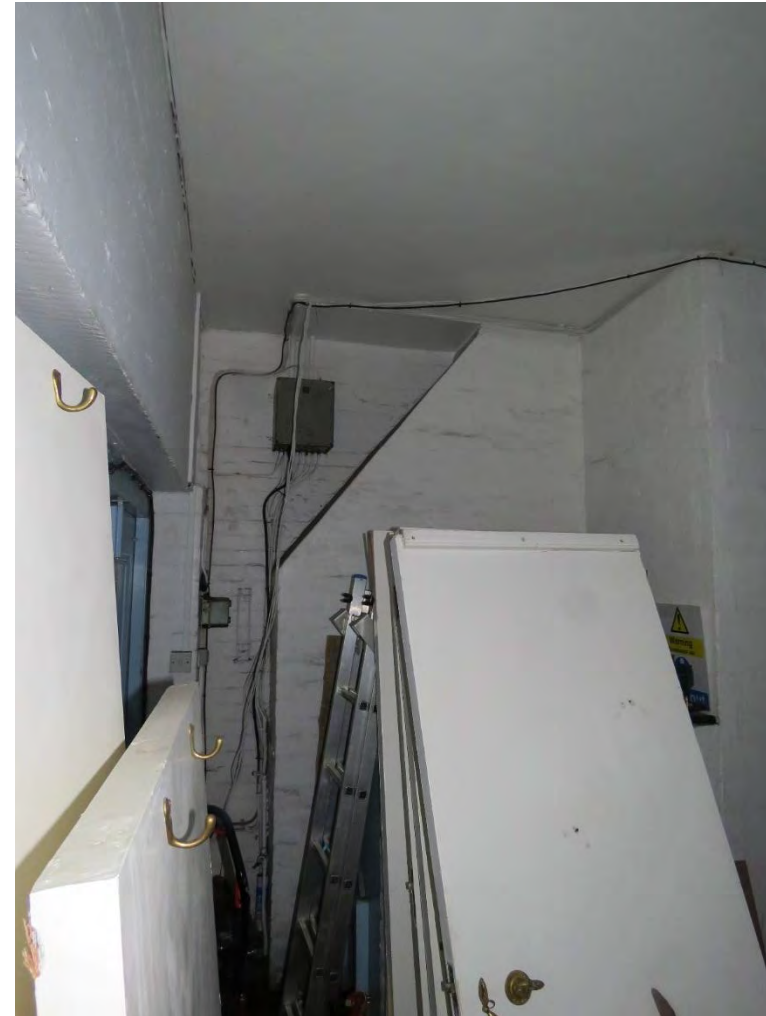
Figure 30: View of the garage looking north.

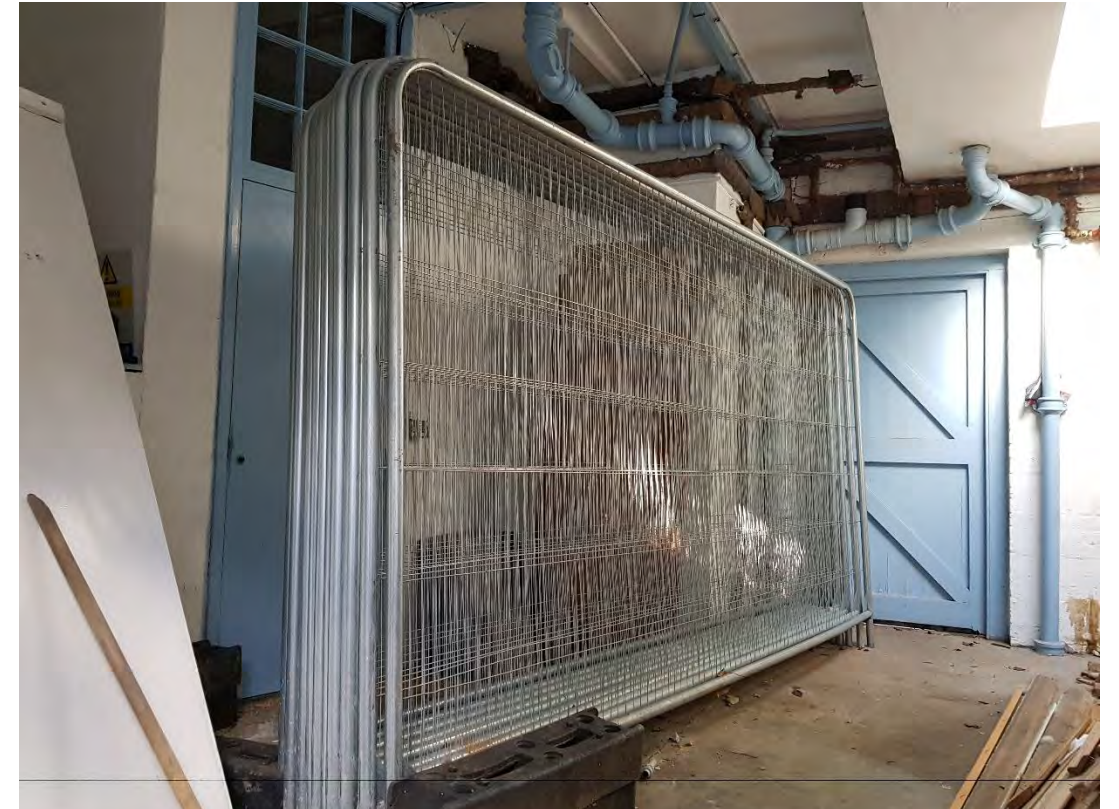
Figure 31: View of the garage looking east.

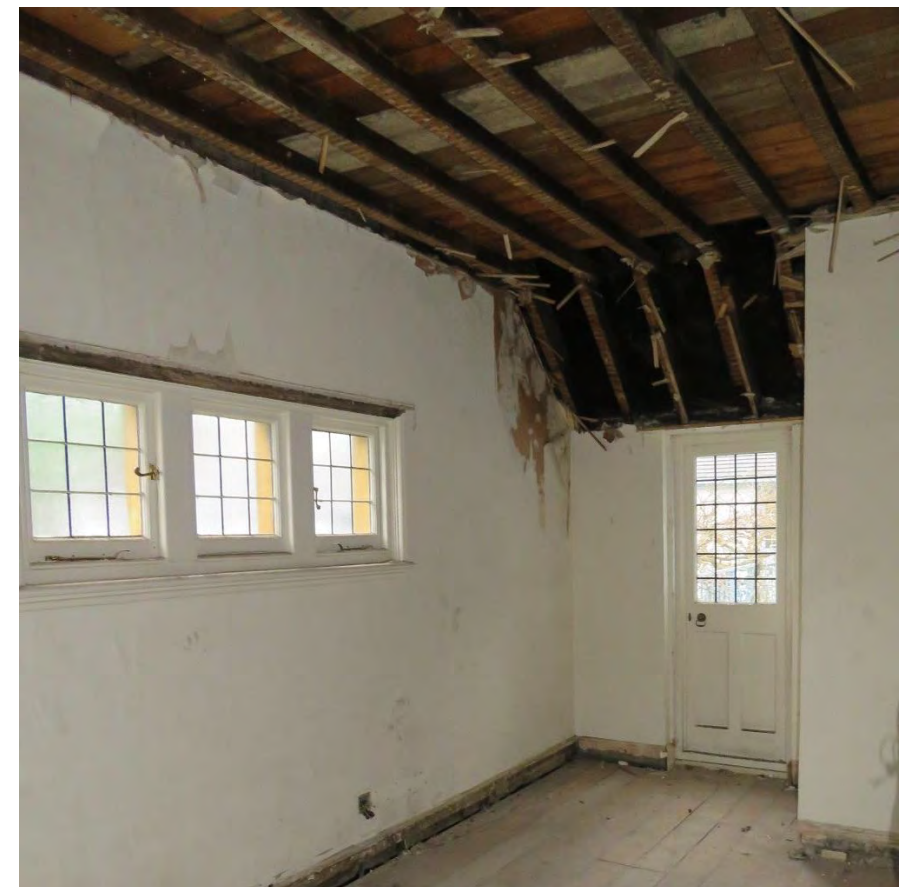
Figure 44: View looking northwest, showing the leaded windows in the gable (left) and the door leading to the balcony (right)

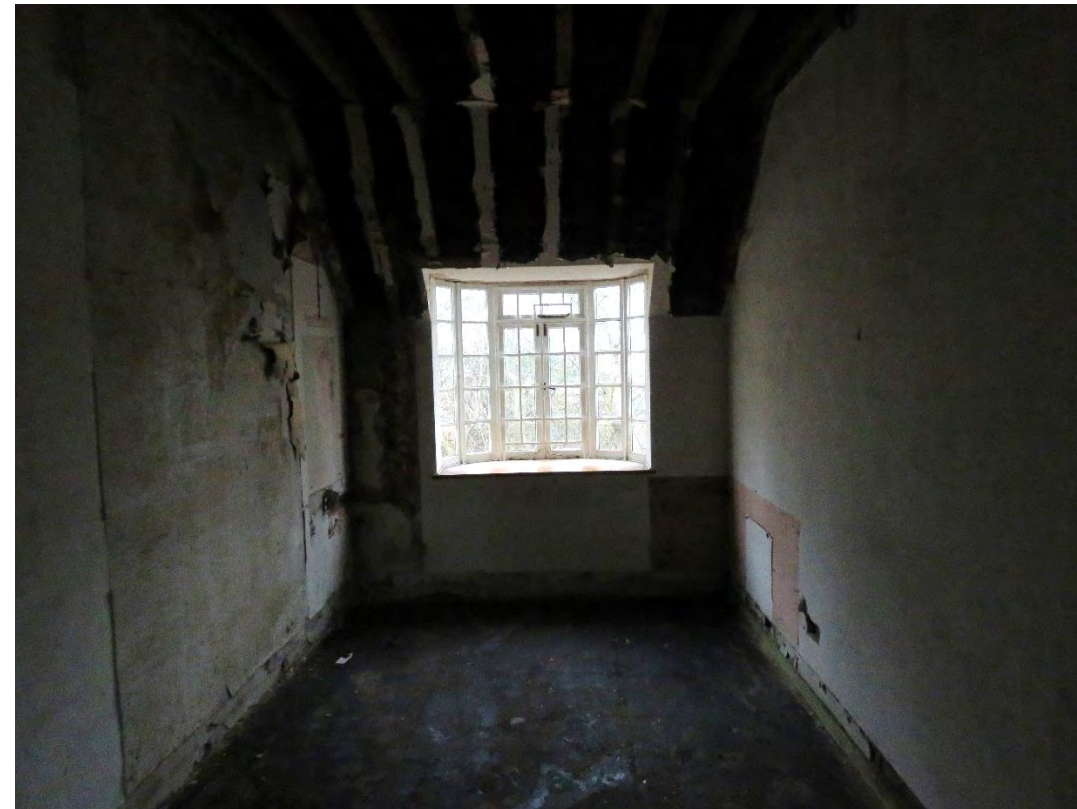
Figure 47: View looking east towards the c.1960s bay window.

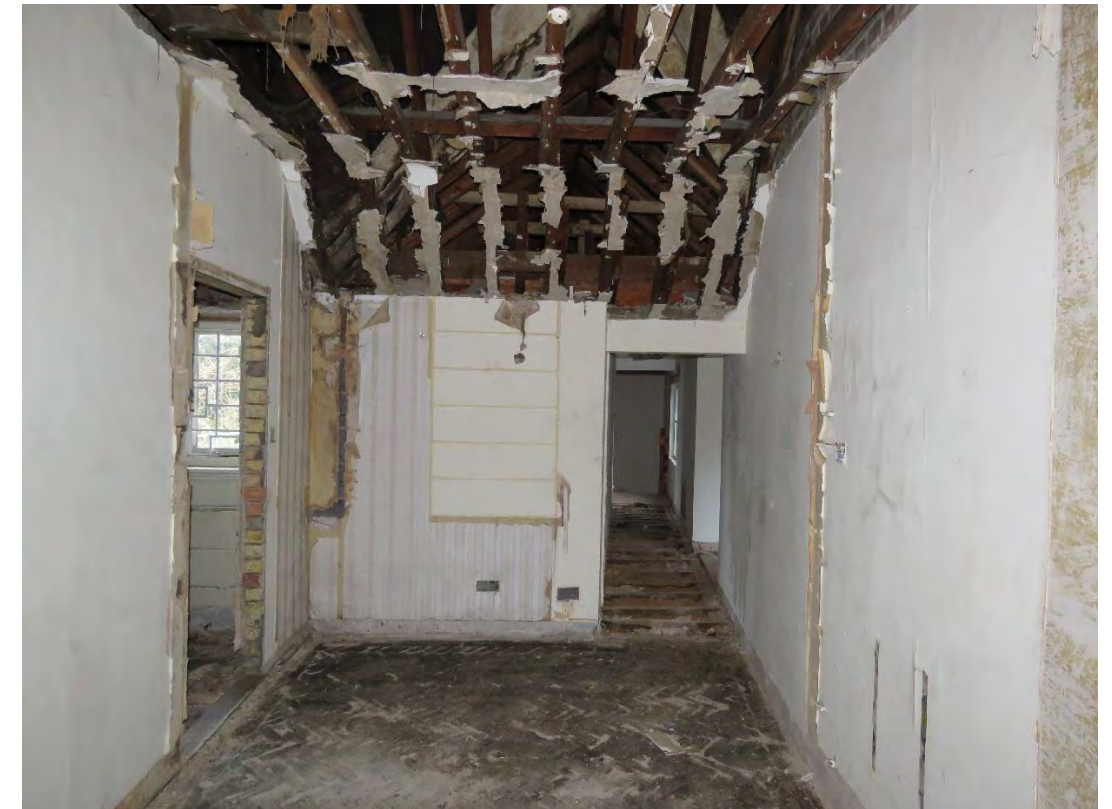
Figure 49: View looking west. The door opening to the left leads to the sitting room while the opening to the right (background) leads to the modern extension.

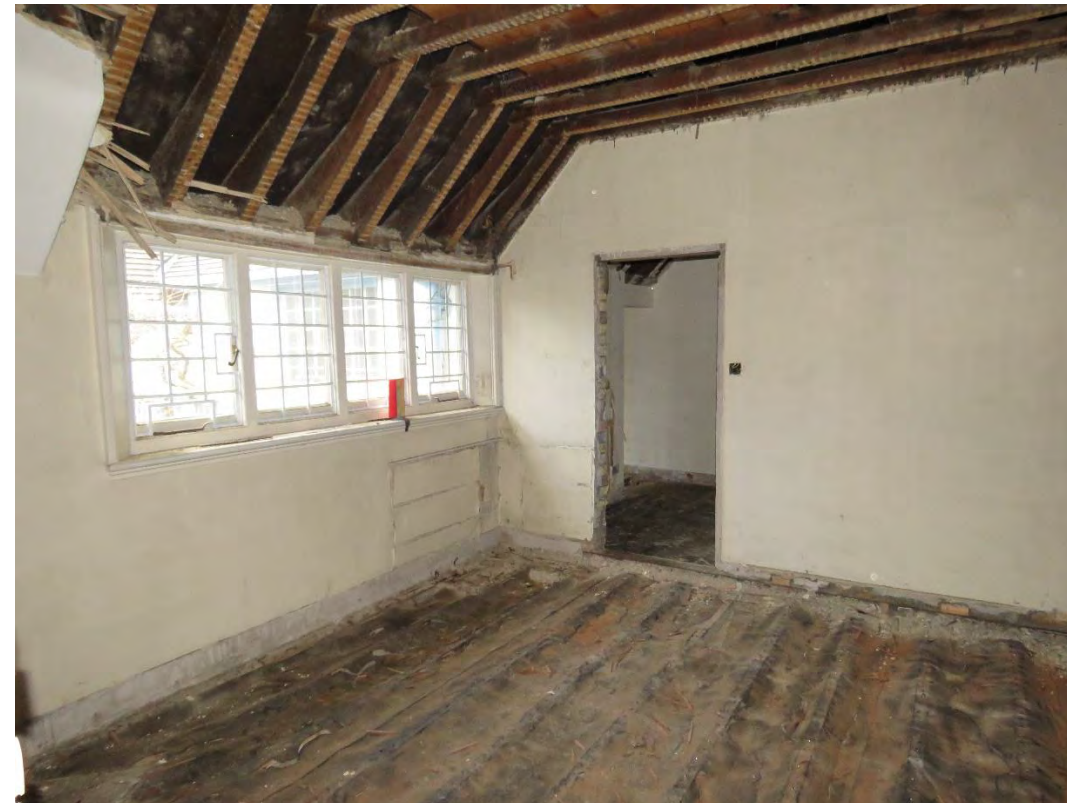
Figure 51: View of the sitting room looking northeast. The doorway leads to Bedroom 3. The leaded windows are seen on the front (west) elevation. The chimney breast (partly seen in this view) is to the far left of this image.

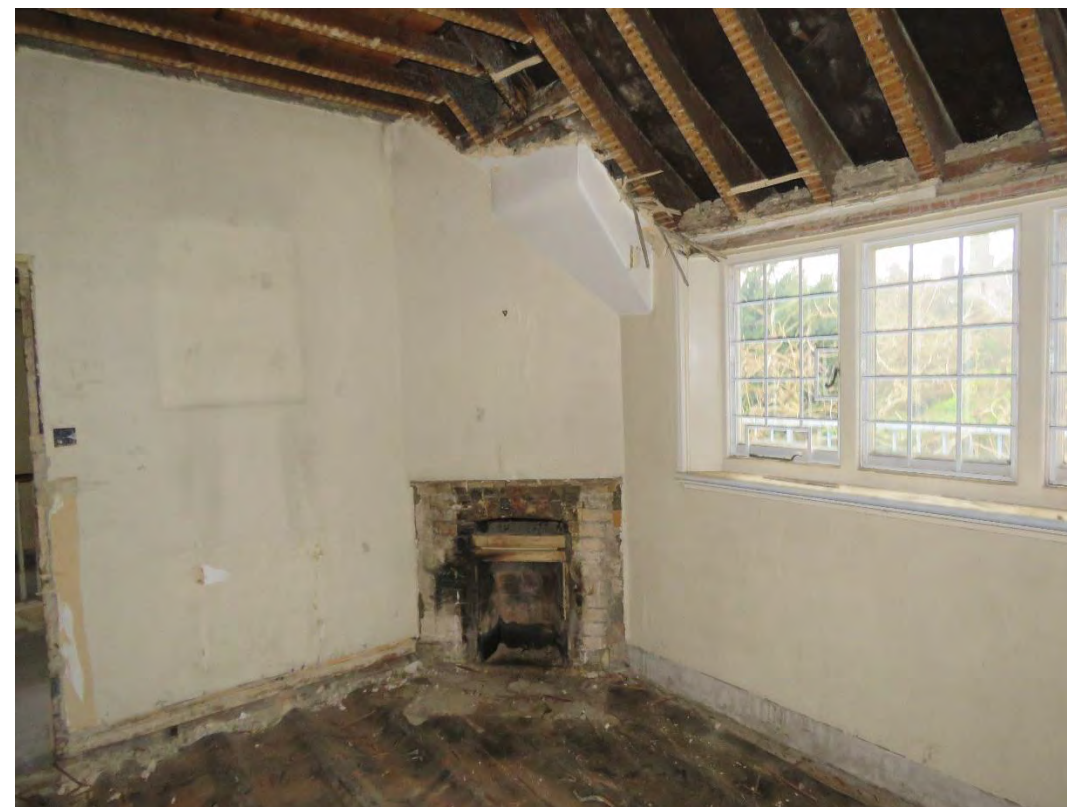
Figure 52: View looking southwest with the corner chimney breast seen to the front. The leaded windows are seen to the right. The doorway (partly seen to the left) leads to the stair landing.

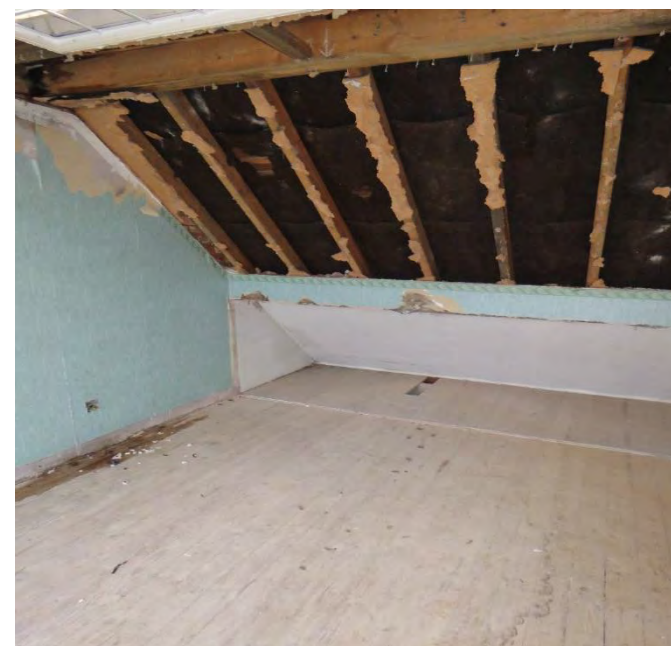
Figure 57: View towards the west showing the timber rafters and small eaves storage area.

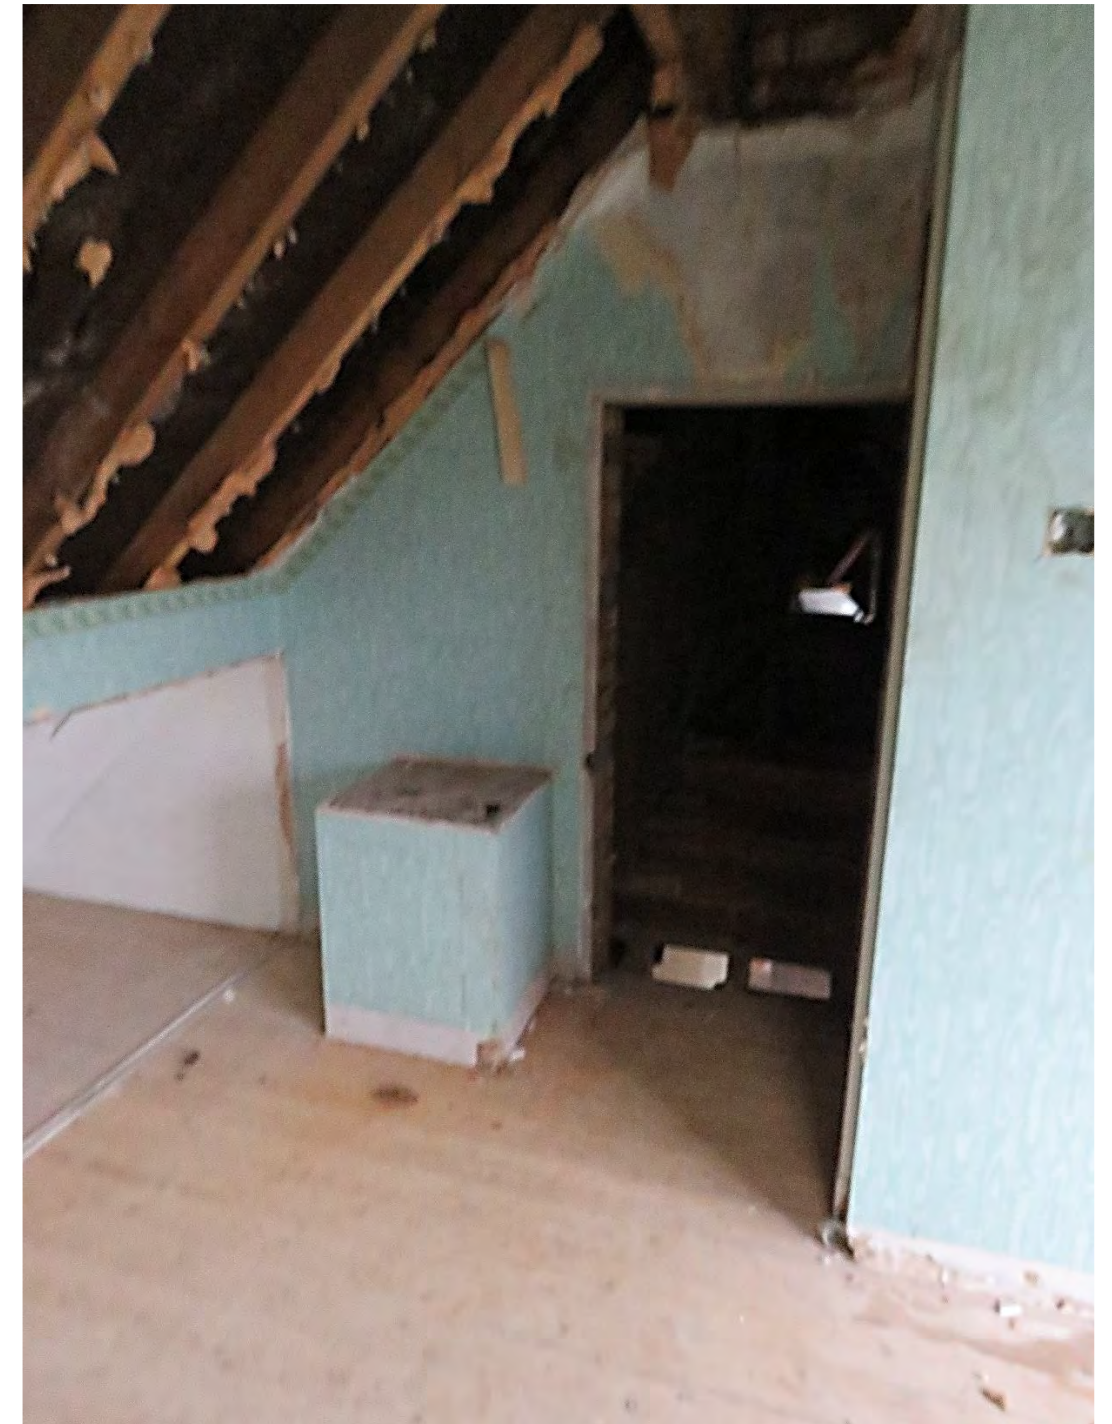
Figure 58: View of the doorway leading to the stairs. The eaves storage is seen to the left.

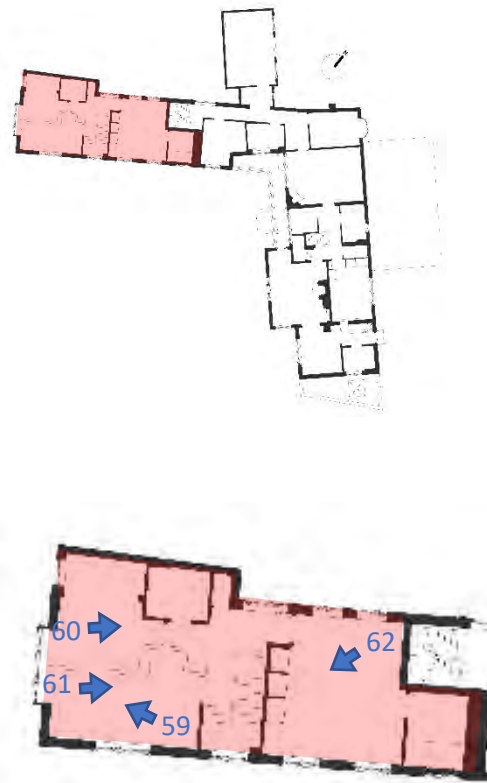
Figure 59: View of one of the rooms in the 1955-65 extension. Note the timber casement windows, modern studwork walls and cheap pine floorboards

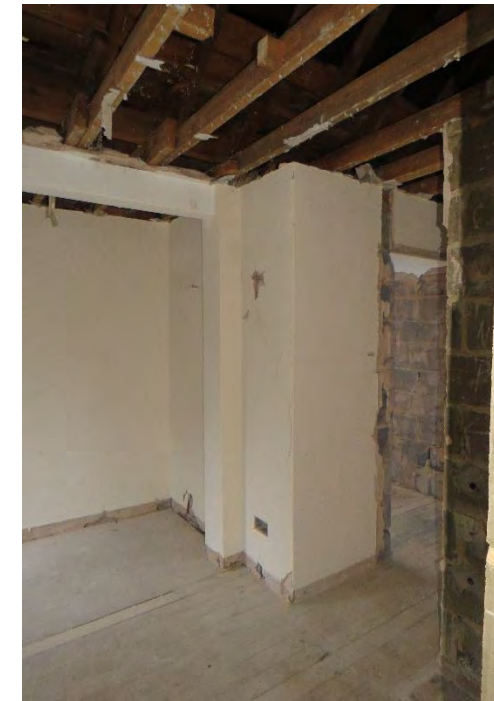
Figure 61: View of one of the rooms in the 1955-65 extension; all modern partitions.

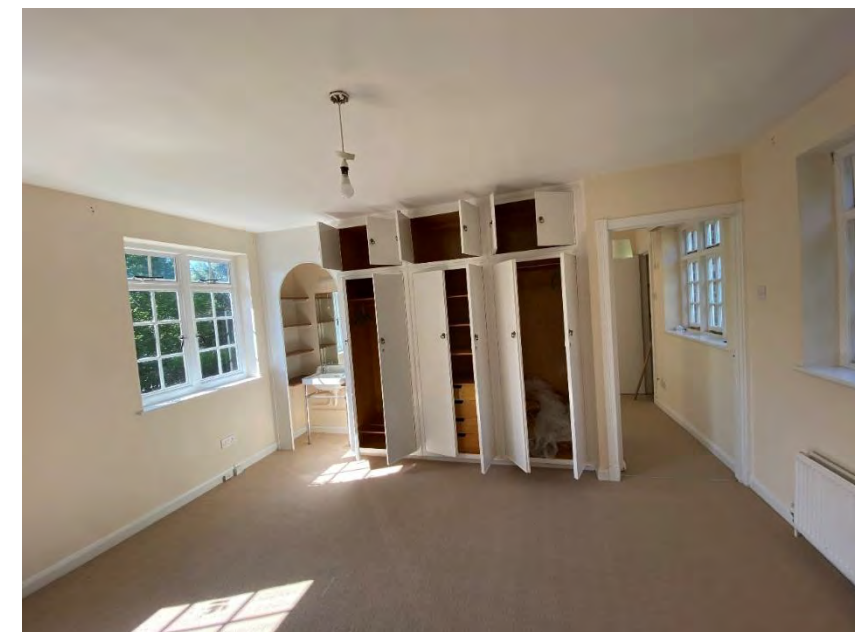
Figure 62: View of one of the rooms in the 1955-65 extension pre strip-out.

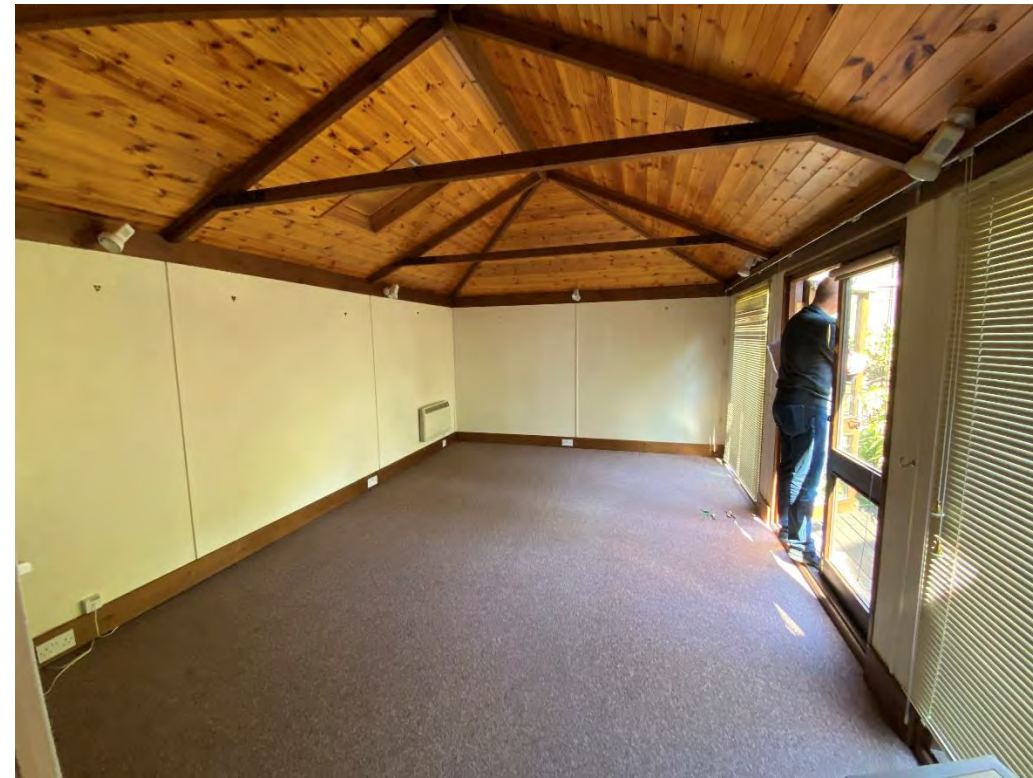
Figure 63: View of one of the modern pool house extension.

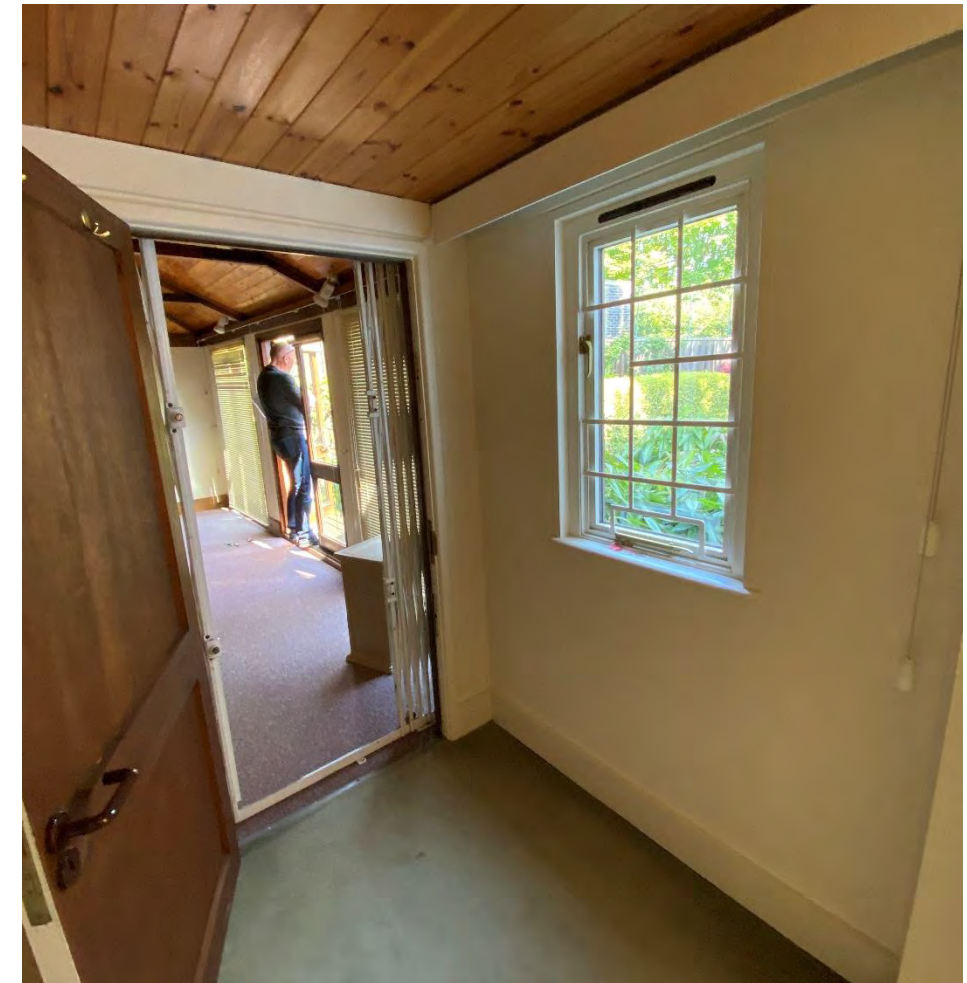
Figure 65: View of one of the modern pool house extension.

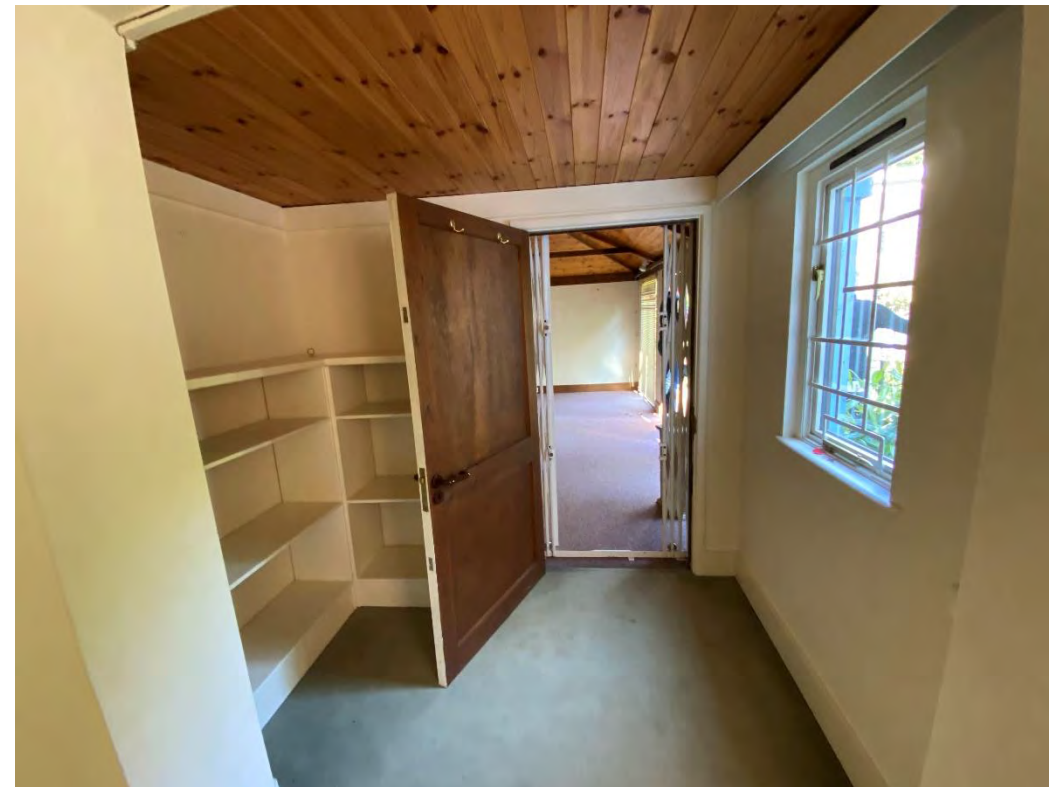
Figure 64: View of one of the lobby prior to the modern pool house extension.

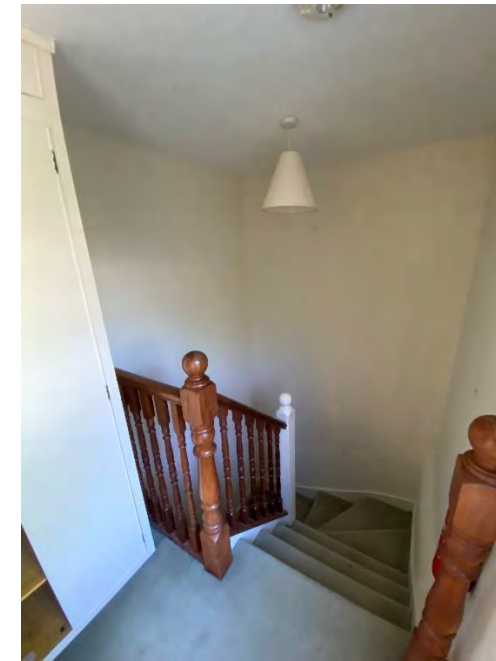
Figure 67: View of one of the rooms in the 1955-65 extension; modern staircase (pre-strip out)

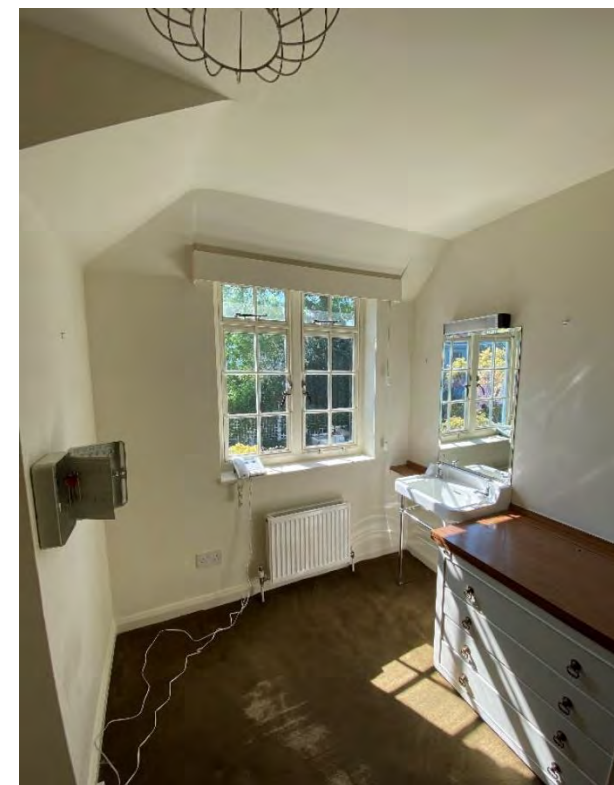
Figure 69: View of one of the rooms in the 1955-65 extension (pre-strip out).

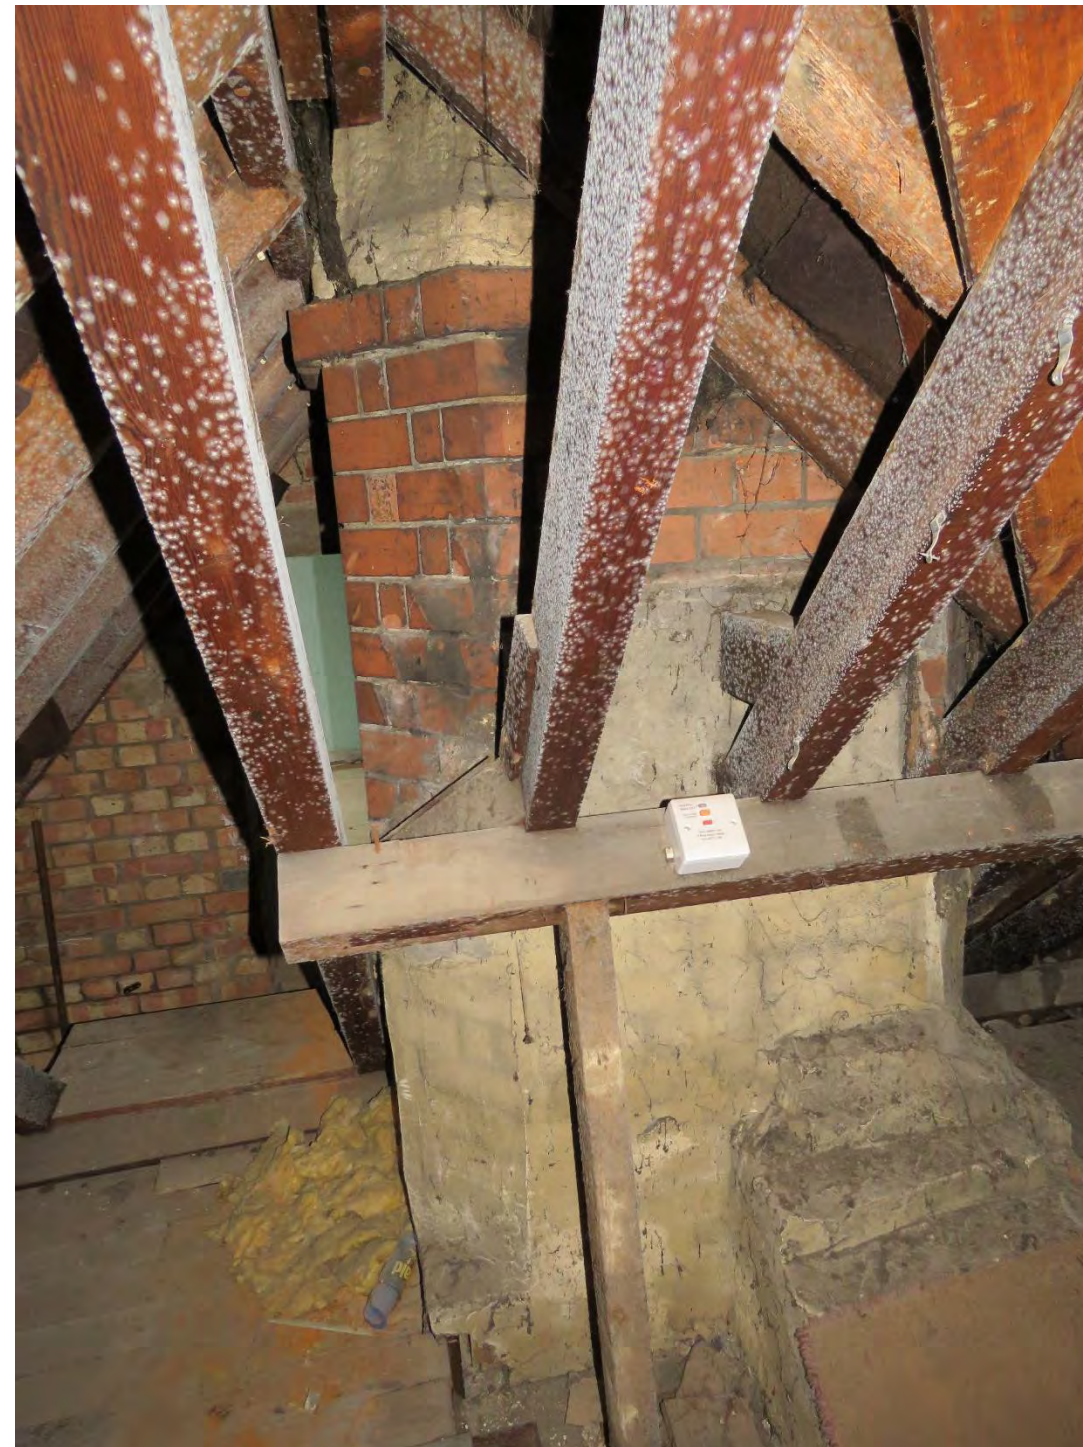
Figure 70: View of one of the existing and original 1915 chimney within main building.

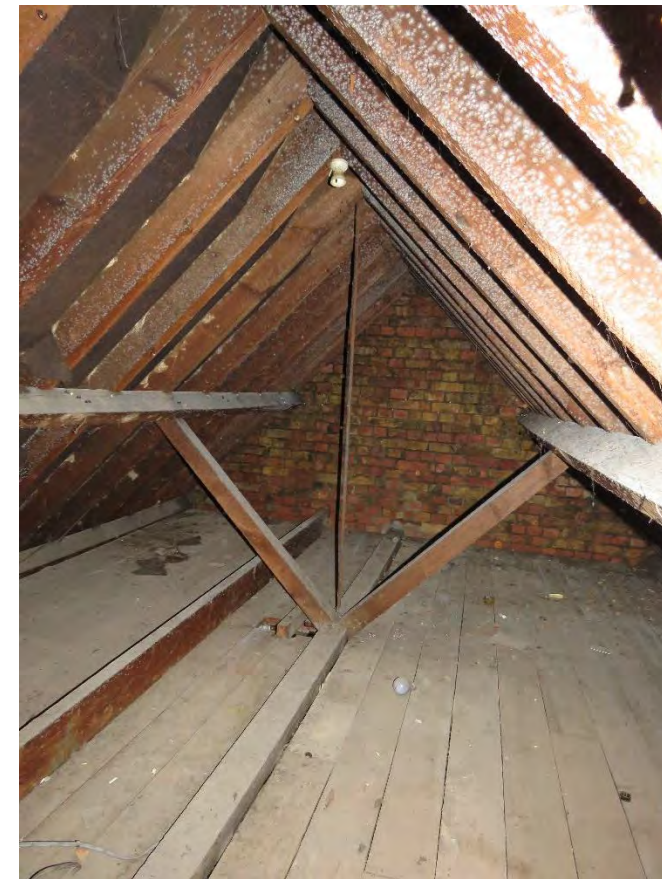
Figure 71: View of the cut roof construction towards the west (front) elevation.

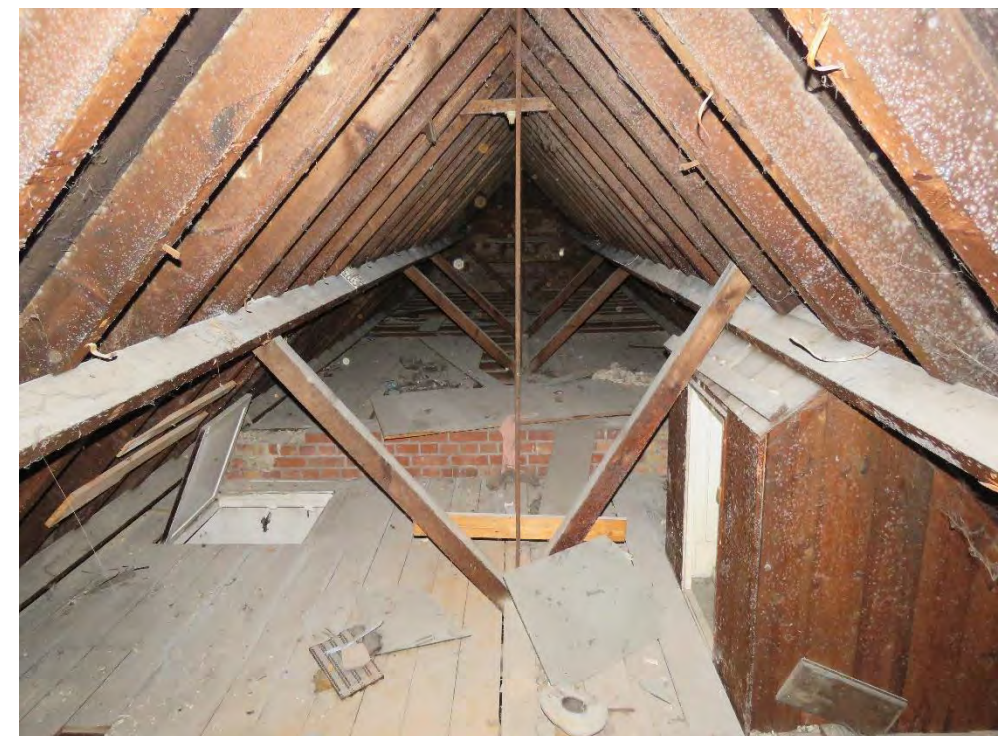
Figure 72: View of the cut roof construction through the main building and towards the north elevation.
