## Dartmouth Park Hill Service Tunnel Report

C&I New In-Patient Facility

Camden and Islington NHS Foundation Trust

## INVESTIGATIVE WORKS TO INSPECTION CHAMBER AND TUNNELS AT DARTMOUTH PARK HILL MENTAL HEALTH UNIT TO PEDESTRIAN RAMP PLUS PEDESTRIAN RAMP TO FORMER GENERATOR FUEL TANK REPORT No. WI/WH/0016

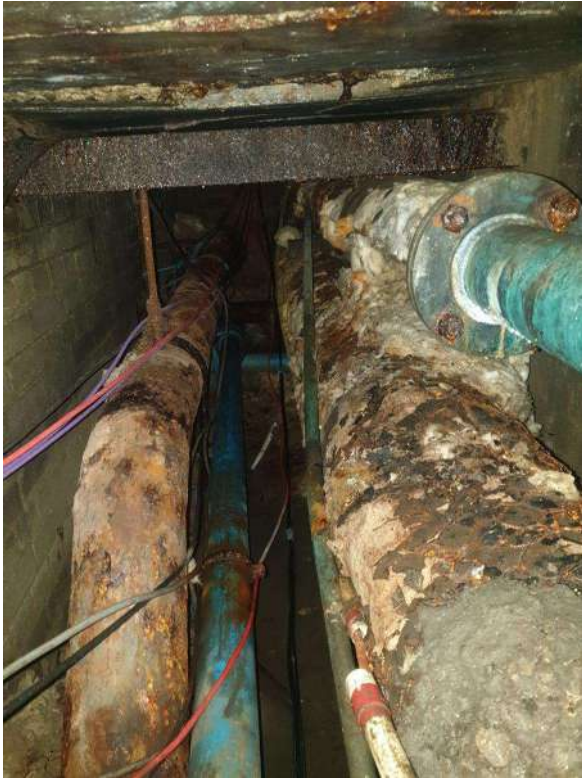
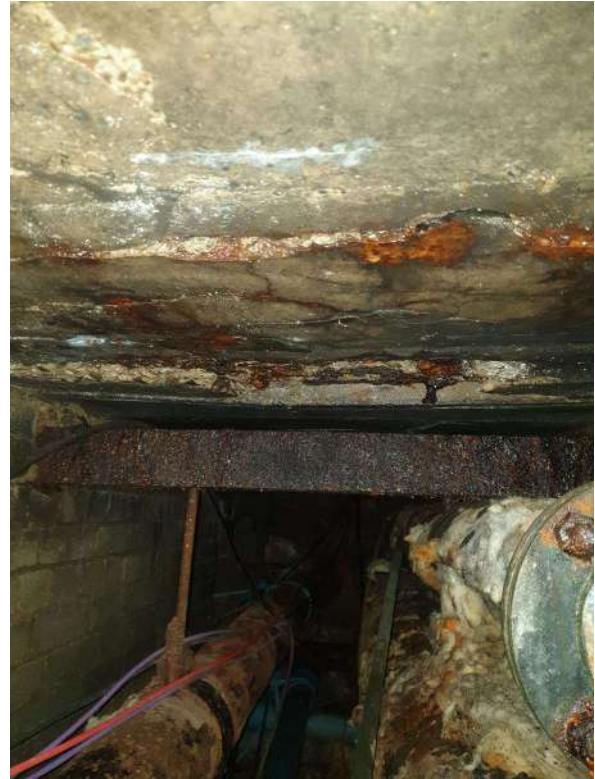
**MH2 LOOKING TOWARDS MH1 – CORROSION BEGINS 2 METRES IN FROM MH2 TOWARD MH1**

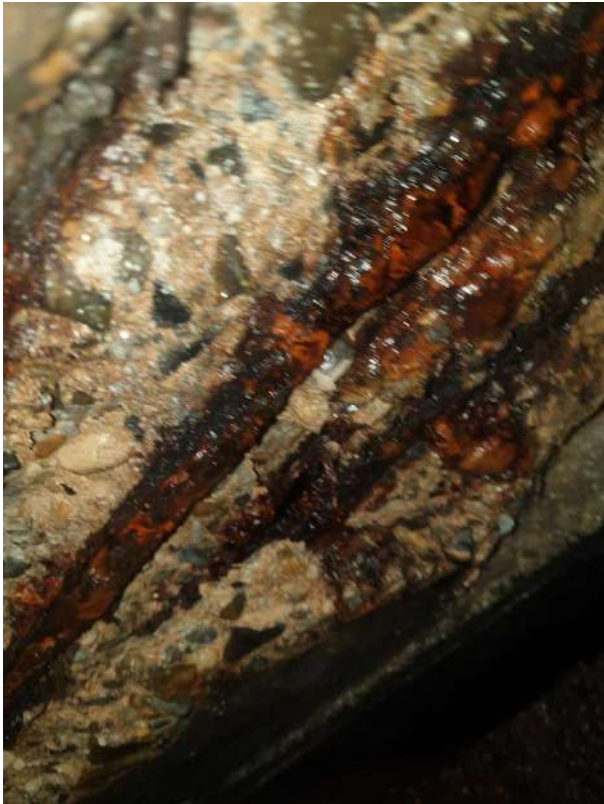
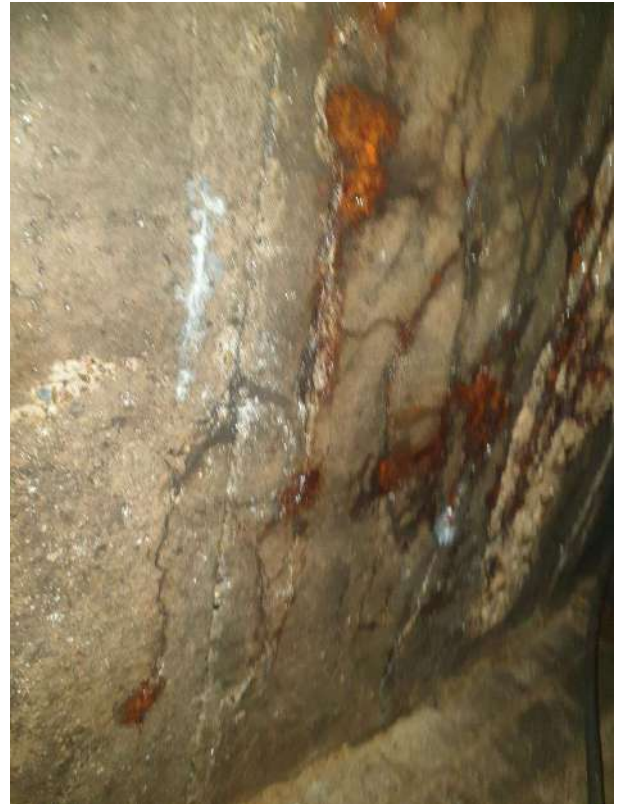
**MH2 LOOKING TOWARDS MH1 – CORROSION BEGINS 2 METRES IN FROM MH2 TOWARD MH1**

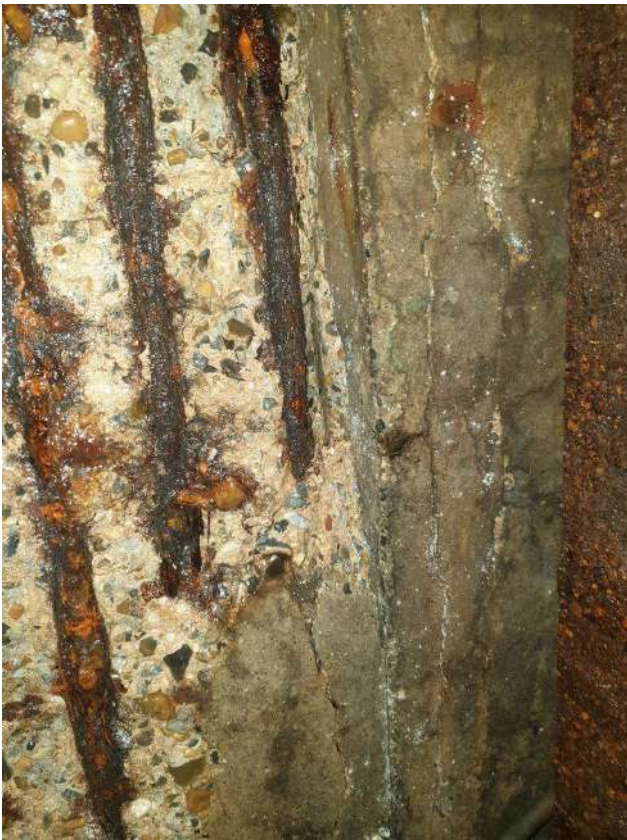
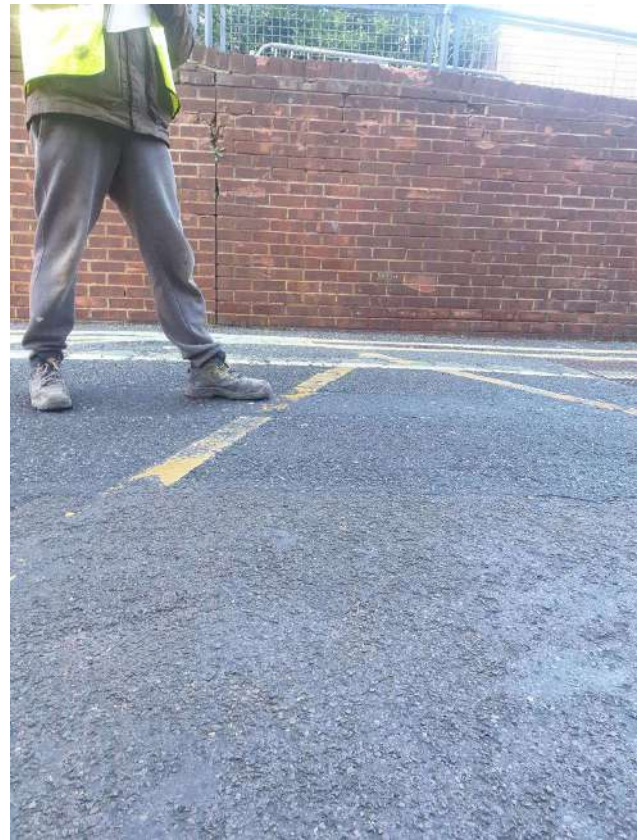
MH1 TOWARDS MH2 – APPROXIMATE LOCATION ON ROADWAY SURFACE OF CORROSION

- **Medium Term (Applicable to Perimeter Roadway Tunnel)**
  - Replace corroded lintels in sections in 5 no. areas within 12 months as this roadway is the main exit from the Hospital.

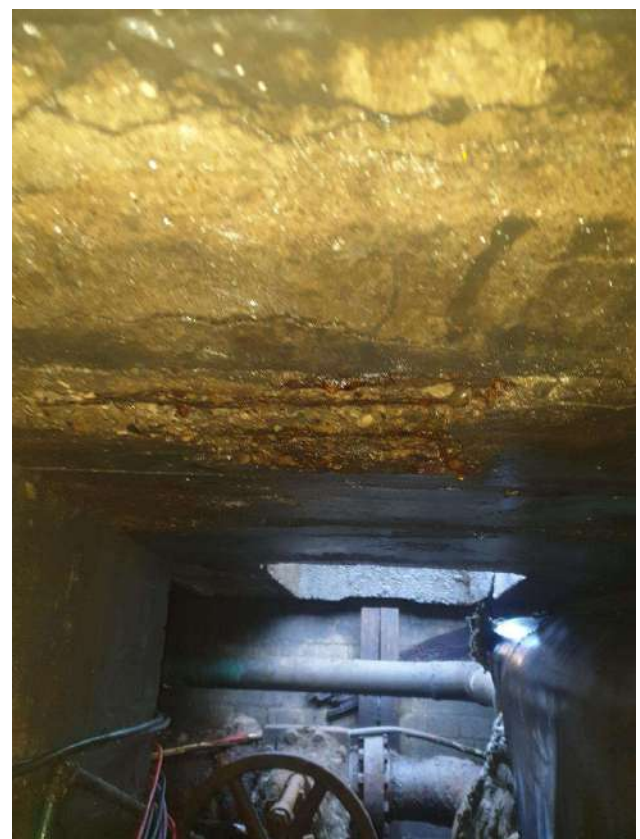
CORROSION BEGINS 2 METRES FROM MH2  
TOWARD MH3

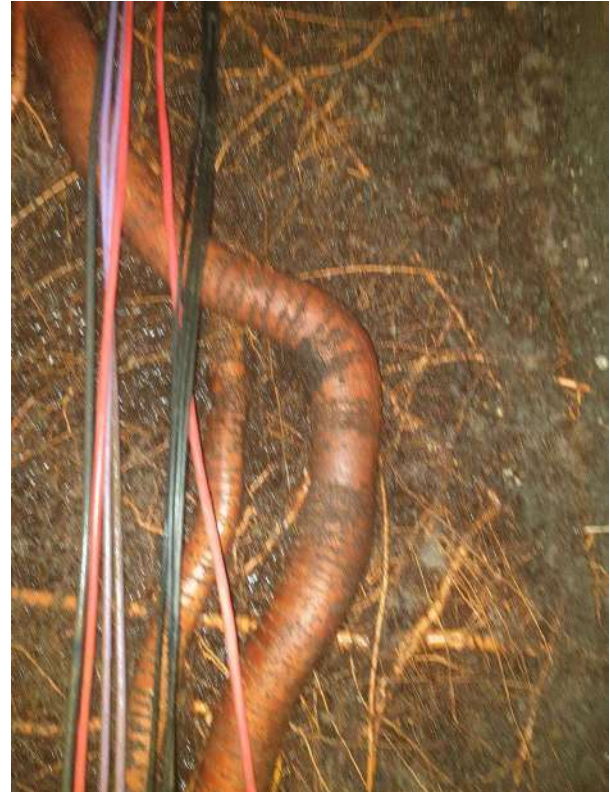
**MH6 TOWARDS MH5 – ENTIRE LENGTH OF  
RUN**
